Inspection Photos

Operator: Crowheart Energy LLC - #10776

Location Name: Bakers Peak Unit-611N91W /12SWSE

Inspection Document #: 702800610

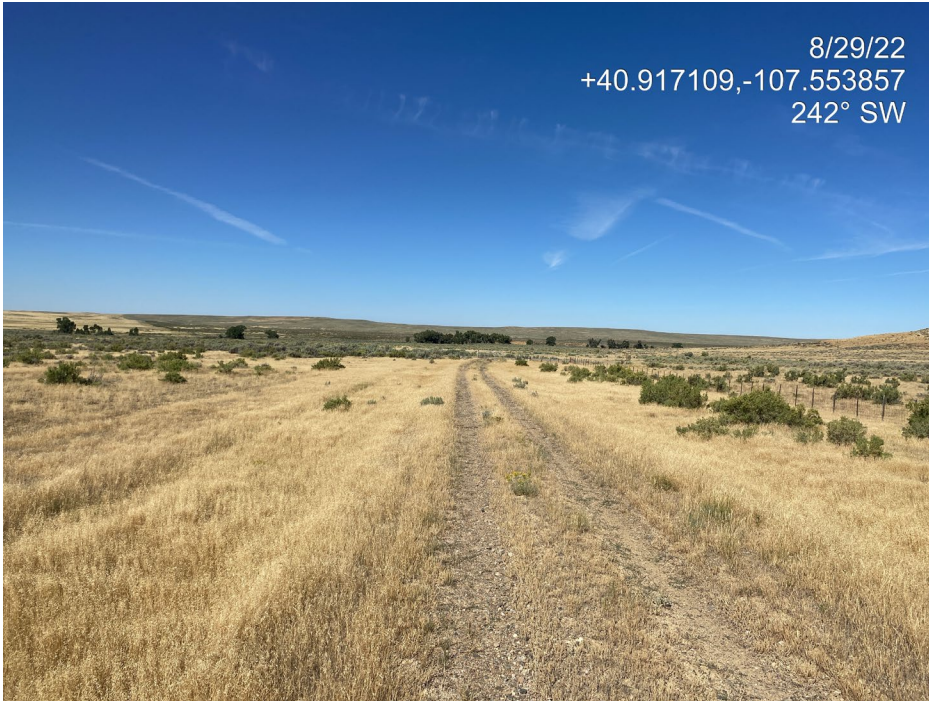
Photo 1. Photo taken from the northwest of the Location shows the access road. The road has not been reclaimed.

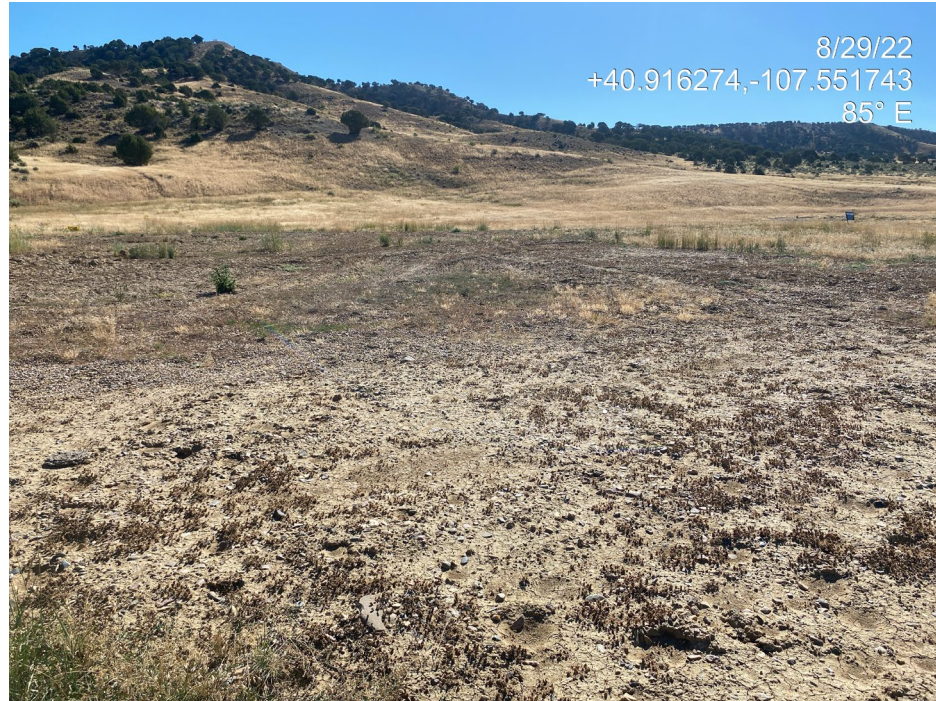
Photo 2. Photo taken from the north shows an overview of the Location. The Location has not been reclaimed.

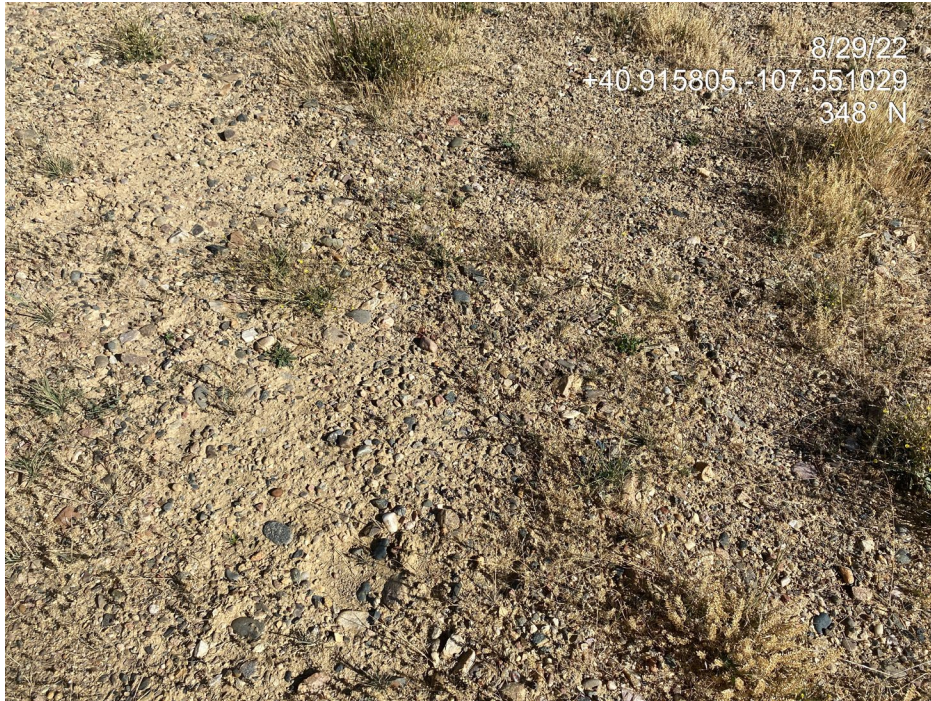
Photo 3. Photo taken from the south of the Location shows the pad has not been reclaimed. The pad surface is flat, compacted and graveled.

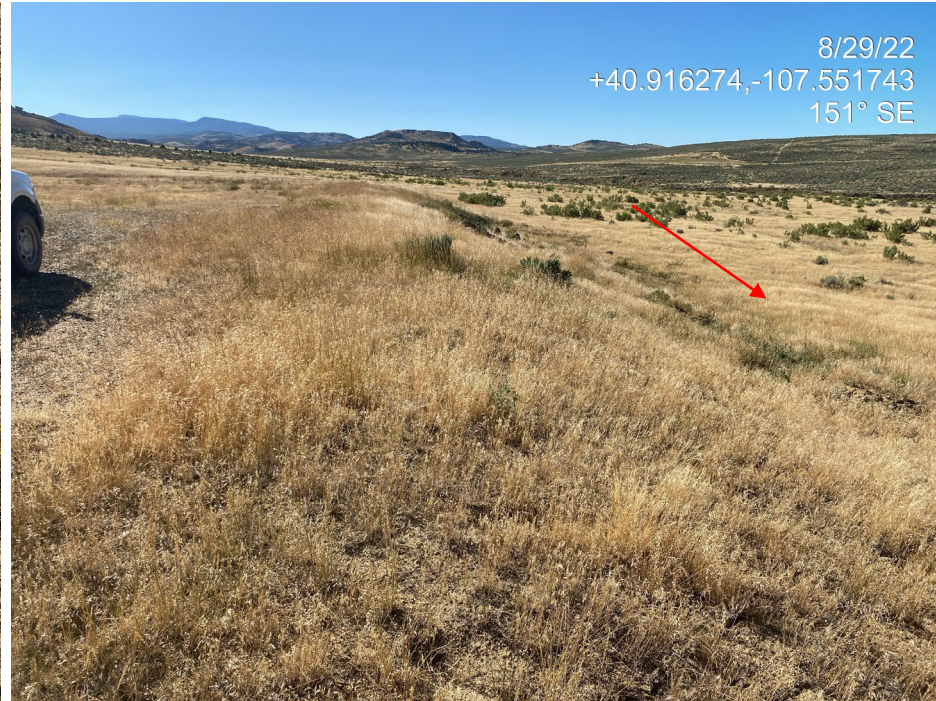
Photo 4. Photo taken from the west shows the fill slope remains. The Location has not been recontoured/regraded to match the surrounding landscape. Also note areas adjacent to the working pad/areas previously disturbed during pad construction have not been properly reclaimed and are a monoculture of cheatgrass.

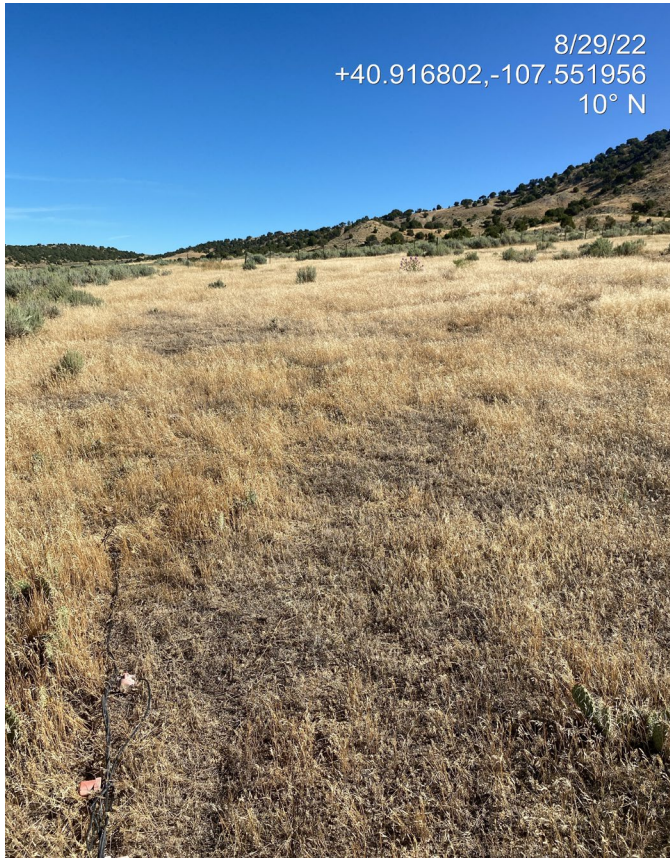
Photo 5. Photo taken from the north of the Location shows areas adjacent to the working pad/areas previously disturbed during pad construction have not been properly reclaimed and are a monoculture of cheatgrass.

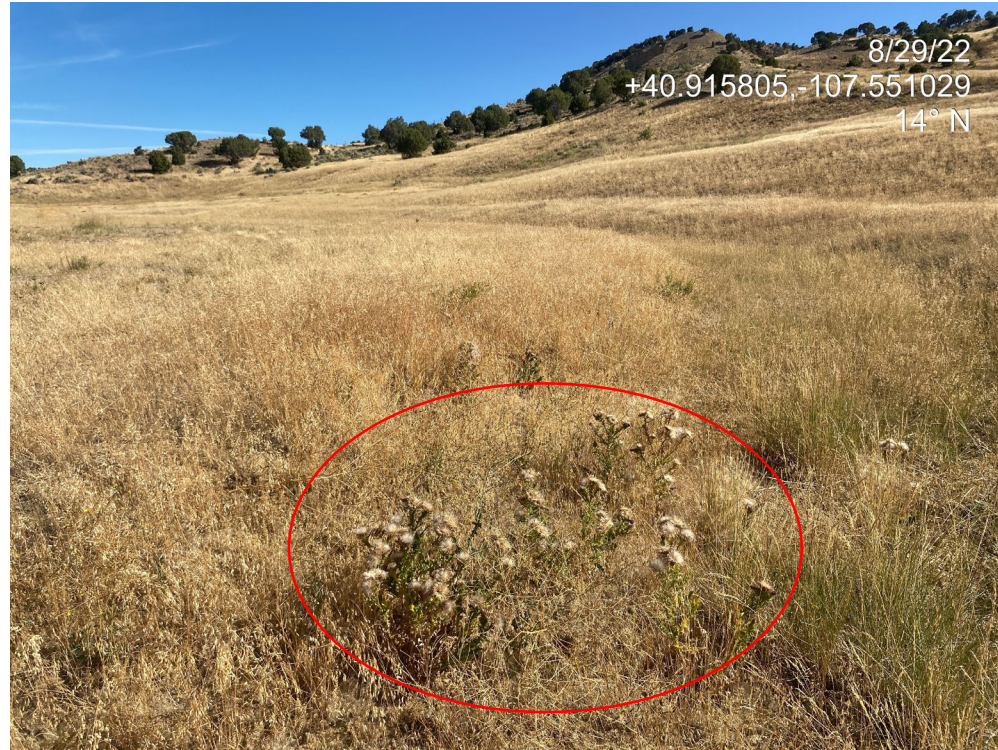
Photo 6. Photo taken from the southern edge of the working pad area. Photo shows the Location has not been recontoured; the flat pad and cut slopes are evident. Photo also shows bull thistle, a List B Noxious Weed (red circle) and a monoculture of cheatgrass, on the working pad and cut slopes.

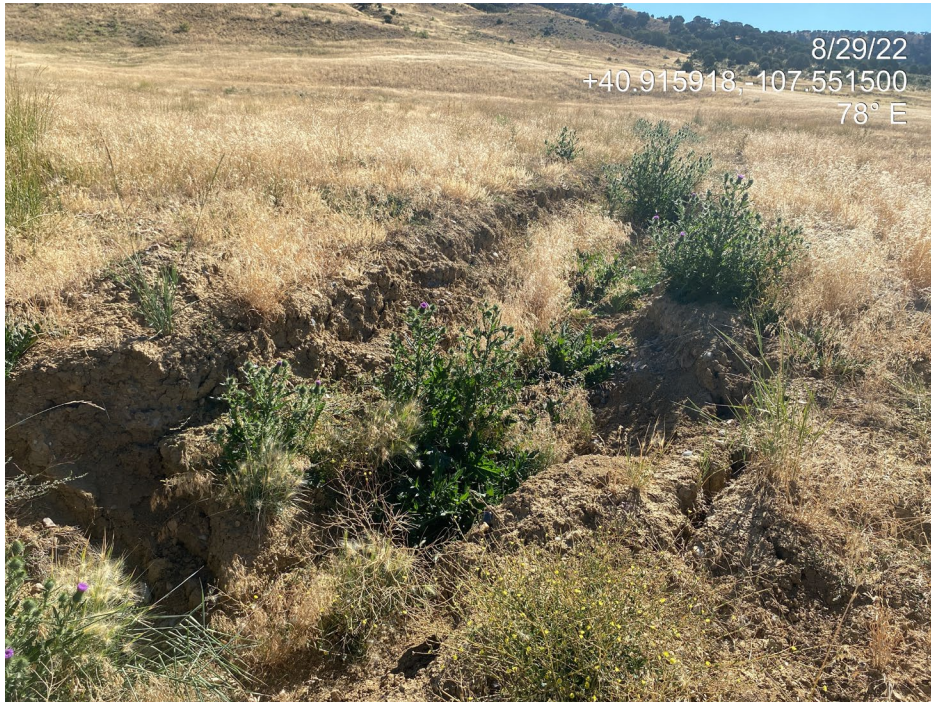
Photo 7. Photo taken from the southwest of the working pad shows gully erosion with an active headcut and unstable sides. Photo also shows multiple bull thistle plants (dark green vegetation) and a monoculture of cheatgrass (tan vegetation).

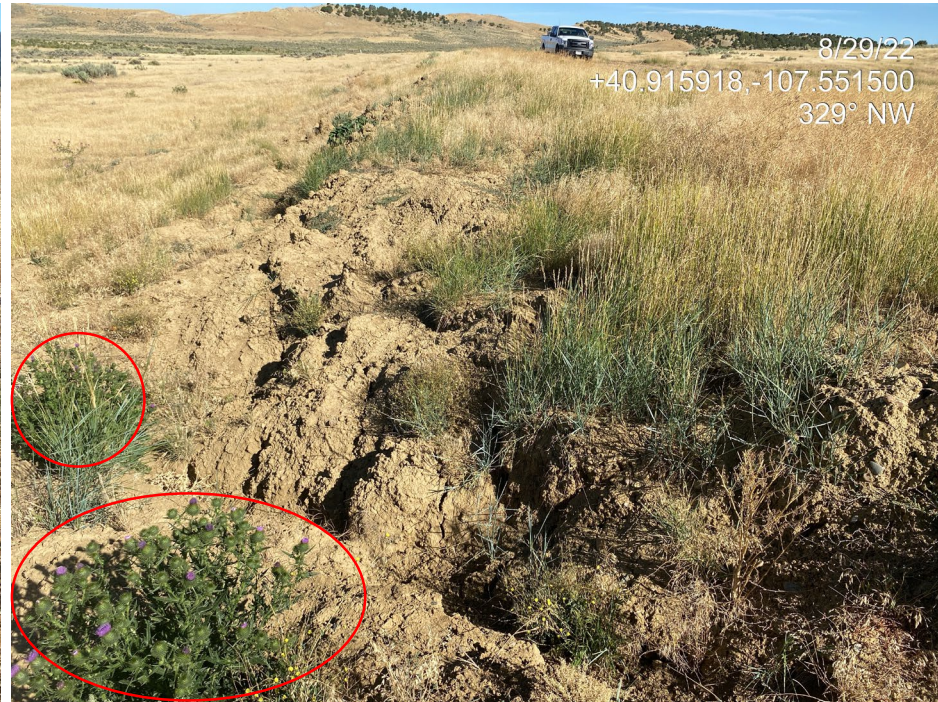
Photo 8. Photo taken from the southwest of the working pad shows gully erosion. Photo also shows multiple bull thistle plants (red circles).
