WELLHEAD ABANDONMENT FORM

SITE NAME: West Farms 2-14 A							DATE: 9/8/2021	REM. PROJECT #:	WEATHER:	
SITE DIRECTIONS: CR 23 and 23.5, west 0.2 and north 0.2 into							CLIENT: Oxy			
LEGALS AND LAT/LONG: 40.2279486, -104.8547085							TASMAN PERSONNEL: Brandon LeVasseur			
SOIL TYPES: Well Graded Sand - SW							SURFACE GRADIENT: North			
SOIL SAMPLING							FACILITY INFRASTRUCTURE			
Date/Time	Soil Sample ID	PID (ppm)	Visual	Olfactory	Photo?	Grab or Lab Sample?	EQUIPMENT		Quantity	
							Above Ground Storage Tank (AST)			
9/8/2021 12:43	WH-B01 @4'	31.8	No Staining	No Odor	Yes	Lab	Buried or Partially Buried Vessel			
9/8/2021 12:44	WH-N01 @2'	38.9	Organic Content	Slight Organic Odor	Yes	On-Hold	Separator			
9/8/2021 12:45	WH-S01 @2'	28.7	No Staining	No Odor	Yes	On-Hold	Emission Control Device (ECD)			
9/8/2021 12:46	WH-E01 @2'	30.9	No Staining	No Odor	Yes	On-Hold	Dump Line			
9/8/2021 12:47	WH-W01 @2'	46.9	Organic Content	Slight Organic Odor	Yes	Lab	Wellhead

FLOWLINE ABANDONMENT FORM

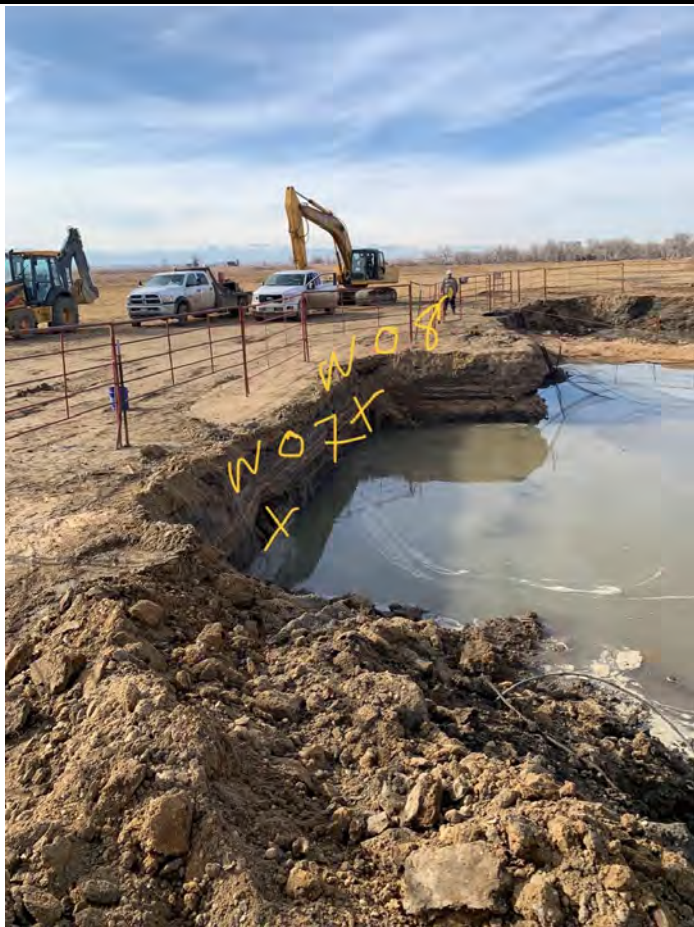
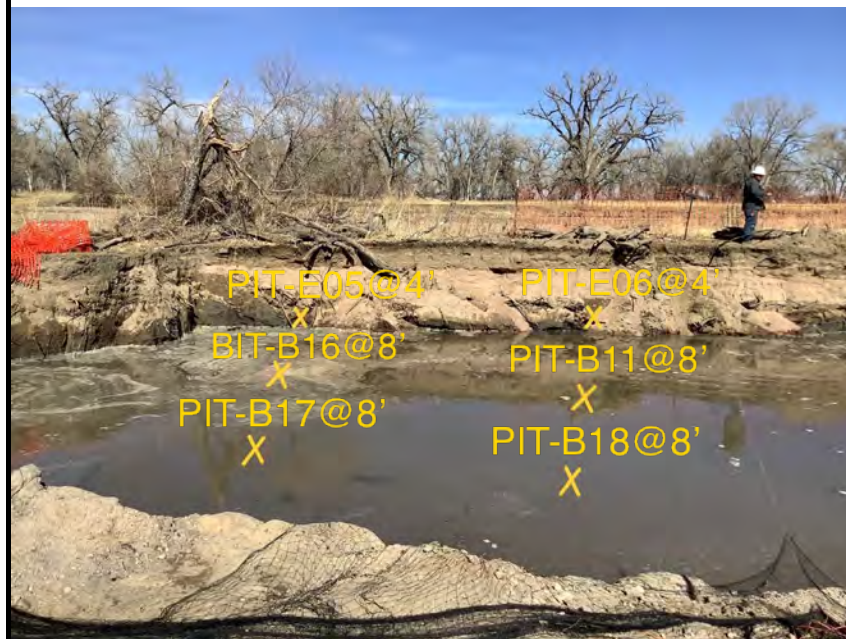
Equipment ID:		Equipment Type:		Equipment ID:		Equipment Type:	
Material:	Volume:	Contents:		Material:	Volume:	Contents:	
Notes/Conditions:				Notes/Conditions: Soil sampling and screening locations 3/15/22

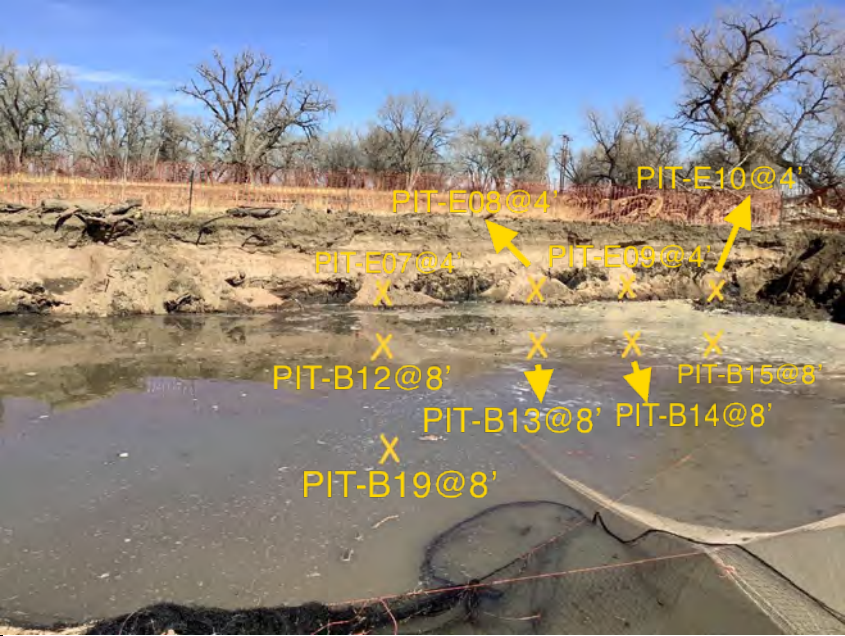
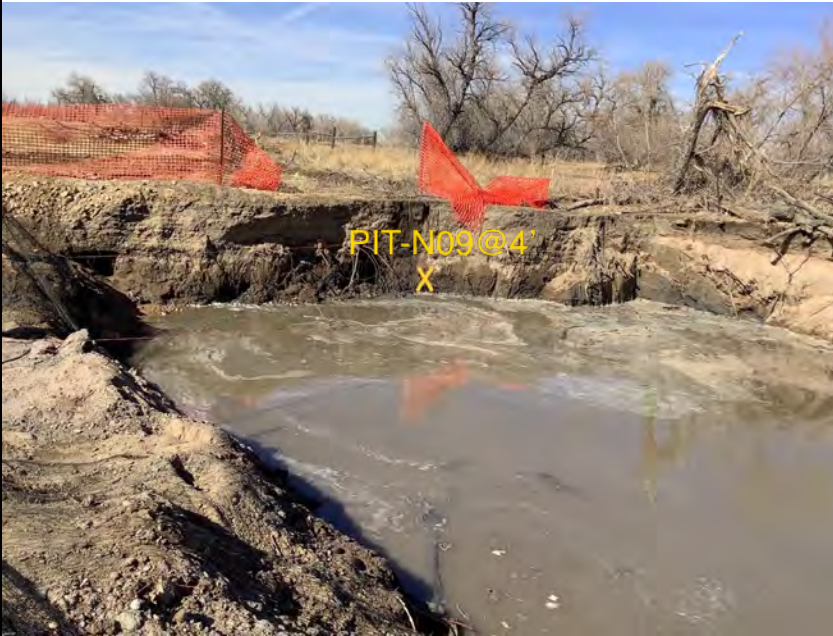
Equipment ID:		Equipment Type:	Equipment ID:		Equipment Type:
Material:	Volume:	Contents:	Material:	Volume:	Contents:
Notes/Conditions: Soil sampling and screening locations 3/15/22			Notes/Conditions: Soil sampling and screening location 3/15/22
