# Inspection Photos

Operator: EOG Resources Inc - #27742

Location Name: Bakers Peak State-611N91W /12NWSE

Inspection Document #: 702800614

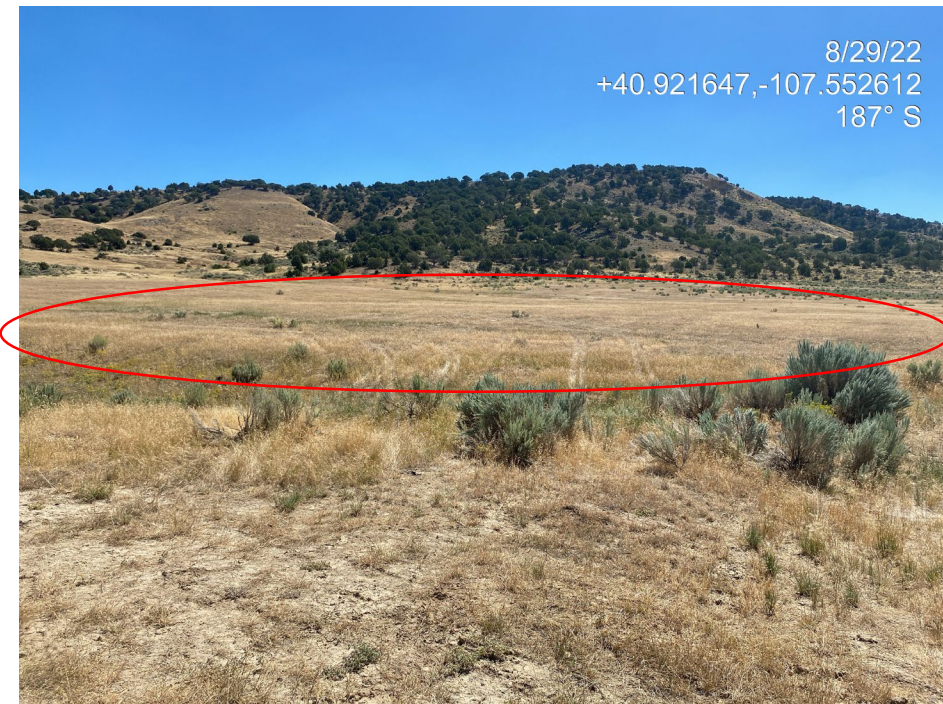
**Photo 1.** Photo taken from the northwest of the Location shows the access road in the foreground of the photo has been reclaimed. Photo also shows an overview of the Location (red circle). Note also, tire tracks showing vehicles accessing Location.

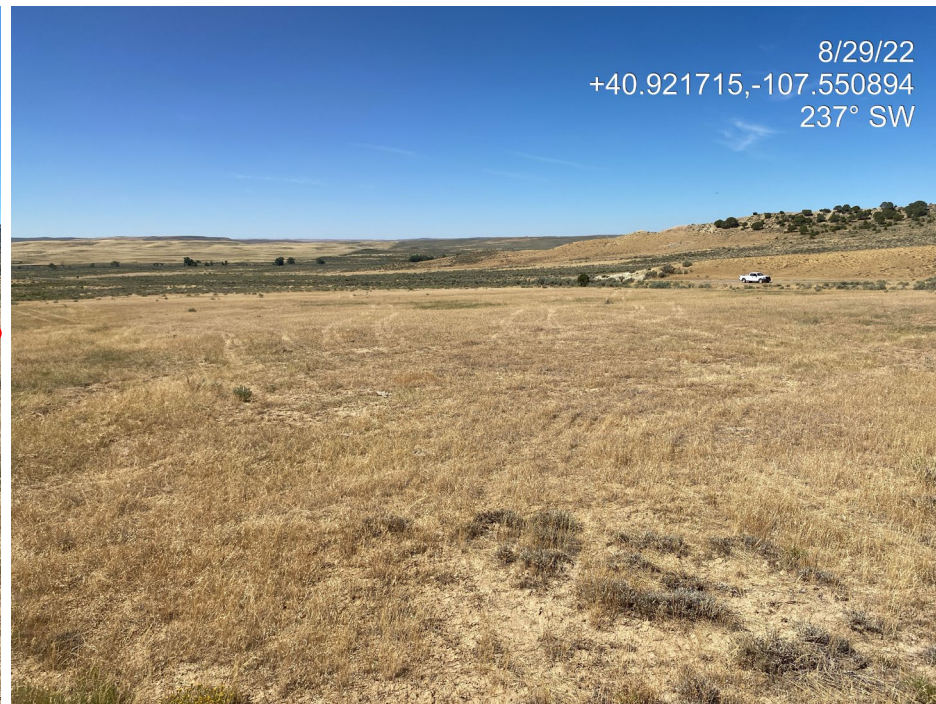
**Photo 2.** Photo taken from the northeast shows an overview of the Location. Note vehicle tracks throughout.

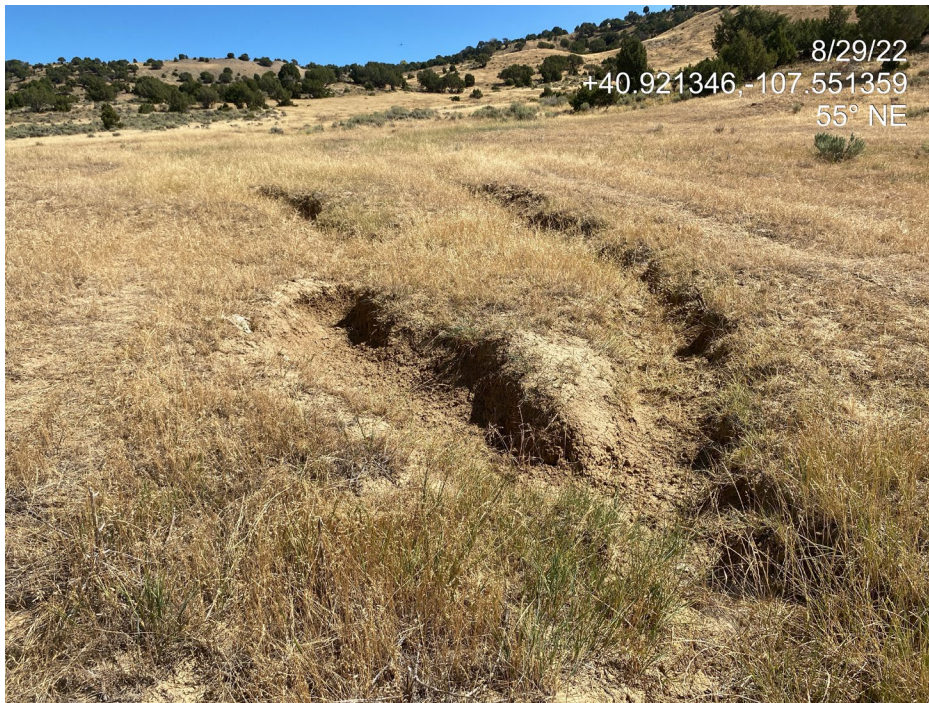
**Photo 3.** Photo taken from the center of the Location shows gully erosion. Photo also shows patches of desirable western wheatgrass in foreground compared to cover of cheatgrass (Noxious Weed) and alyssum (annual undesirable plant species/weed) in other areas.

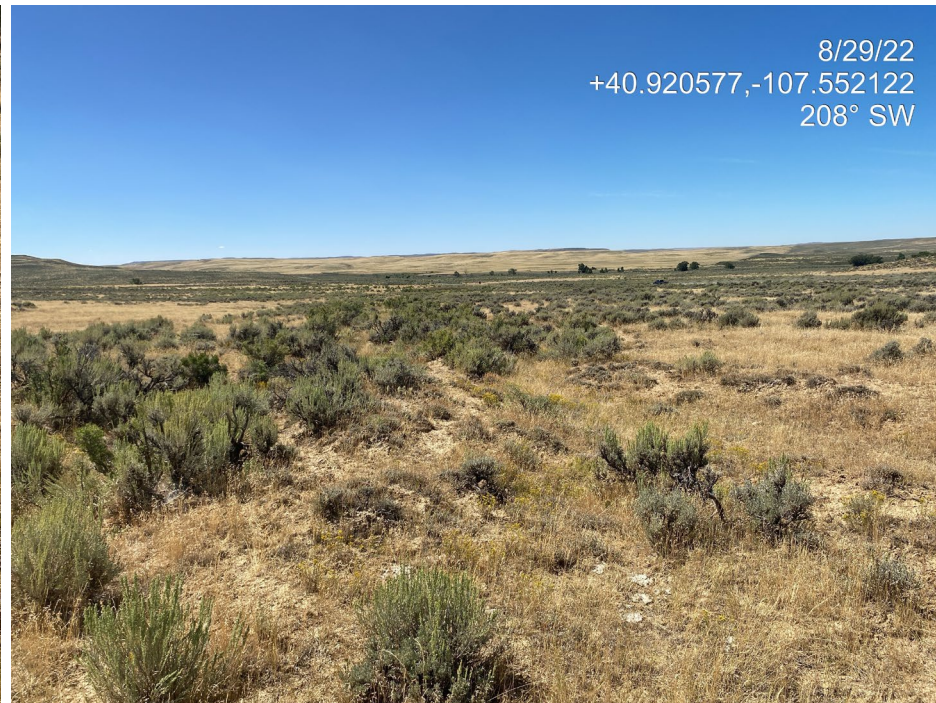
**Photo 4.** Photo taken from the south of the Location shows a natural drainage off-site which also runs through the Location. The sides of this drainage are well stabilized by perennial vegetation and gully erosion is not present, as it is on Location. See Photo 3.

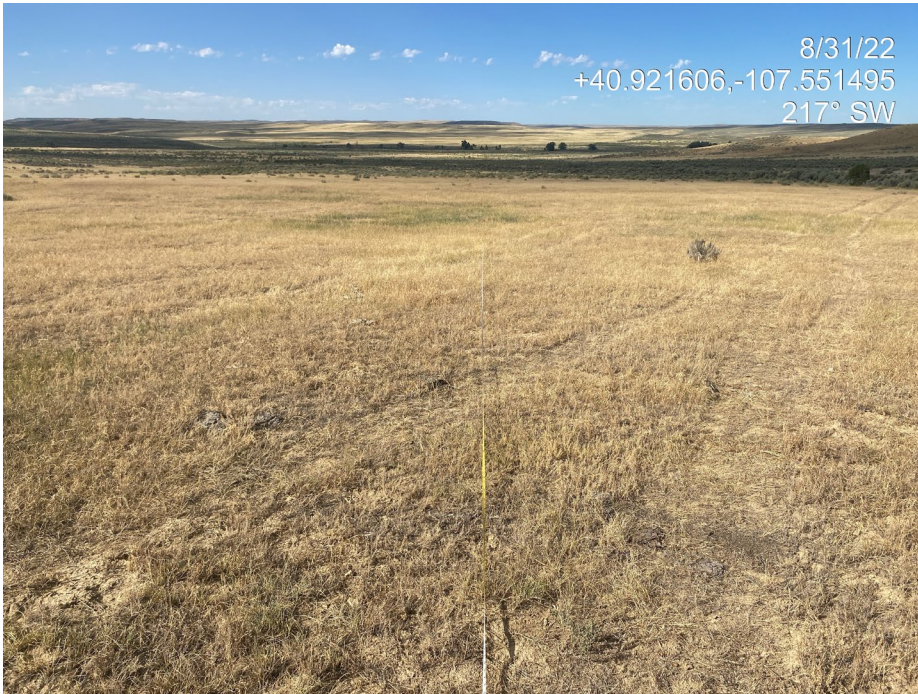
**Photo 5.** Photo taken from the north of the Location shows the start of the disturbed area vegetation monitoring transect.

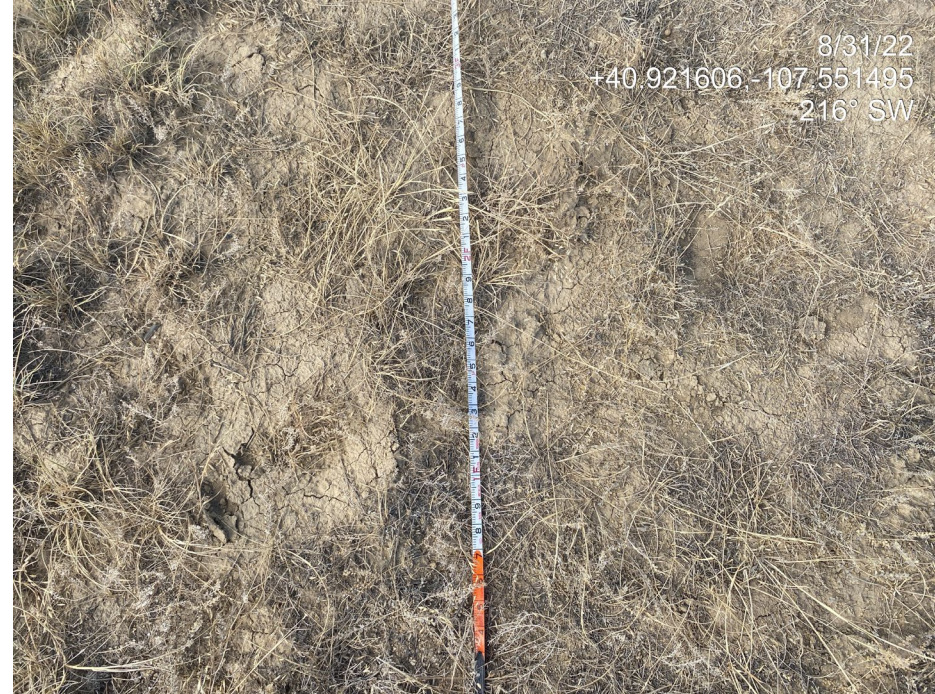
**Photo 6.** Photo taken from the north of the Location shows the ground surface at the start of the disturbed area vegetation monitoring transect.

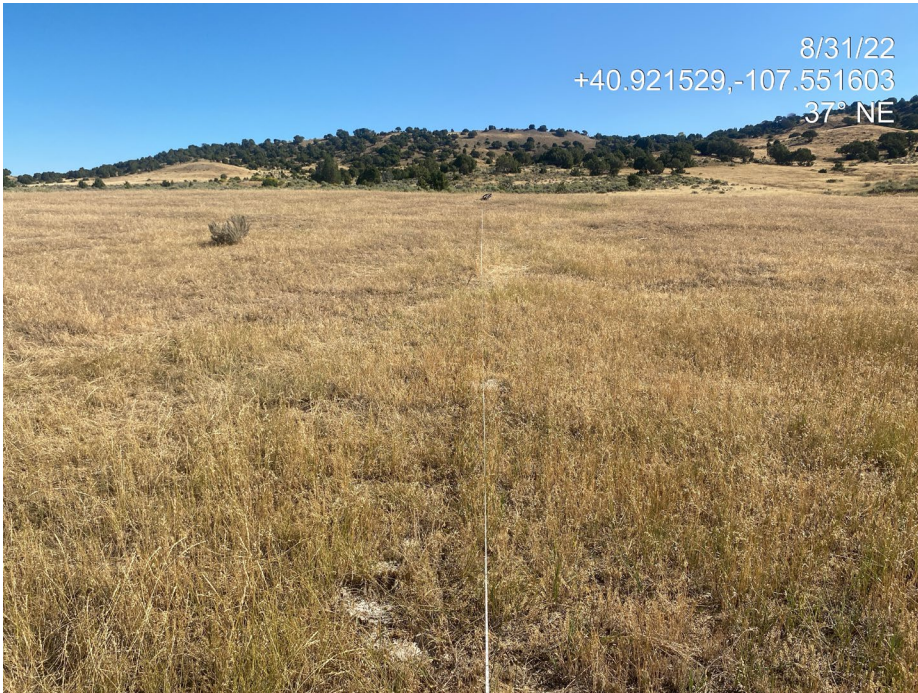
**Photo 7.** Photo taken from the center of the Location shows the end of the disturbed area vegetation monitoring transect.

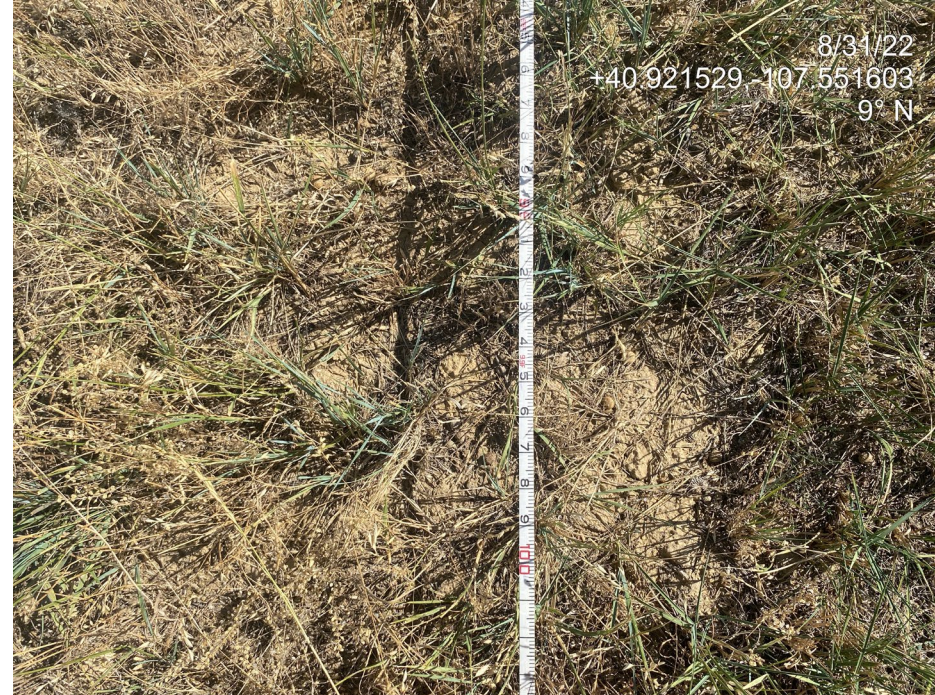
**Photo 8.** Photo taken from the center of the Location shows the ground surface at the end of the disturbed area vegetation monitoring transect.

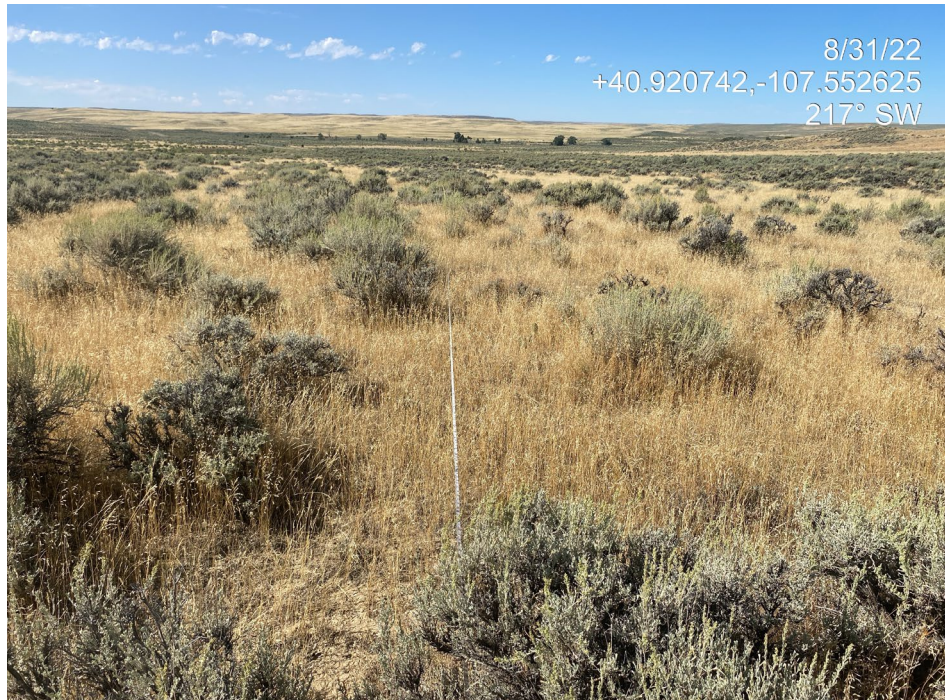
**Photo 9.** Photo taken to the south of the Location shows the start of the reference area vegetation monitoring transect.

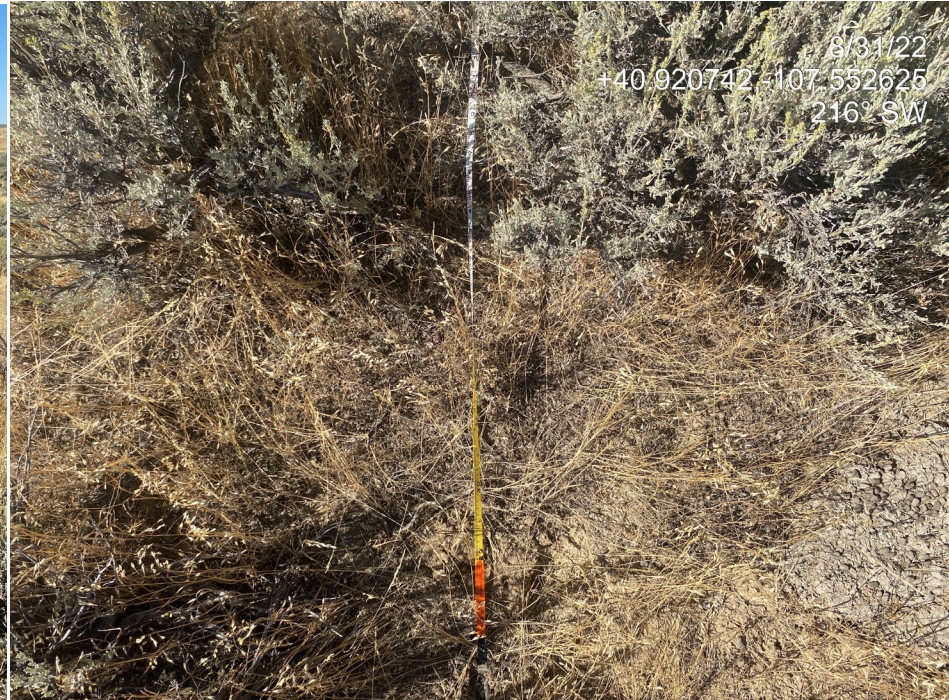
**Photo 10.** Photo taken to the south of the Location shows the ground surface at the start of the reference area vegetation monitoring transect.

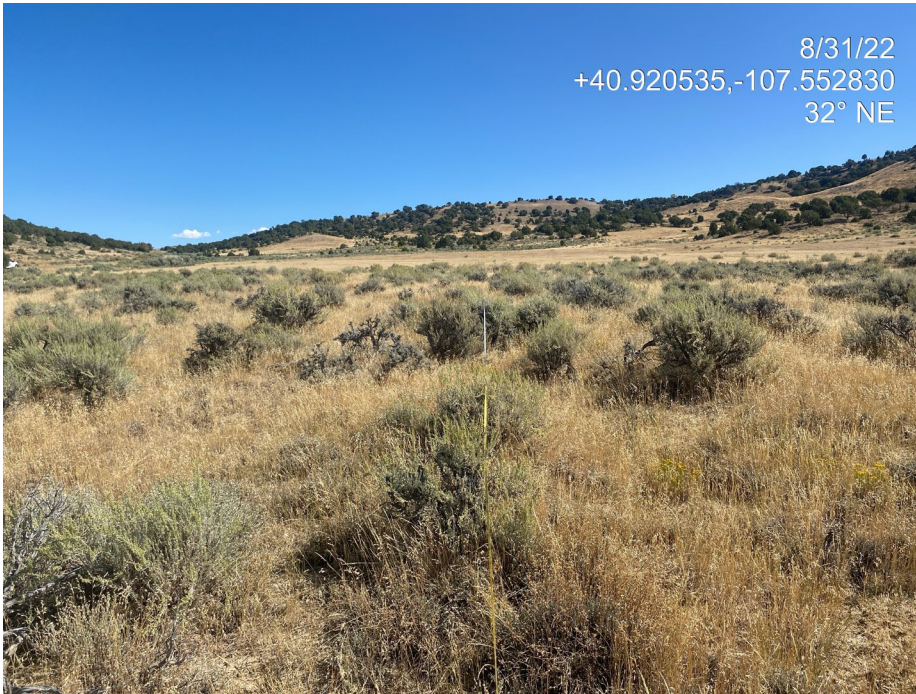
**Photo 11.** Photo taken to the south of the Location shows the end of the reference area vegetation monitoring transect.

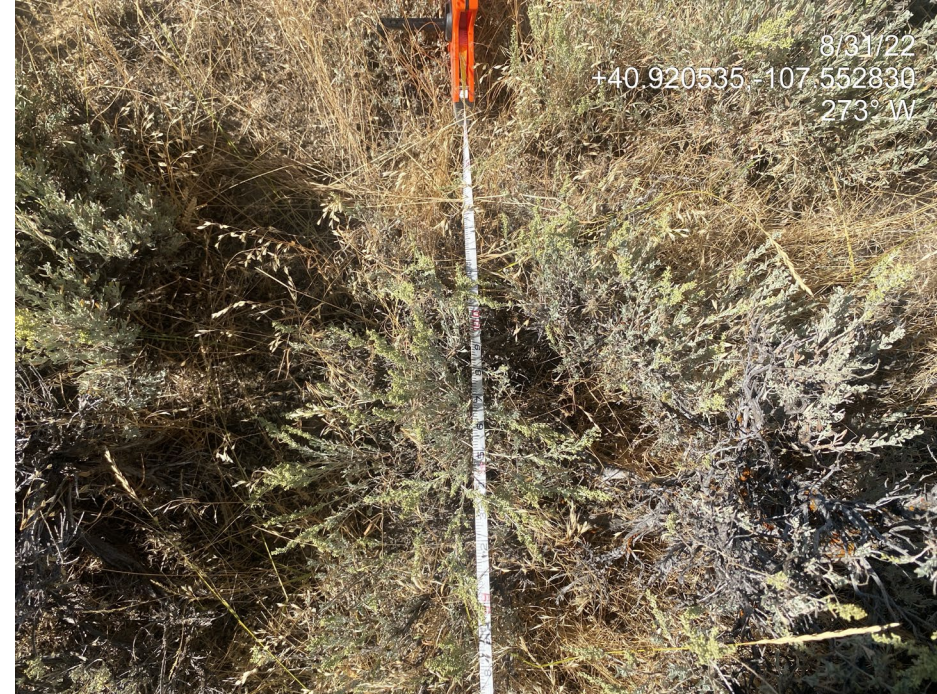
**Photo 12.** Photo taken to the south of the Location shows the ground surface at the end of the reference area vegetation monitoring transect.

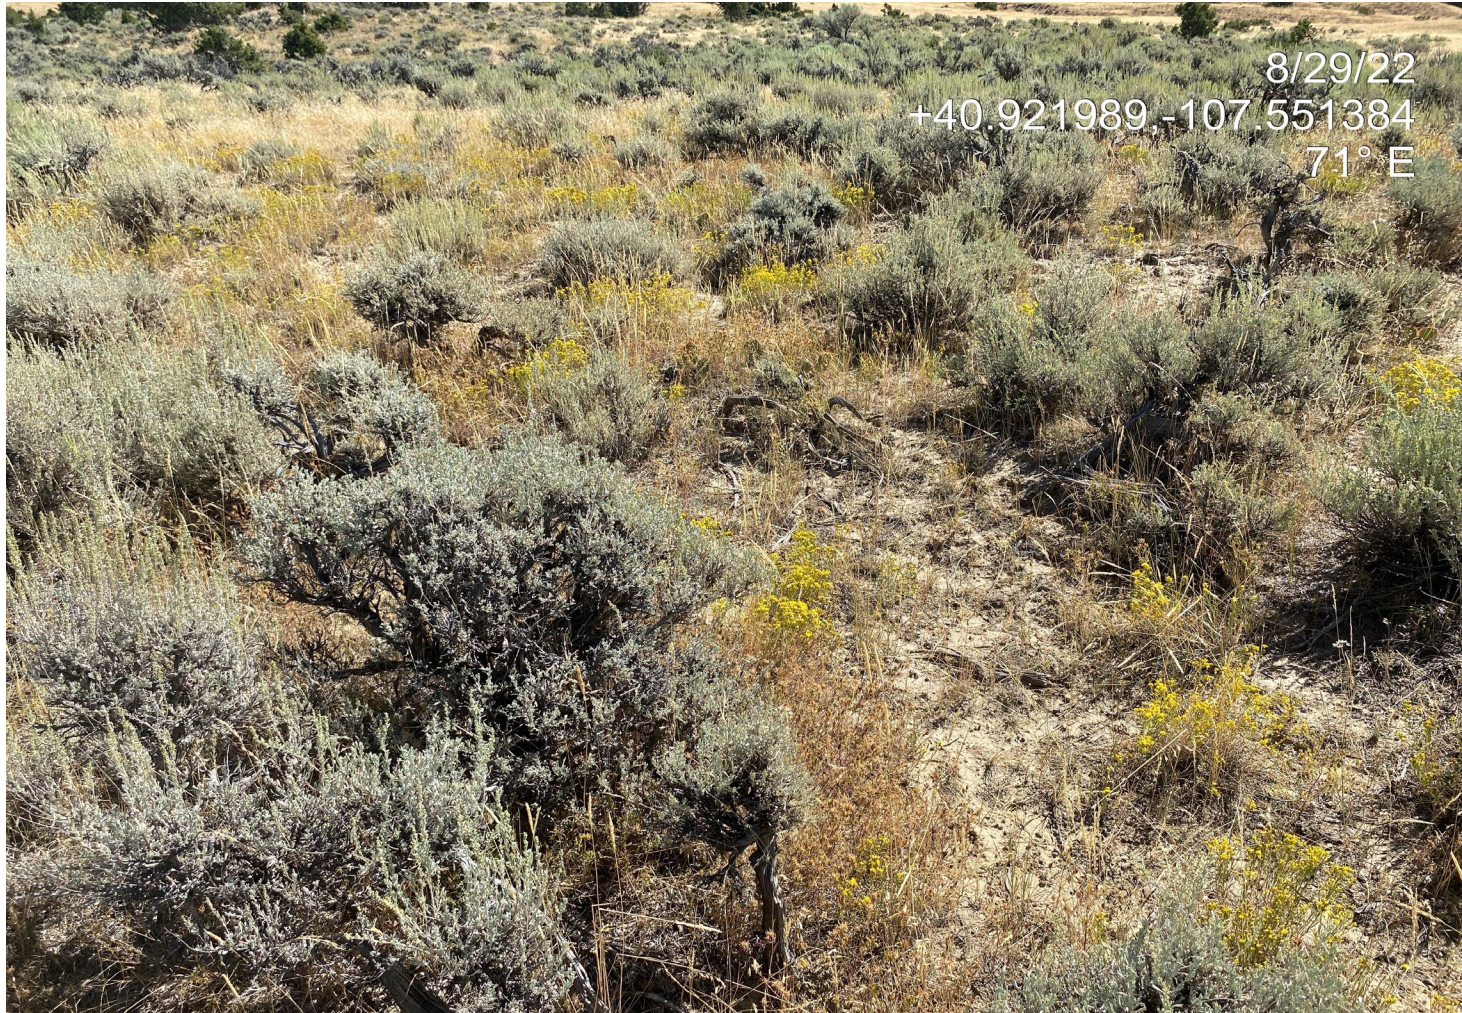
**Photo 13.** Photo shows reference area vegetation to the north of the Location.
