# Inspection Photos

Operator: EOG Resources Inc - #27742

Location Name: Bakers Peak-611N91W /12NWSE

Inspection Document #: 702800619

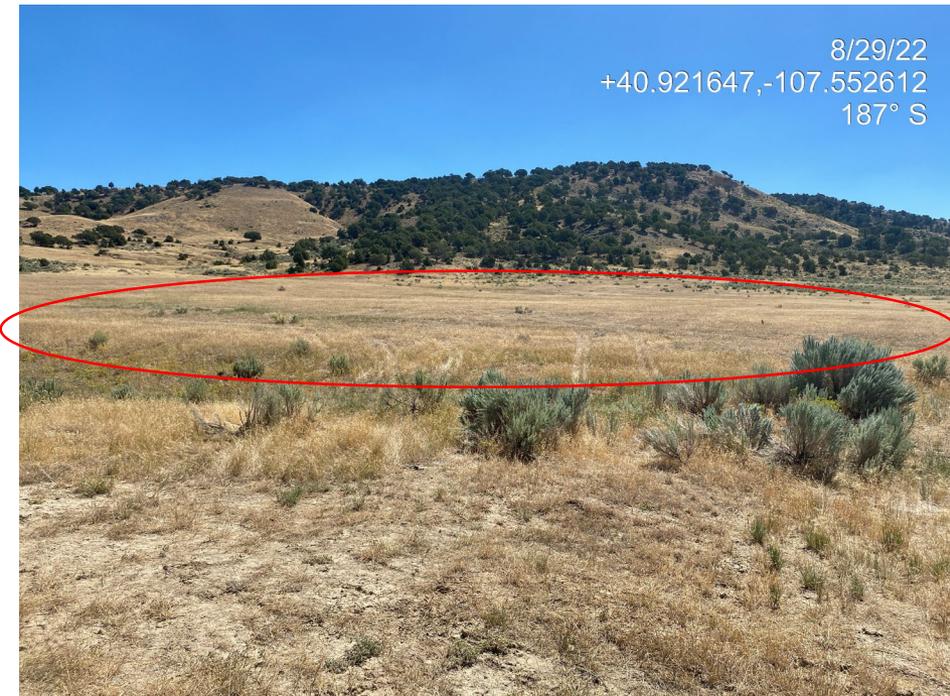
**Photo 1.** Photo taken from the northwest of the Location shows the access road in the foreground of the photo has been reclaimed. Photo also shows an overview of the Location (red circle). Note also, tire tracks showing vehicles accessing Location.

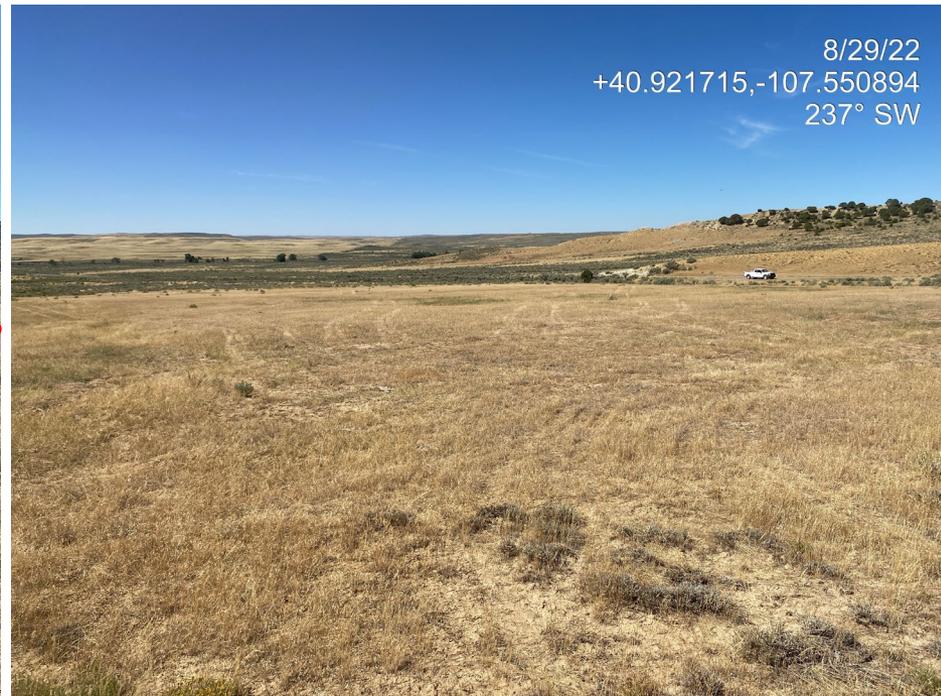
**Photo 2.** Photo taken from the northeast shows an overview of the Location. Note vehicle tracks throughout.

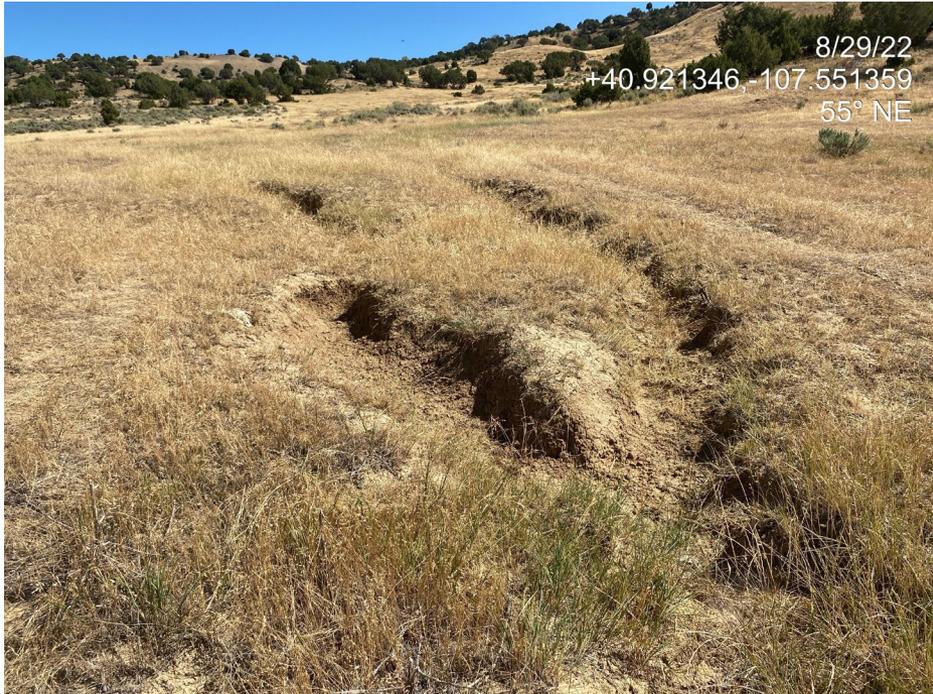
**Photo 3.** Photo taken from the center of the Location shows gully erosion. Photo also shows patches of desirable western wheatgrass in foreground compared to cover of cheatgrass (Noxious Weed) and alyssum (annual undesirable plant species/weed) in other areas.

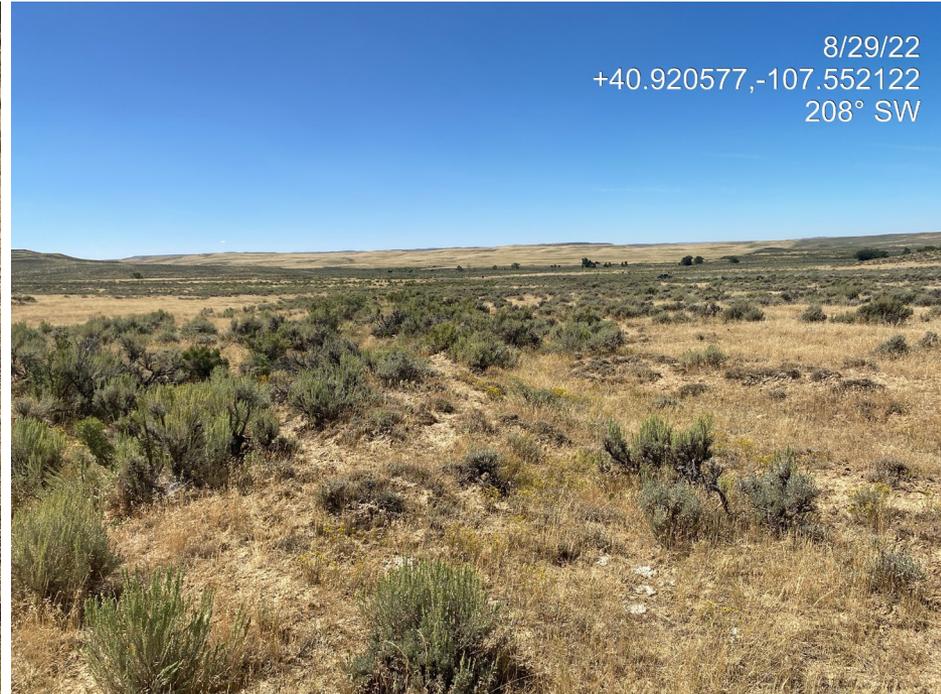
**Photo 4.** Photo taken from the south of the Location shows a natural drainage off-site which also runs through the Location. The sides of this drainage are well stabilized by perennial vegetation and gully erosion is not present, as it is on Location. See Photo 3.

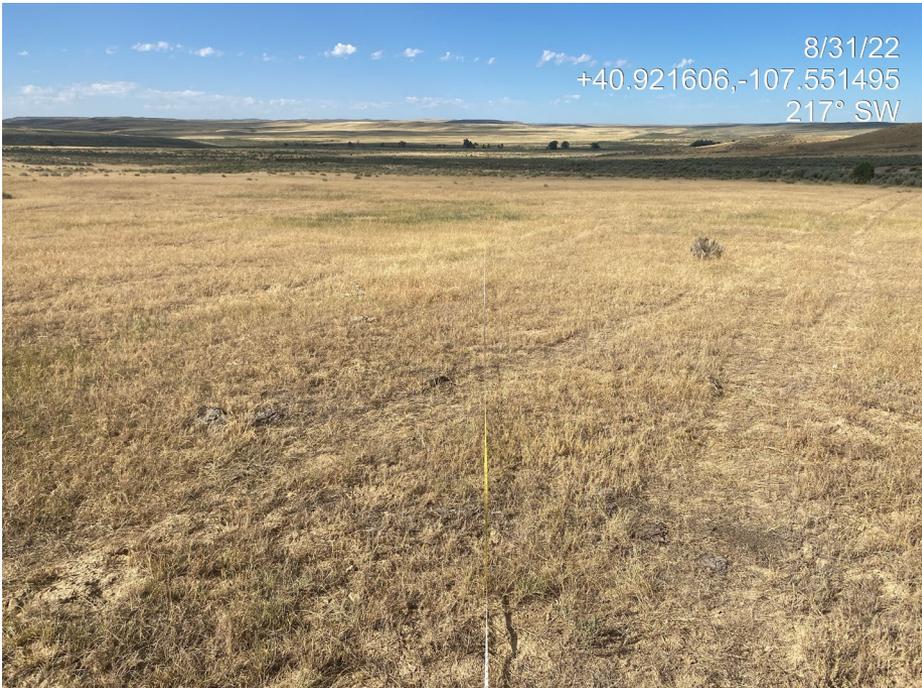
**Photo 5.** Photo taken from the north of the Location shows the start of the disturbed area vegetation monitoring transect.

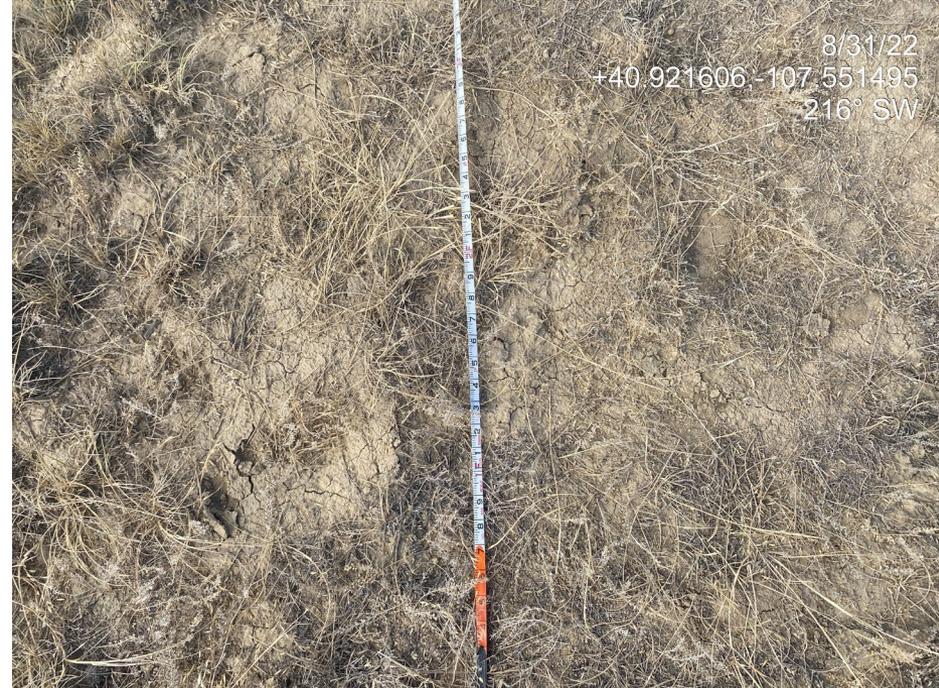
**Photo 6.** Photo taken from the north of the Location shows the ground surface at the start of the disturbed area vegetation monitoring transect.

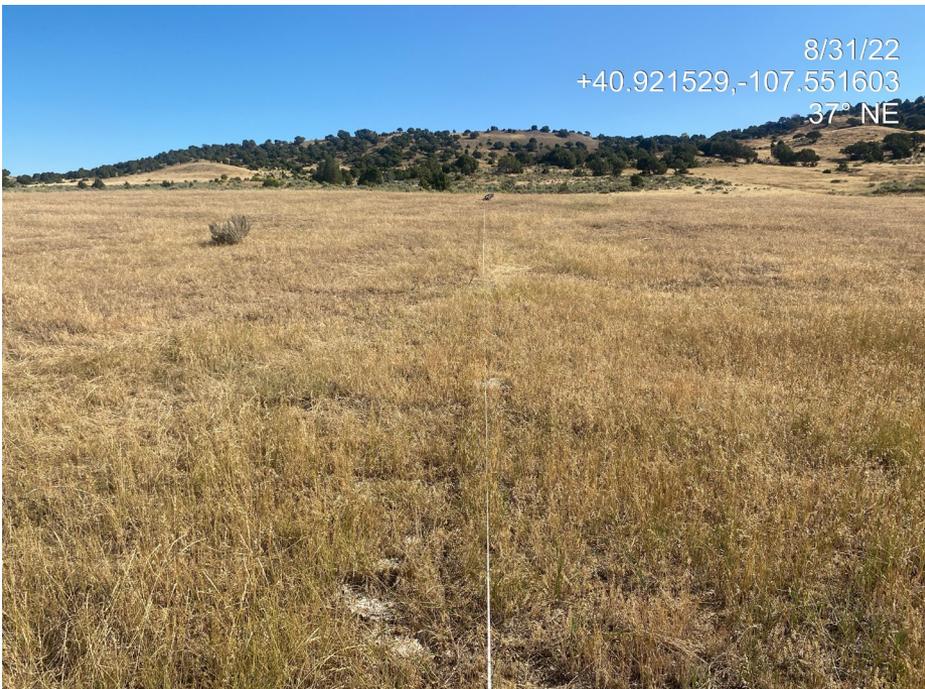
**Photo 7.** Photo taken from the center of the Location shows the end of the disturbed area vegetation monitoring transect.

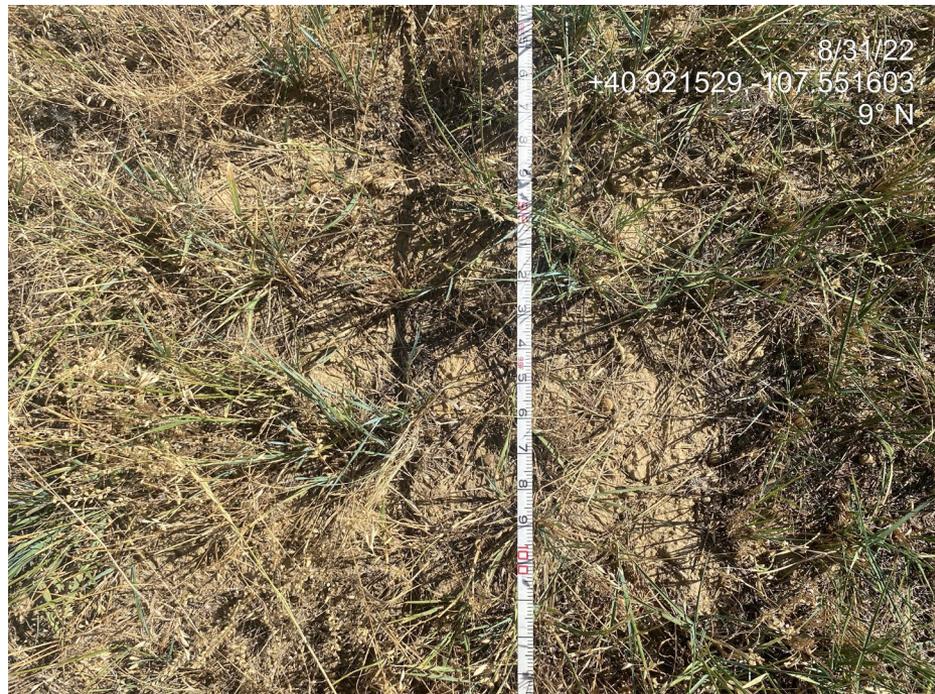
**Photo 8.** Photo taken from the center of the Location shows the ground surface at the end of the disturbed area vegetation monitoring transect.

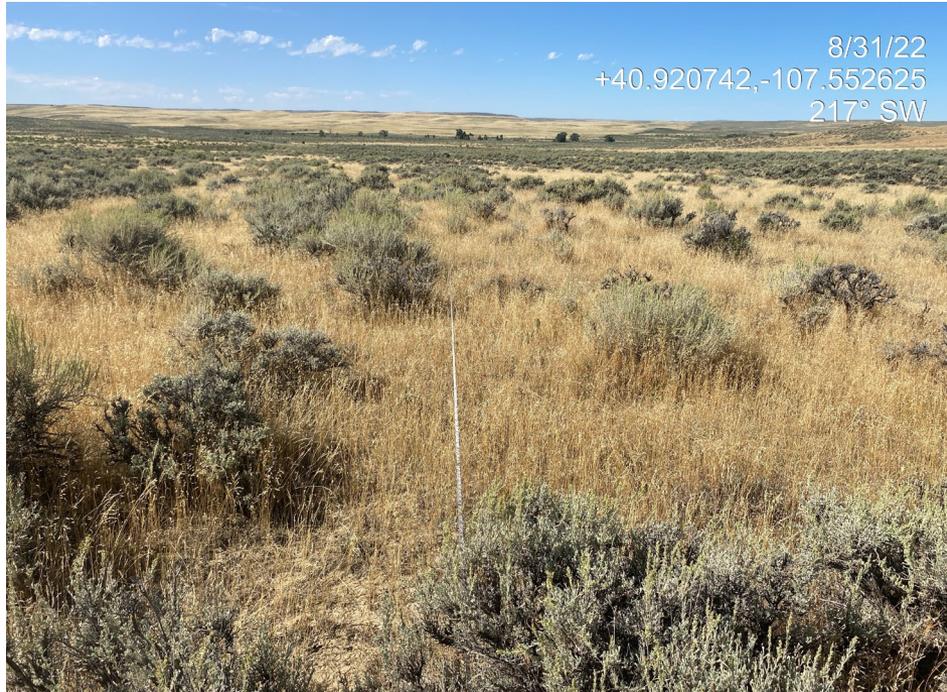
**Photo 9.** Photo taken to the south of the Location shows the start of the reference area vegetation monitoring transect.

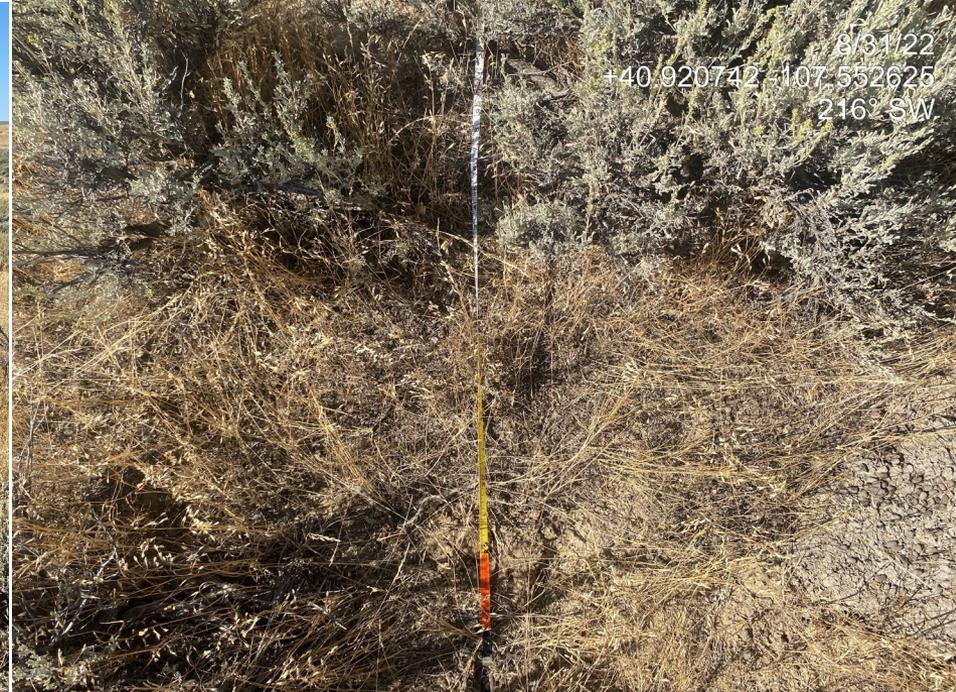
**Photo 10.** Photo taken to the south of the Location shows the ground surface at the start of the reference area vegetation monitoring transect.

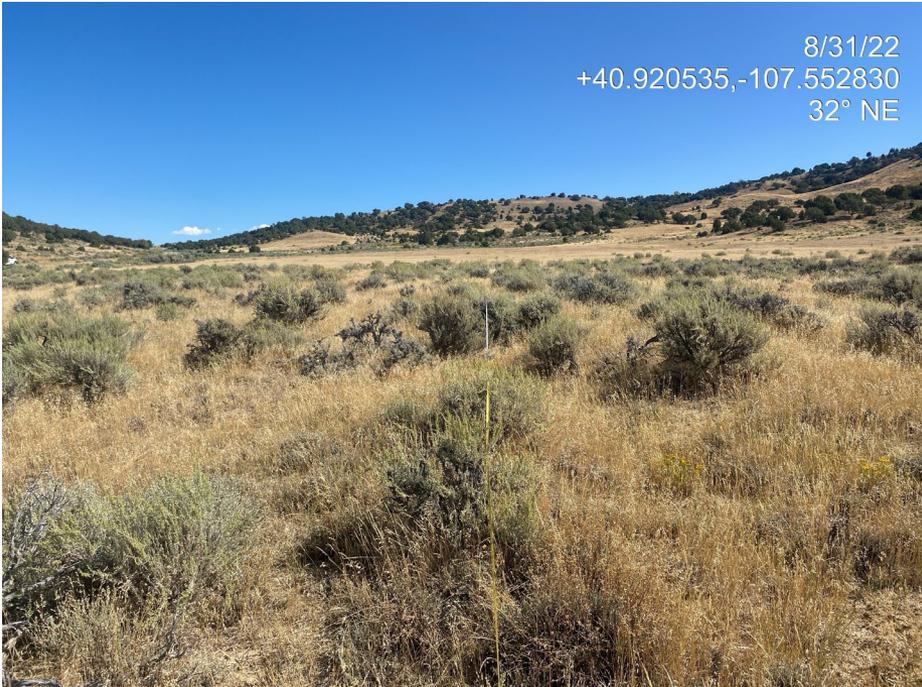
**Photo 11.** Photo taken to the south of the Location shows the end of the reference area vegetation monitoring transect.

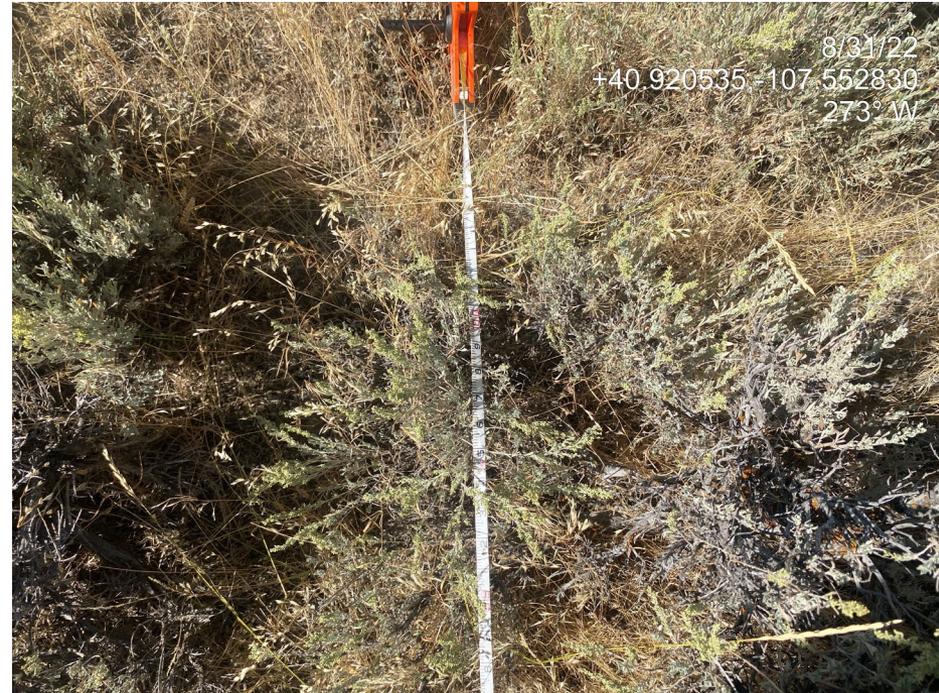
**Photo 12.** Photo taken to the south of the Location shows the ground surface at the end of the reference area vegetation monitoring transect.

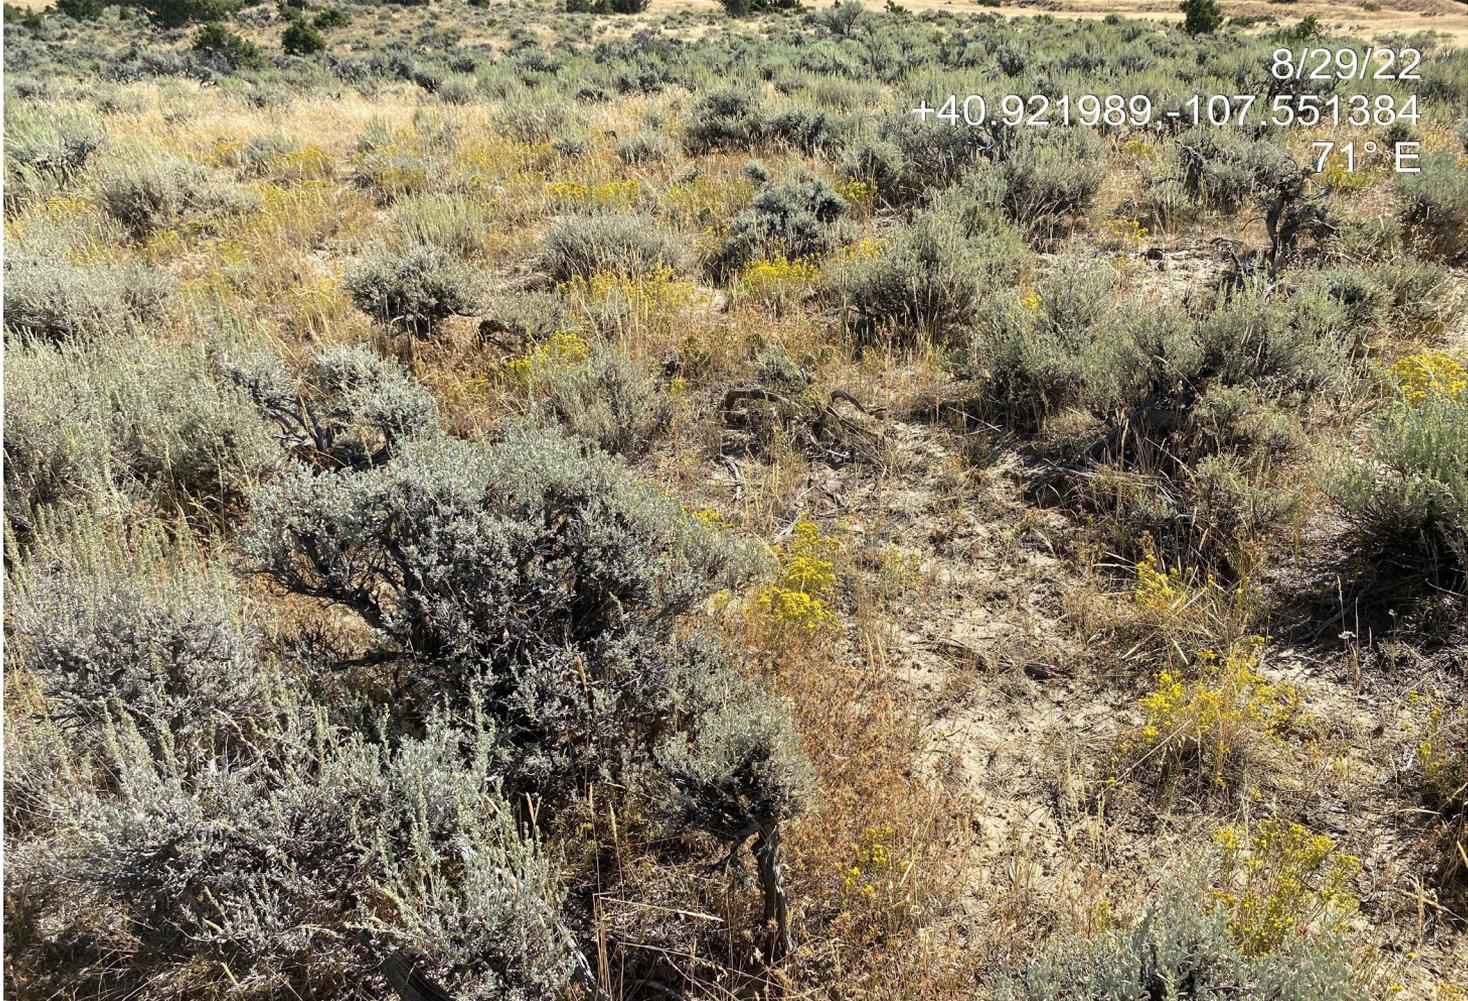
**Photo 13.** Photo shows reference area vegetation to the north of the Location.
