Inspection Photos and Issue Report

Operator: NONSUCH NATURAL GAS INC

Location #324169

Garfield County, CO

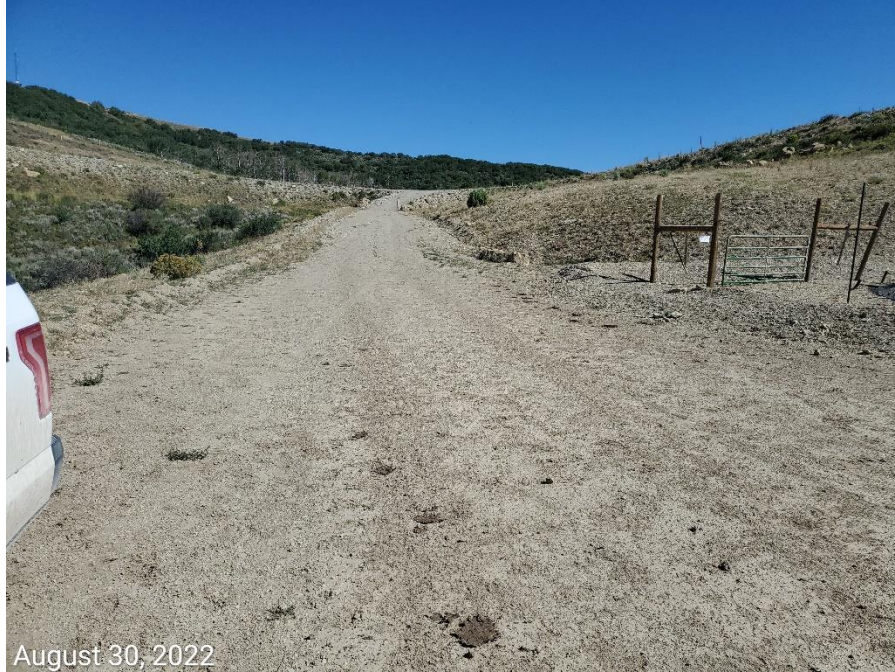
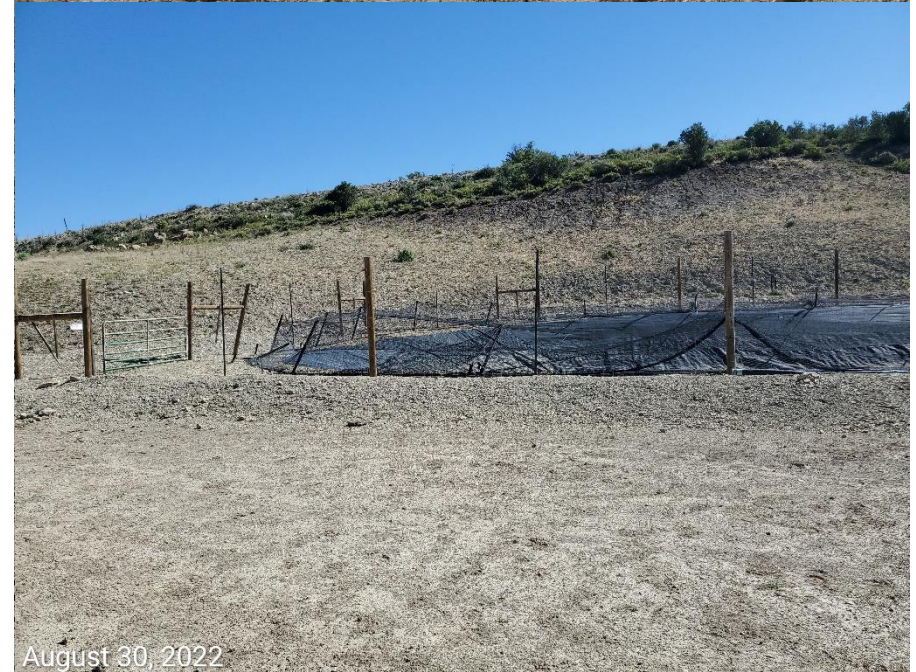
Photo 1: Photos taken from the west end of the Location. Photos 1-2 provide an overview of the Location from north, northeast, southeast to south.

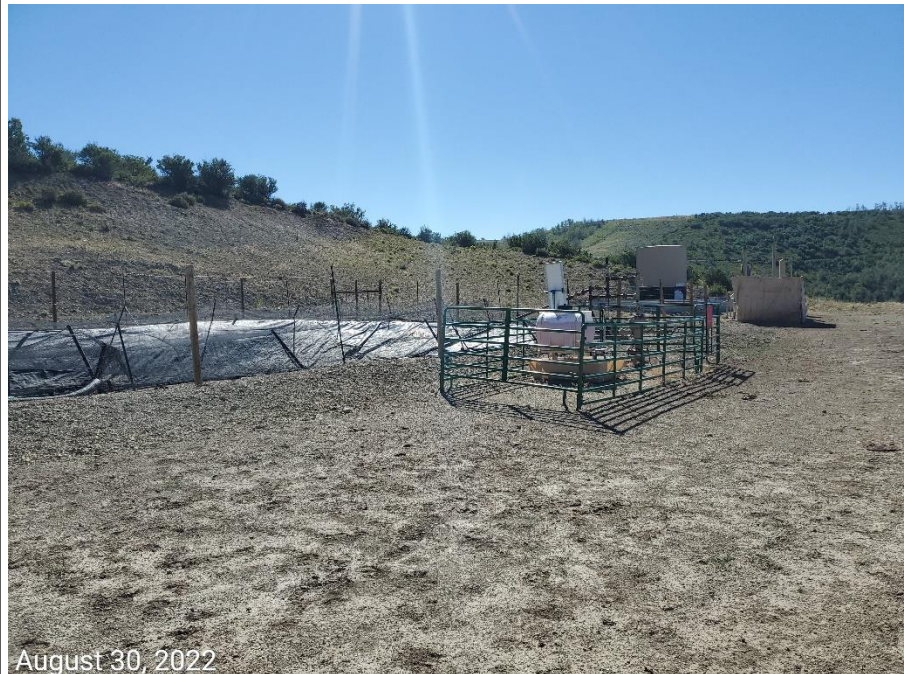
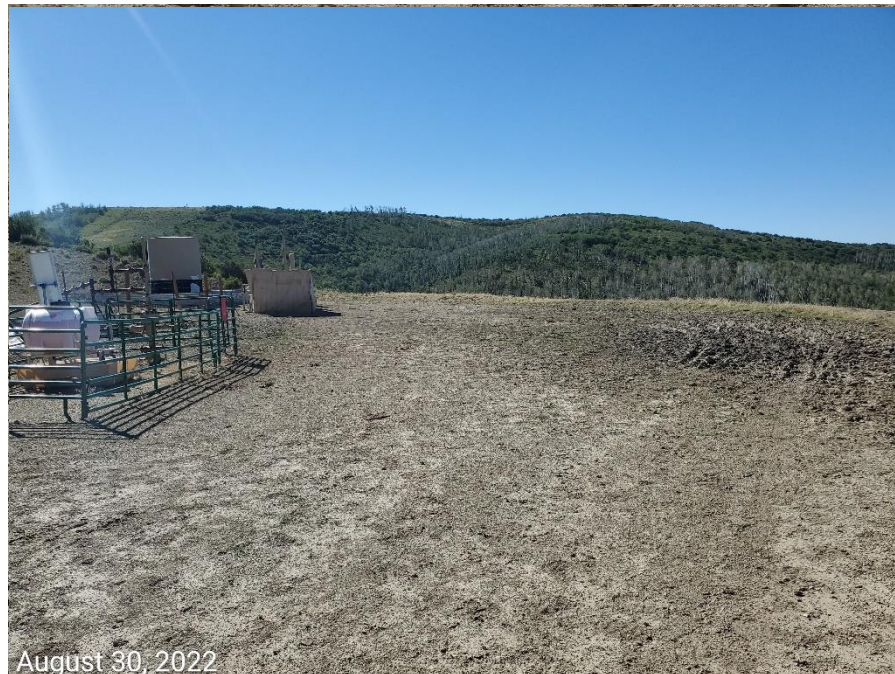
Photo 2: See comments under photo 1.

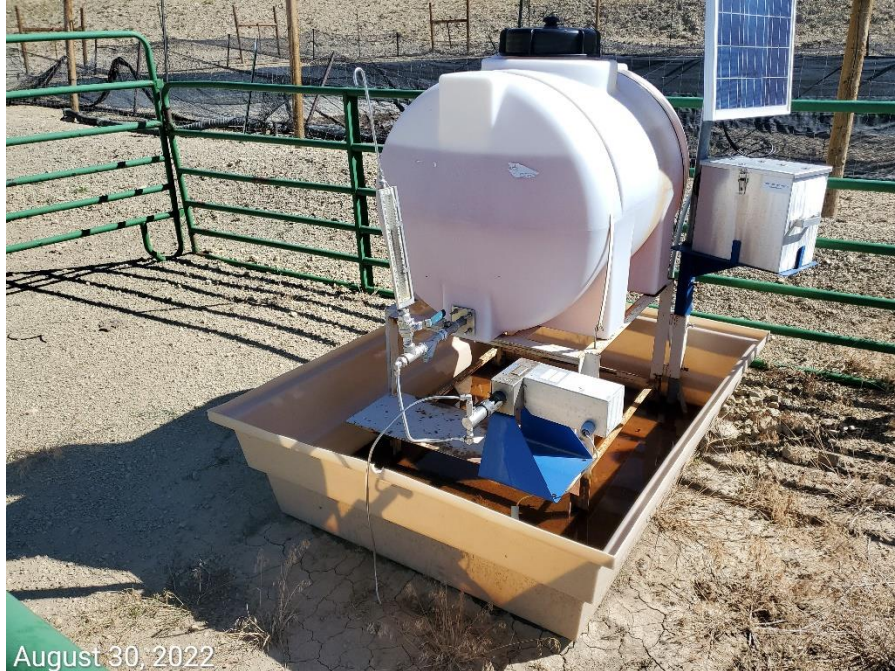
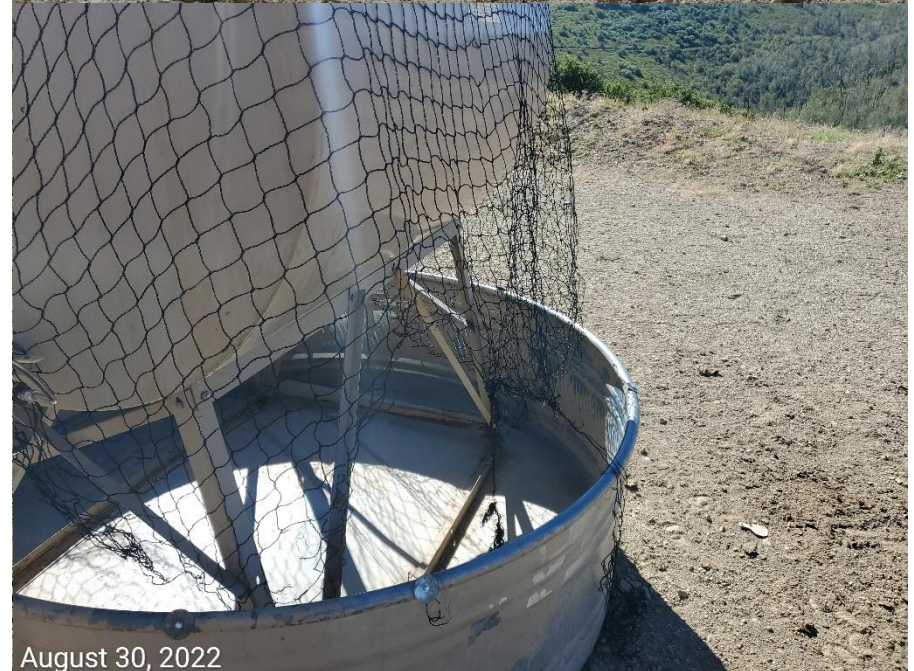
Photo 3: Photos show wildlife protection devices at the two methanol tanks on the Location remain missing or insufficient.

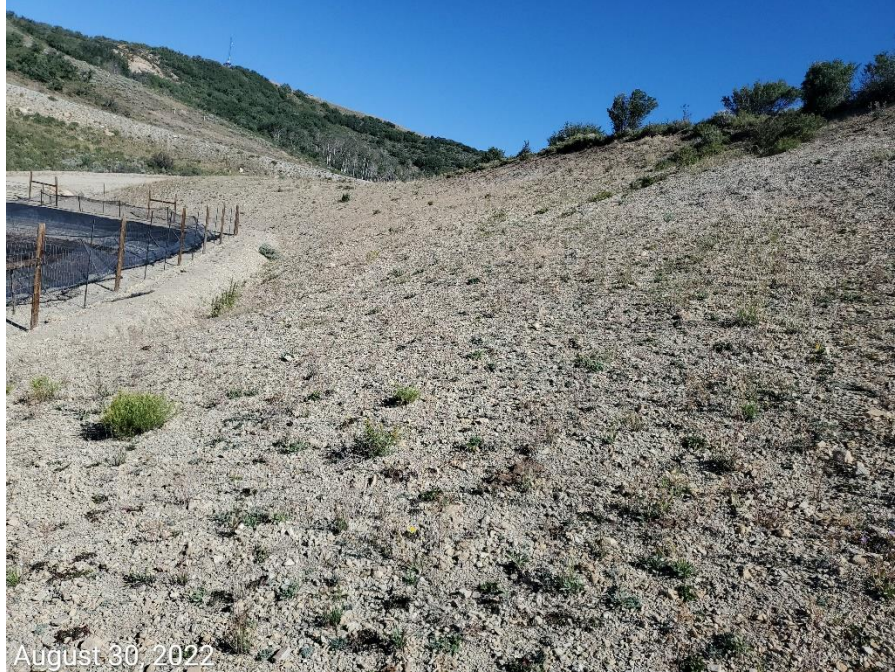
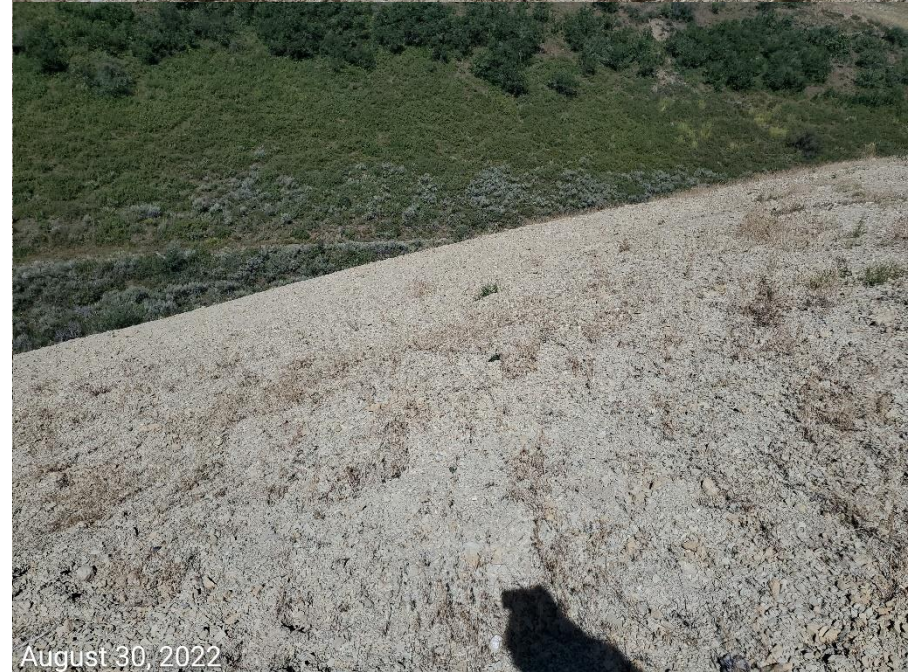
Photo 4: Photos taken from the interim areas of the Location; interim areas remain predominantly bare; Location remains out of compliance with 1003 rules.

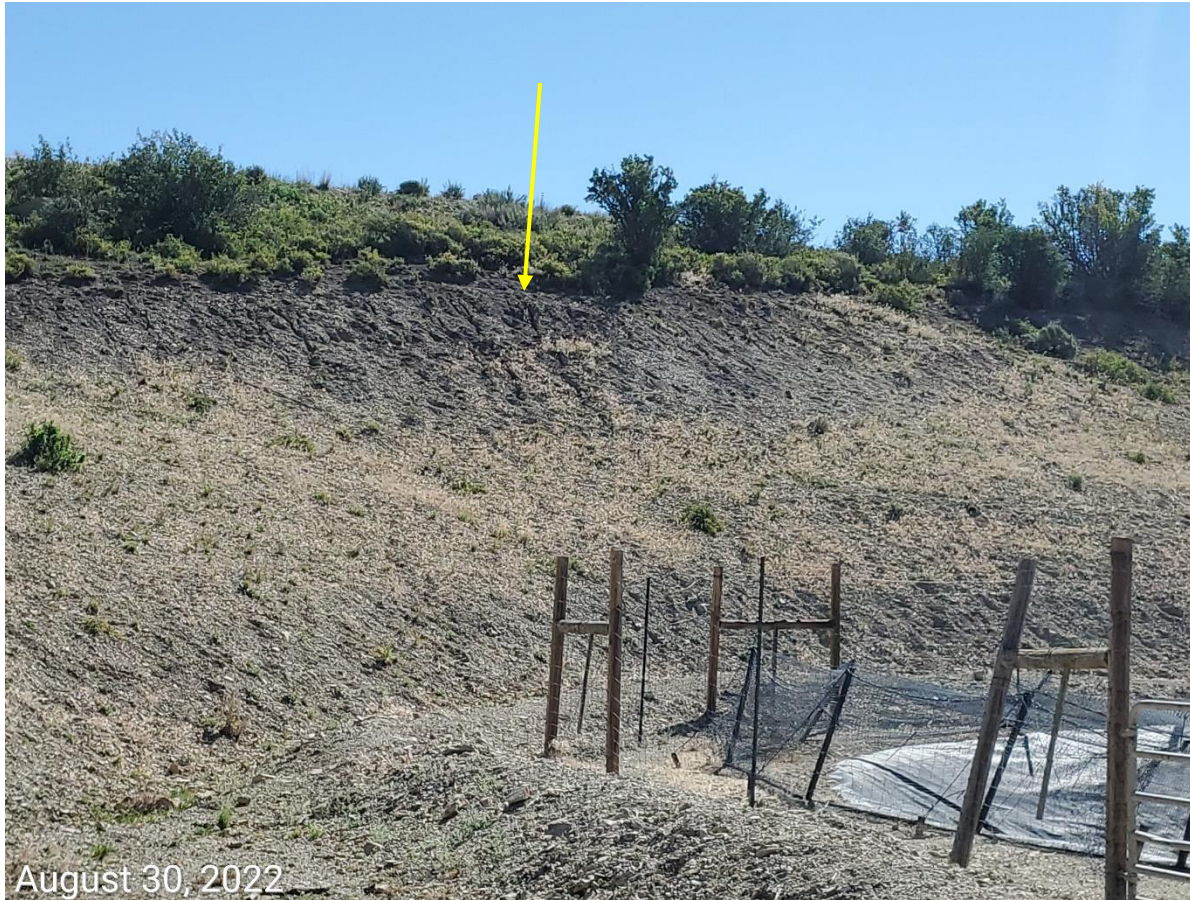
Photo 5: Photo shows erosion degradation on the cut slopes; stormwater and erosion control BMPs remain missing or insufficient.

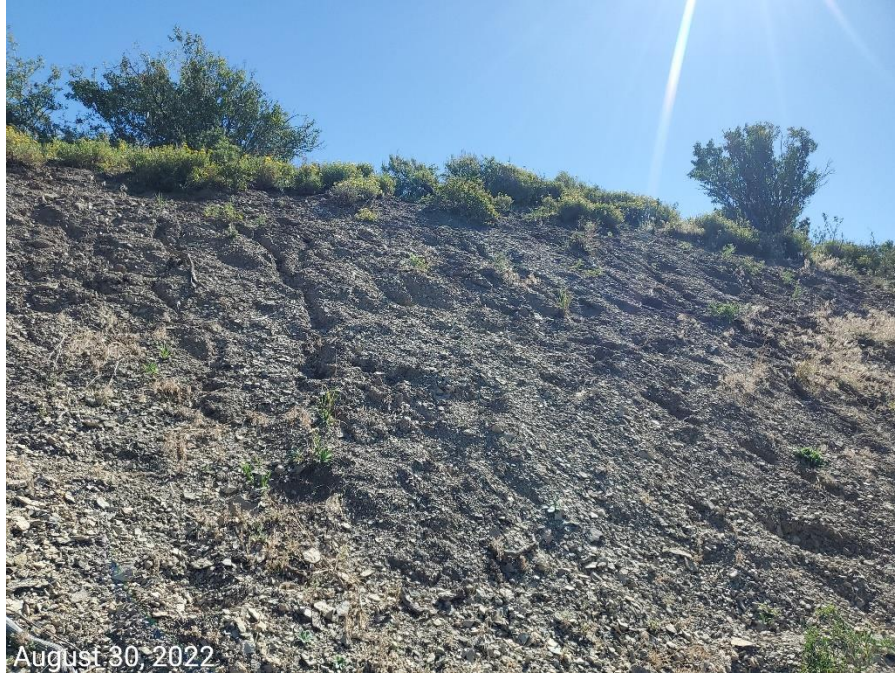
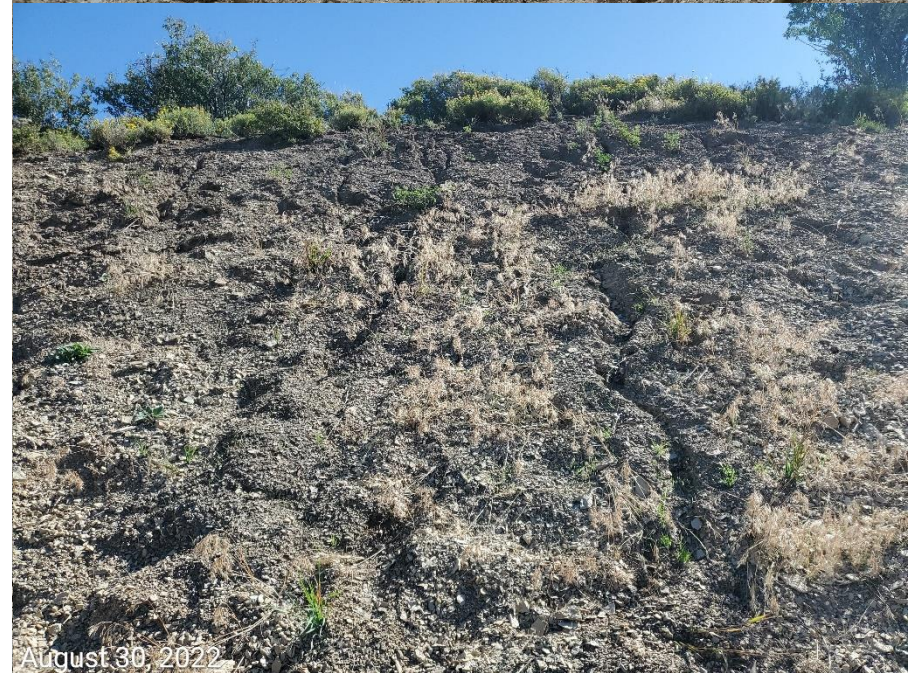
Photo 6: Continued from photo 5. Photos examples showing stormwater and erosion control BMPs to minimize erosion and degradation remains missing or insufficient at the cut slopes.

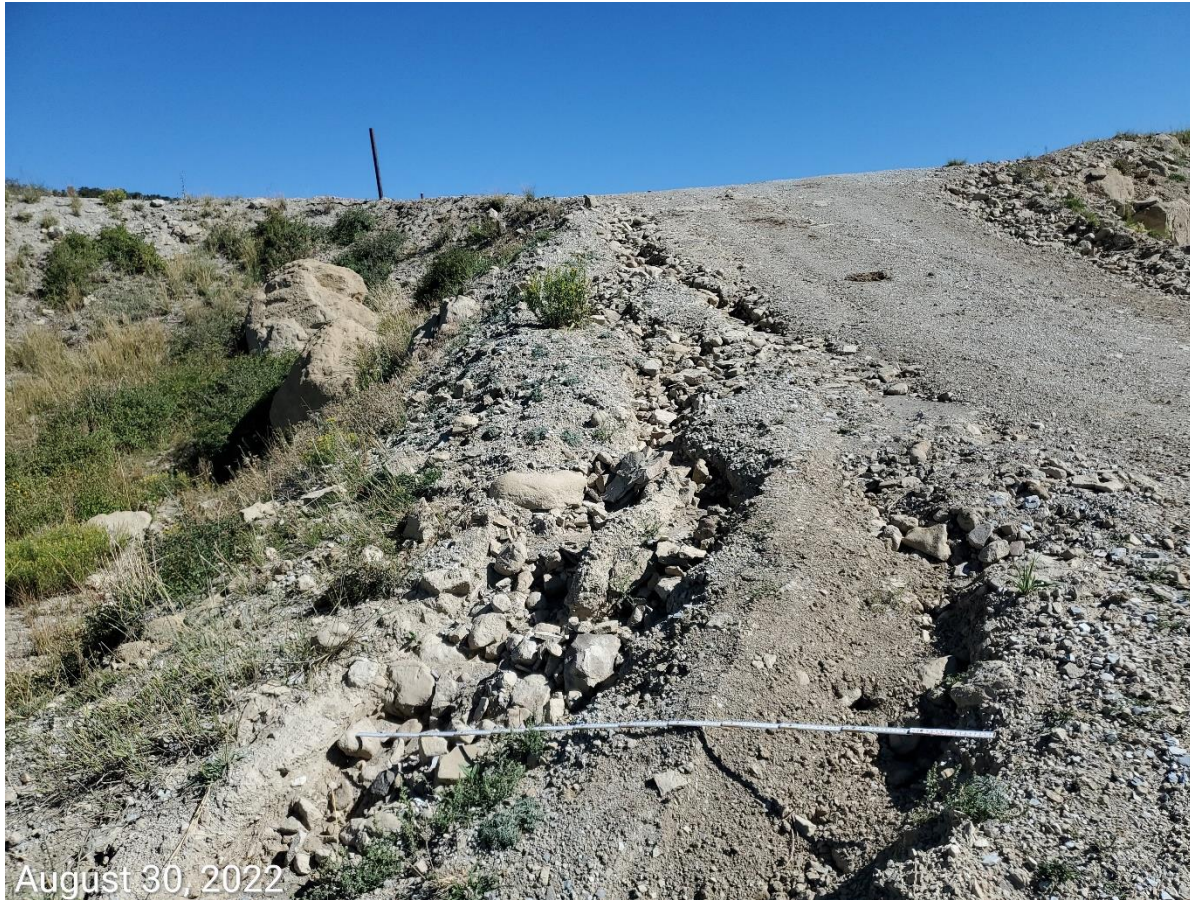
Photo 7: Photo shows degradation due to stormwater runoff from the access road; BMPs to stabilize and properly manage runoff from the Location remains missing or insufficient, resulting in continued degradation and sediment transport. 6 foot measuring stick for reference.

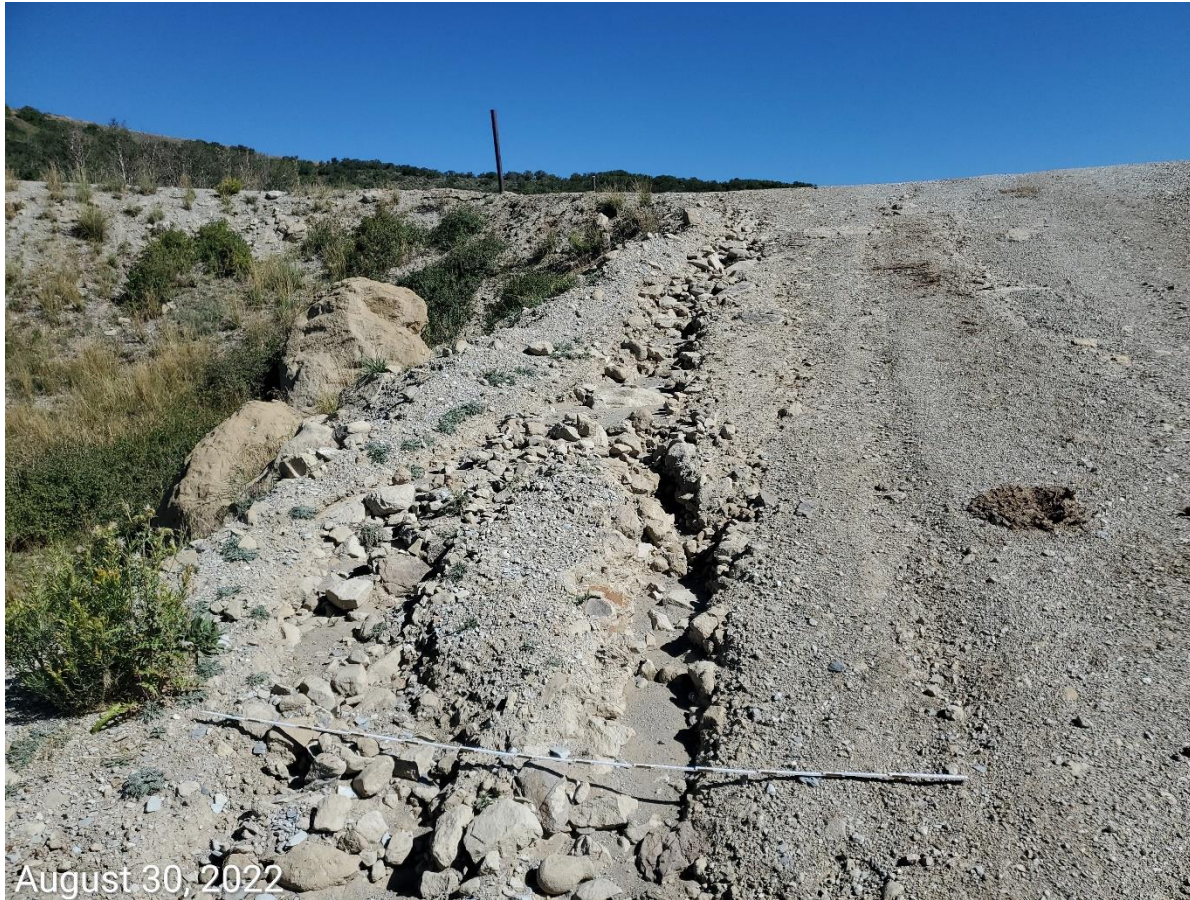
Photo 8: See comments under photo 7.

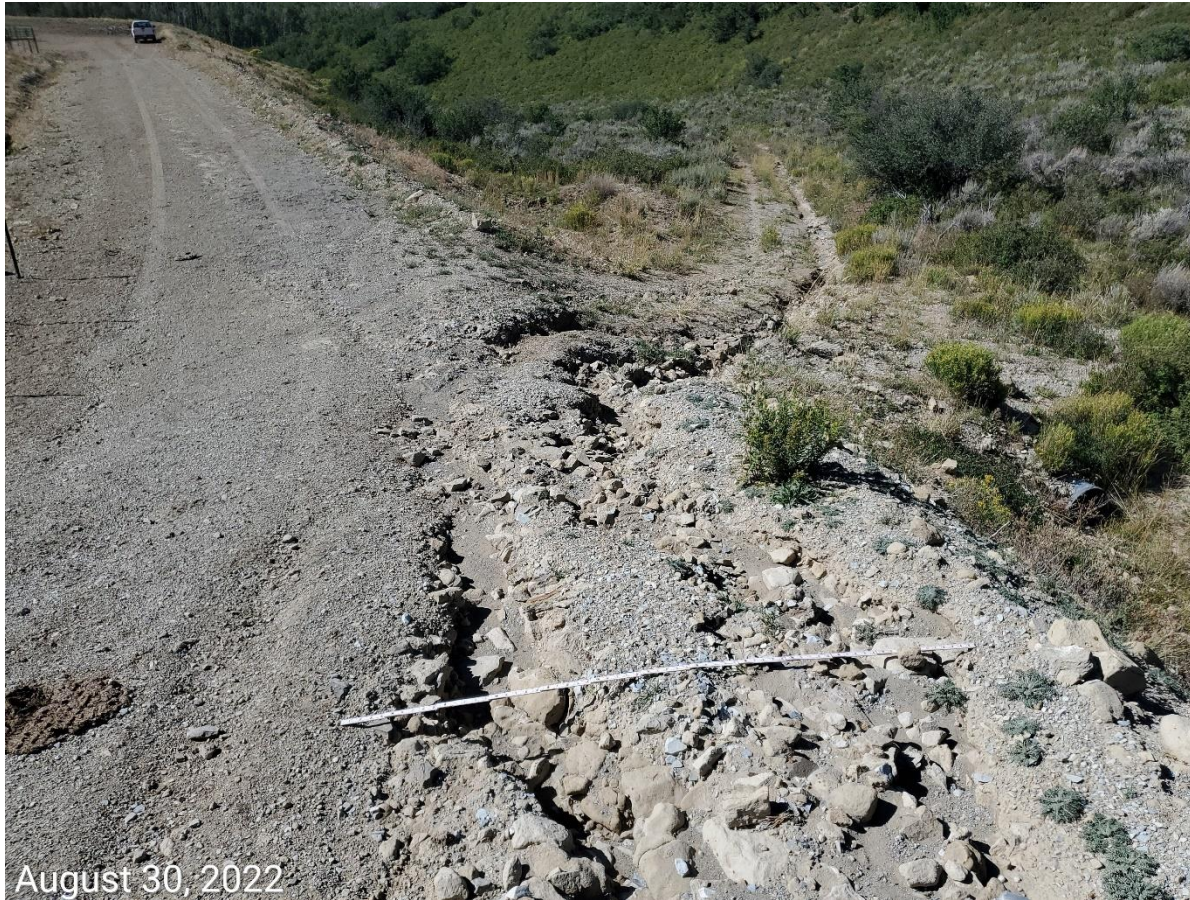
Photo 9: See comments under photo 7.

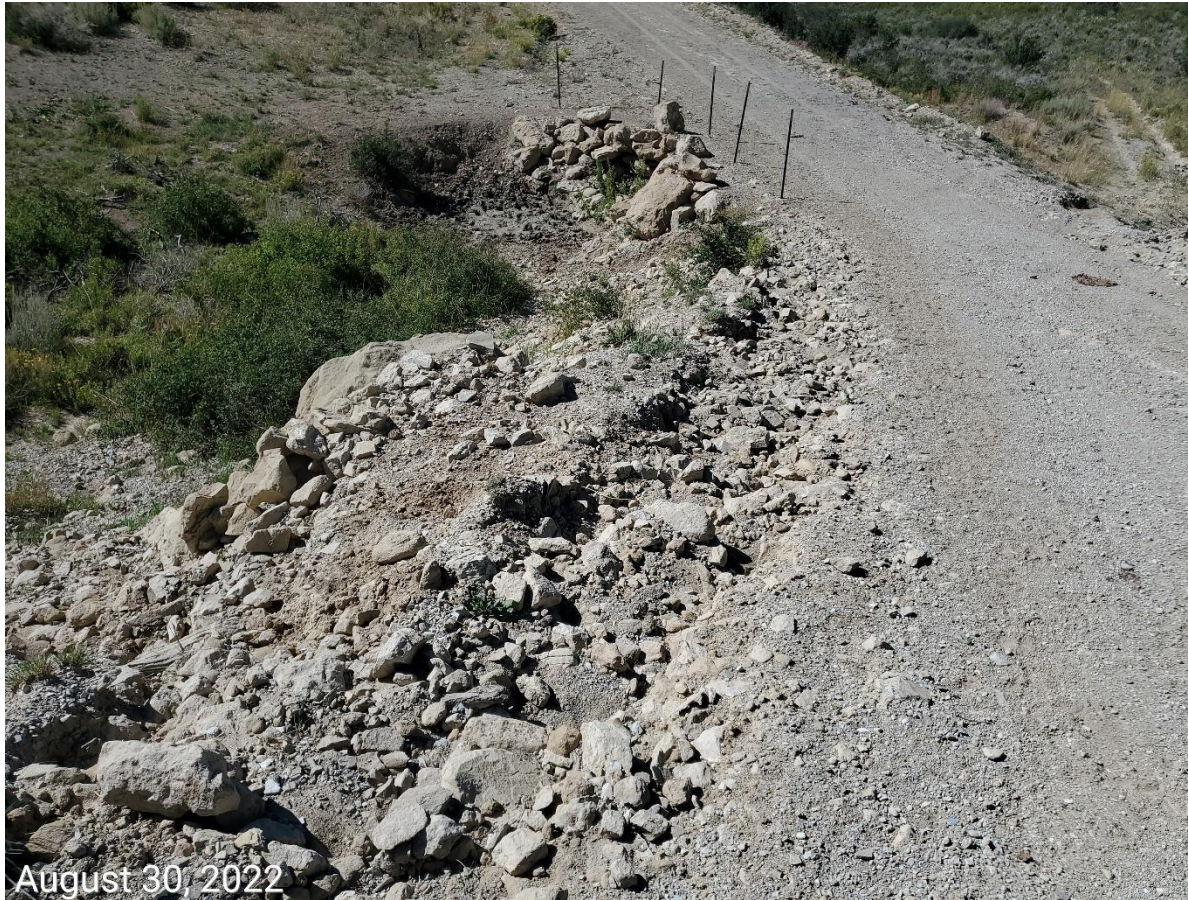
Photo 10: See comments under photo 7.

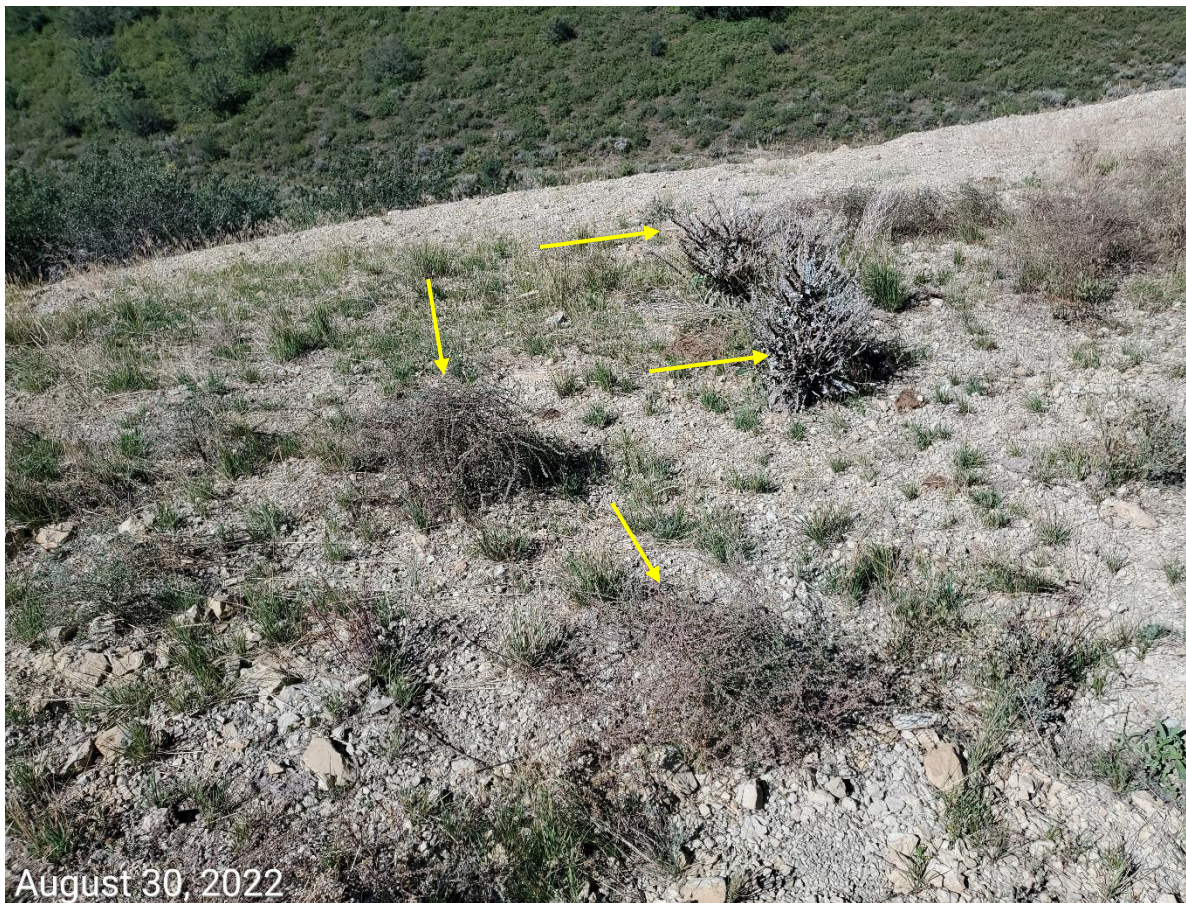
Photo 11: Photos examples showing Noxious weed (Houdstongue) on the Location; ongoing weed monitoring/management inadequate. Rosettes evident throughout location. Larger plants have matured with viable seeds.
