Inspection Photos and Issue Report

Operator: NONSUCH NATURAL GAS INC

Location #453726

Garfield County, CO

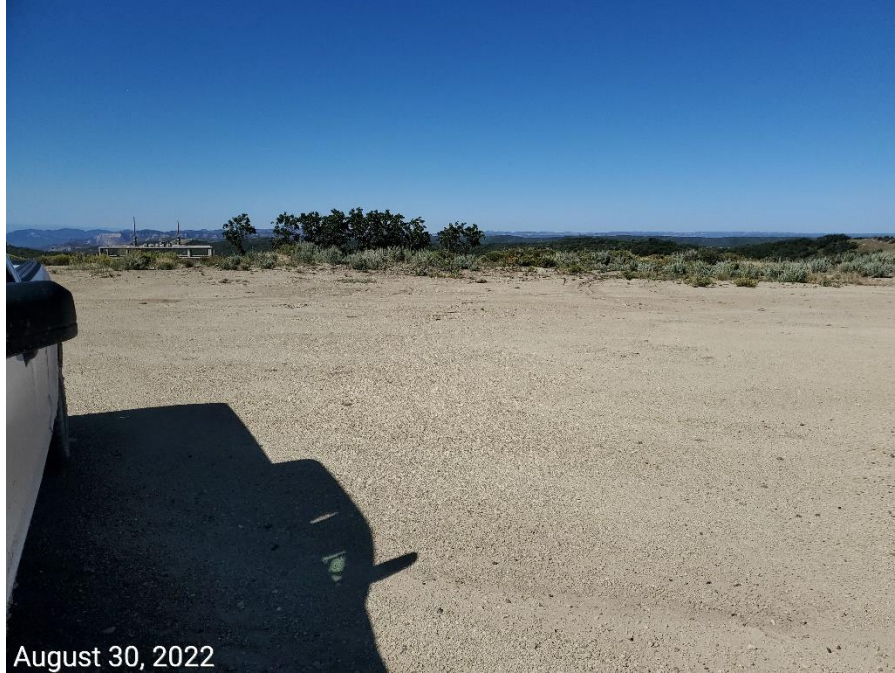
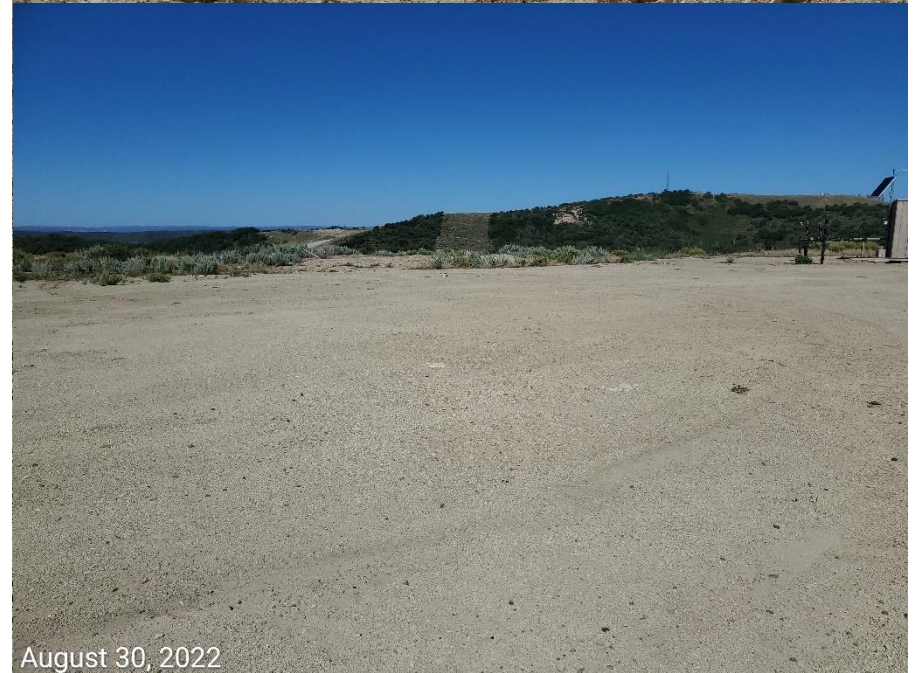
Photo 1: Photos taken from the east end of the Location. Photos 1-2 provide an overview of the Location from south, southwest, northwest to north.

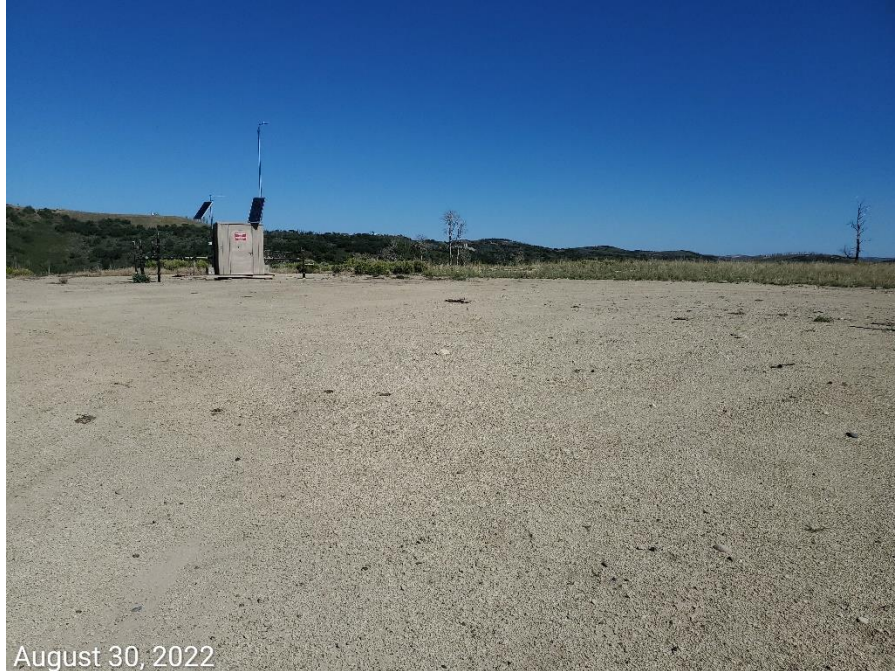
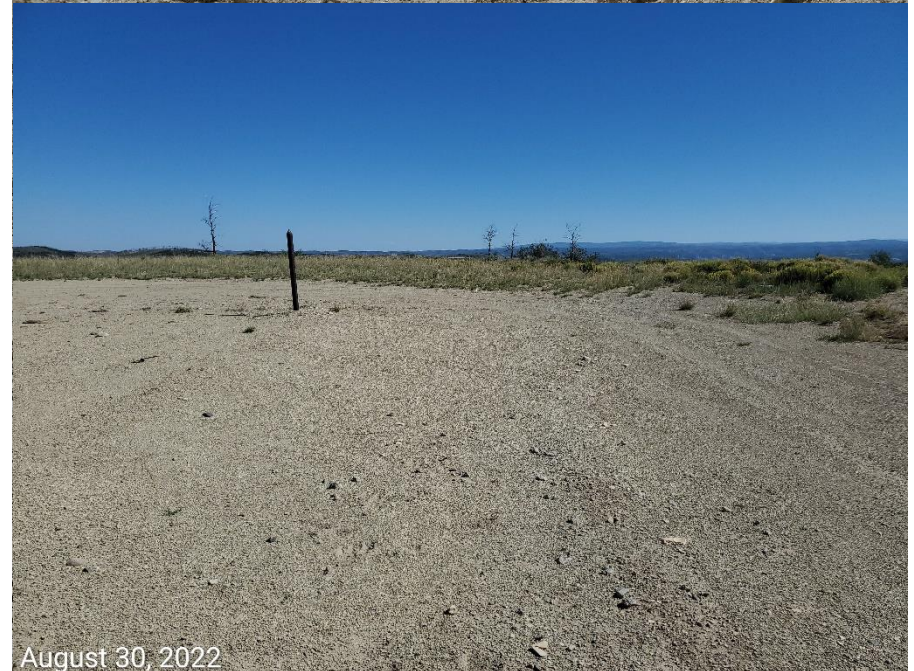
Photo 2: See comments under photo 1.

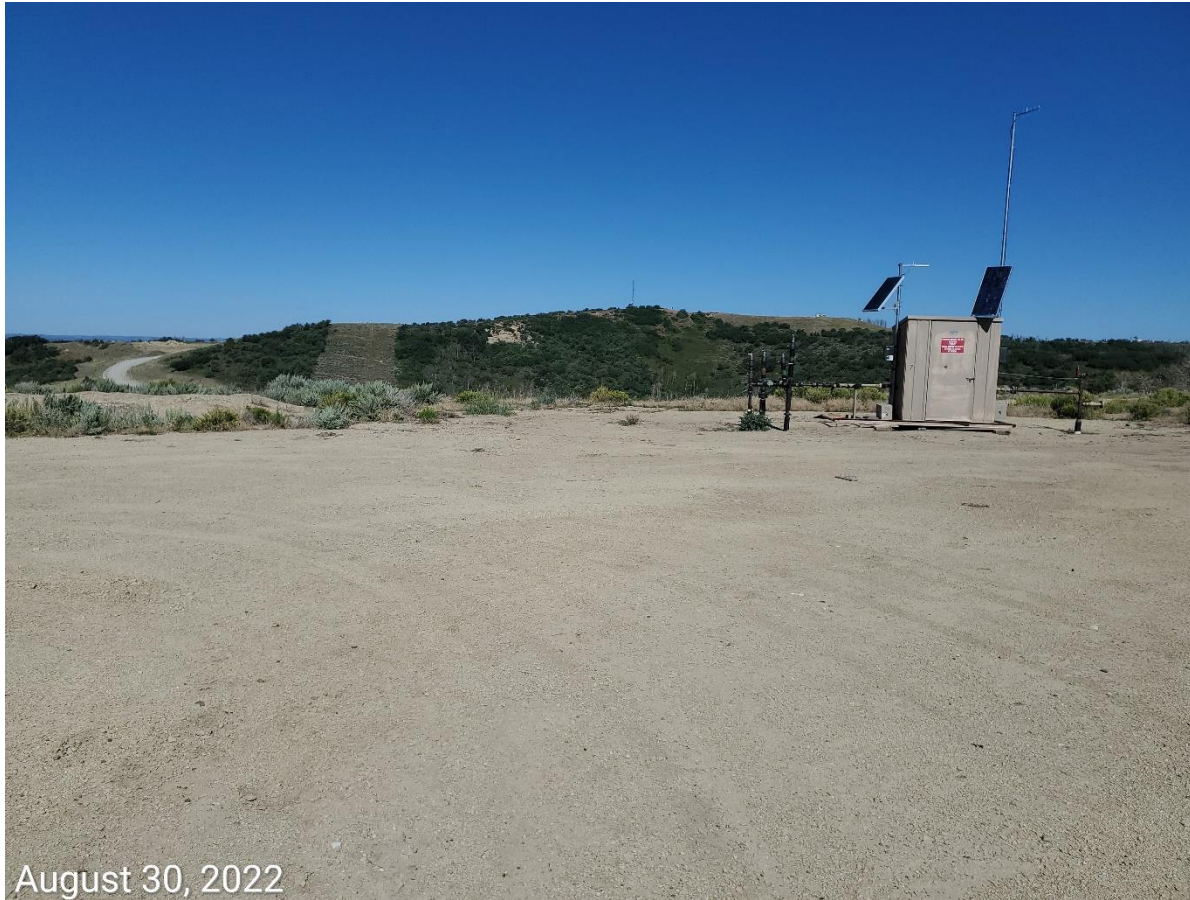
Photo 3: Photo shows unused equipment has been removed from the Location.

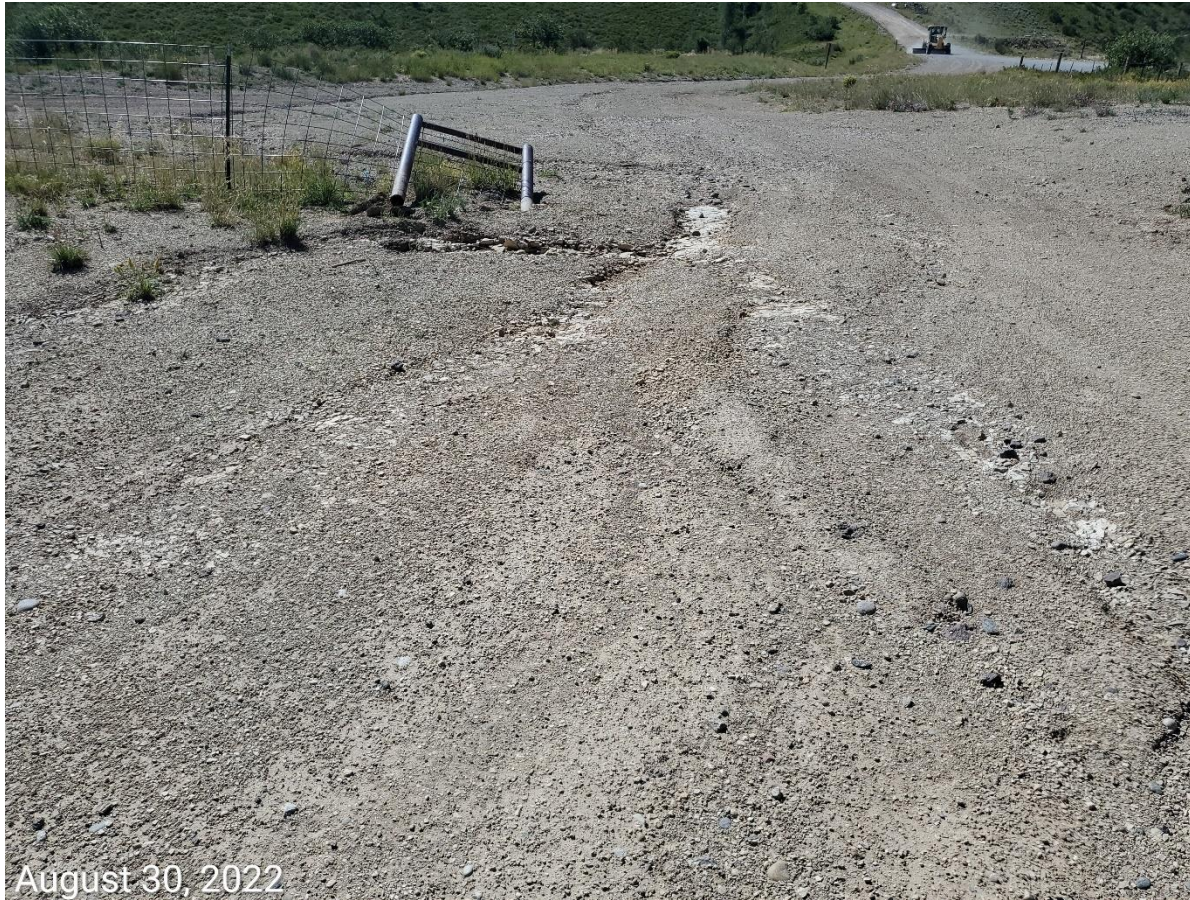
Photo 4: Photo taken from the east end of the Location, facing east. Photo shows stormwater runoff from the Location has resulted in erosion degradation at the Location entrance, and the access road; required stormwater and erosion control measures pursuant to Rule 1002.f remain missing or insufficient.

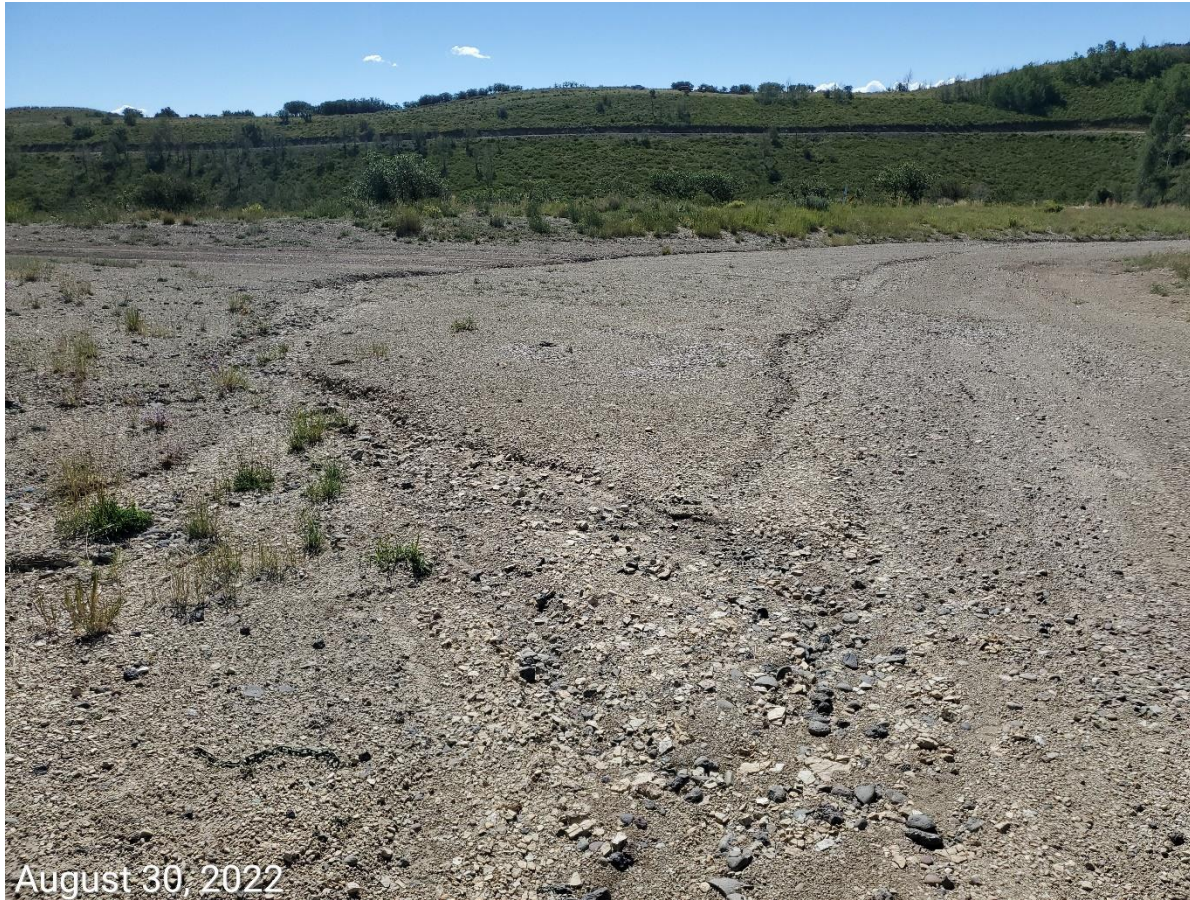
Photo 5: Photo taken from the access road, facing east. Photo shows stormwater runoff from the Location has resulted in erosion degradation at the Location entrance, and the access road; required stormwater and erosion control measures pursuant to Rule 1002.f remain missing or insufficient.

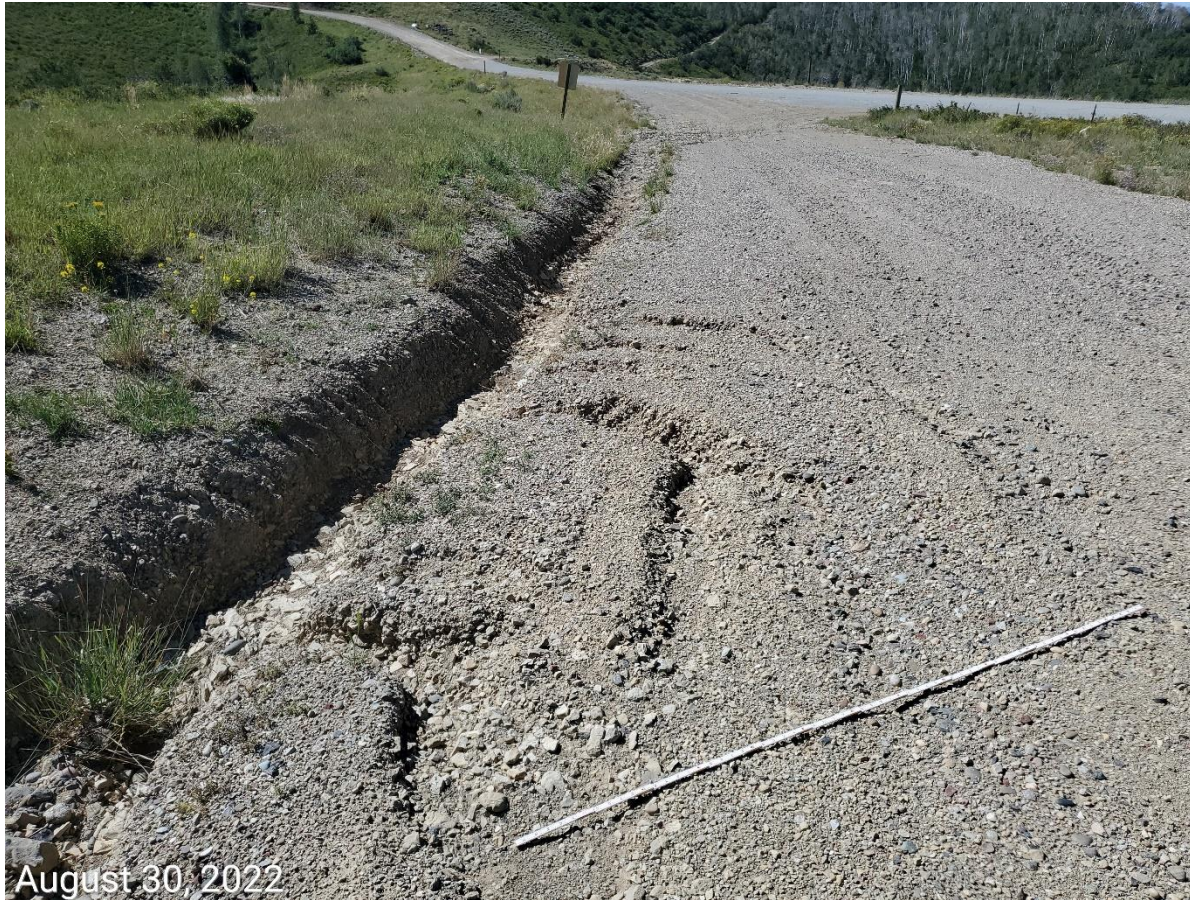
Photo 6: Photo taken from the access road, facing south. Photo shows stormwater runoff from the Location has resulted in erosion degradation at the Location entrance, and the access road; required stormwater and erosion control measures pursuant to Rule 1002.f remain missing or insufficient. 6 foot measuring stick for reference.

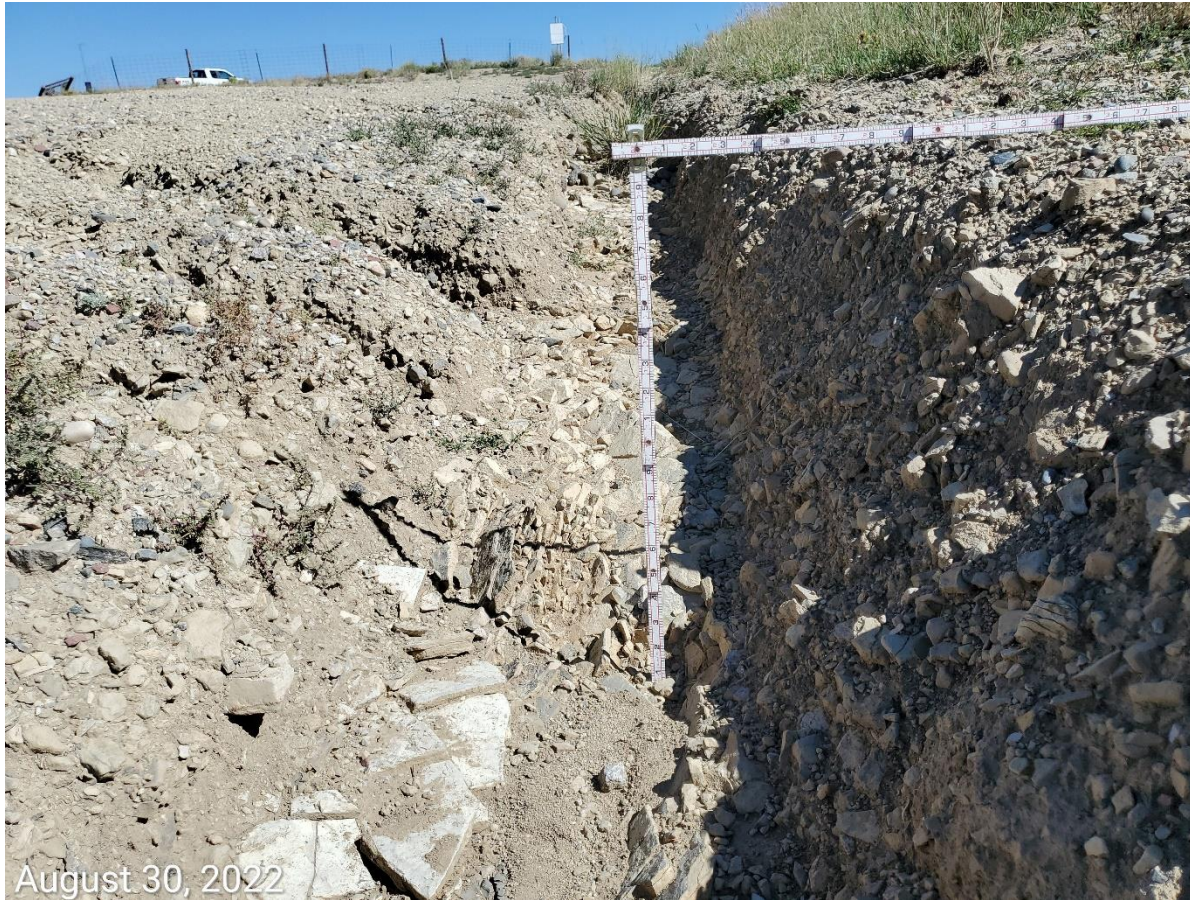
Photo 7: Photo taken from the access road. Photo shows gully erosion at access road is ~2 feet deep.
