Inspection Photos and Issue Report

8/30/2022

Operator: CAERUS PICEANCE LLC

Location #335455

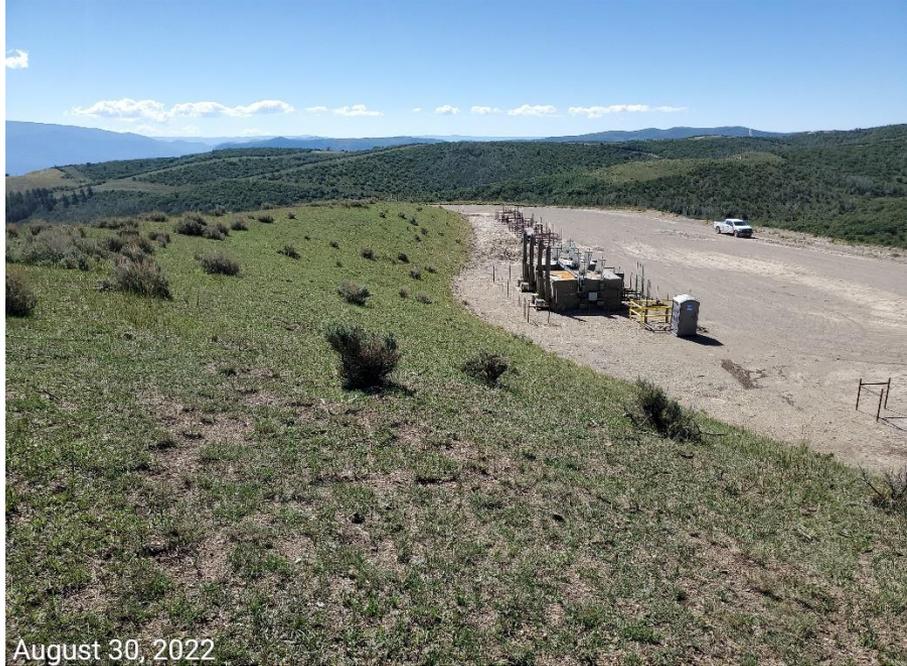
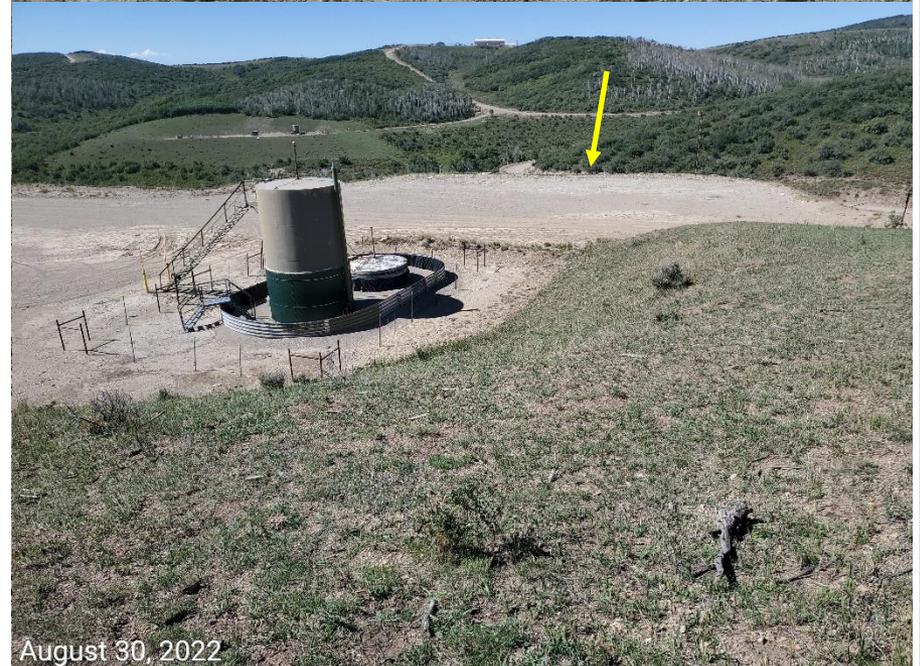
Photo 1: Photos taken from the north end of the Location. Photos provide an overview of the upper areas of the Location from south to southwest. Photo right also shows areas associated with the closed facility (arrow); are not needed for production operations.

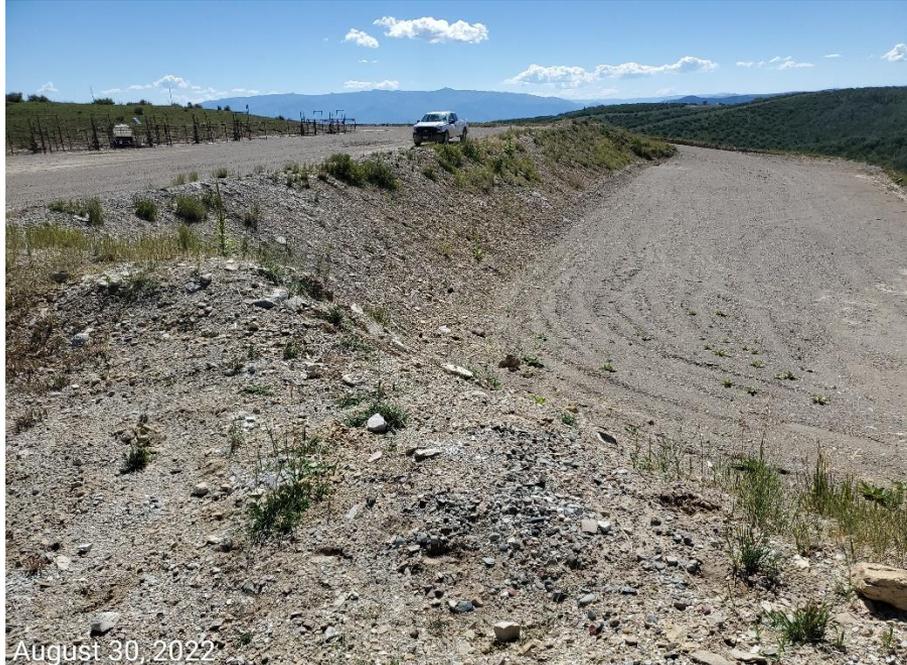
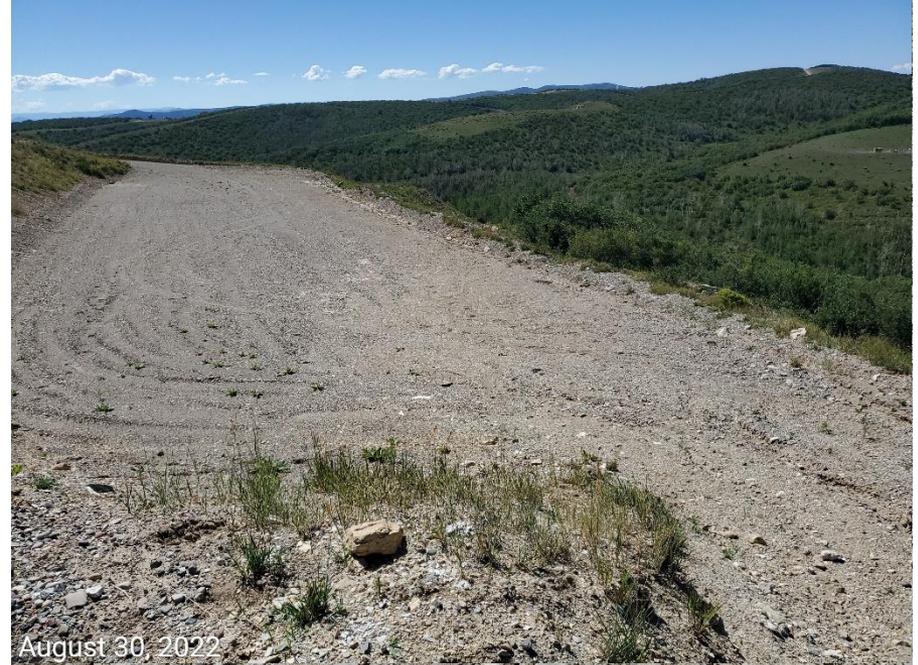
Photo 2: Photo taken from the west end of the Location, facing south. Photo shows the lower areas of the Location where the UIC facility existed; Facility has been closed and equipment removed; areas are not longer needed for production.

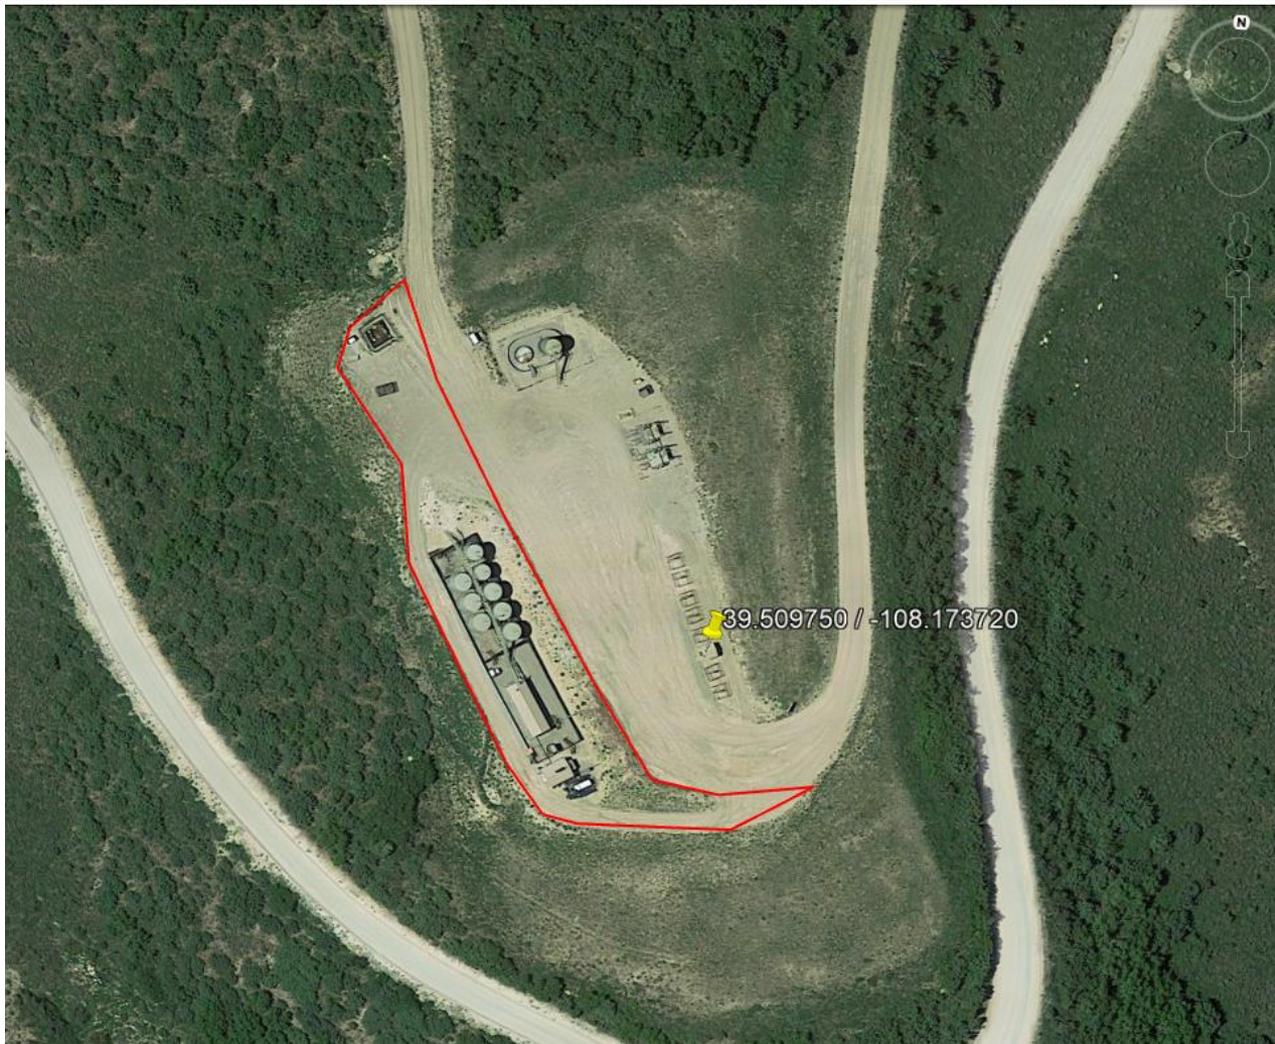
Photo 3: 2016 Google earth aerial imagery. Red polygon represents approximate areas (0.75 acres) of the Location no longer needed for production, subject to 1003 reclamation requirements; equipment has been removed and facility closed.

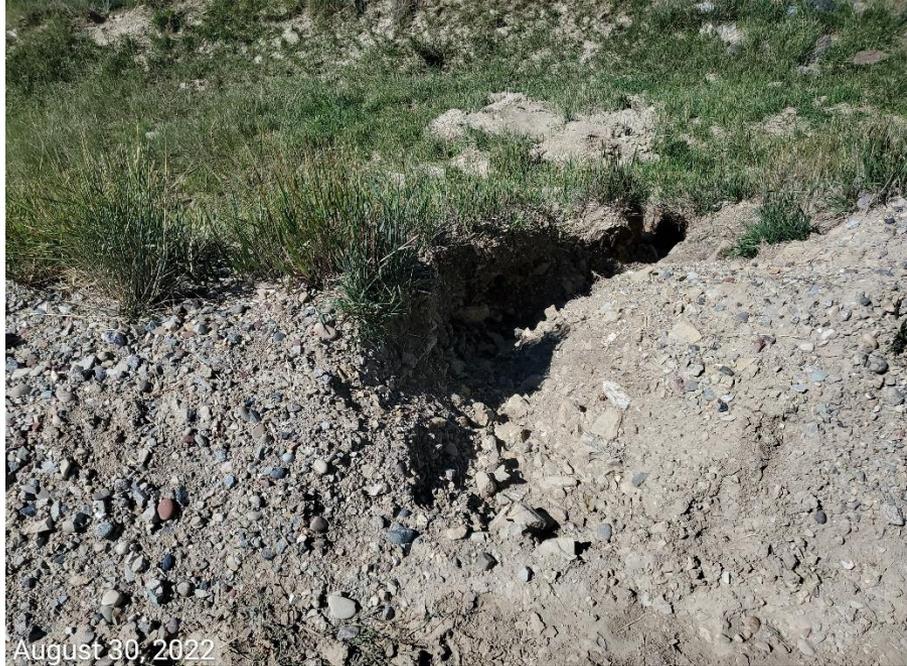
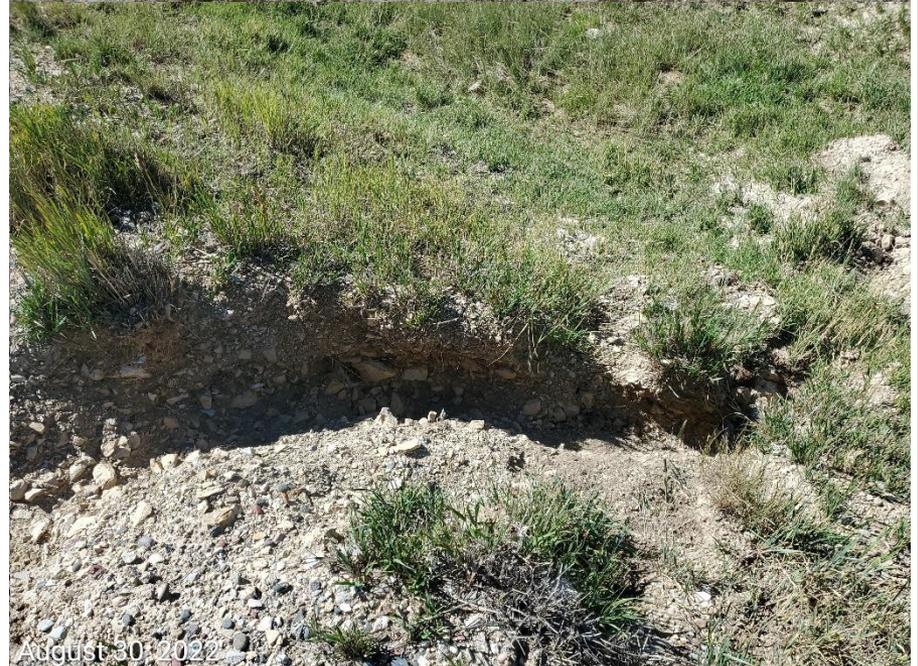
Photo 4: Photo taken from the sediment trap on the southwest end of the Location; BMP has not been maintained in proper functioning condition; photo shows gully erosion and degradation to the control.
