Inspection Photos and Issue Report

8/30/2022

Operator: LARAMIE ENERGY LLC #10433

Location #481742

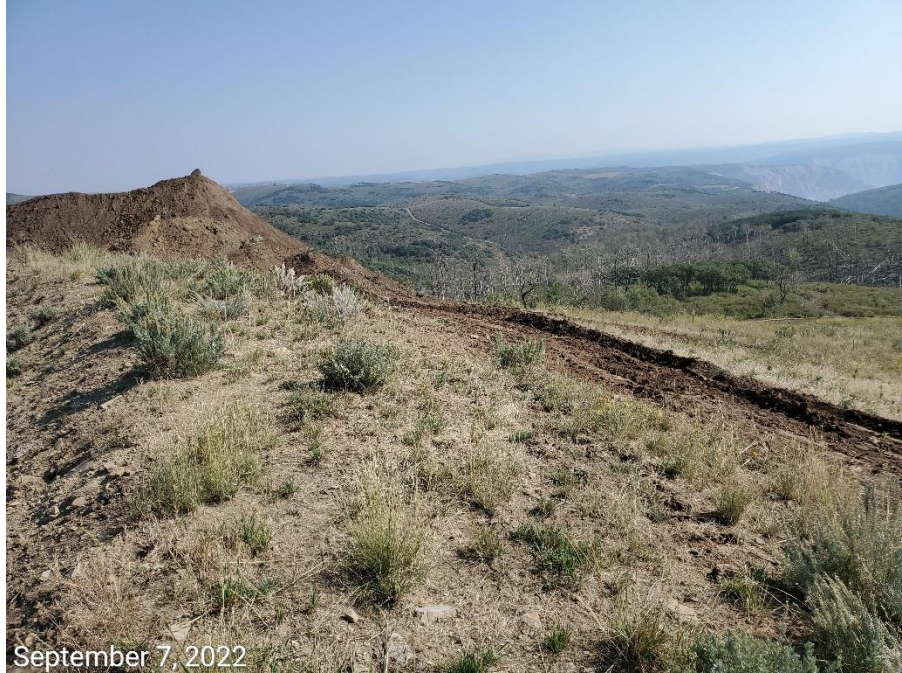
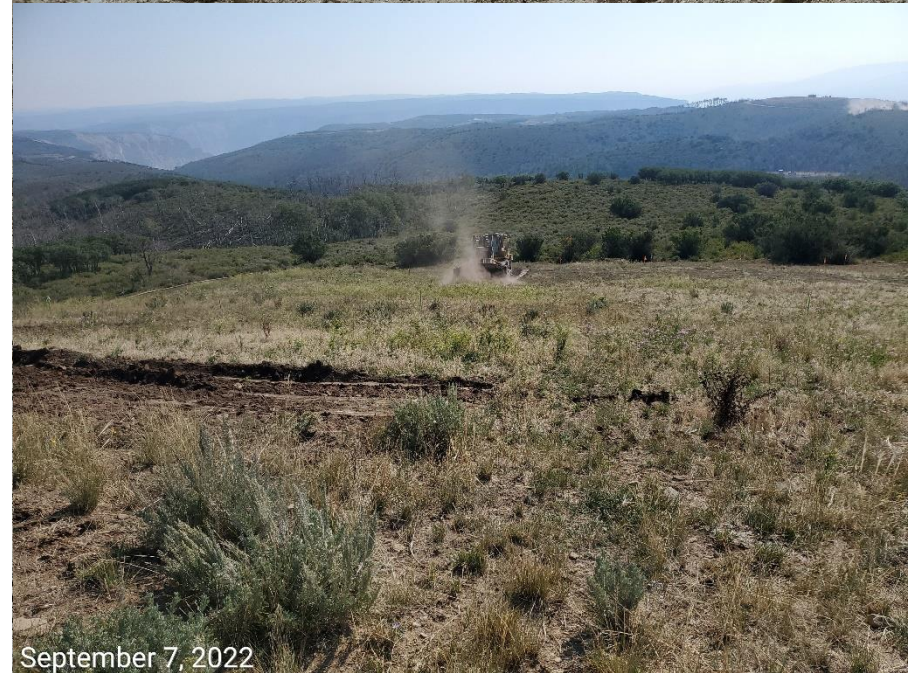
Photo 1: Photos taken from the west end of the current CC 697-15-54 Location #335803 working pad area; construction of the Annex Cuttings Facility Location #481742 will include portions of the CC working pad. Photos 1-2 provide an overview of the Location from north, northeast, southeast, to south. Photos show construction (soil salvage) operations “in-process” at time of inspection.

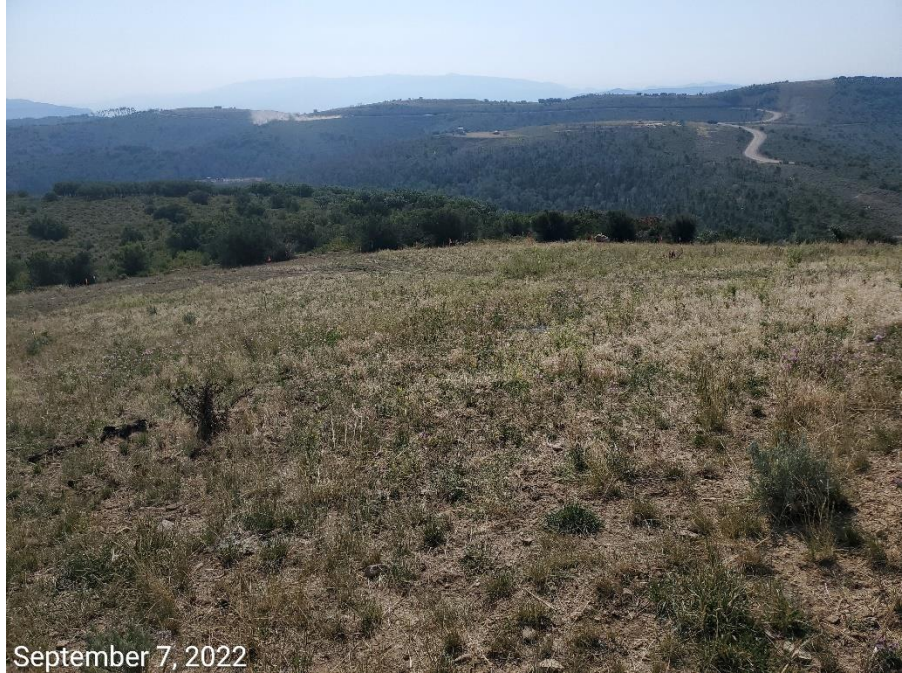
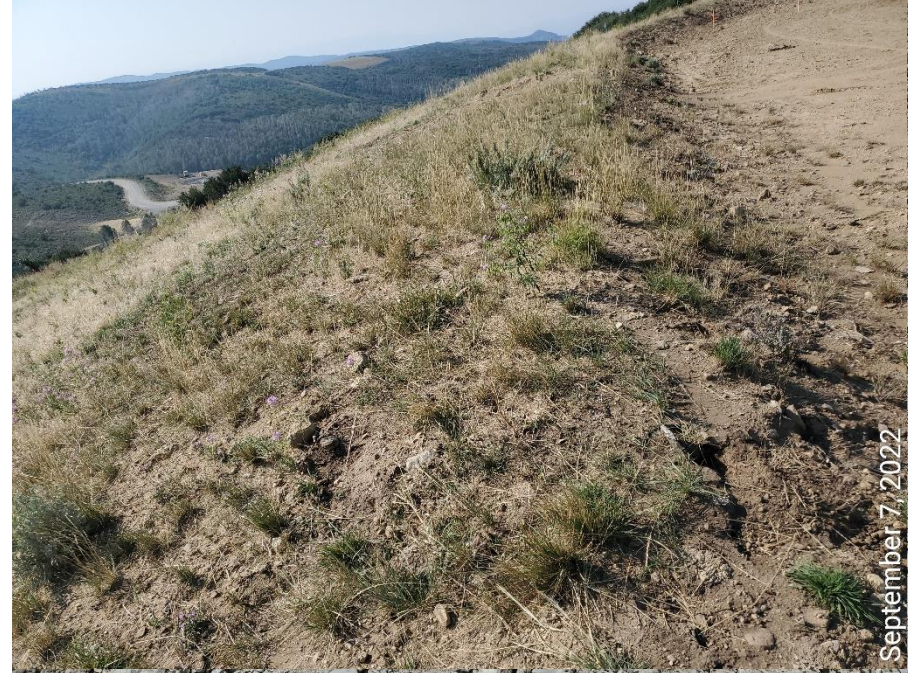
Photo 2: See comments under photo 1.

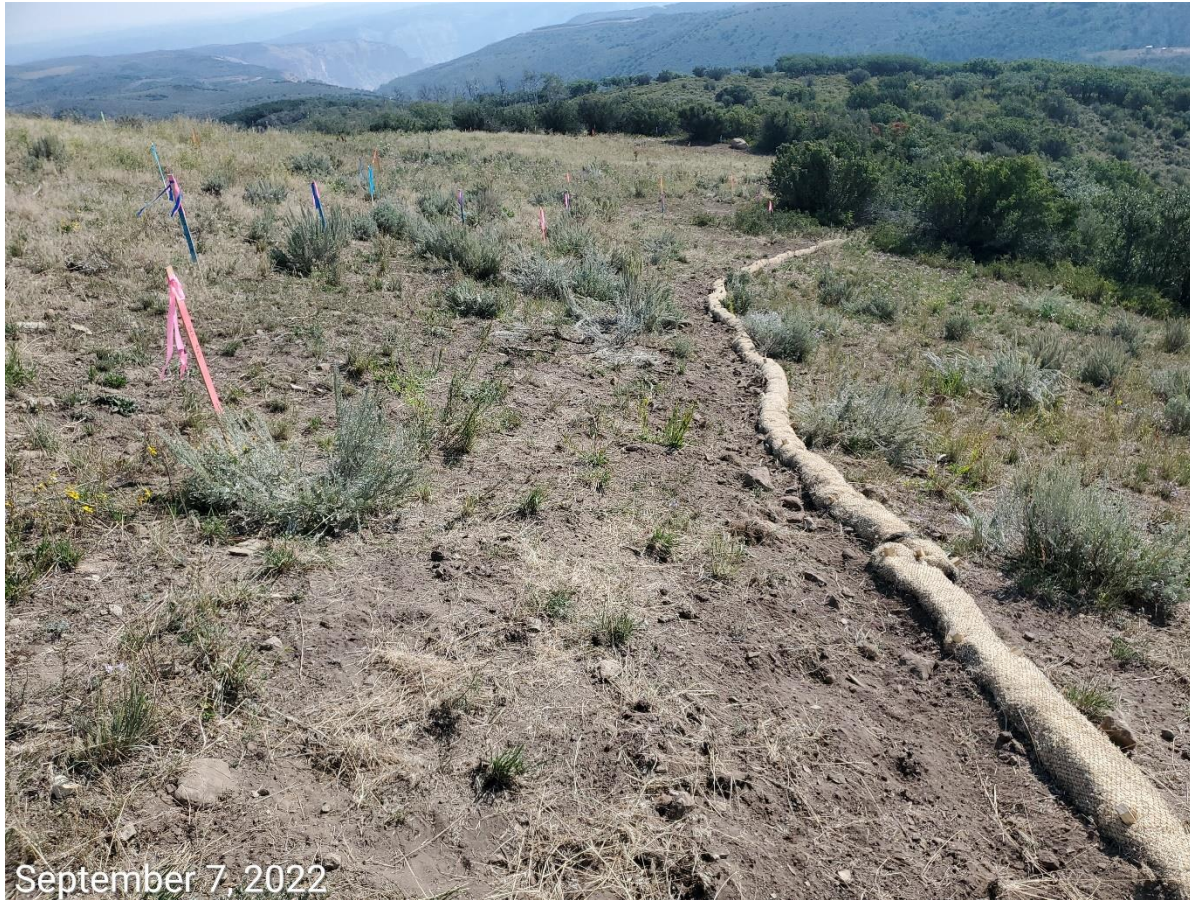
Photo 3: Photo example showing erosion logs (straw wattles) installed along the eastern perimeter of the Location.

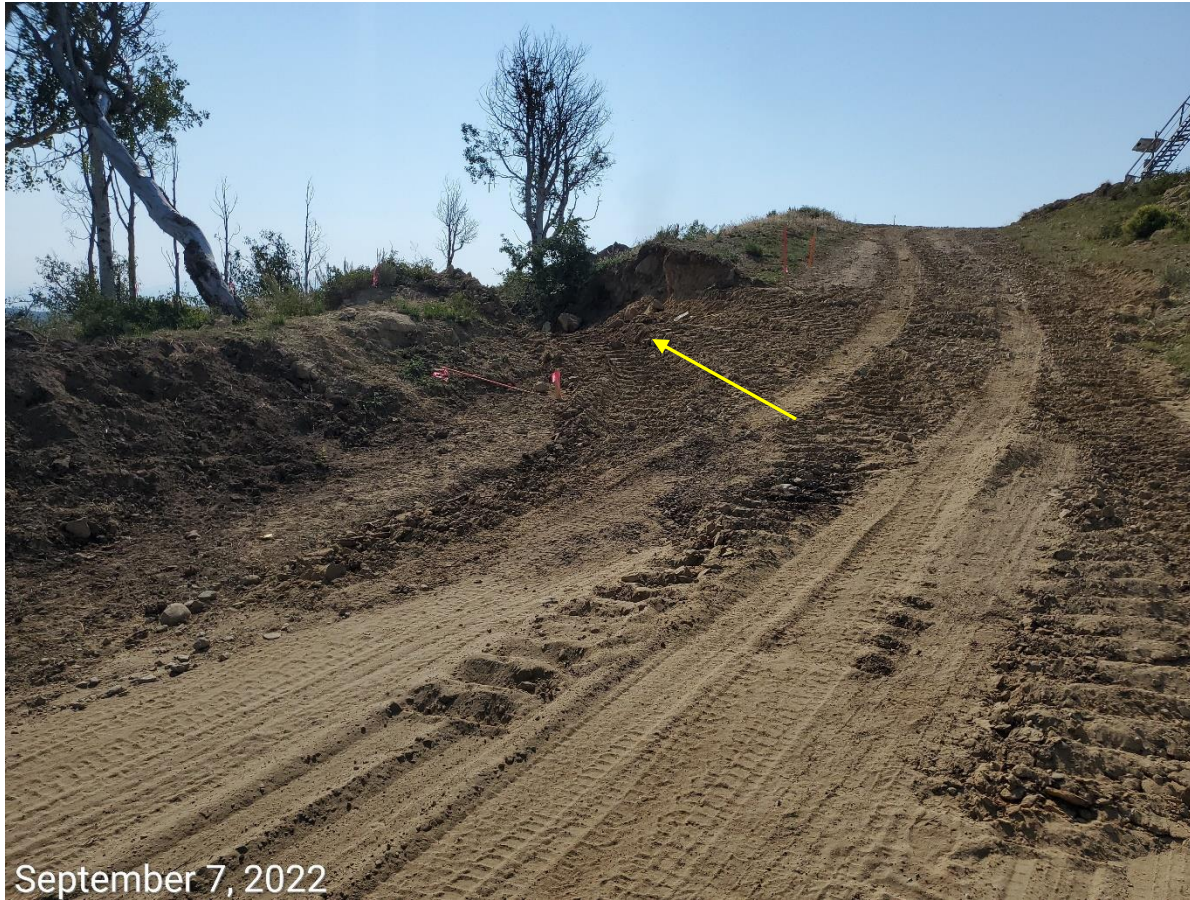
Photo 4: Photo taken from the access road. Photo shows Location entrance for the Annex Cuttings Facility (arrow). Location entrance signage not posted; Form 2A also not posted on Location.

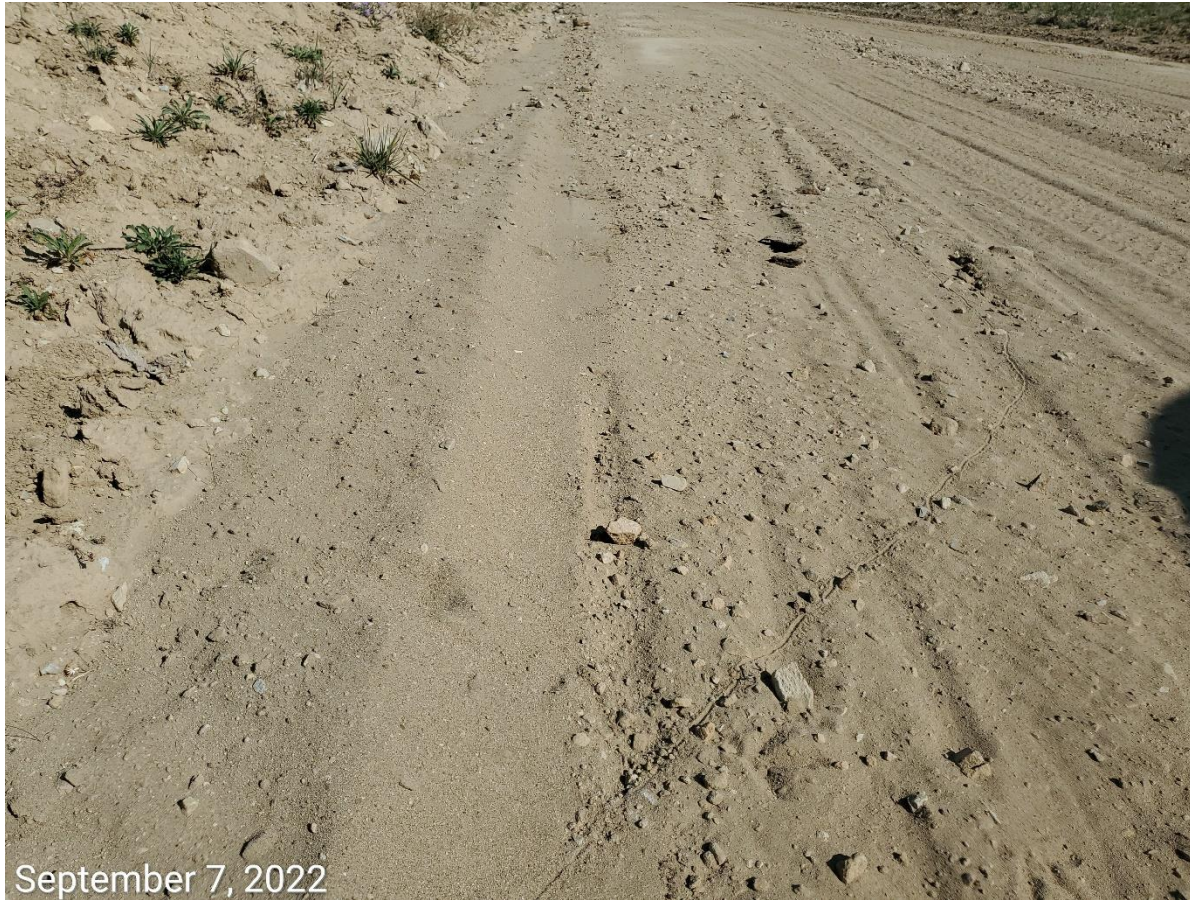
Photo 5: Photo taken from the access road. Soil along access road loose/powdery and at risk to wind erosions; application of freshwater to soils not observed; water truck not observed on site or within immediate areas.

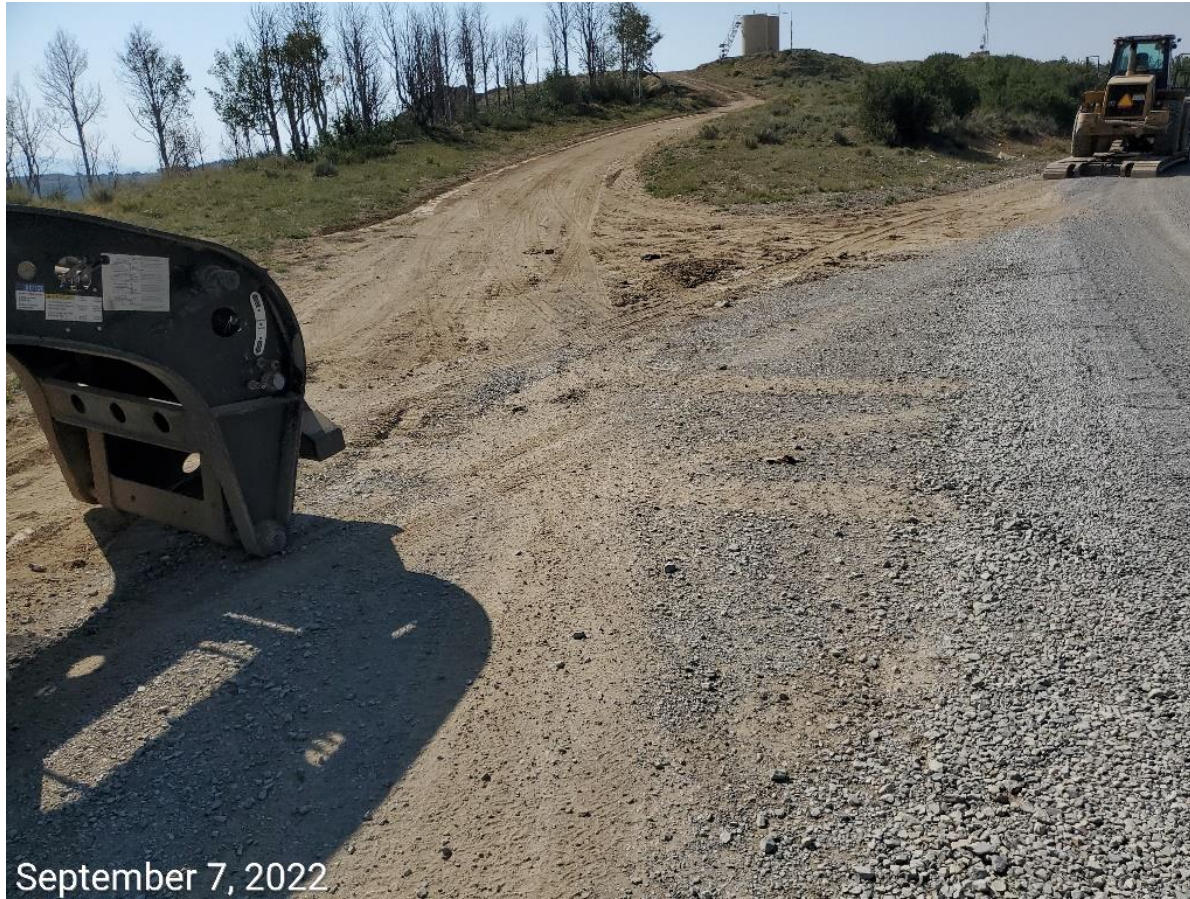
Photo 6: Photo taken from the turn-off from the main lease road, and the access road leading to the Location. Photo shows controls to minimize tracking and sediment transport was missing or insufficient; sediment transport observed.
