# Inspection Photos

Operator: EOG Resources Inc - #27742

Location Name: Warlock State-611N91W /3NWNE

Inspection Document #: 702800661

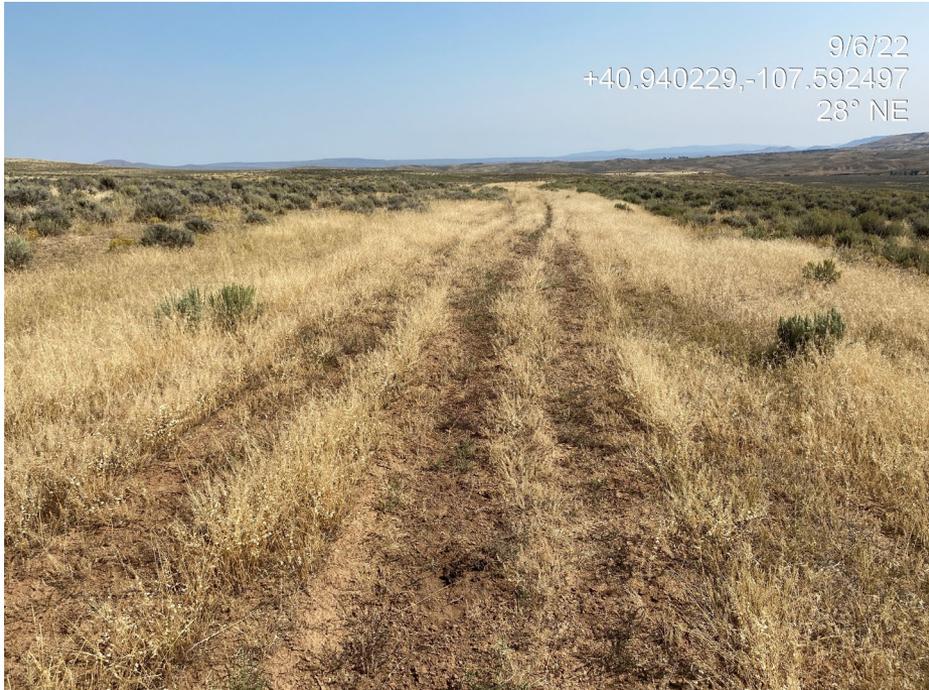
**Photo 1.** Photo taken to the west of the Location shows a portion of the access road dominated by annual undesirable plant species (clasping pepperweed, Russian thistle, alyssum) and Noxious Weeds (cheatgrass).

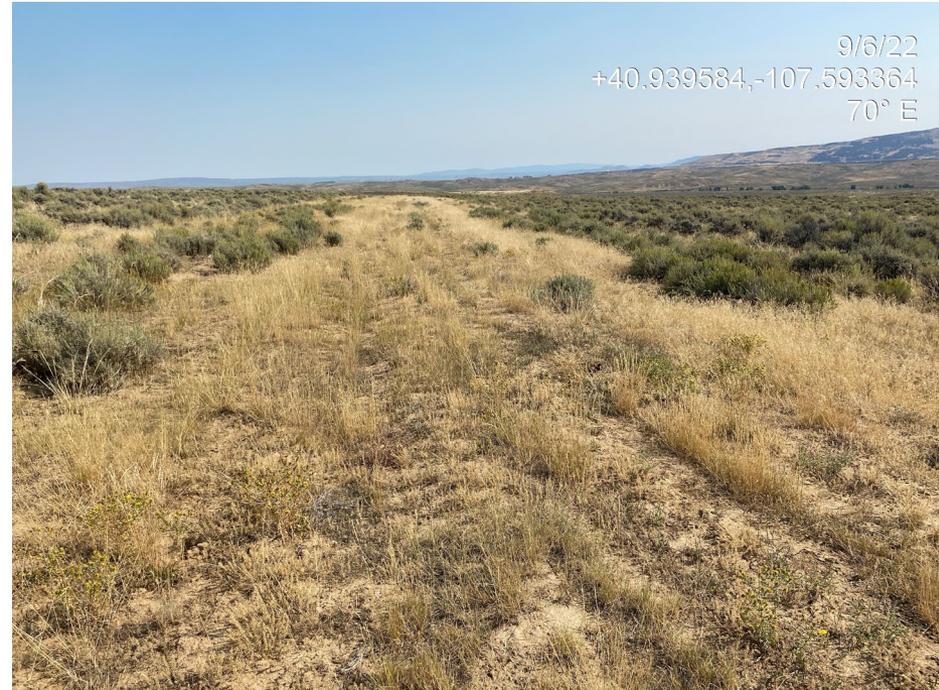
**Photo 2.** Photo taken to the west of the Location shows a portion of the access road where desirable perennial vegetation is well established.

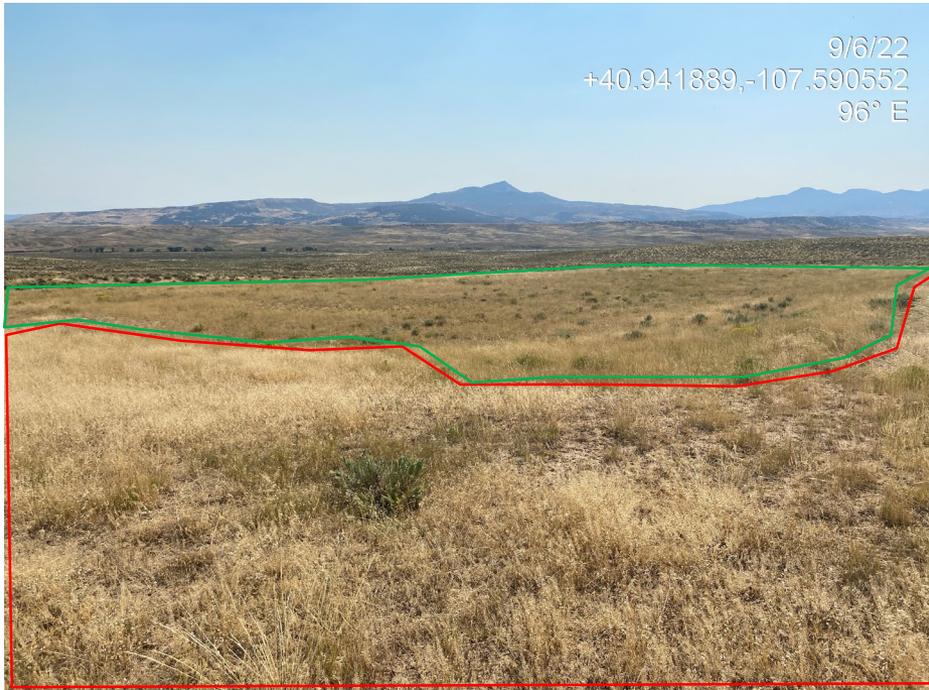
**Photo 3.** Photo taken from the northwest shows an overview of the Location. Photo shows areas of the Location with good perennial establishment (green) and poor perennial establishment/high cover of annual weeds including cheatgrass (red).

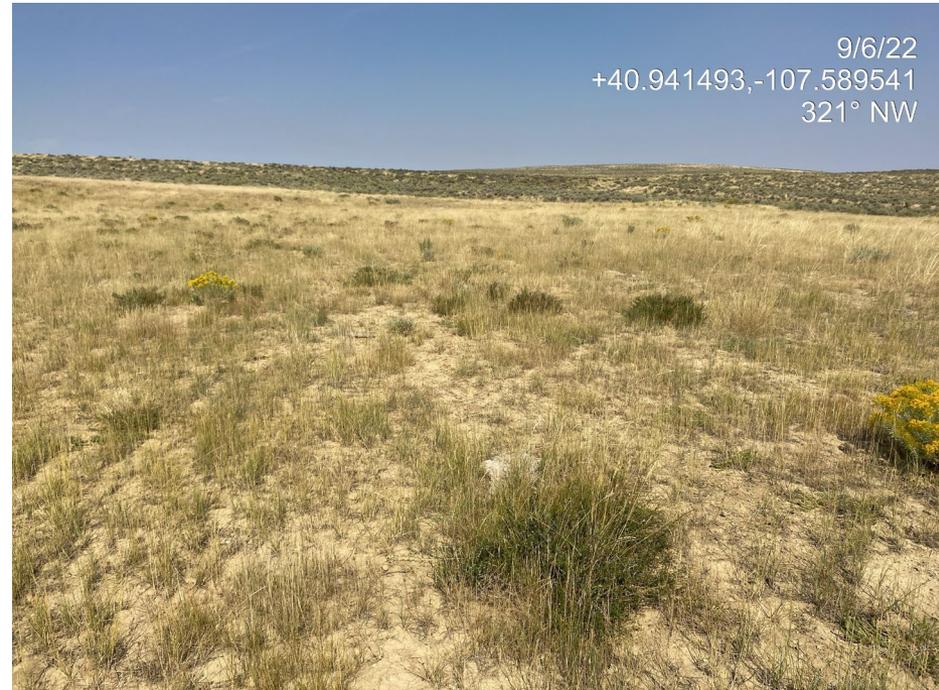
**Photo 4.** Photo shows the vegetation community on the eastern portion of the Location (see Photo 3 green polygon). Desirable perennial vegetation dominates and additional reclamation is not required in this area.

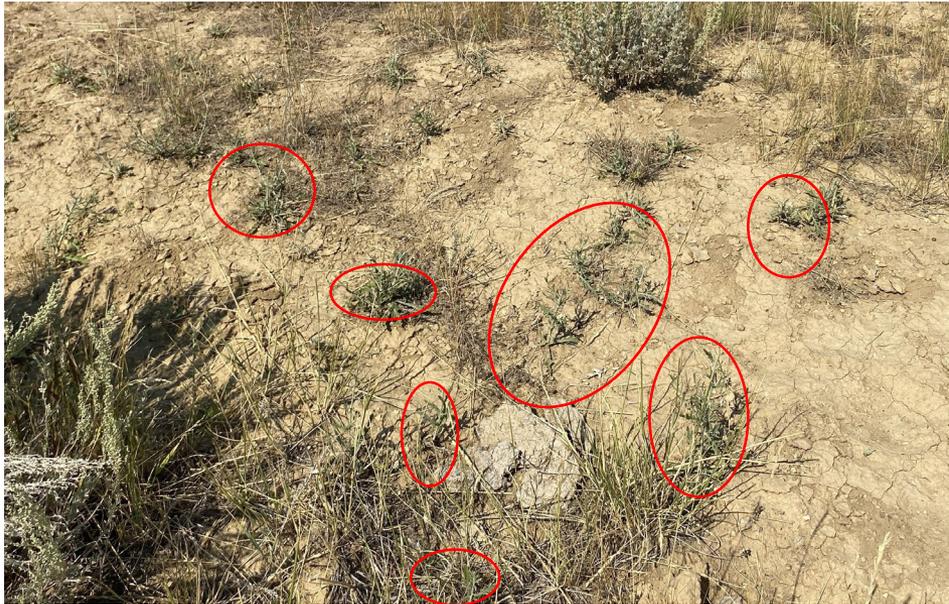
**Photo 5.** Photo shows a close-up of a small patch of Russian knapweed (List B Noxious) at the south of the Location (approximate coordinates: 40.941201, -107.589558).

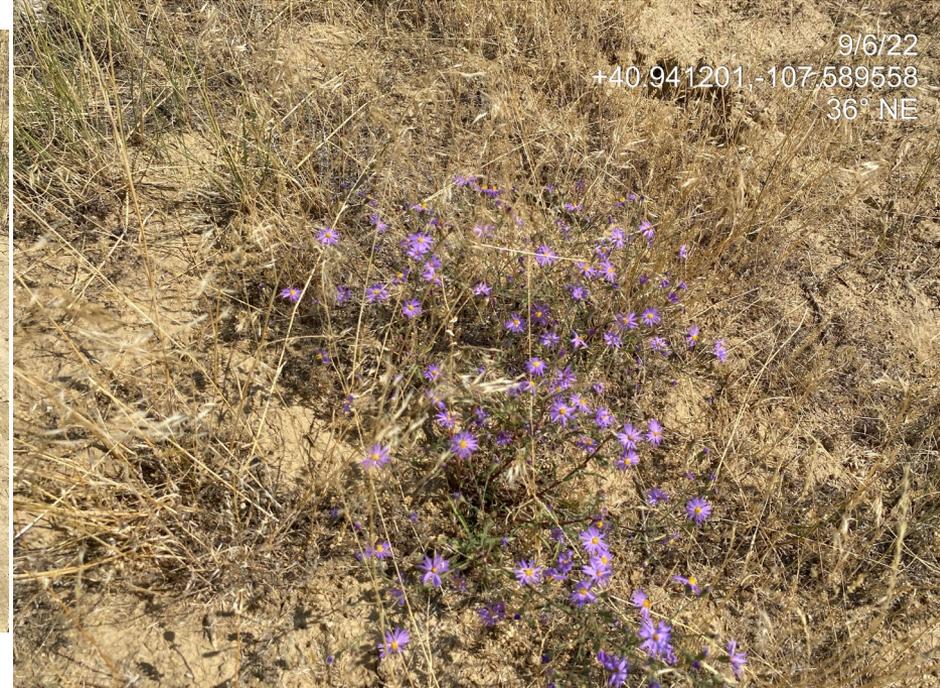
**Photo 6.** Photo shows an example of hoary tansyaster, a native perennial plant often mistaken for knapweed. Hoary tansyaster is widespread and common on Location, and contributing favorably to desirable cover. This plant should not be mistaken for knapweed.

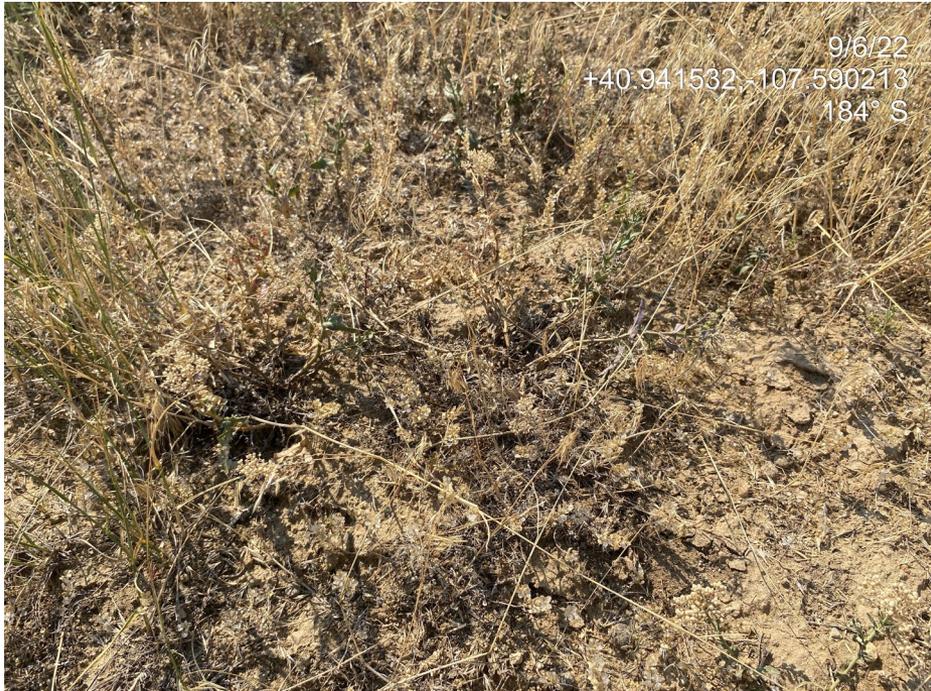
**Photo 7.** Photo taken from the west of the Location shows a patch of whitetop (List B Noxious) which has gone to seed.

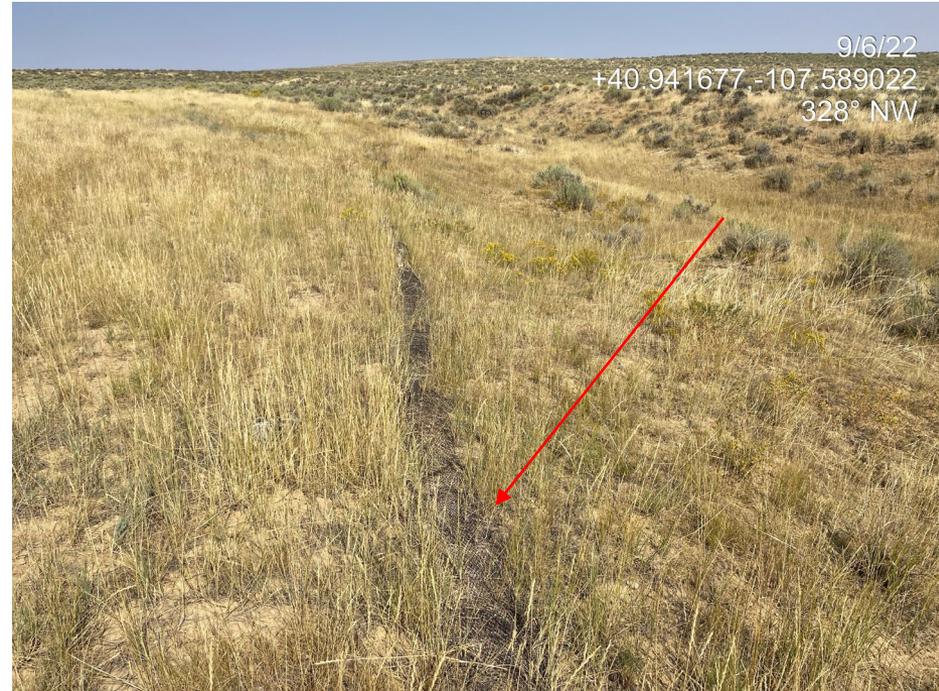
**Photo 8.** Photo taken from the east of the Location shows a straw wattle installed along the downslope perimeter of the Location. This wattle must be removed and long term stabilization must be achieved before the site can receive a passing final reclamation inspection.

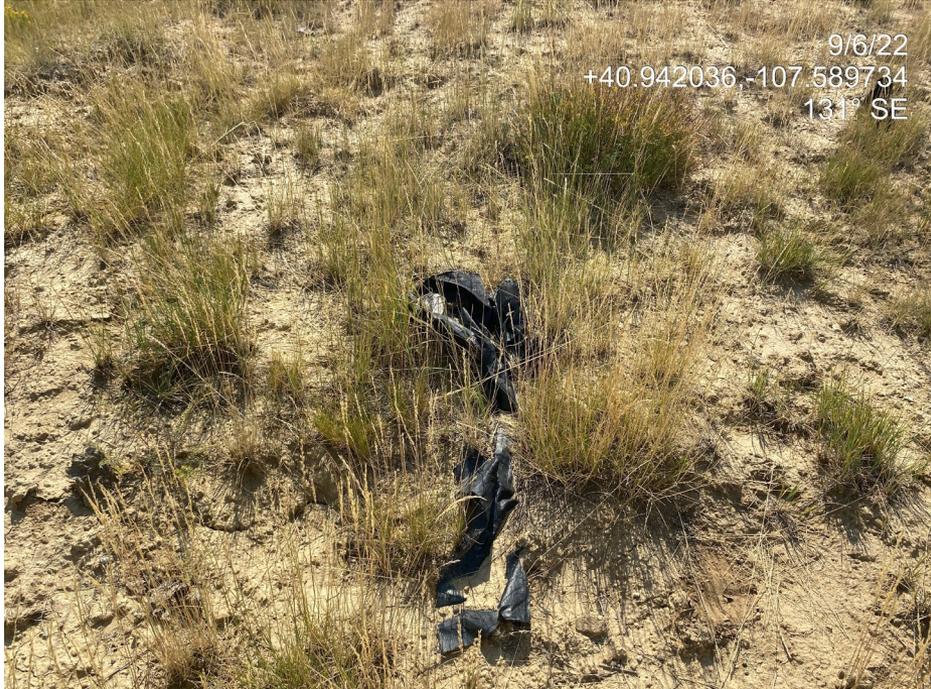
**Photo 9.** Photo shows an example of trash/debris which is scattered throughout the Location.

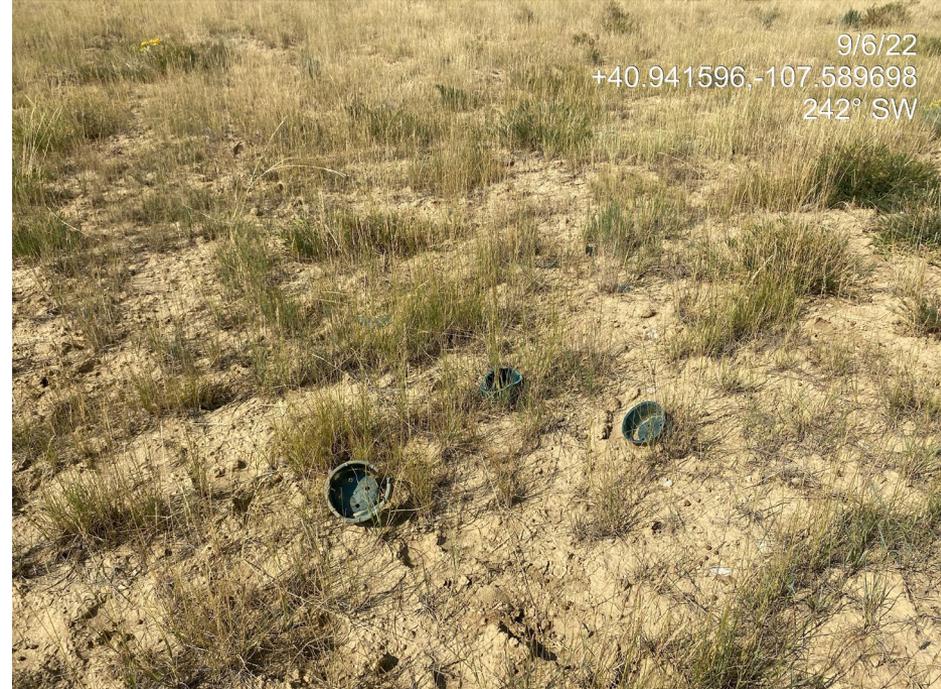
**Photo 10.** Photo shows an example of trash/debris which is scattered throughout the Location.

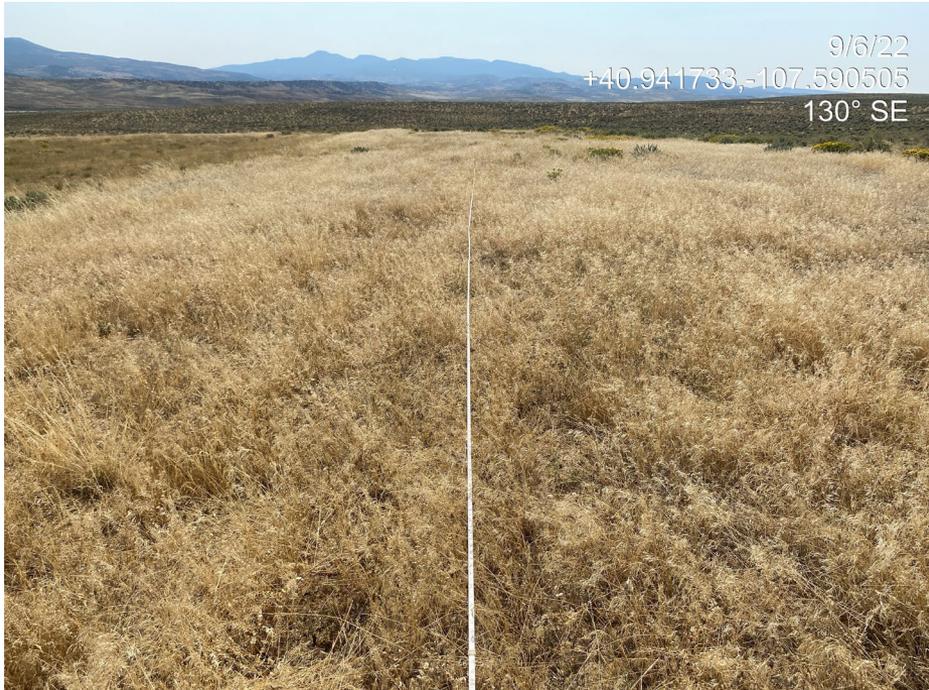
**Photo 11.** Photo taken from the northwest of the Location shows the start of the disturbed area vegetation monitoring transect.

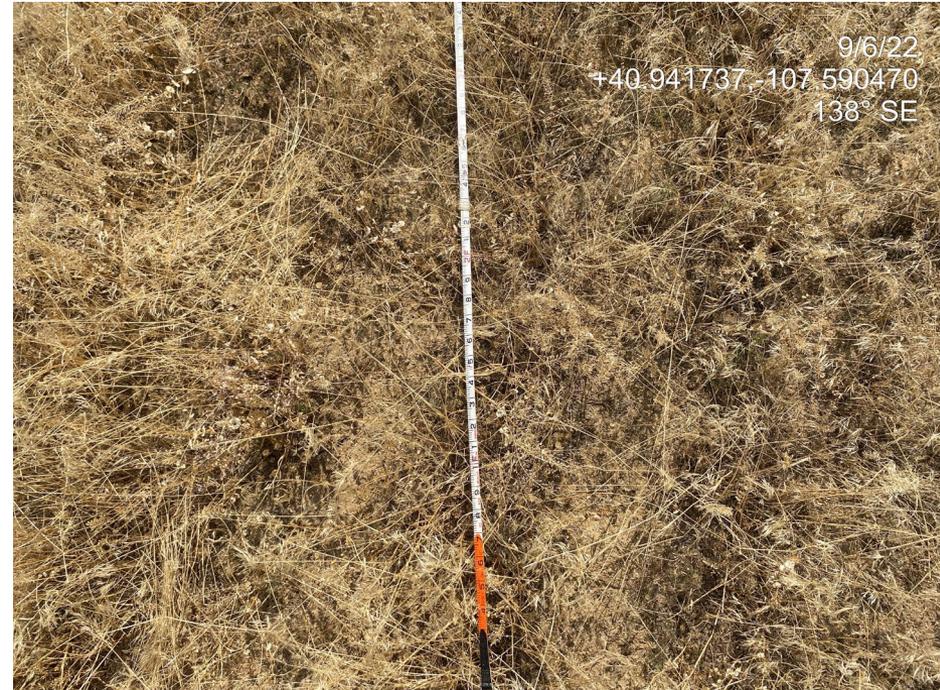
**Photo 12.** Photo taken from the northwest of the Location shows the ground surface at the start of the disturbed area vegetation monitoring transect.

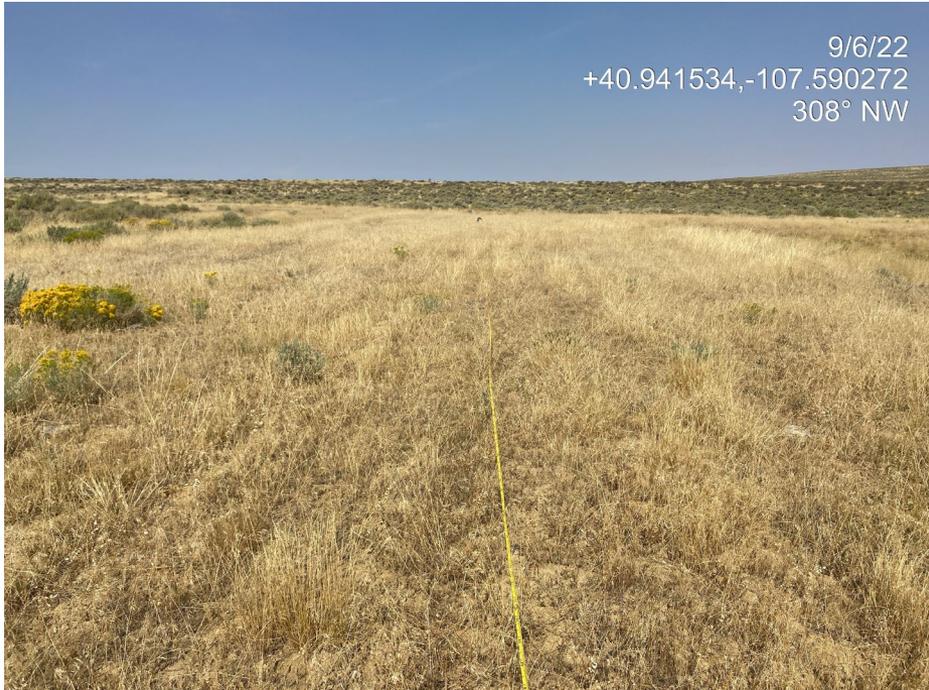
**Photo 13.** Photo taken from the west of the Location shows the end of the disturbed area vegetation monitoring transect.

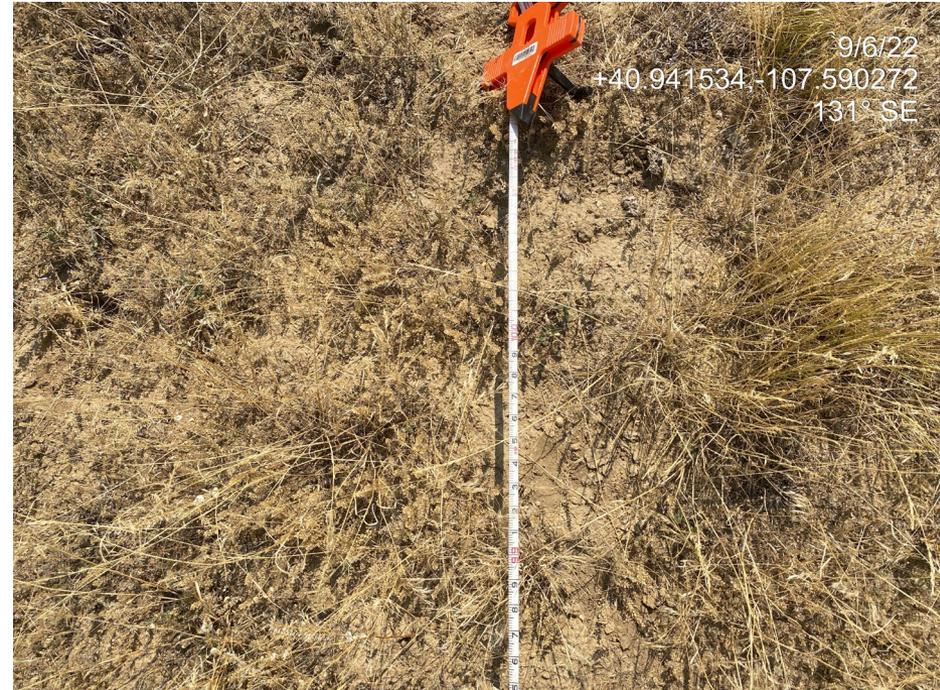
**Photo 14.** Photo taken from the west of the Location shows the ground surface at the end of the disturbed area vegetation monitoring transect.

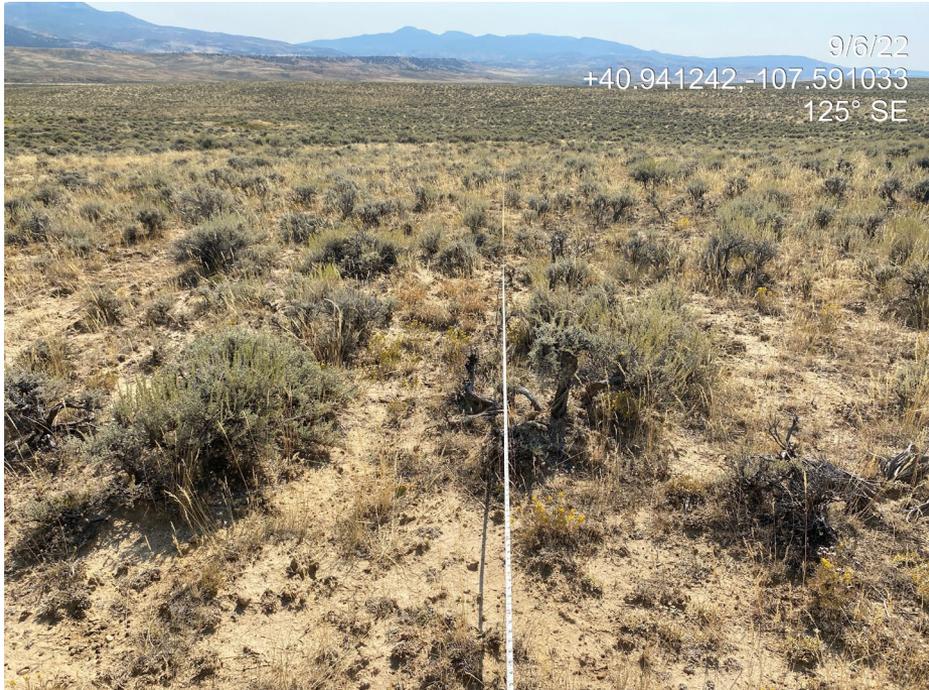
**Photo 15.** Photo taken to the west of the Location shows the start of the reference area vegetation monitoring transect.

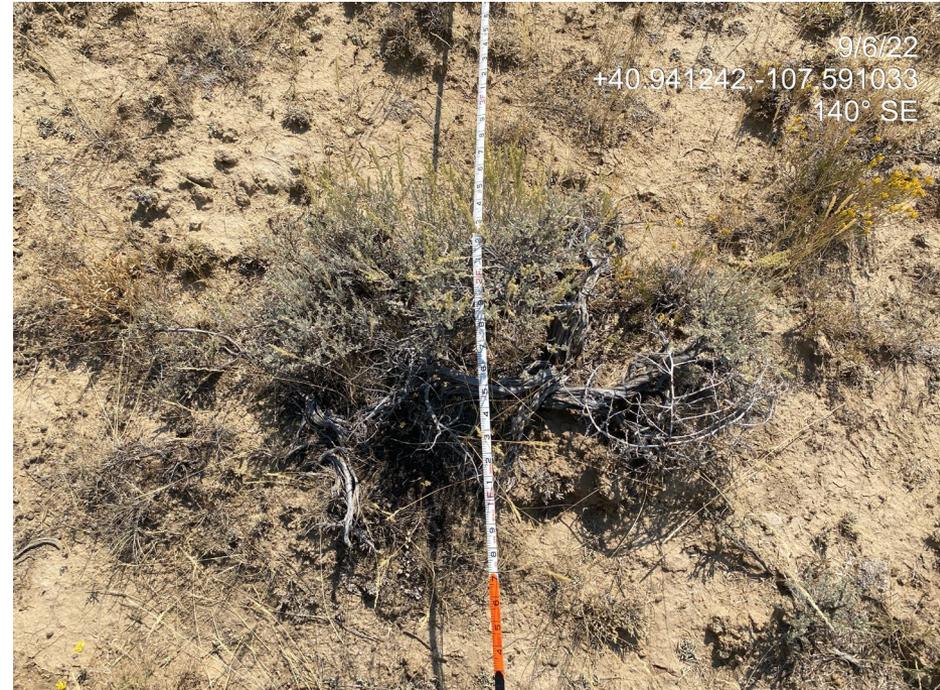
**Photo 16.** Photo taken to the west of the Location shows the ground surface at the start of the reference area vegetation monitoring transect.

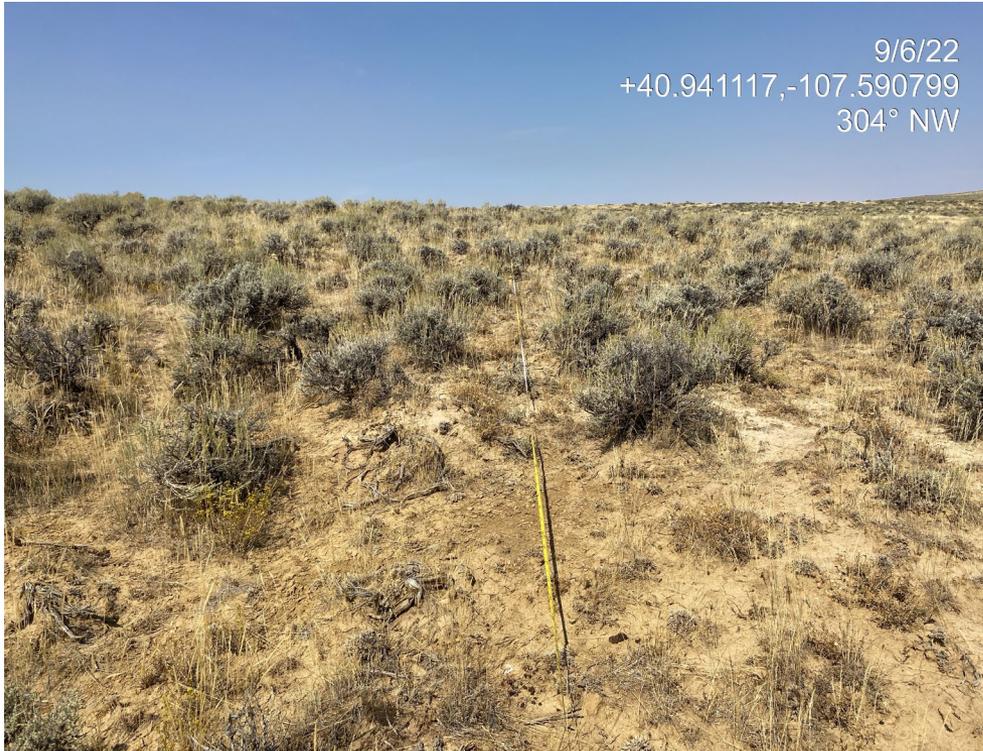
**Photo 17.** Photo taken to the west of the Location shows the end of the reference area vegetation monitoring transect.

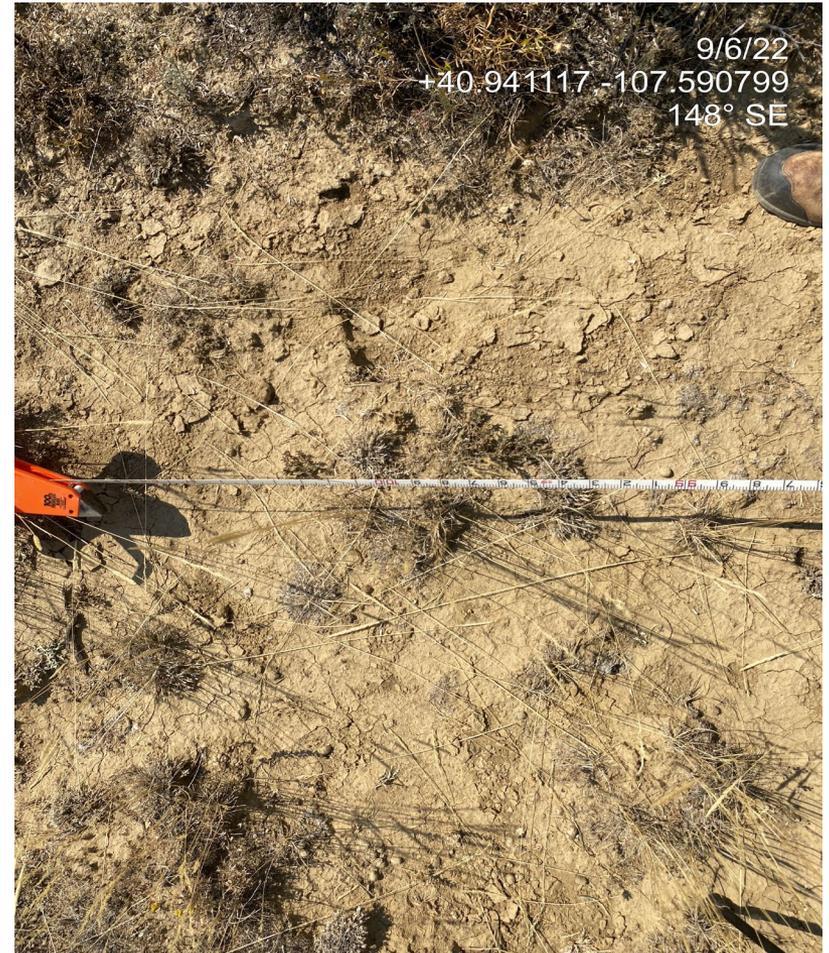
**Photo 18.** Photo taken to the west of the Location shows the ground surface at the end of the reference area vegetation monitoring transect.
