# Inspection Photos

Operator: True Oil LLC - #90450

Location Name: Peak State-611N91W /10NWNW

Inspection Document #: 702800666

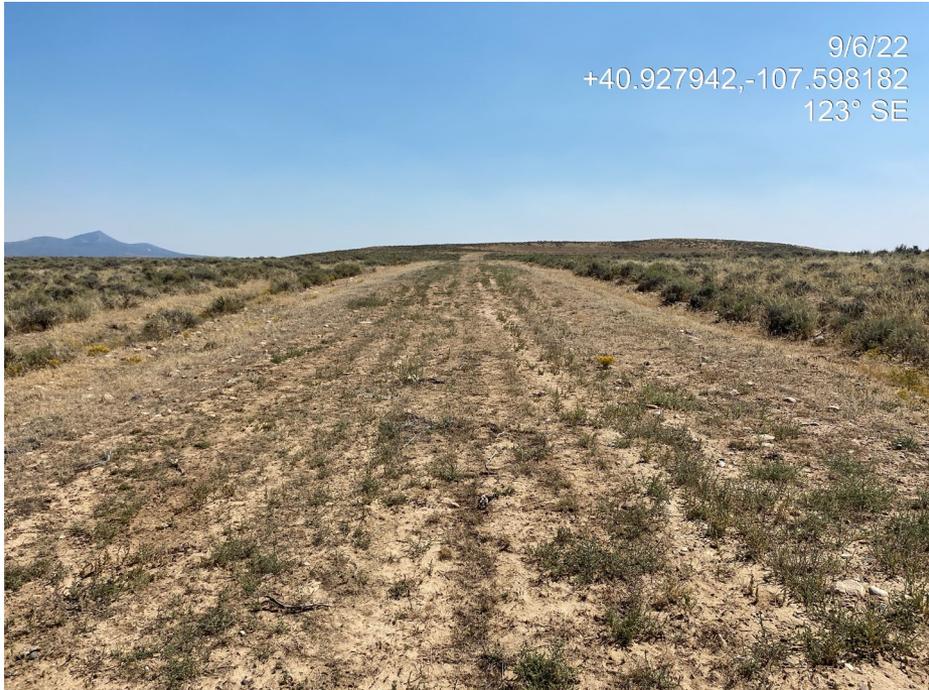
**Photo 1.** Photo taken to the east of the Location shows the access road. Perennial grasses are sparse, while Russian thistle, an undesirable plant species/annual weed is common. Cheatgrass is also present.

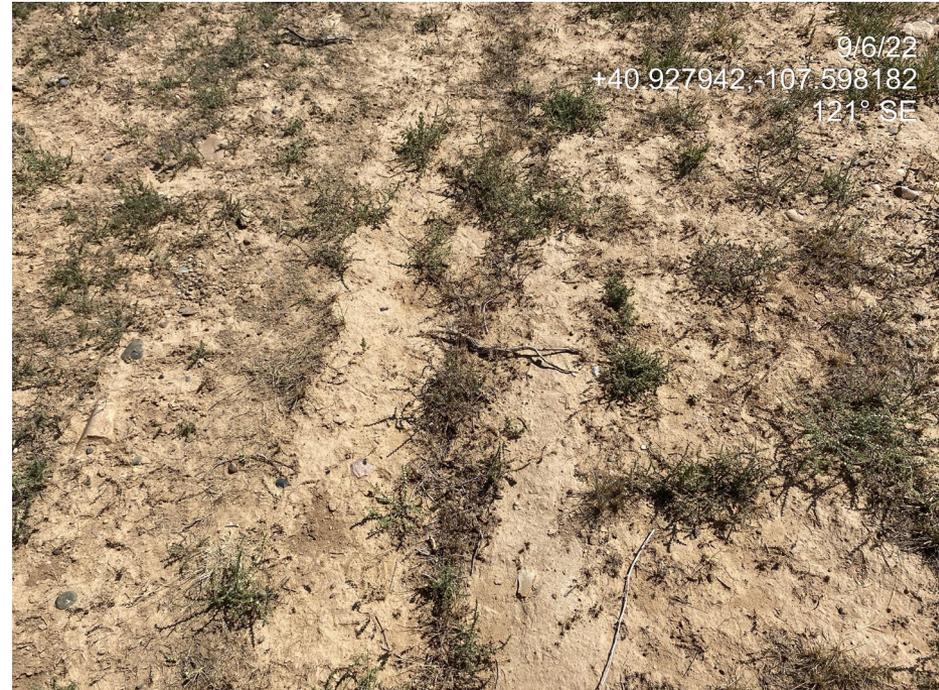
**Photo 2.** Photo shows a close-up of the vegetation on the access road. Perennial grasses are sparse. Russian thistle, an undesirable plant species/annual weed is the greener plant in the photo.

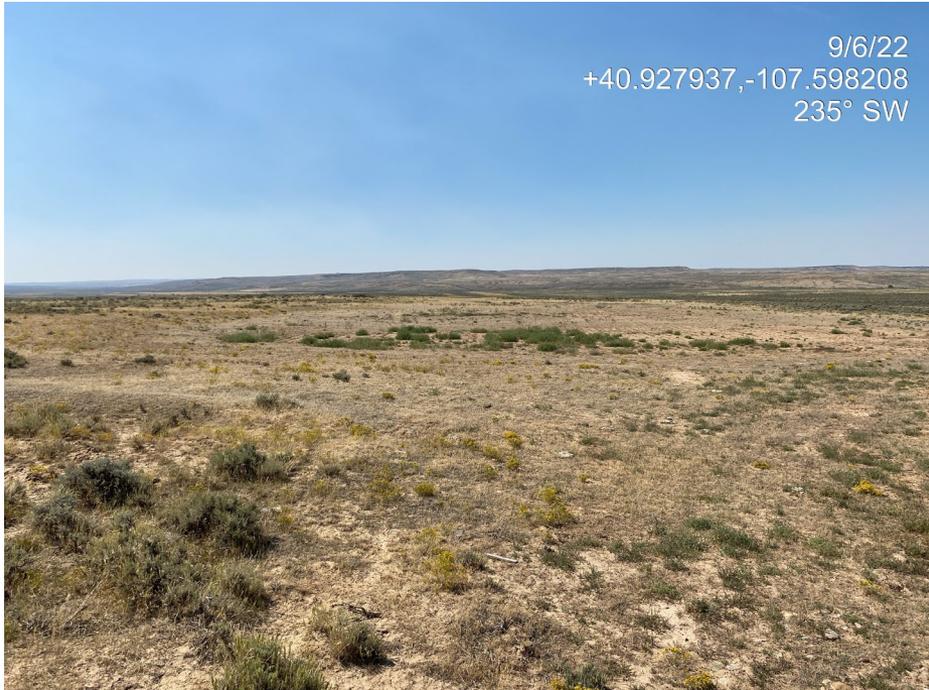
**Photo 3.** Photo taken from the north shows an overview of the Location.

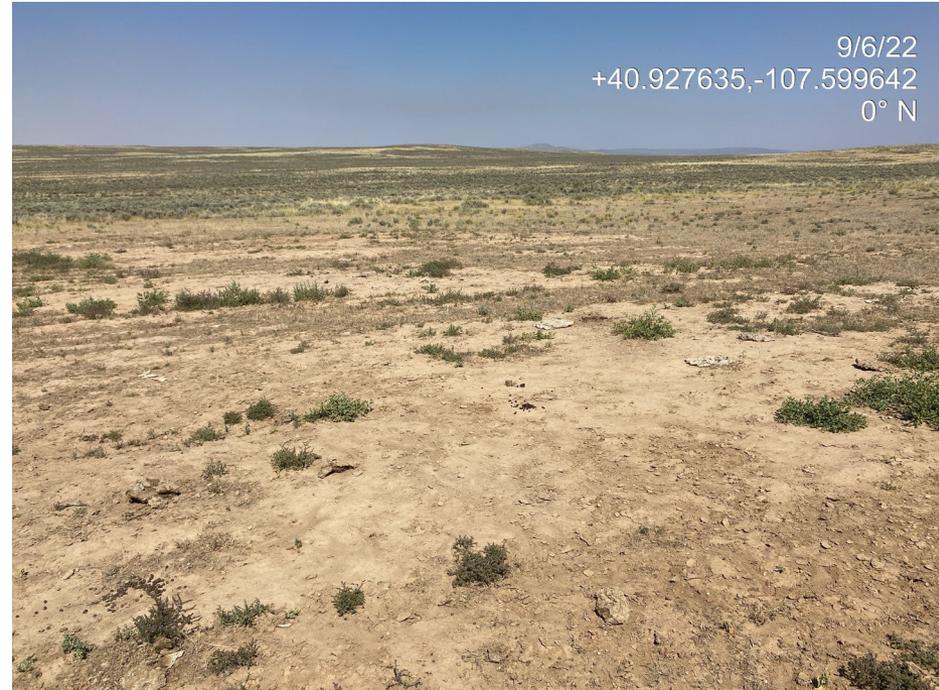
**Photo 4.** Photo shows an example of areas of the Location where bare ground dominates. The darker green vegetation in the photo is tumbling saltweed and Russian thistle (annual/undesirable).

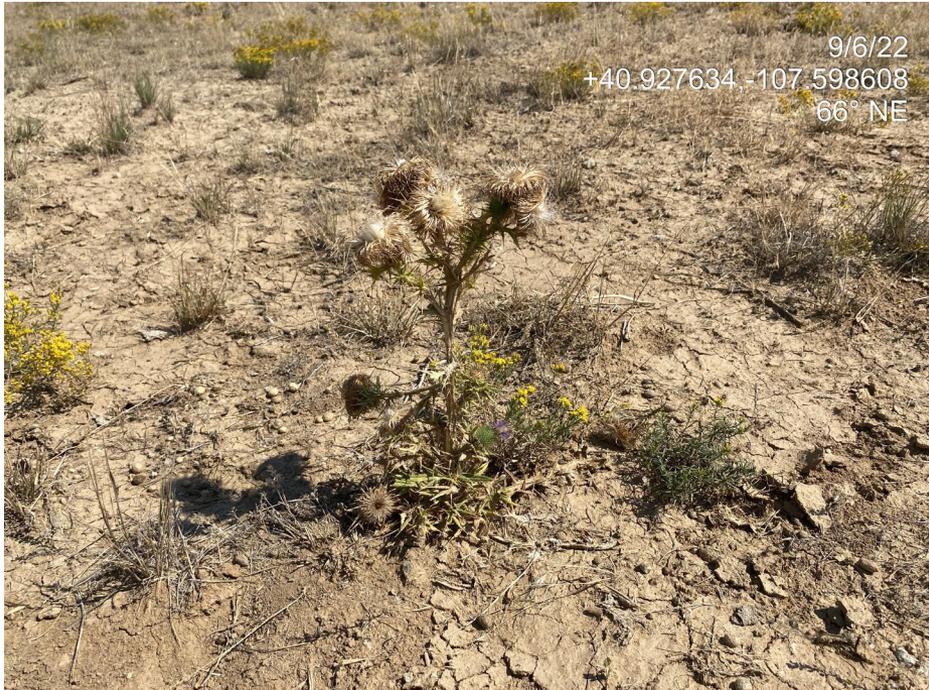
**Photo 5.** Photo shows an example of bull thistle, a List B Noxious weed occasionally found on Location. The plant has gone to seed.

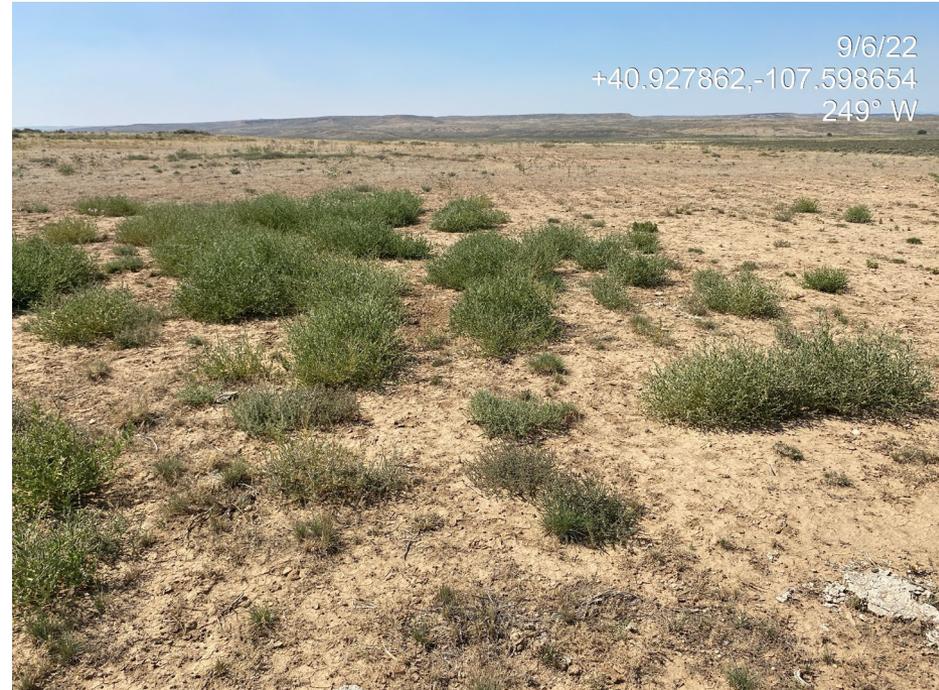
**Photo 6.** Photo shows a patch of tumbling saltweed and Russian thistle (annual/undesirable).

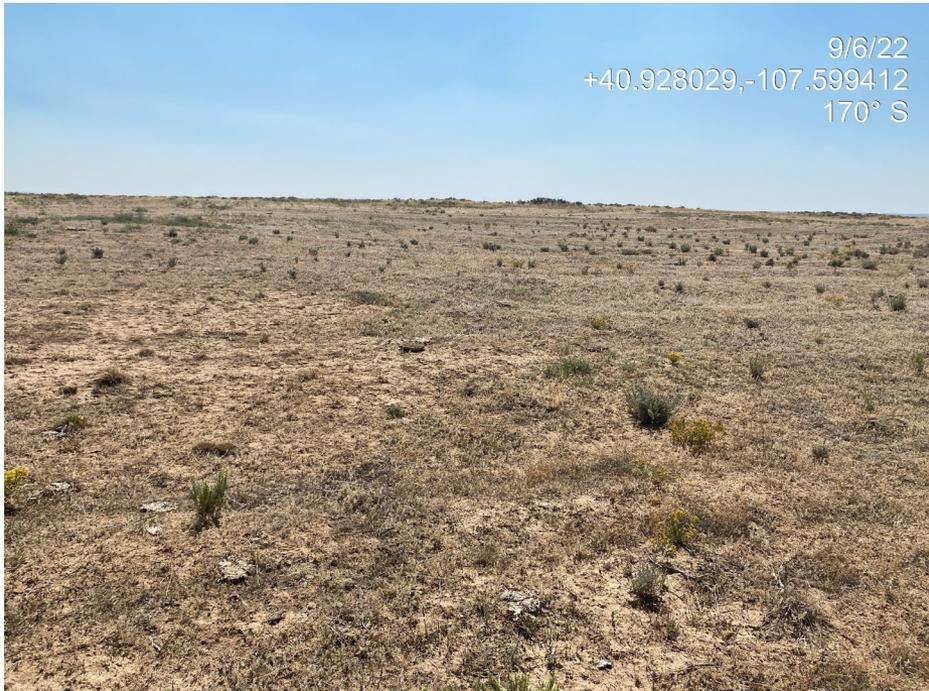
**Photo 7.** Photo shows an overview of the vegetation community on Location.

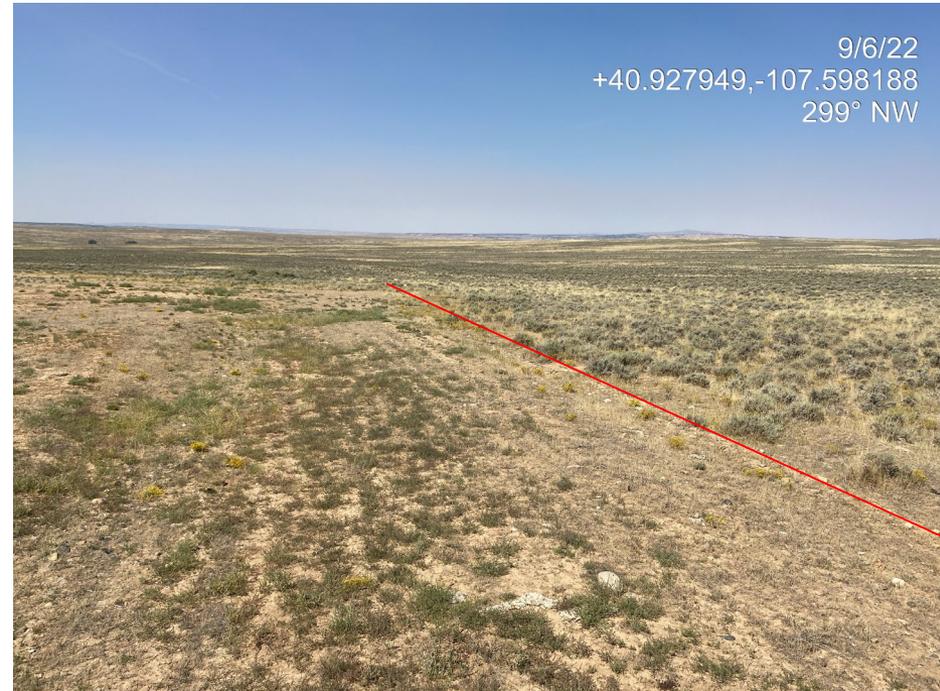
**Photo 8.** Photo taken from the north of the Location shows the transition between the disturbed Location (left) and undisturbed reference area (right). Note, the darker green vegetation on Location is Russian thistle (annual/undesirable).

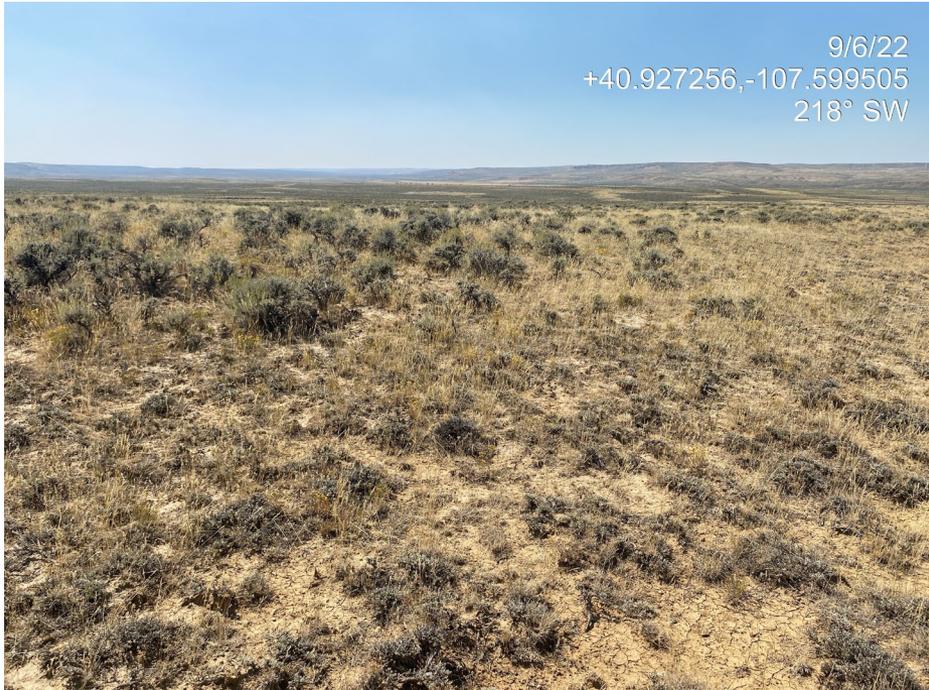
**Photo 9.** Photo taken to the south of the Location shows the reference area vegetation community.

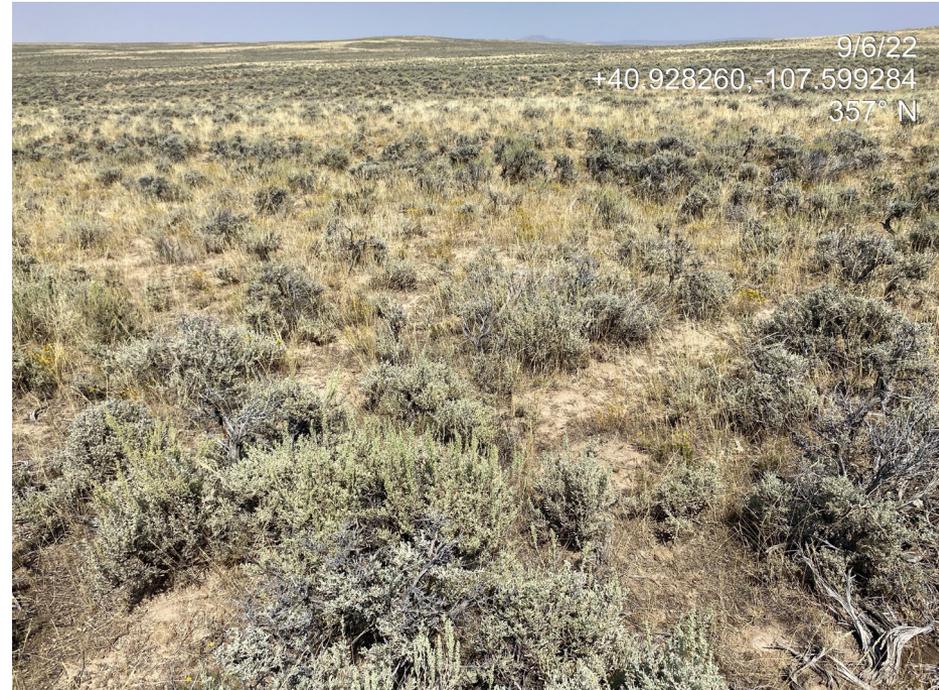
**Photo 10.** Photo taken to the north of the Location shows the reference area vegetation community.
