# Inspection Photos and Issue Report

Operator: TEP ROCKY MOUNTAIN LLC #96850

Location #324411

Garfield County, CO

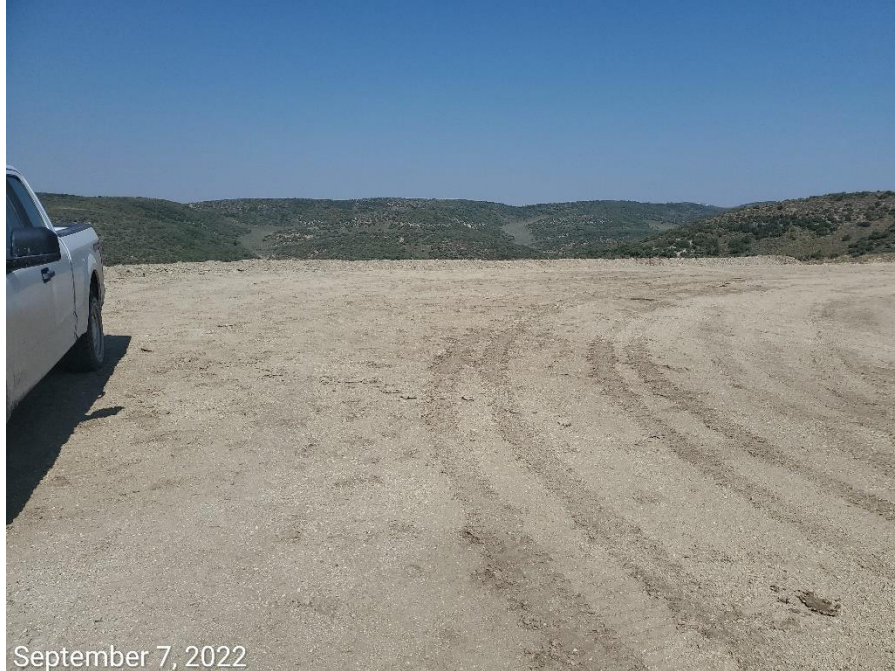
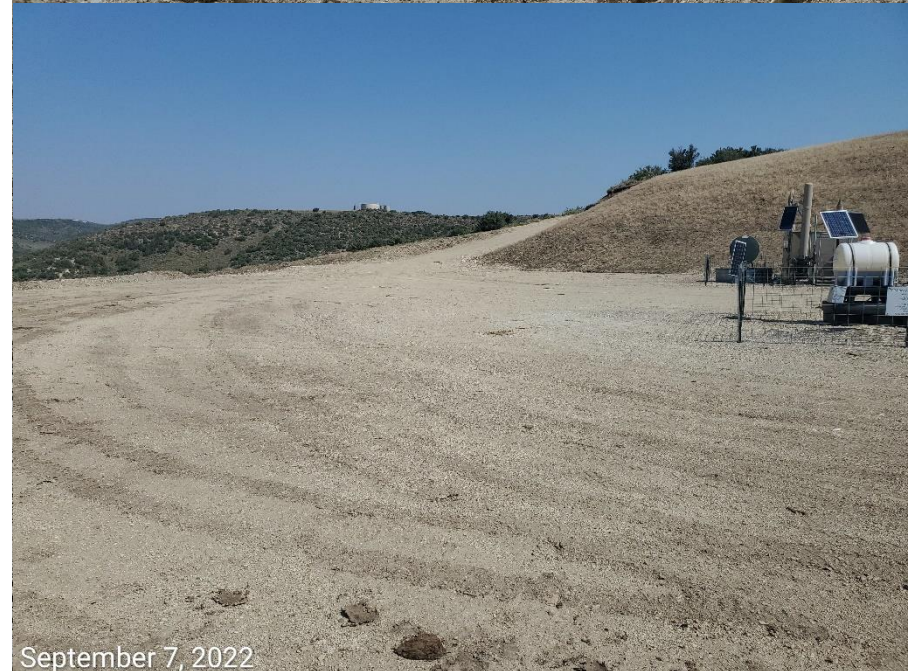
**Photo 1:** Photos taken from the southwest of the working pad. Photos 1-2 provide an overview of the production areas from northwest, north, east to southeast.

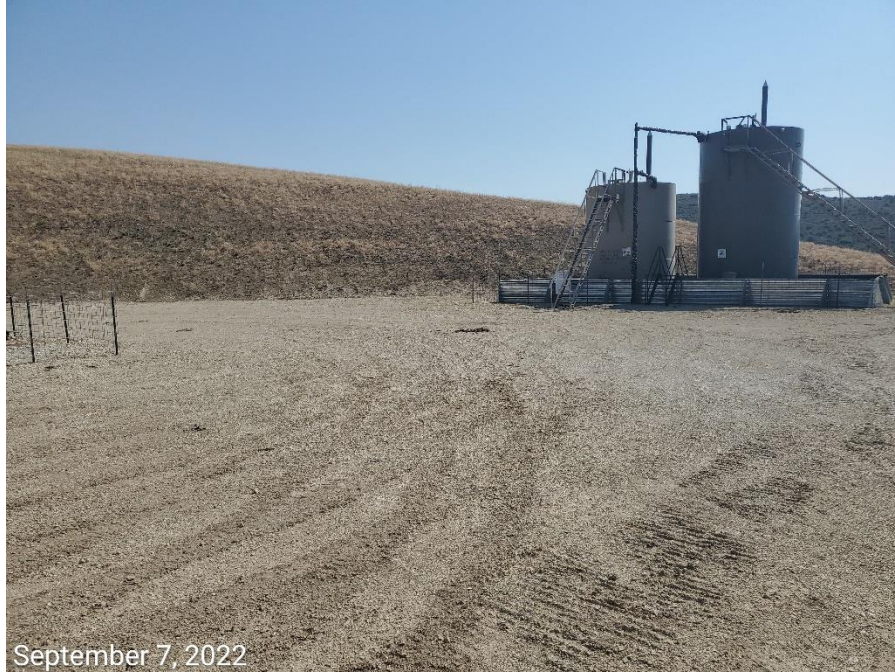
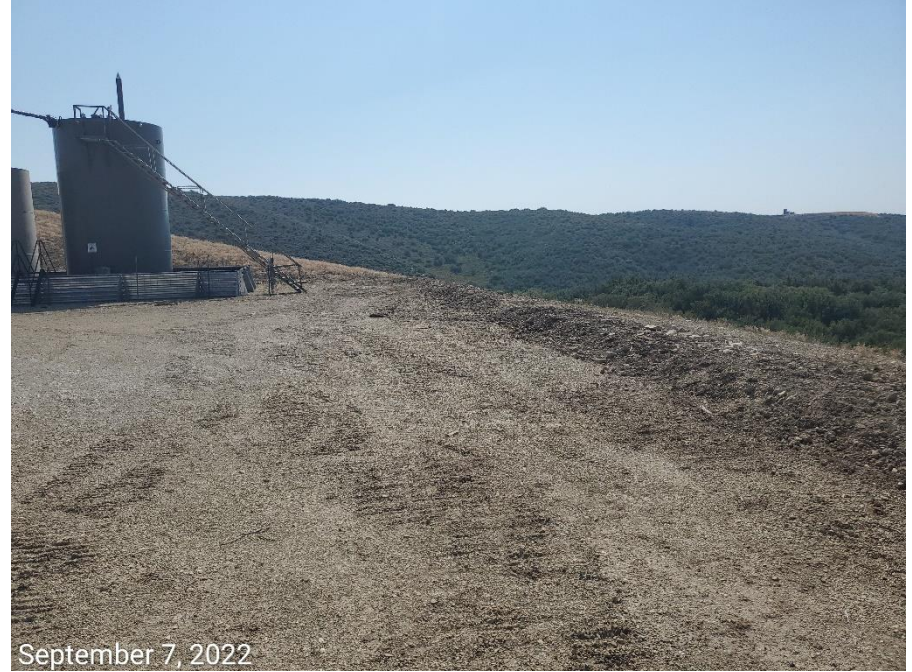
**Photo 2:** See comments under photo 1.

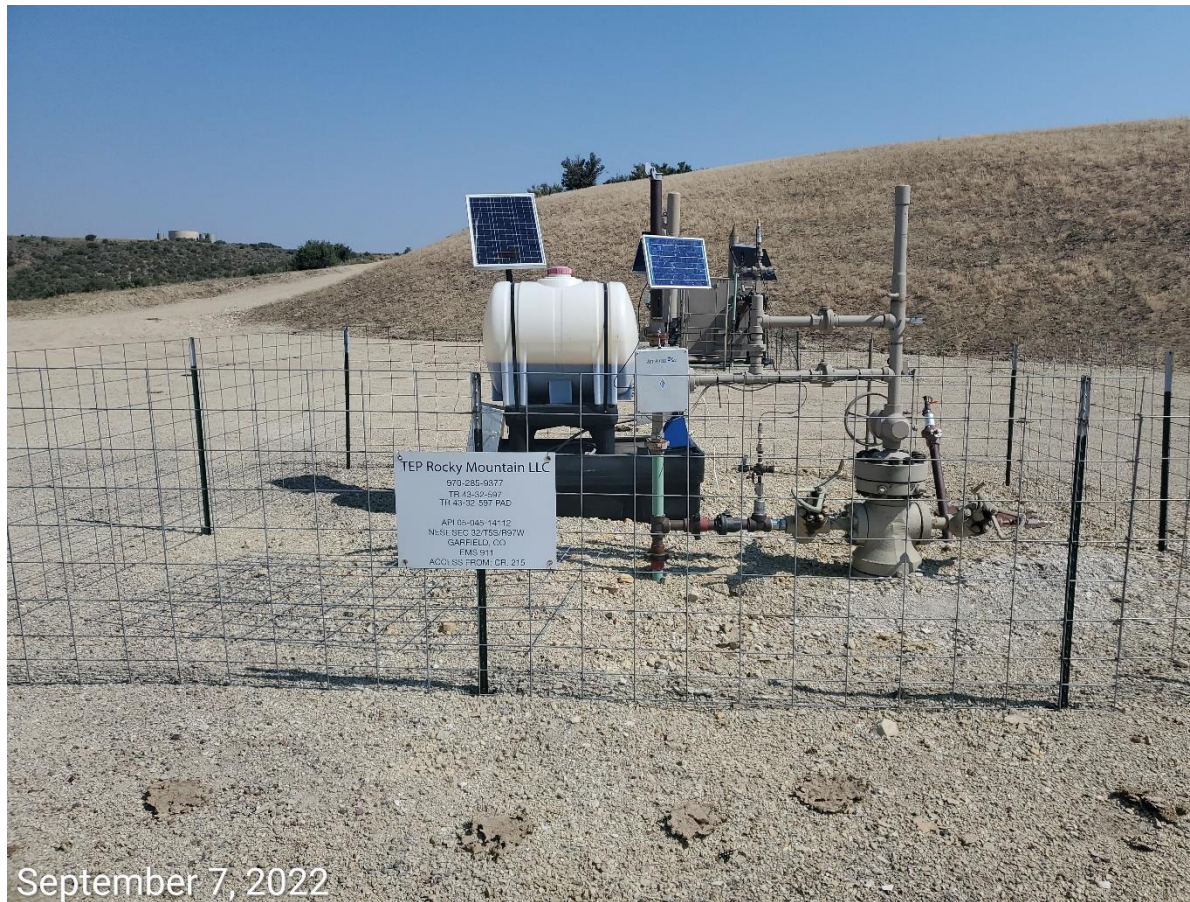
**Photo 3:** Single active well on Location.

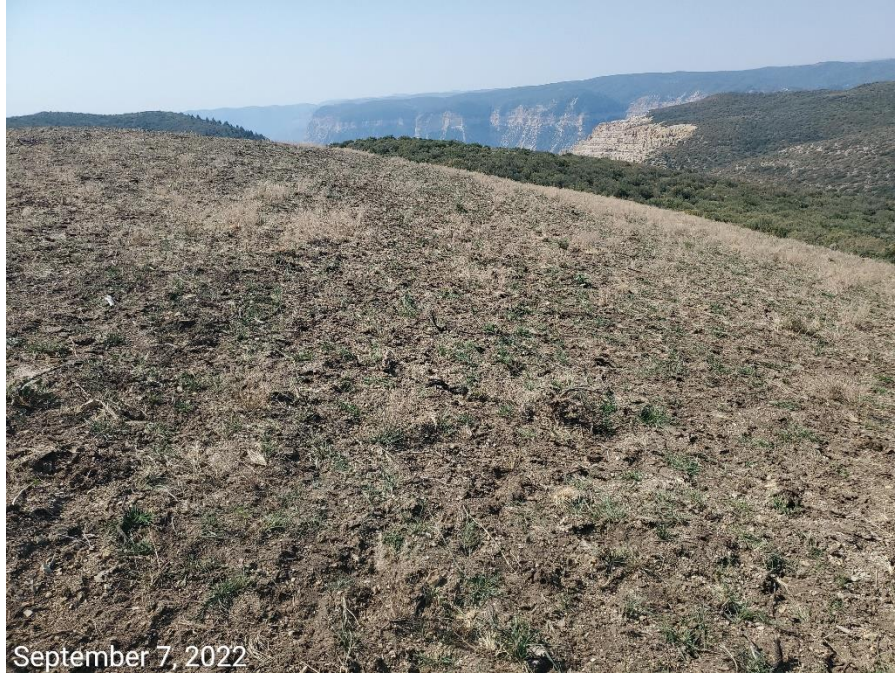
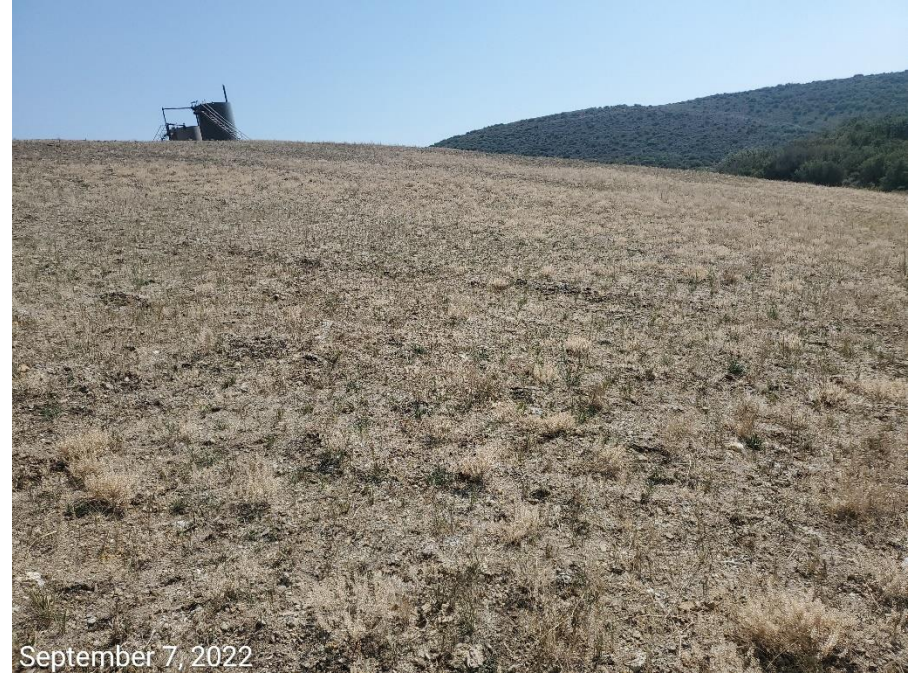
**Photo 2:** Photos example of interim areas on the west end of the Location. Photos example or areas progressing towards 1003 standards.

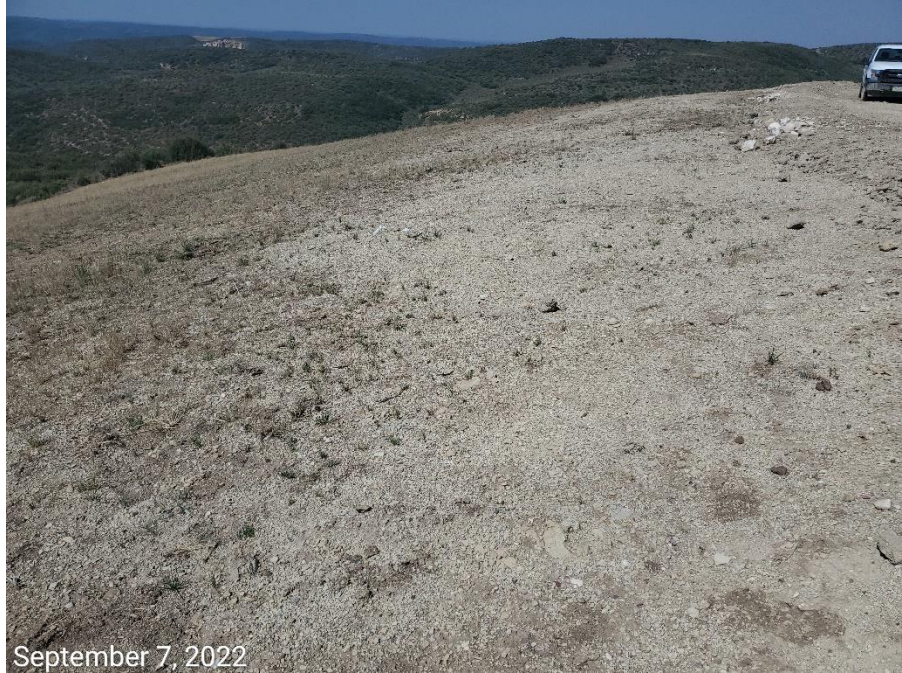
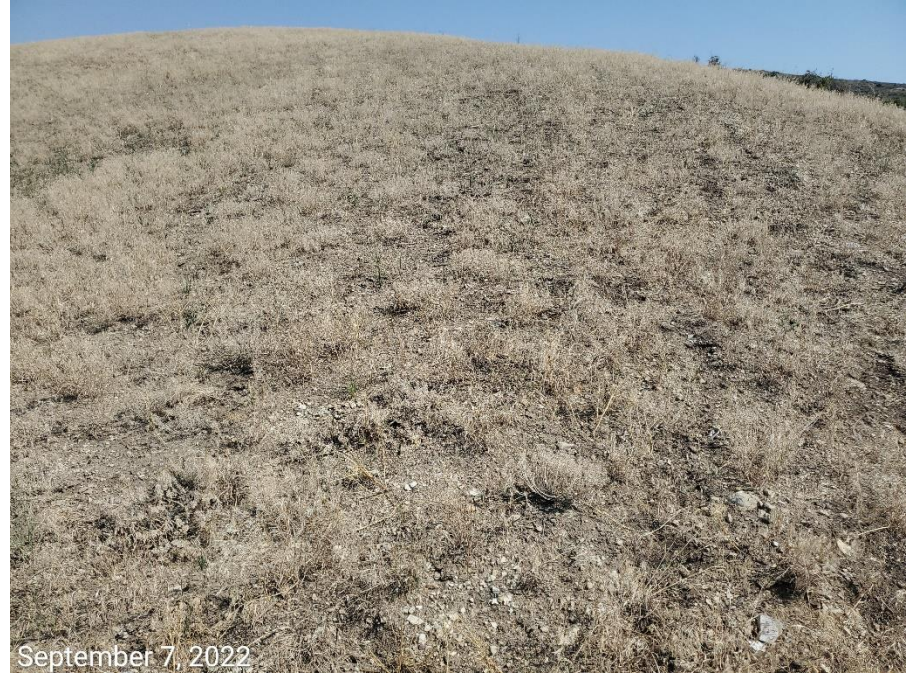
**Photo 5:** Photos examples showing interim areas of the Location where desirable perennial plant germination and establishment is sparse. Additional reclamation efforts will likely be required in these areas.

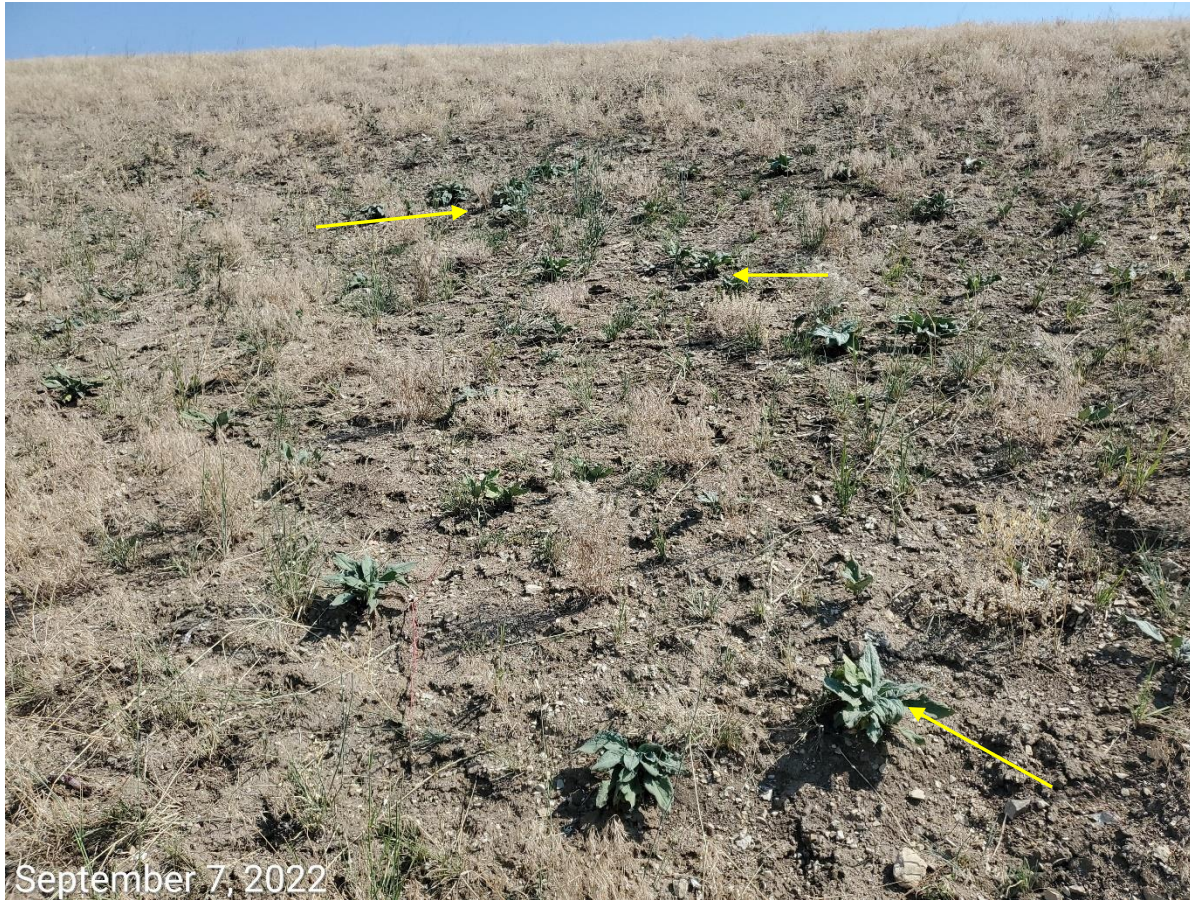
**Photo 6:** Photo taken from the northern interim areas of the Location. Photo shows Houndstongue rosettes established on the Location.
