Inspection Photos and Issue Report

Operator: TEP ROCKY MOUNTAIN LLC #96850

Location #324421

Garfield County, CO

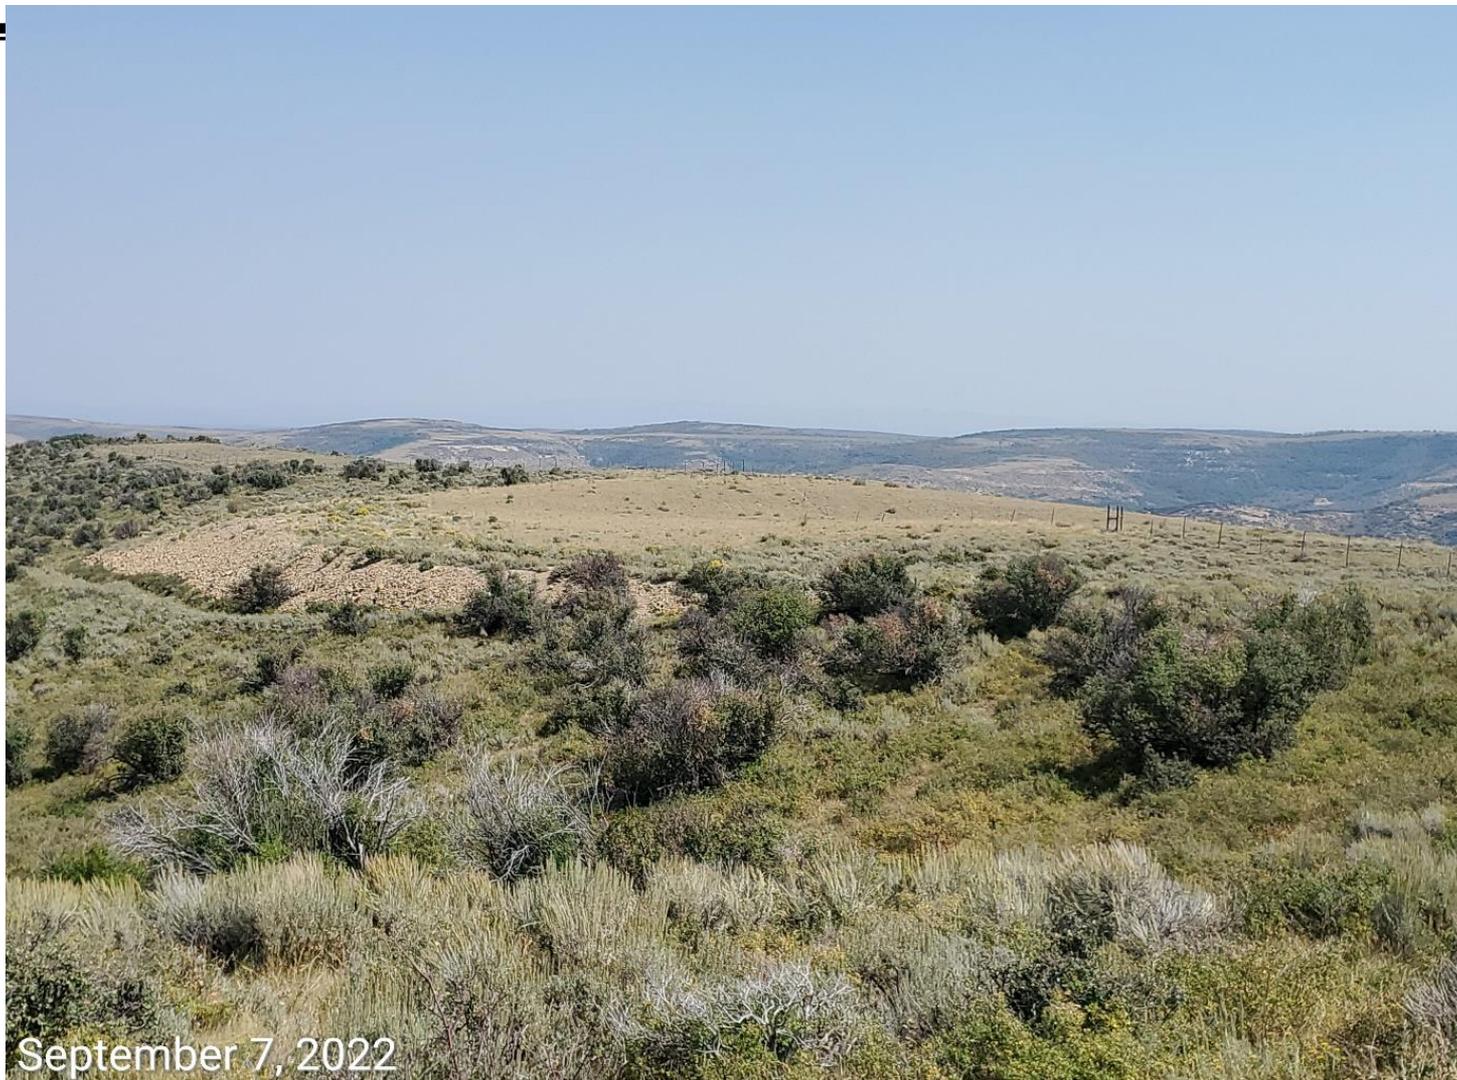
Photo 1: Photo taken from the southwest, and provides an overview of the Location. Photo shows Location has not been recontoured/regraded and reclaimed in accordance with 1004 rules; fill slope remains evident and bare; berms along southeastern perimeter remains apparent.

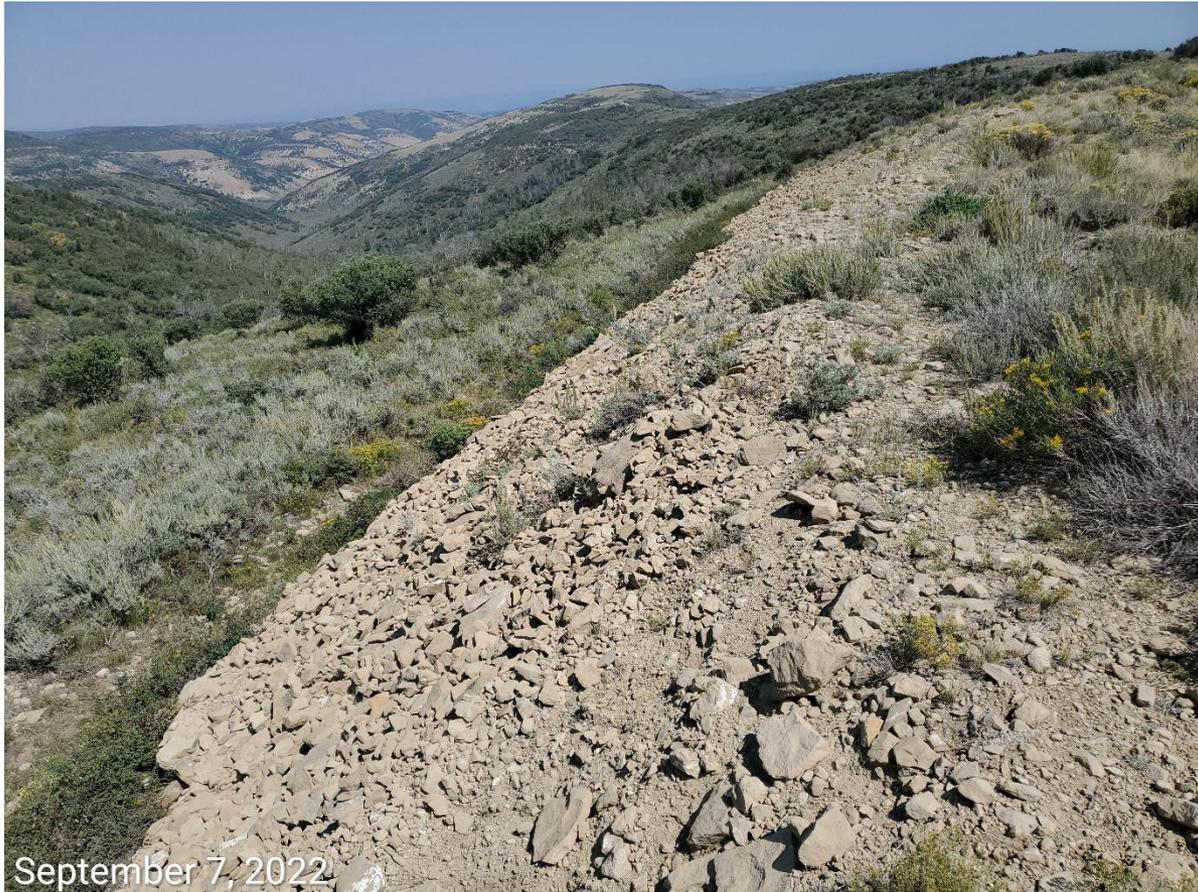
Photo 2: Photo shows bare fill slope; location has not been recontoured/regraded and reclaimed.

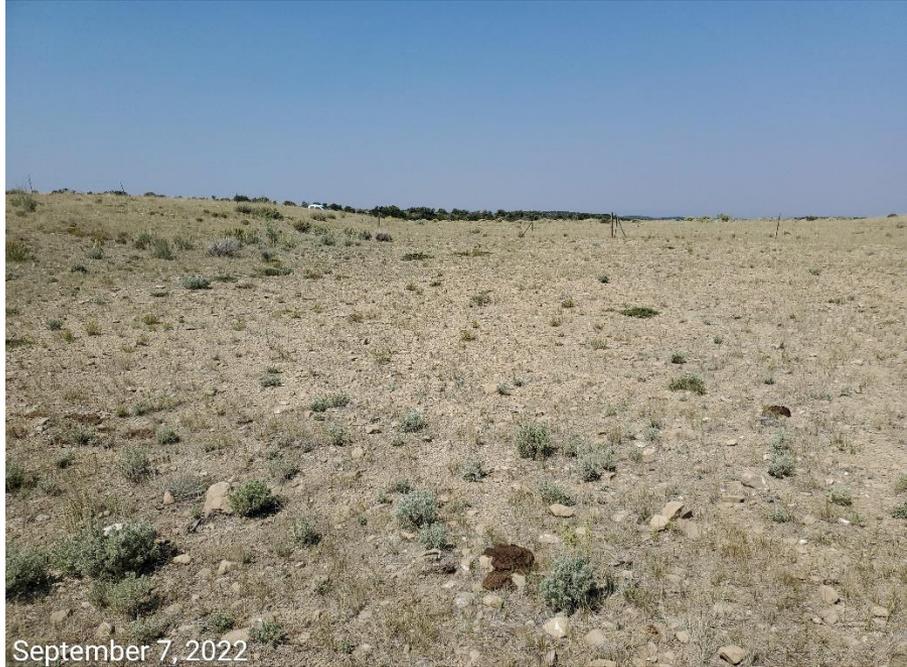
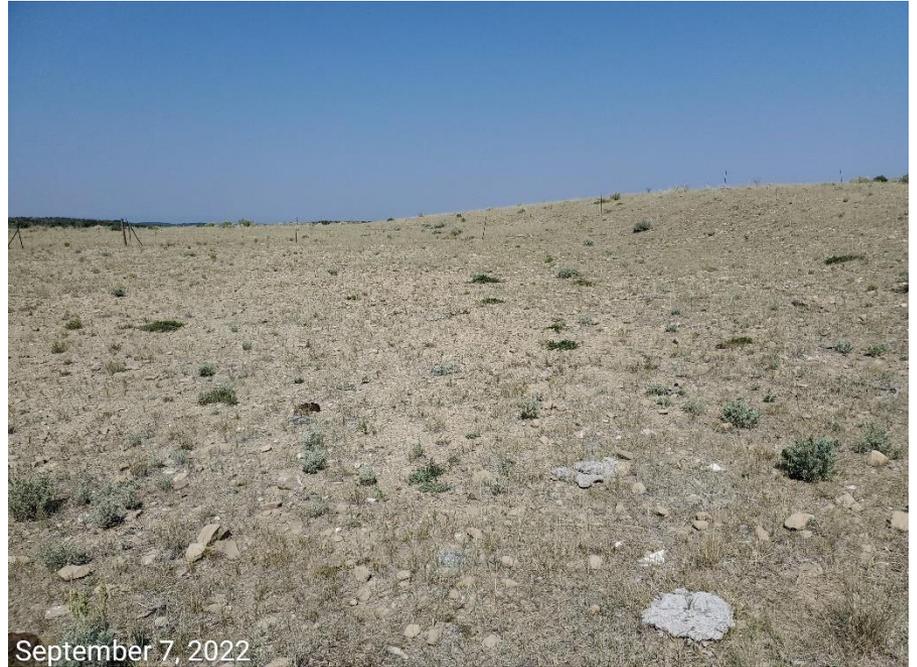
Photo 3: Photos taken from the southeast end of the Location, facing northwest. Photo shows location has not been recontoured/regraded and reclaimed in accordance with 1004 rules.

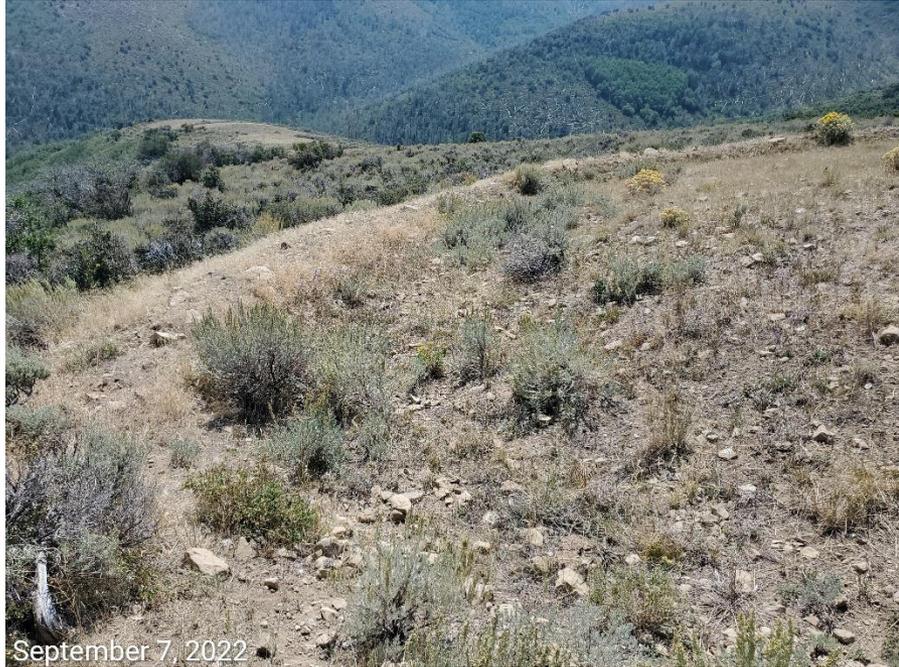
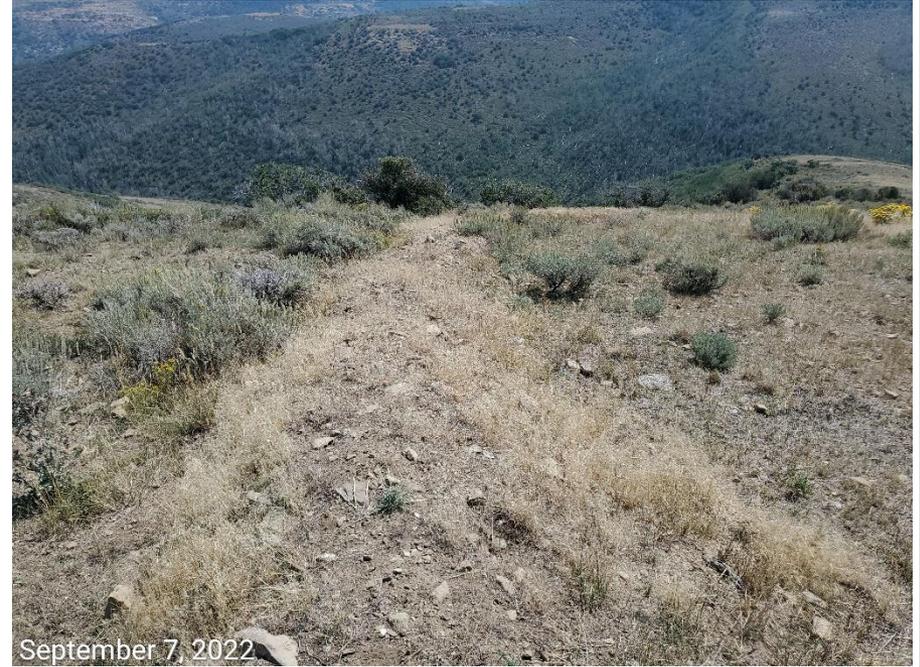
Photo 4: Photos examples showing berm remaining along the southeastern perimeter of the Location; possibly topsoil. Location has not been recontoured/regraded and reclaimed in accordance with 1004 rules.

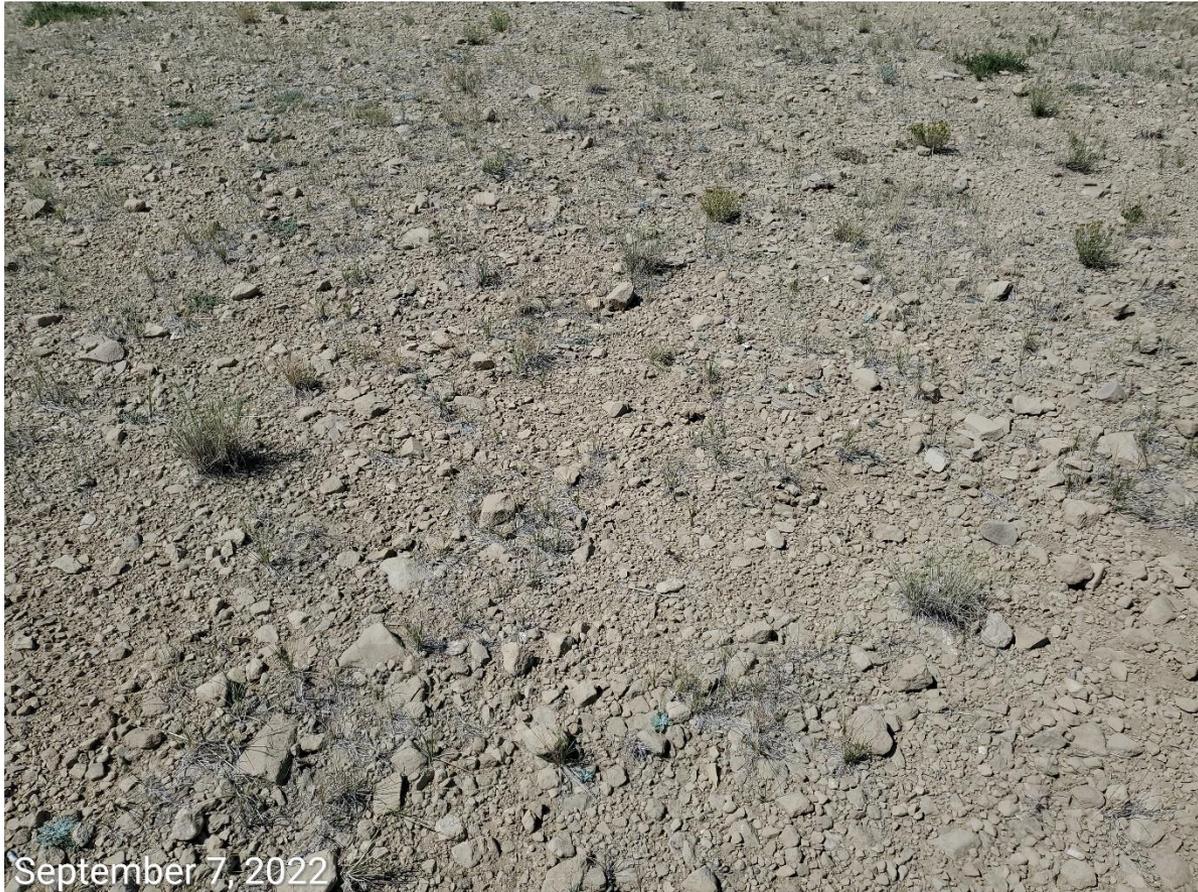
Photo 5: Photo taken from the central area of the Location; photo shows topsoil does not appear to have been replaced; soils observed appear to be subsoils.

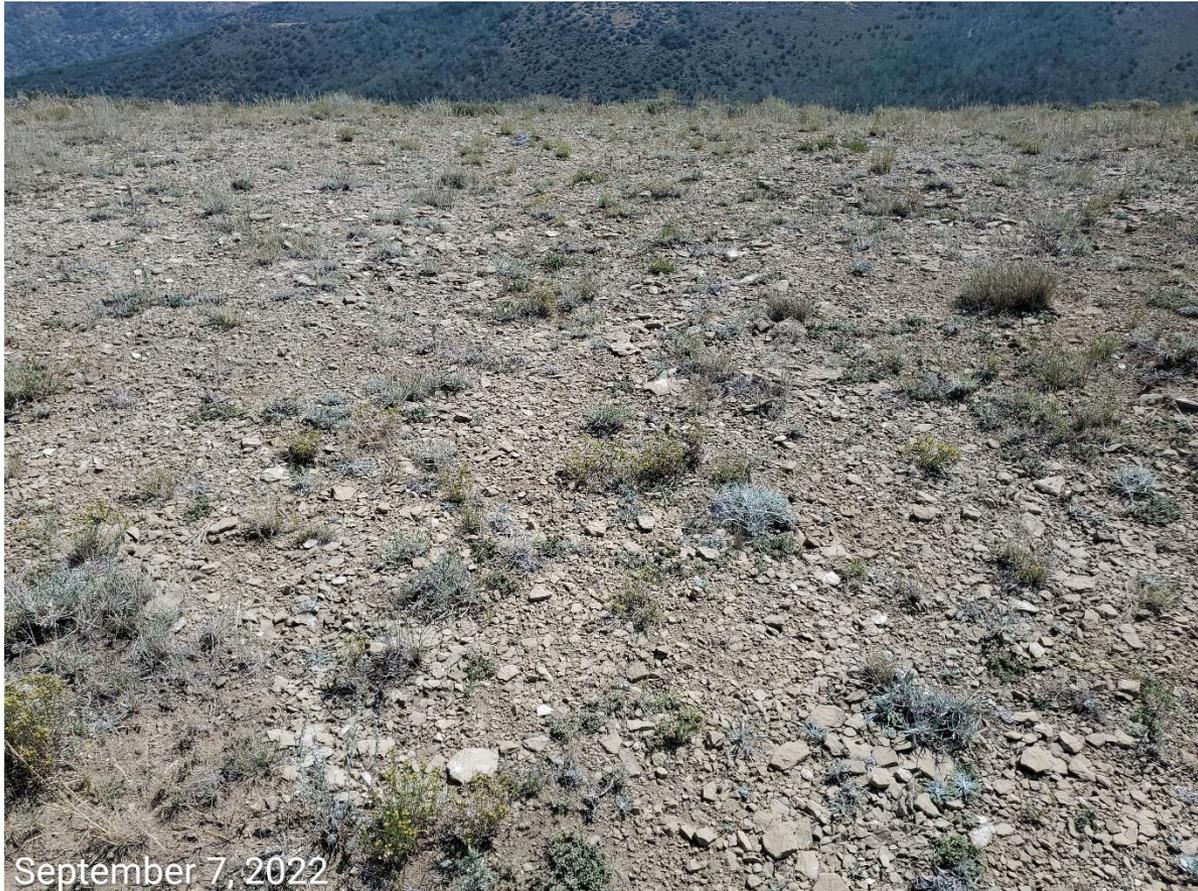
Photo 6: Continued from photo 5. Photo shows additional areas of the Location where topsoils do not appear to have been replaced.

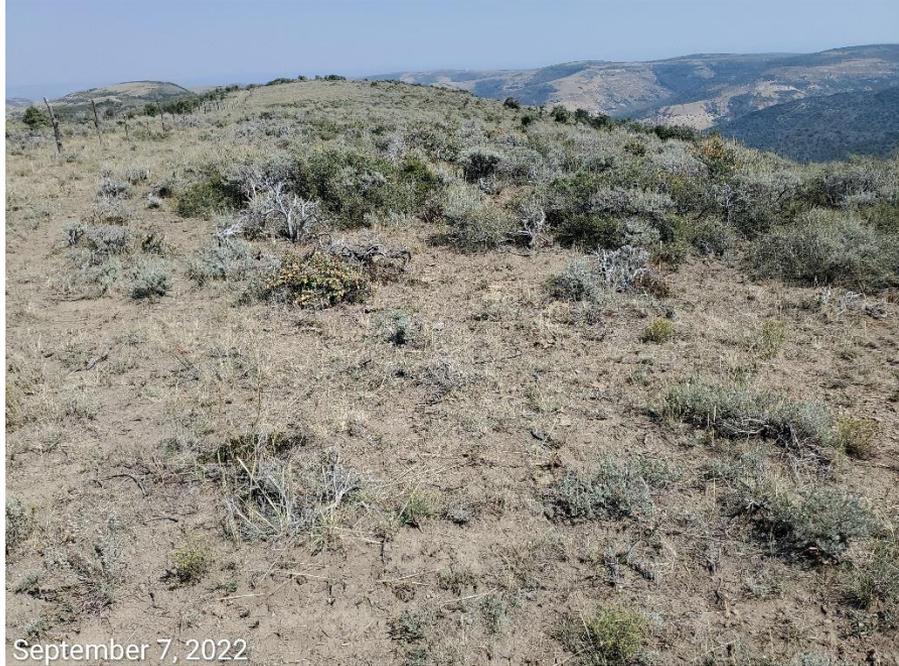
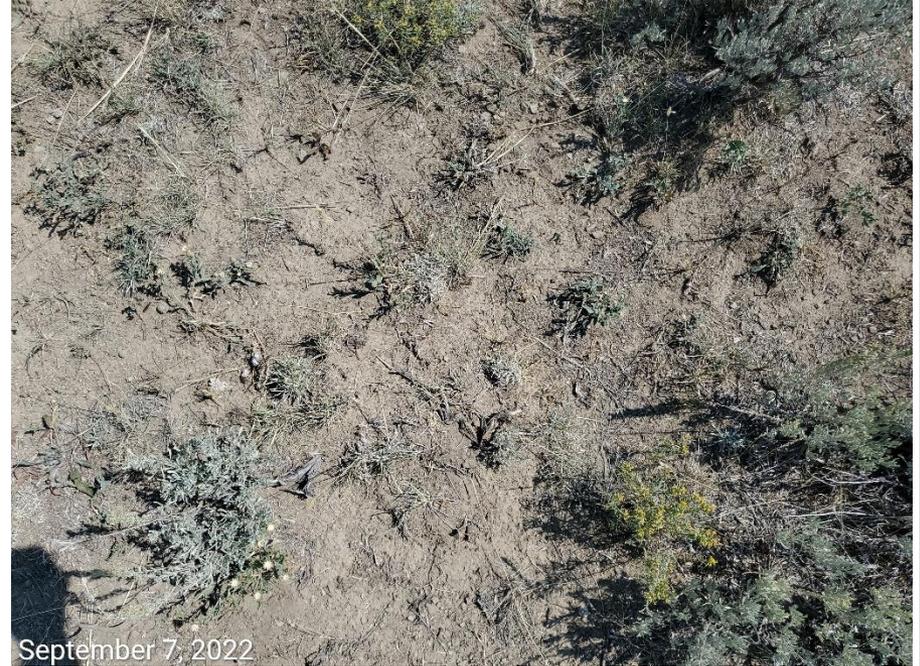
Photo 7: Photos show vegetation and soils of the reference area.
