Final Reclamation and Stormwater Inspection

Operator: O'BRIEN ENERGY RESOURCES CORP - 65110

Location ID: 695830

Inspection Photos
Location Name: TENDERFOOT #3
Location ID: 395830

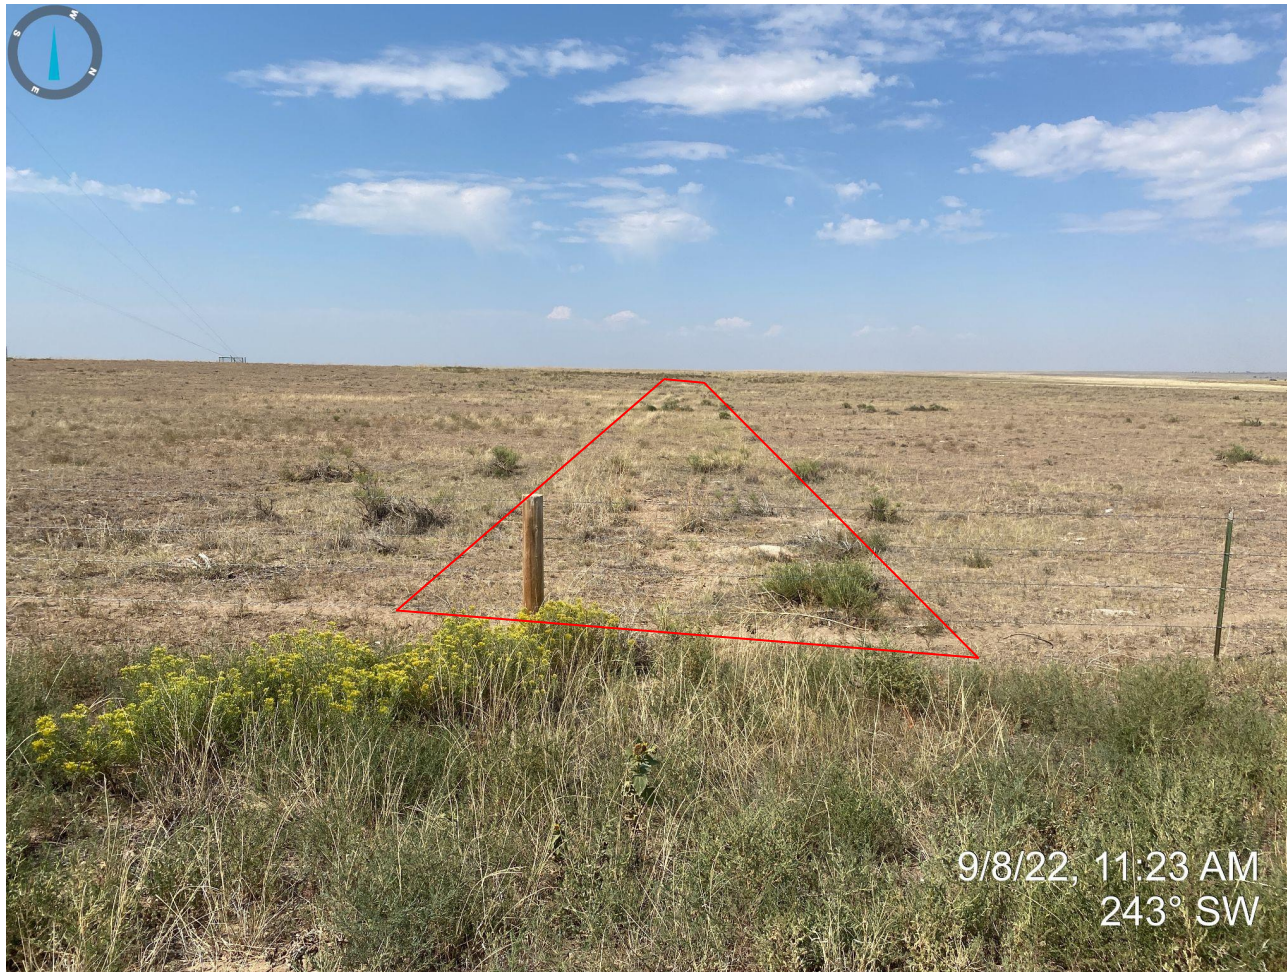
Photo 1. Access road photo taken from county road, facing southwest. Photo illustrates that the access road has not been recontoured or graded to reflect reference areas. “Two track” access road outlined in red.

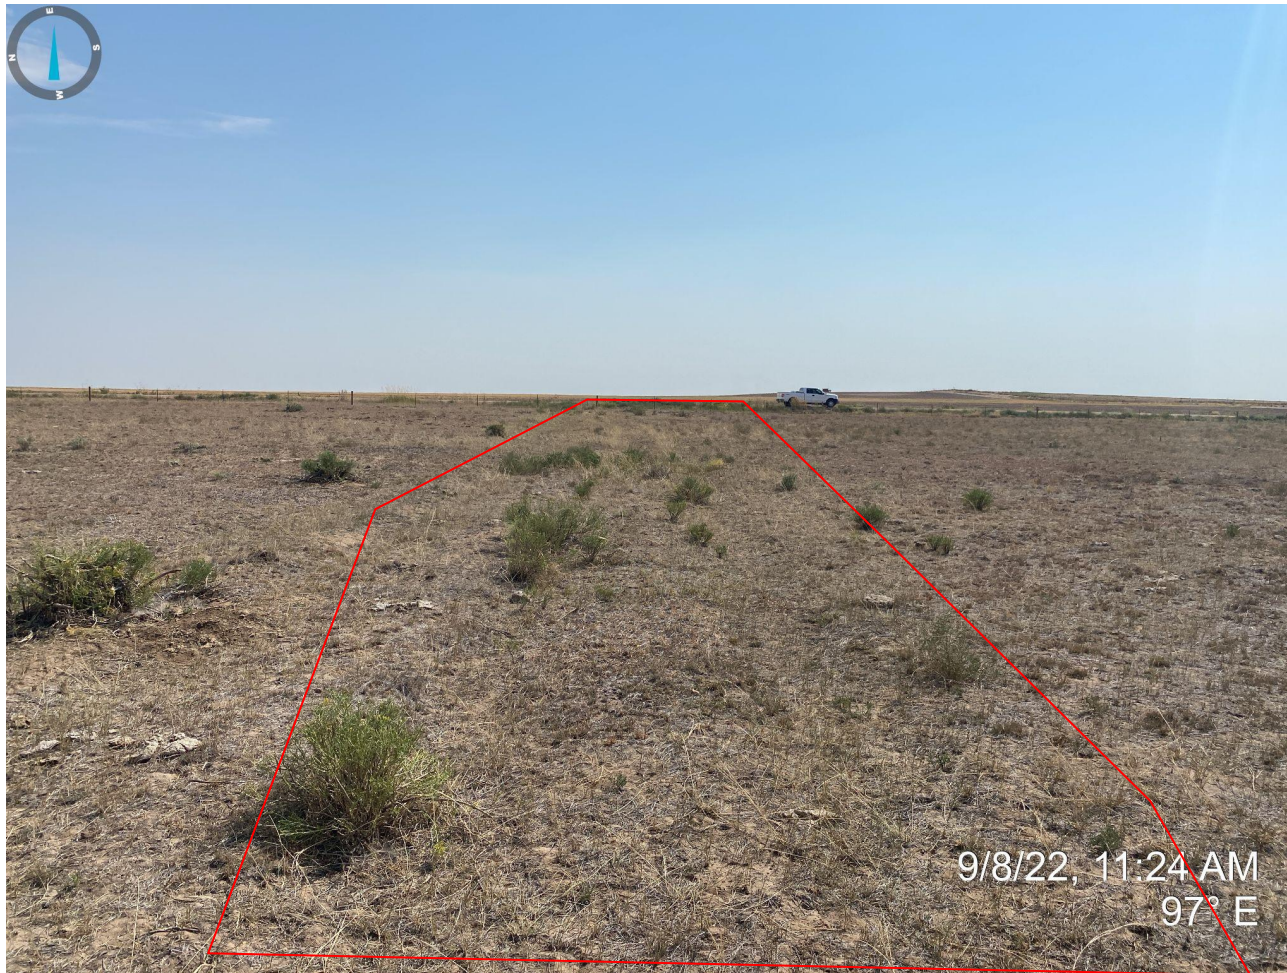
Photo 2. Facing east, see comments in photo 1.

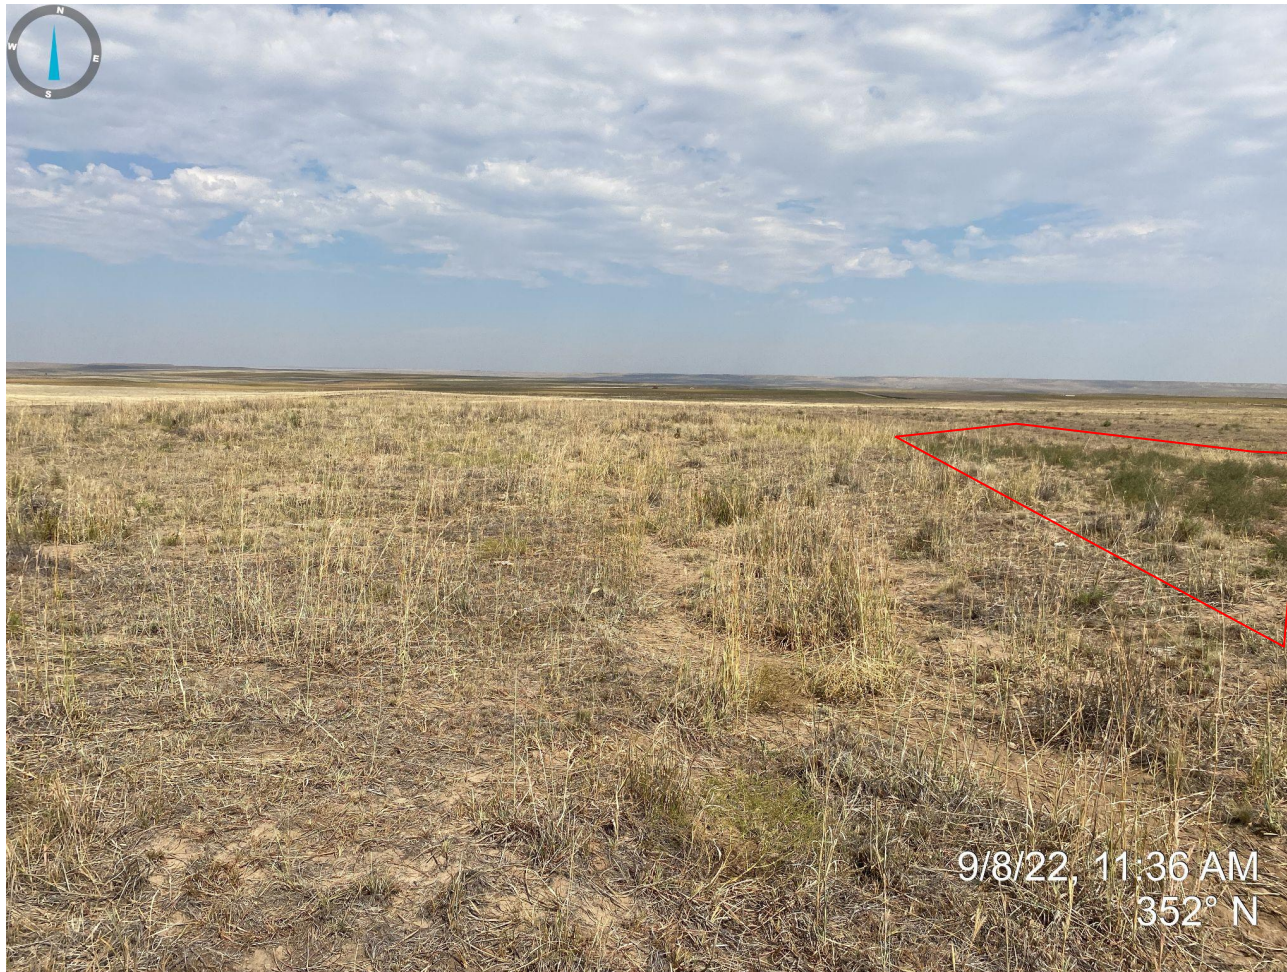
Photo 3. Location photo taken from western portion, facing north. Photo illustrates some desirable revegetation present and annual weedy vegetation (russian thistle) outlined in red.

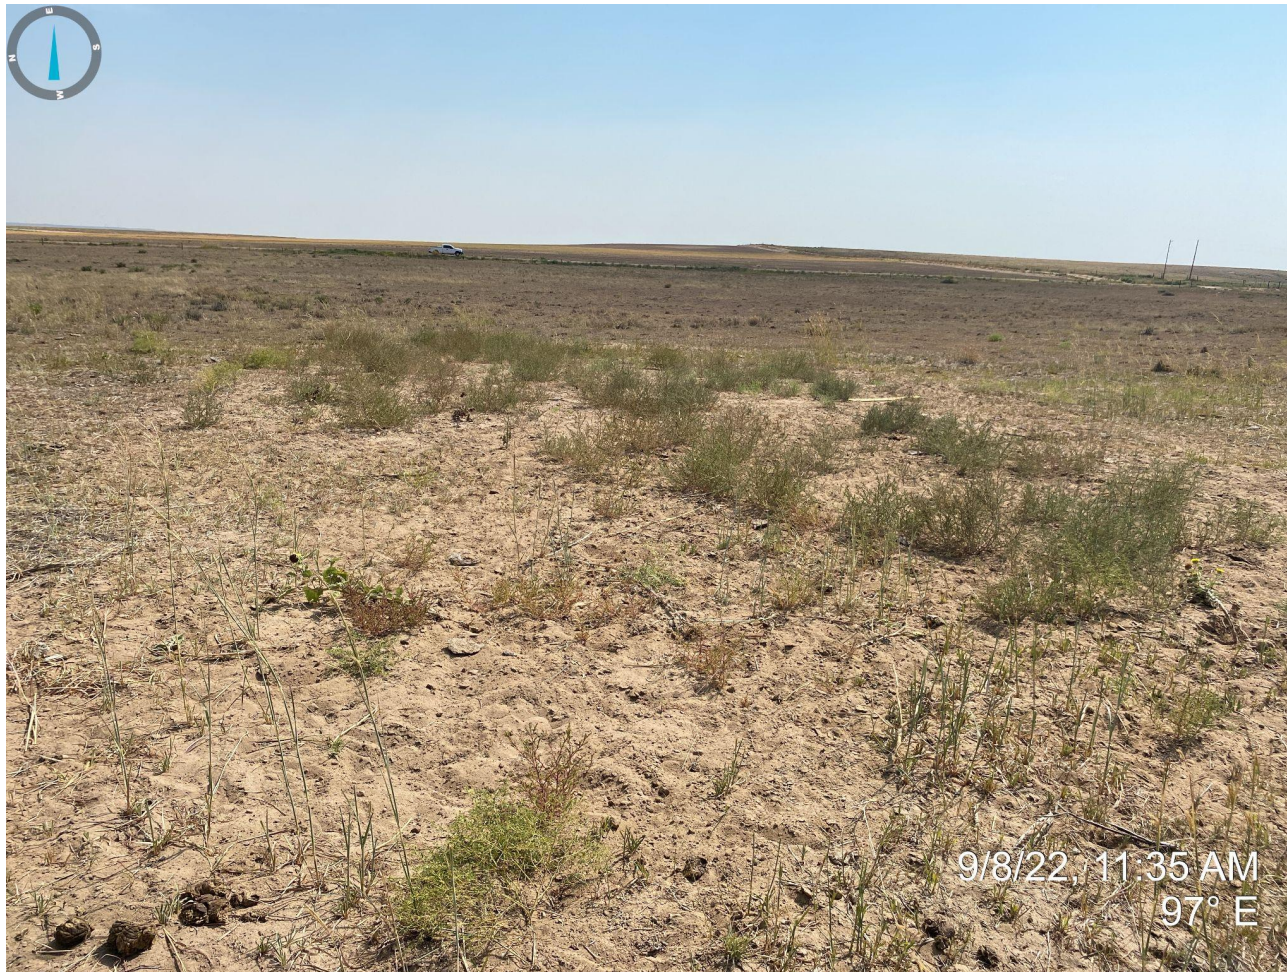
Photo 4. Location photo taken from center portion, facing east. Photo illustrates non-uniform vegetation cover resulting in bare soil and annual weedy vegetation (russian thistle).
