Inspection Photos and Issue Report

Operator: CHEVRON USA INC # 16700

Location #314658

Rio Blanco County, CO

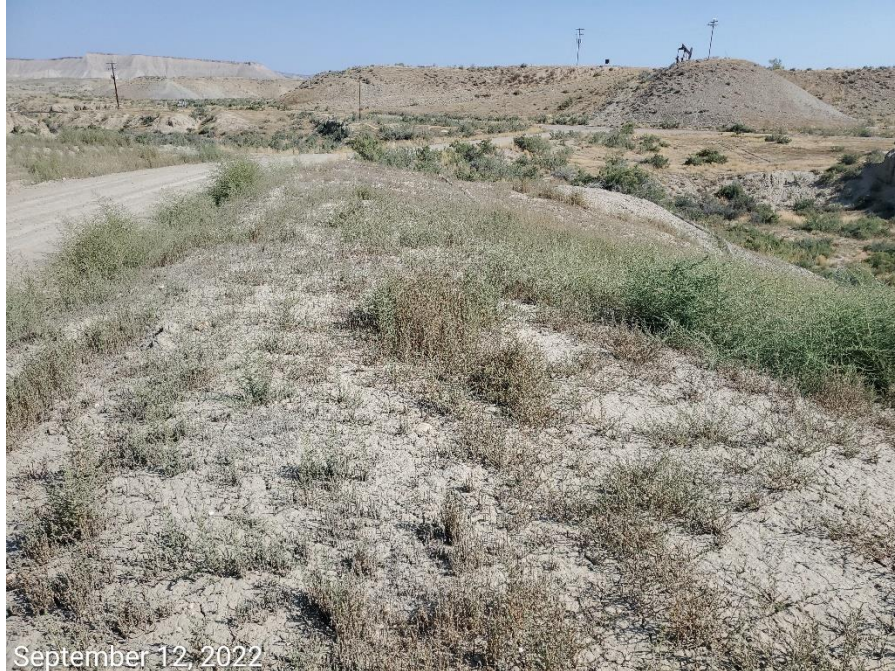
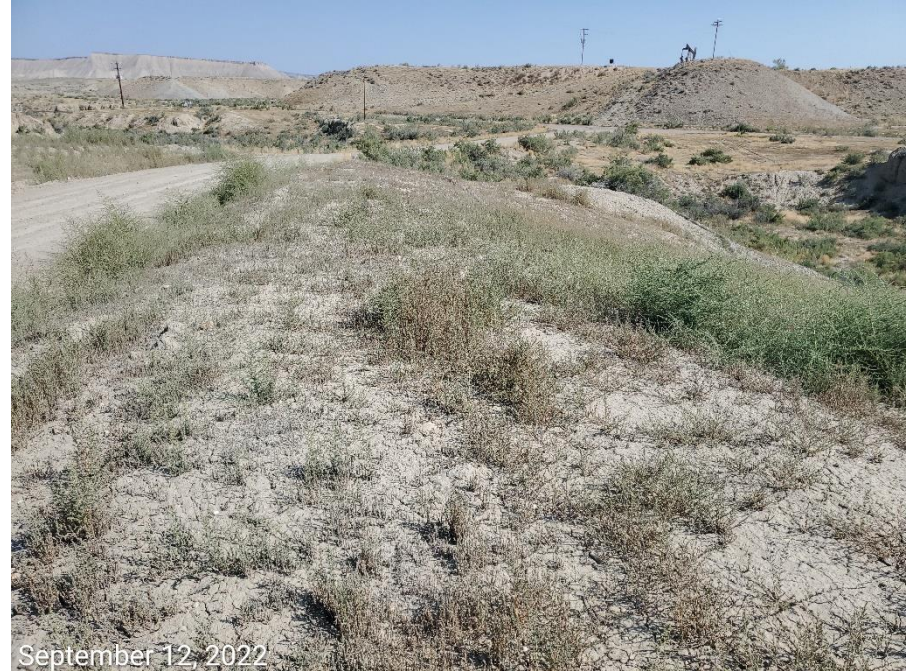
Photo 1: Photo taken from the west end of the Location (east side of the road). Photos provide an overview of the Location from north, northeast, southeast to south. Photos examples showing vegetation on Location is predominantly undesirable and noxious plant species, such as Russian thistle and Halogeton.

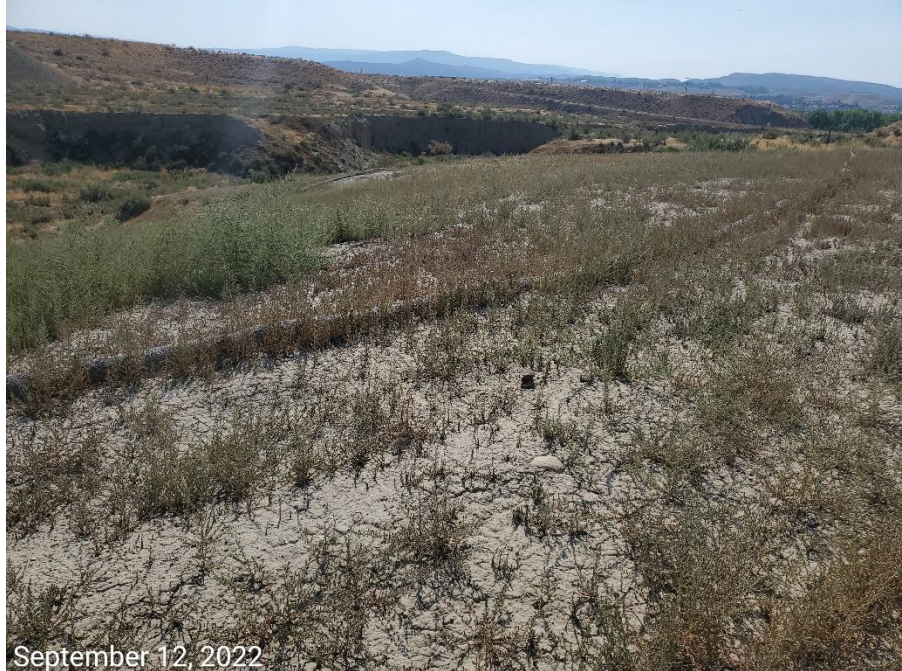
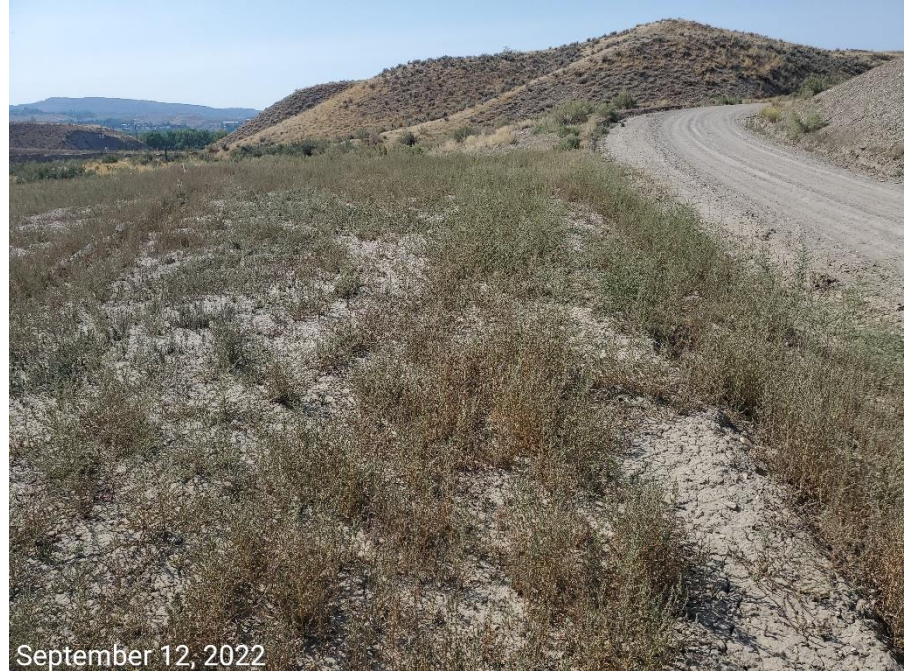
Photo 2: See comments under photo 1.

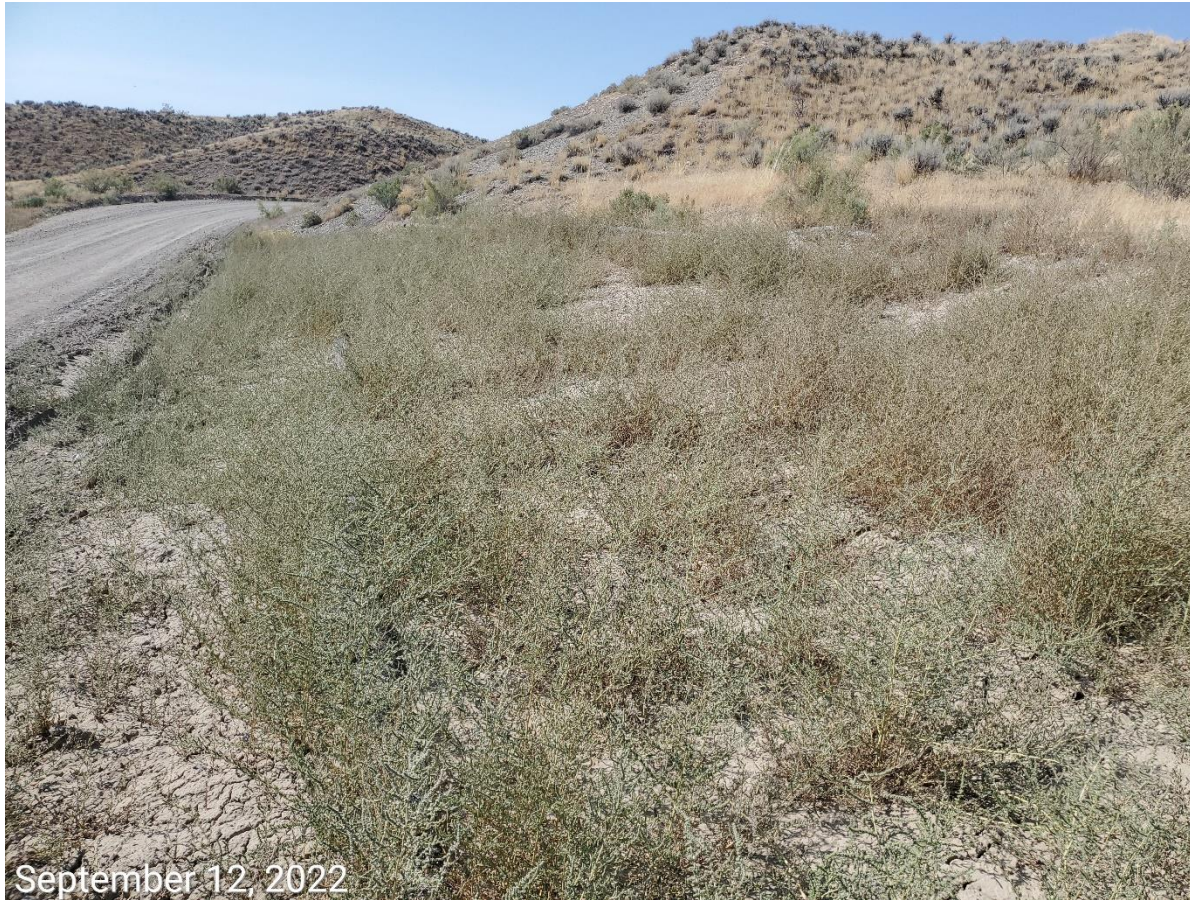
Photo 3: Photo taken from the west end of the Location (west side of the road), facing south. Photo example showing vegetation on Location is predominantly undesirable and noxious plant species, such as Russian thistle and Halogeton.

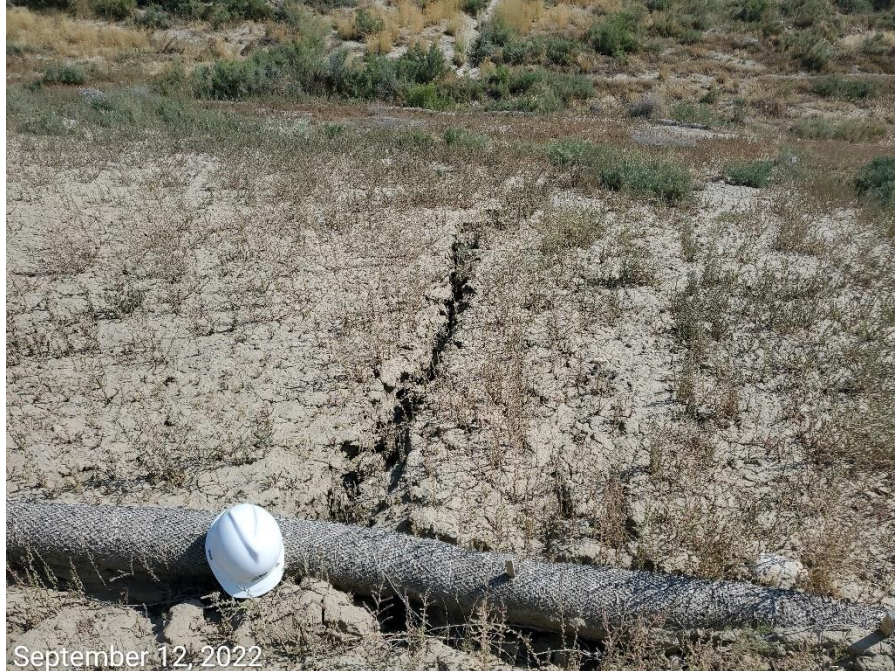
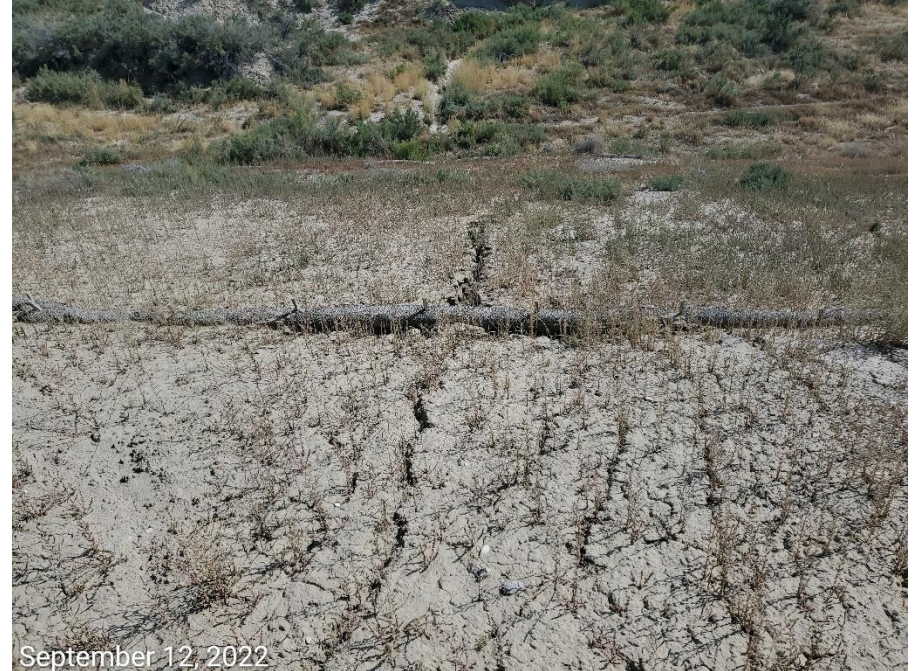
Photo 4: Photos 4-5 are examples showing BMPs to manage stormwater runoff in a manner that minimizes erosion, degradation and sediment transport are missing or insufficient; erosion degradation evident throughout slopes of the Location; erosion logs (straw wattles) have not been maintained in proper functioning condition, and appear insufficient alone in order to stabilize the soils. Hard hat for reference.

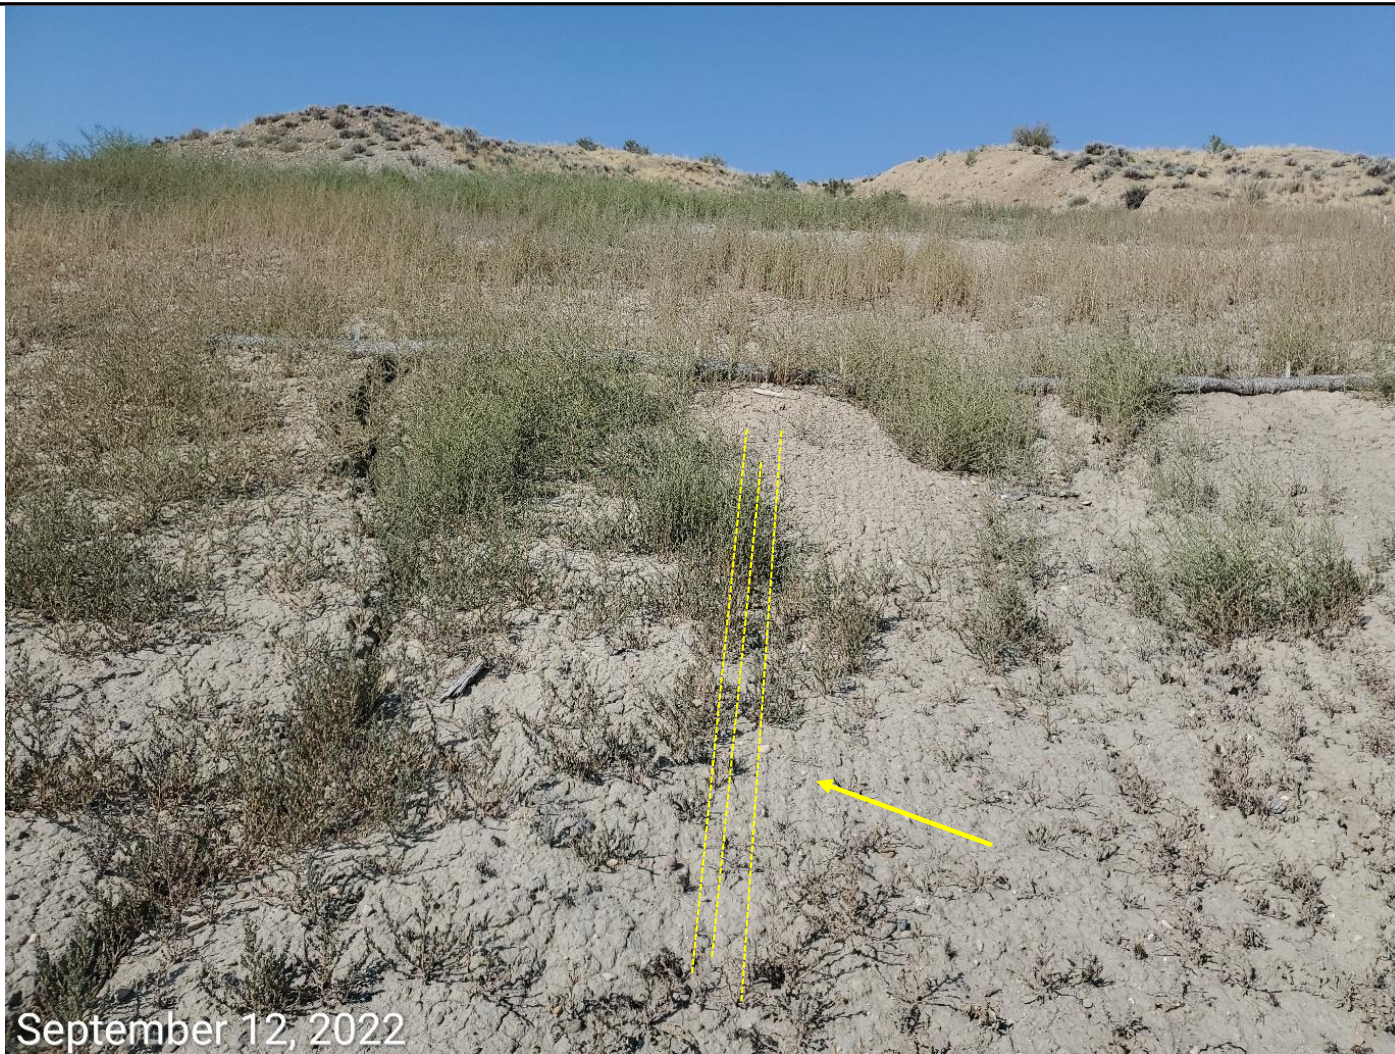
Photo 6: Photo shows Operator appears to have either seeded or tracked parallel to the slope, rather than up and down hill, resulting in vertical grooves and ridges which facilitated rilling and gully erosion.
