Interim Reclamation Inspection

Operator: K P KAUFFMAN COMPANY INC - 46290

Location ID: 480698

Inspection Photos
Location Name: Martin J Schaefer #2 Flowline
Location ID: 480698

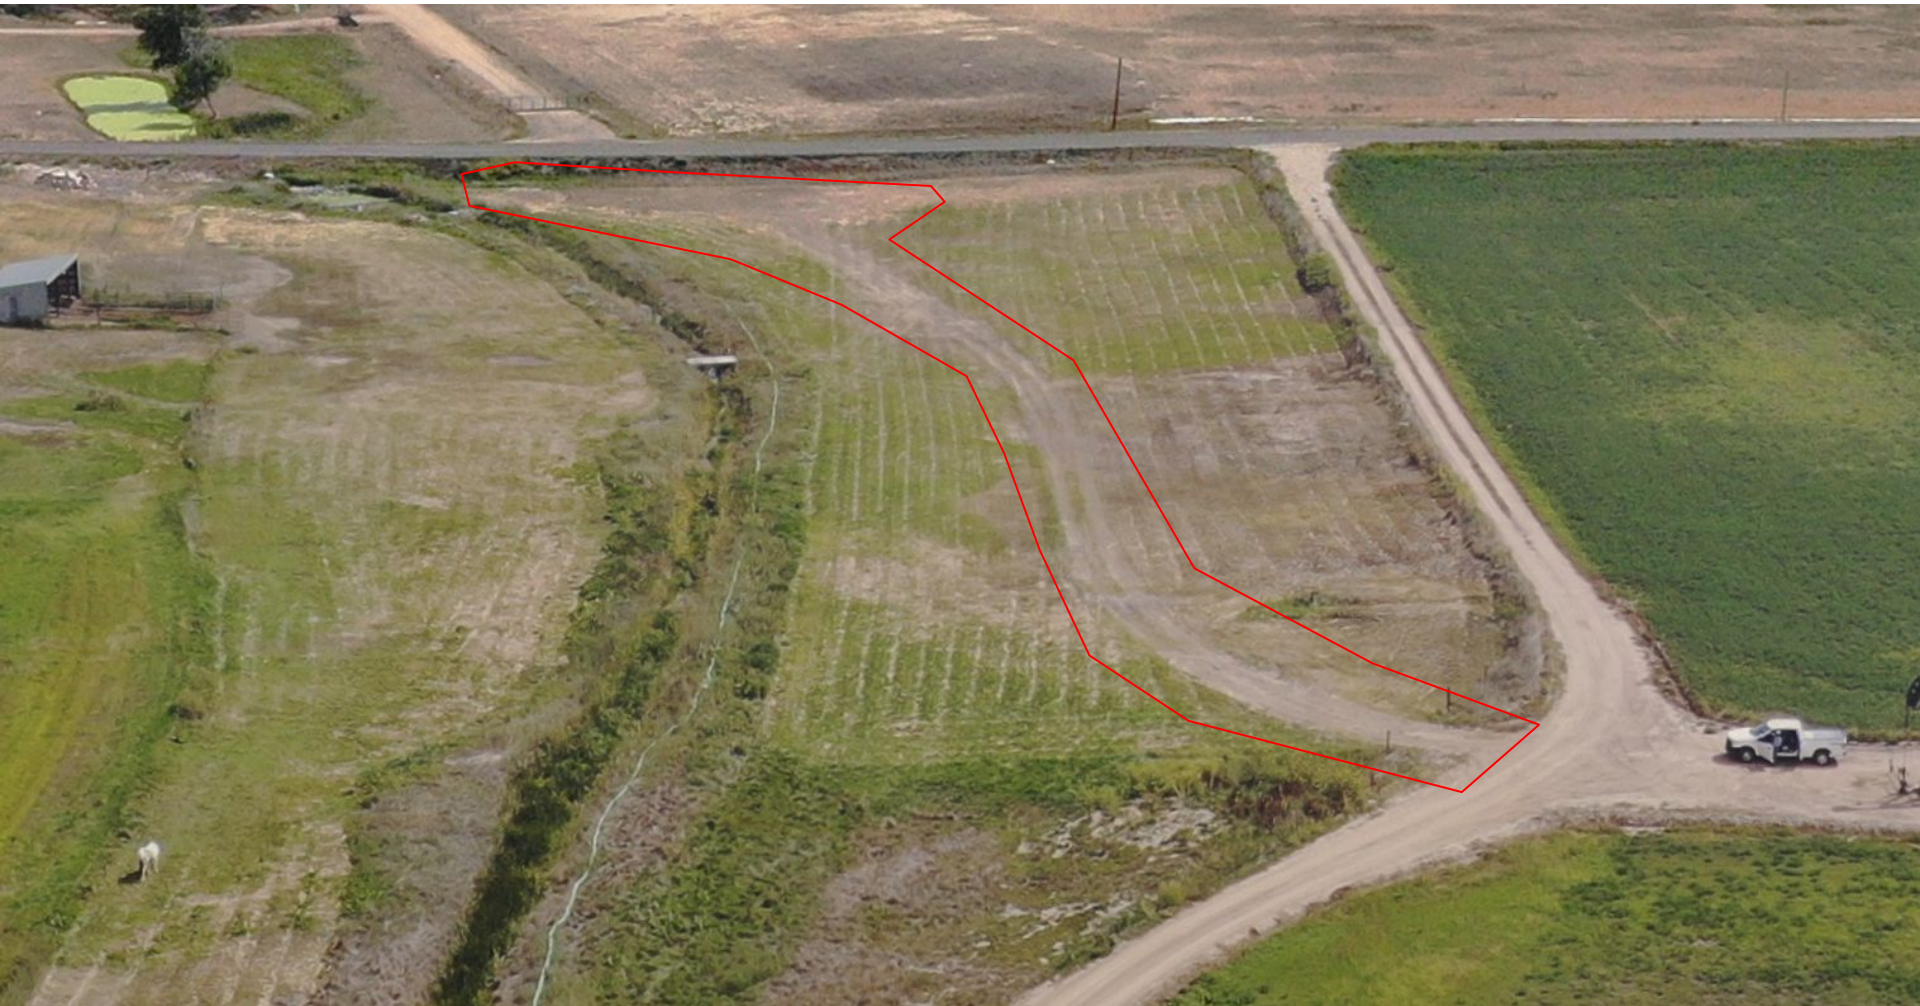
Photo 1. COGCC drone aerial imagery taken on September 13, 2022 documenting the scope of reclamation work to be performed. This image is the approximate extent of reclamation along the eastern project area.

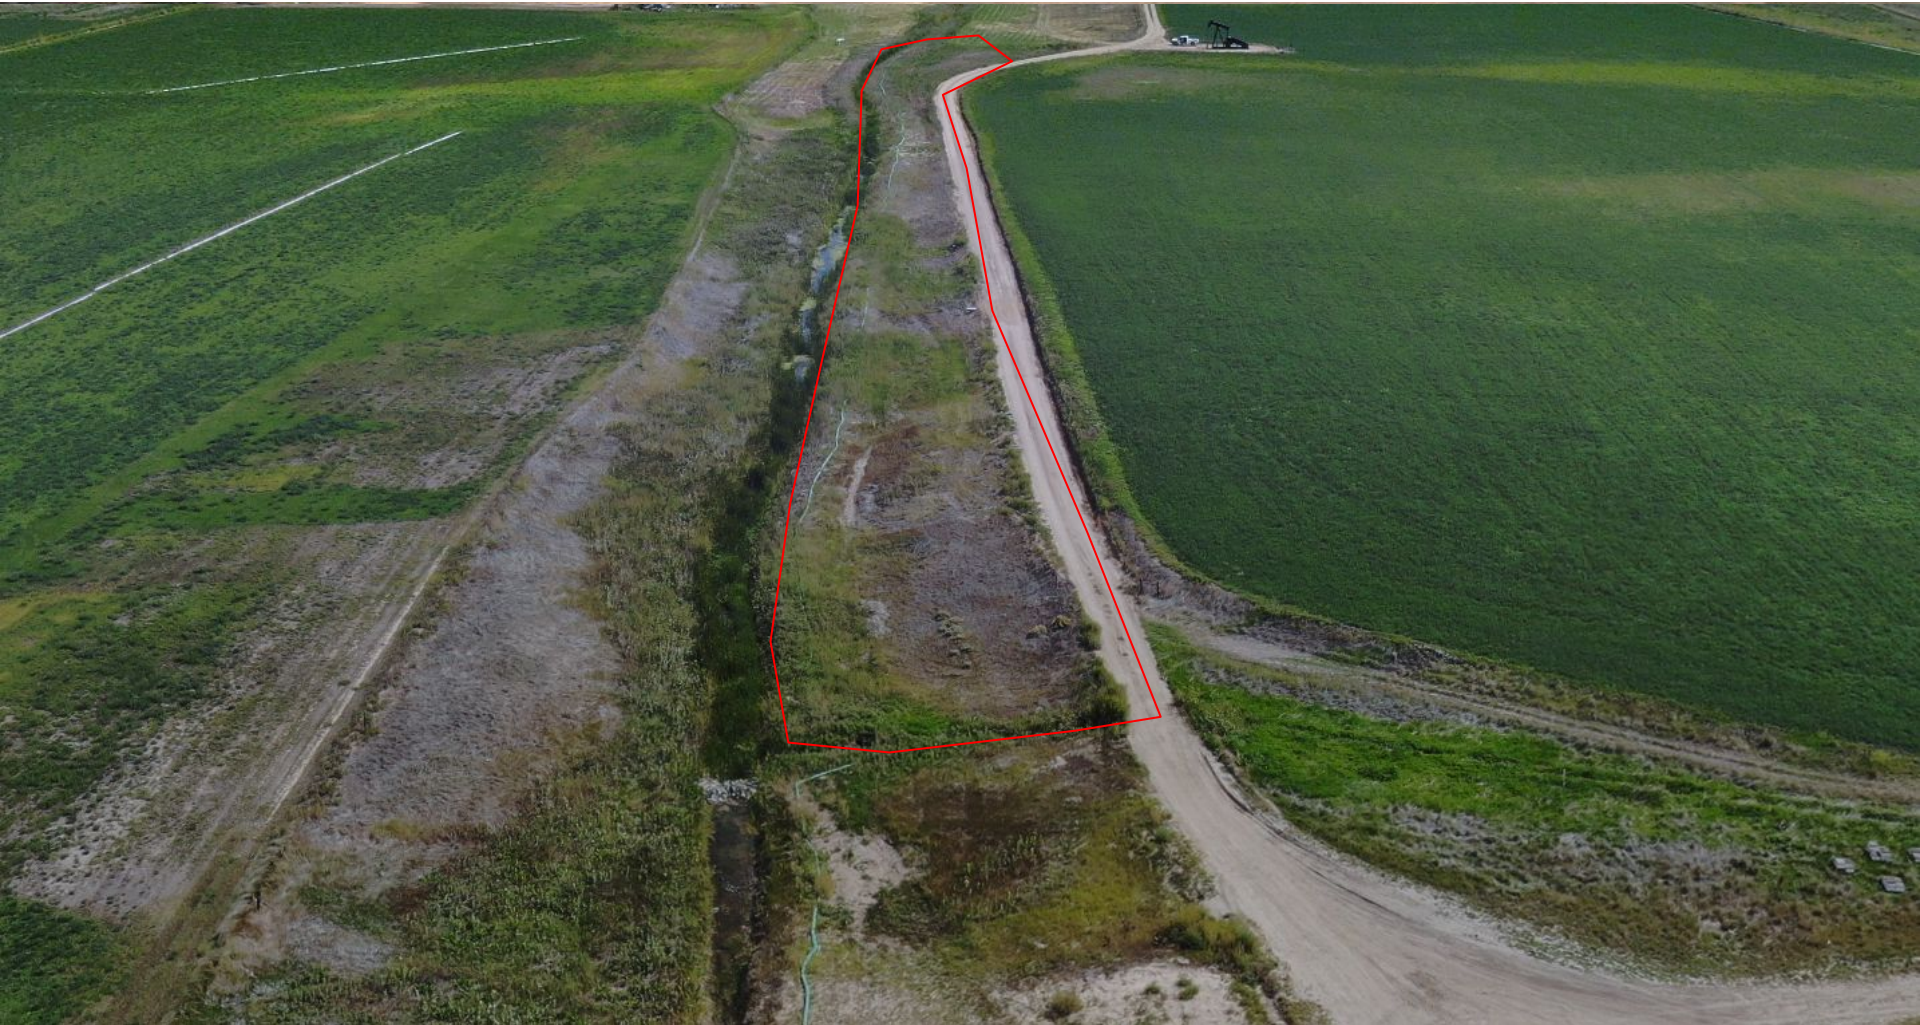
Photo 2. COGCC drone aerial imagery taken on September 13, 2022 documenting the scope of reclamation work to be performed. This image is the approximate extent of reclamation along the western and central project area.

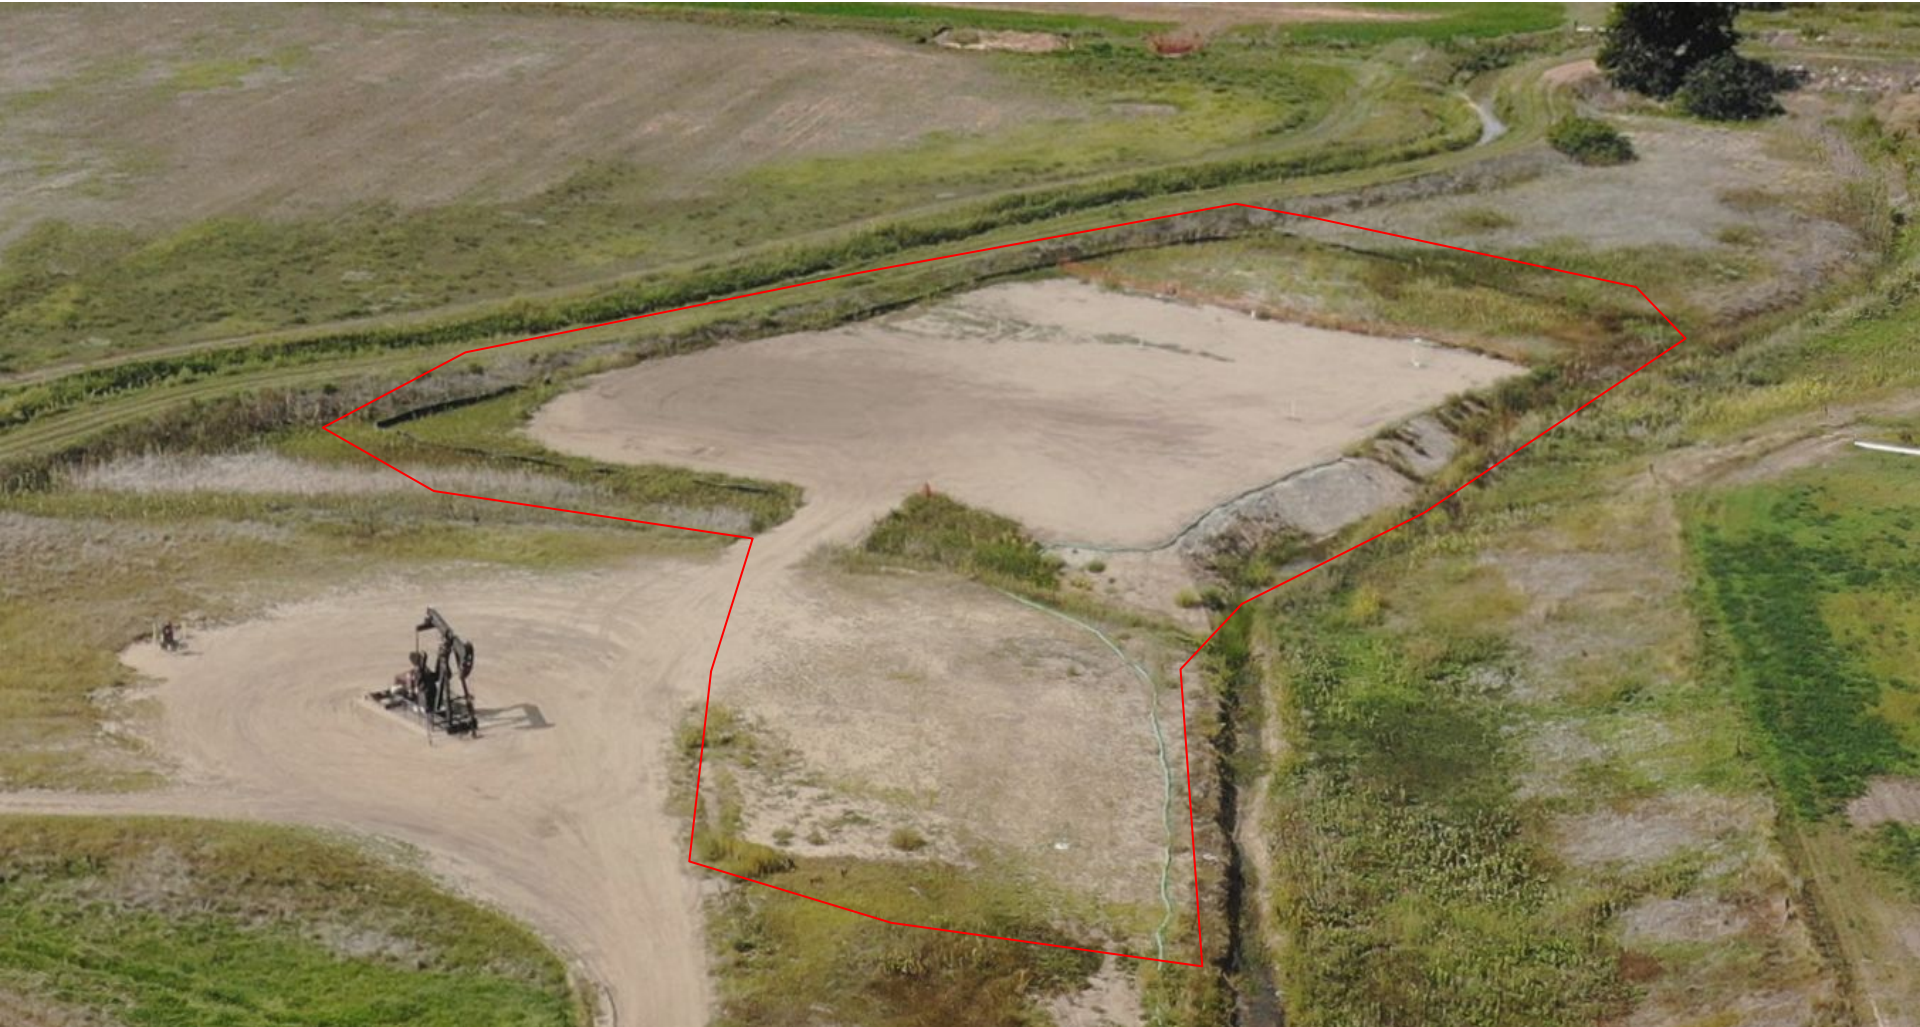
Photo 3. COGCC drone aerial imagery taken on September 13, 2022 documenting the scope of reclamation work to be performed. This image is the approximate extent of reclamation along the western project area.

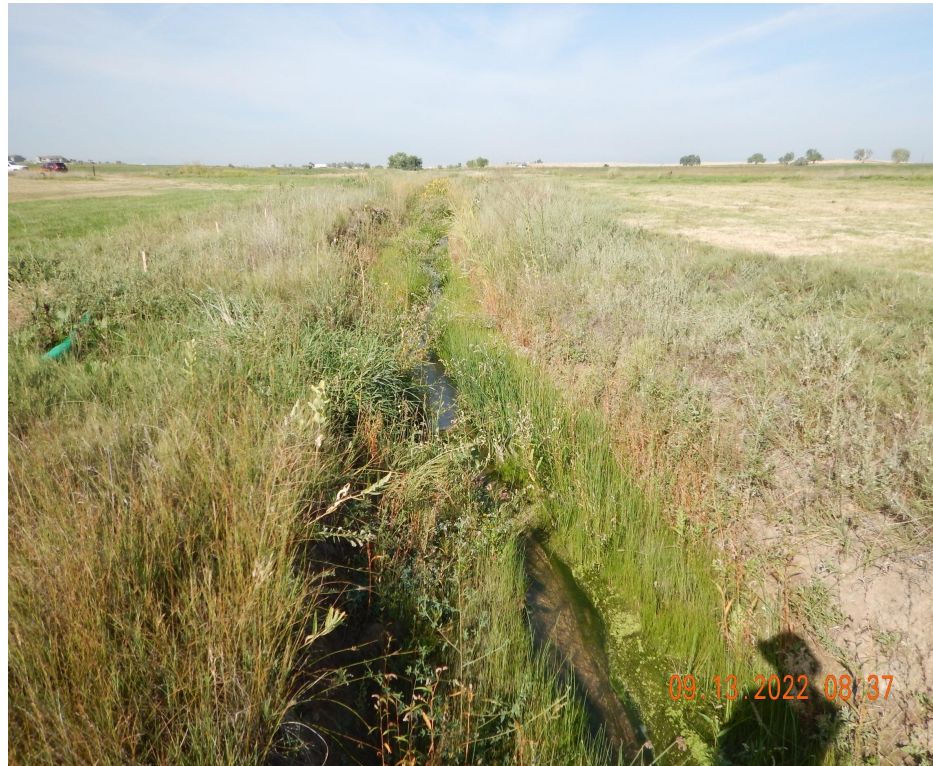
Photo 4. Photo taken from the eastern ditch, facing West. Photo illustrates native wetland vegetation has established within the ditch.

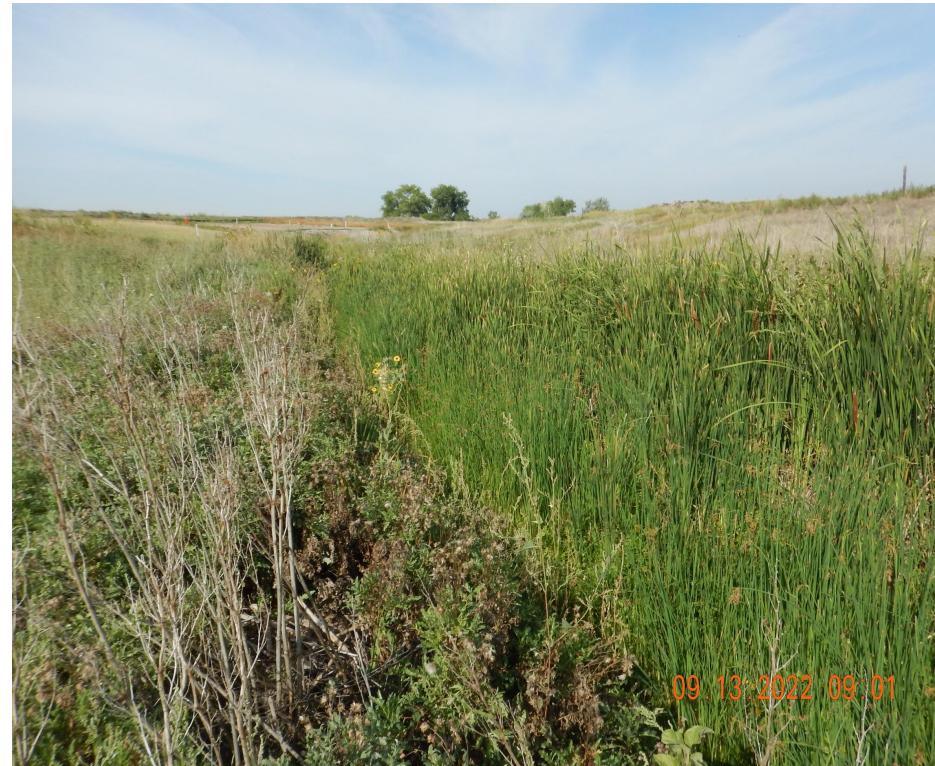
Photo 5. Photo taken from the central ditch, facing West. See comments under Photo 4.

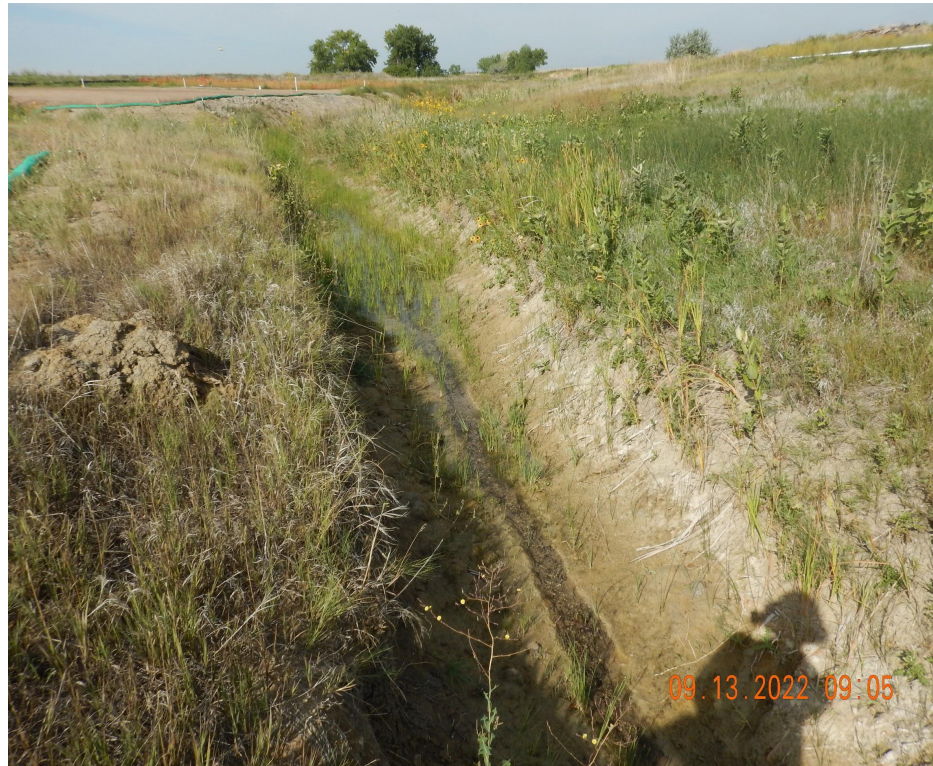
Photo 6. Photo taken from the western ditch, facing West. See comments under Photo 4.

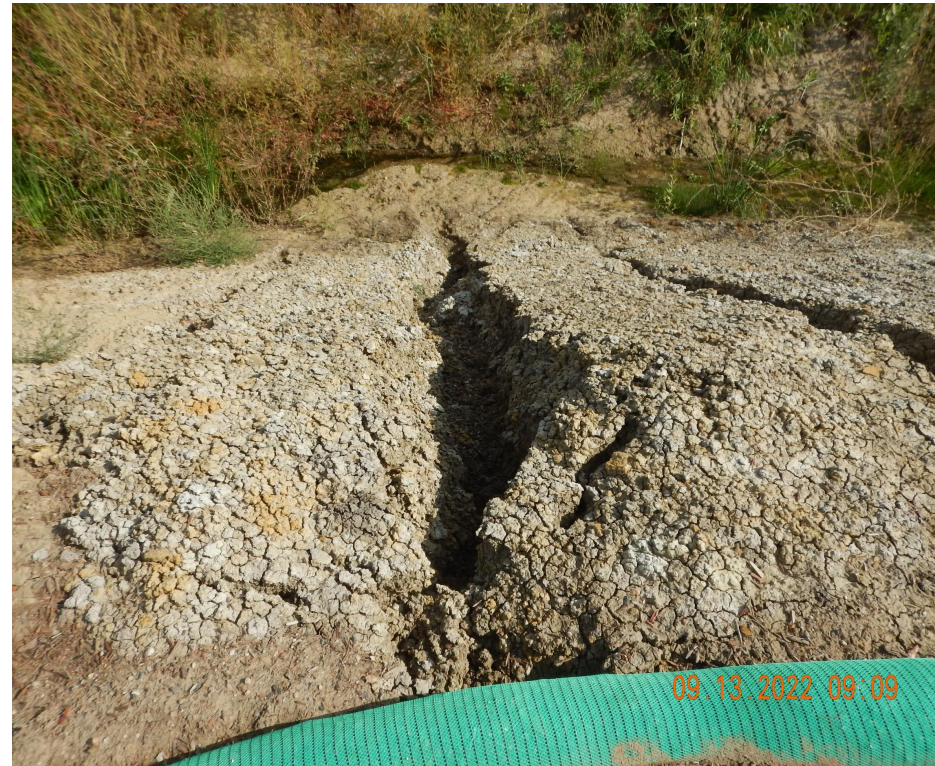
Photo 7. Photo taken from the western fill slope, facing North. Photo illustrates erosion along the fill slope that needs to be repaired during reclamation. The erosion is believed to be from a recent irrigation event by the surface owner.
