Final Reclamation and Stormwater Inspection

Operator: H2E OPERATIONS LLC - 10498

Location ID: 438081

Inspection Photos
Location Name: H2E SCHAAL #3-4-22-10-45
Location ID: 438081

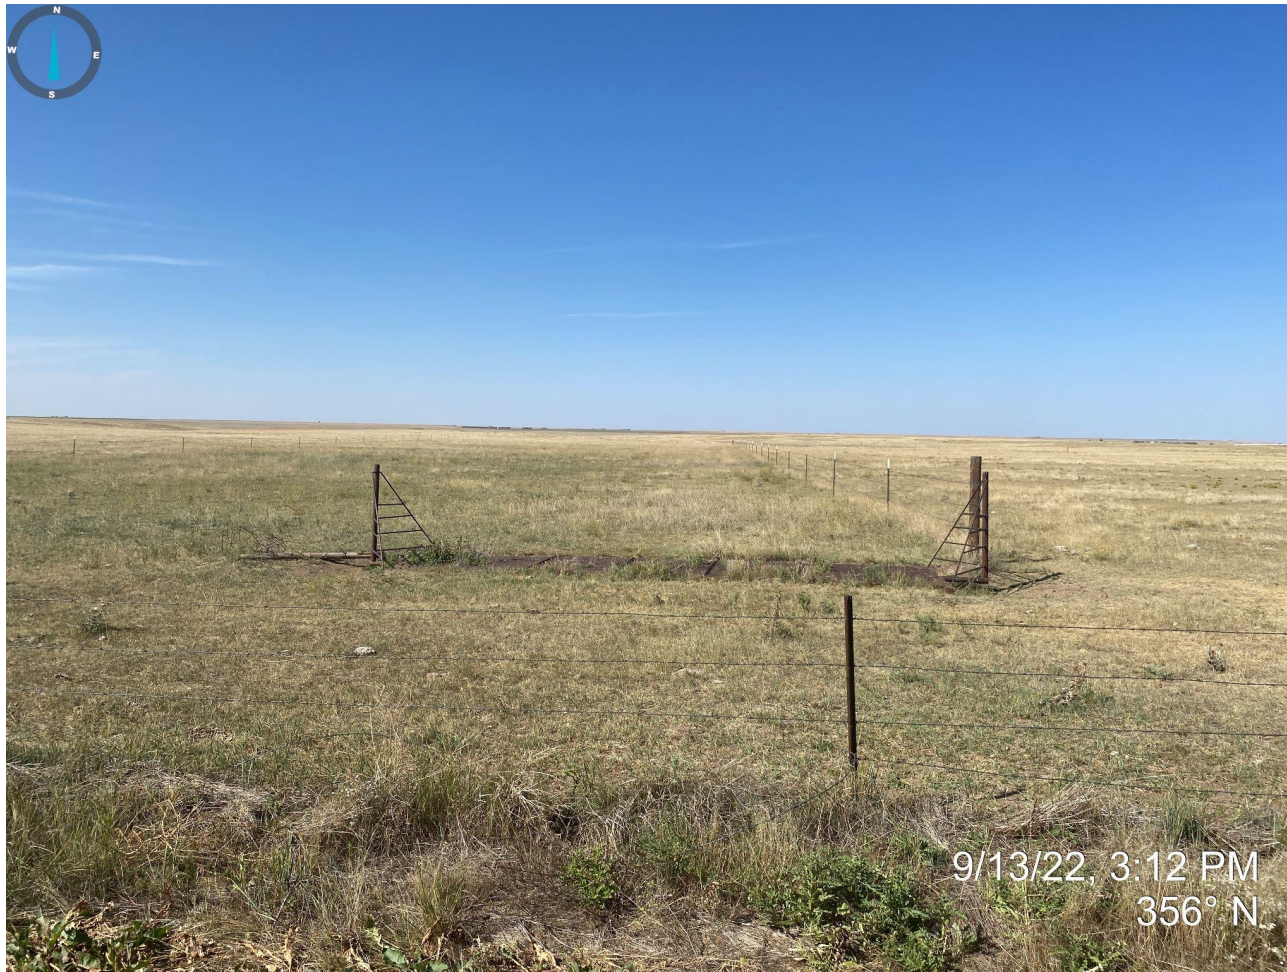
Photo 1. Photo taken from county road, facing north. Photo illustrates cattle guard remains at old access road entrance; fencing on perimeter of location remains. This material is now considered equipment/debris and needs to be removed.

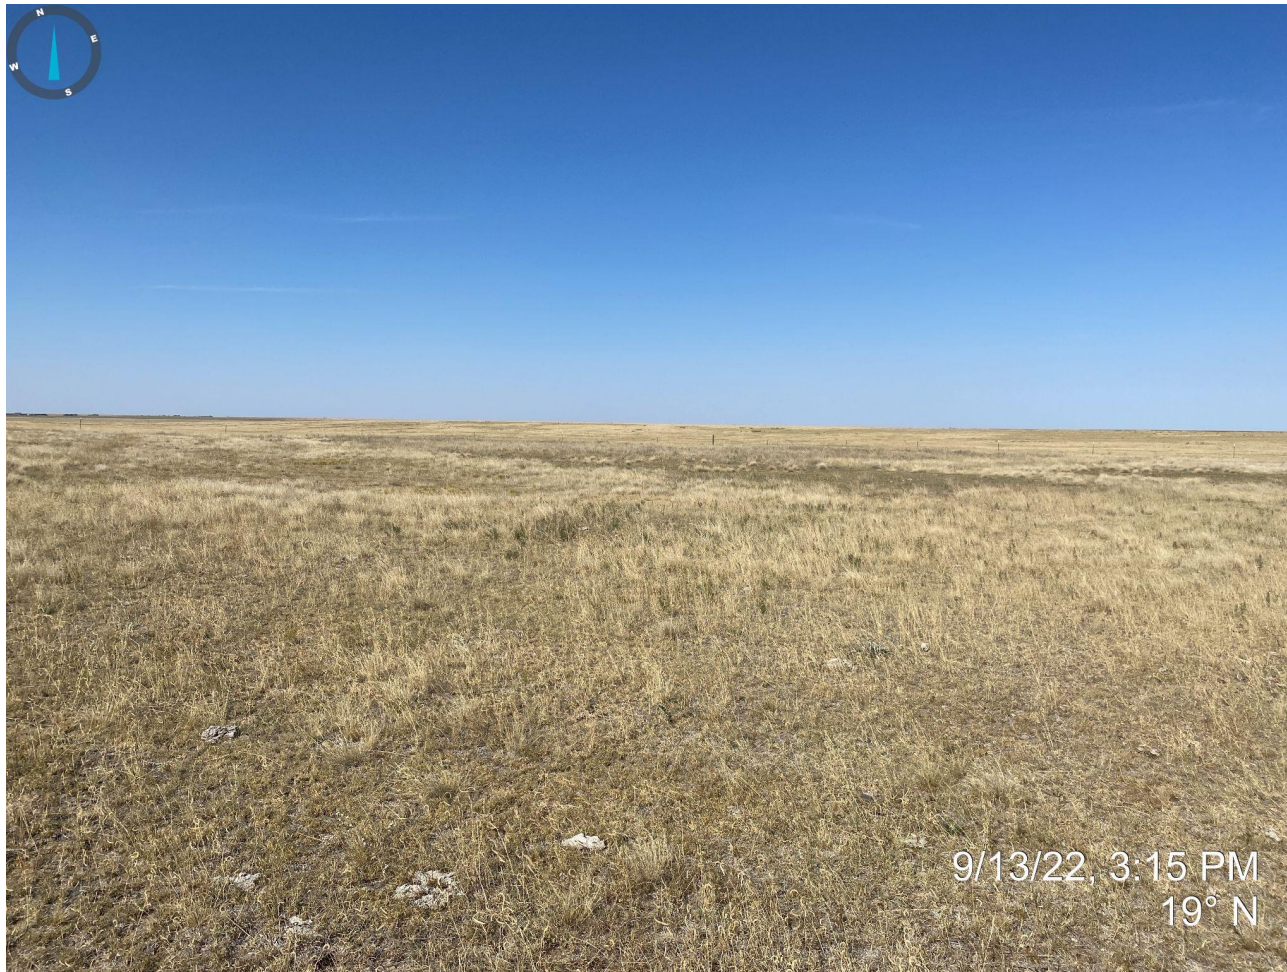
Photo 2. Photo taken from southern portion of location facing north. Photo illustrates desirable vegetation has established; buffalo grass, sand drop seed, blue grama, etc was observed during this inspection. This location meets final reclamation rules and standards for revegetation.

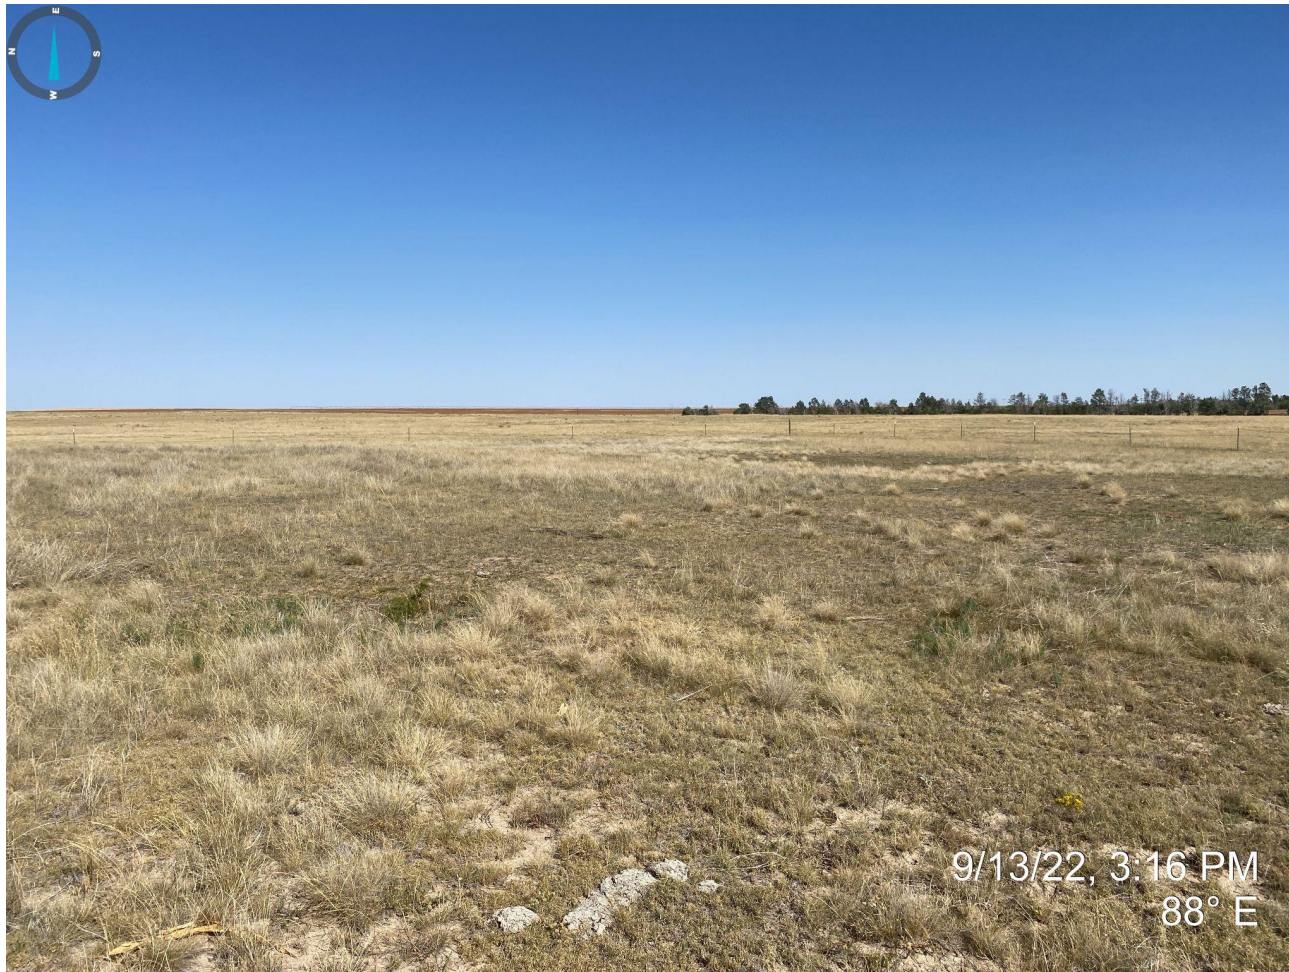
Photo 3. Facing east, see comments in photo 2.

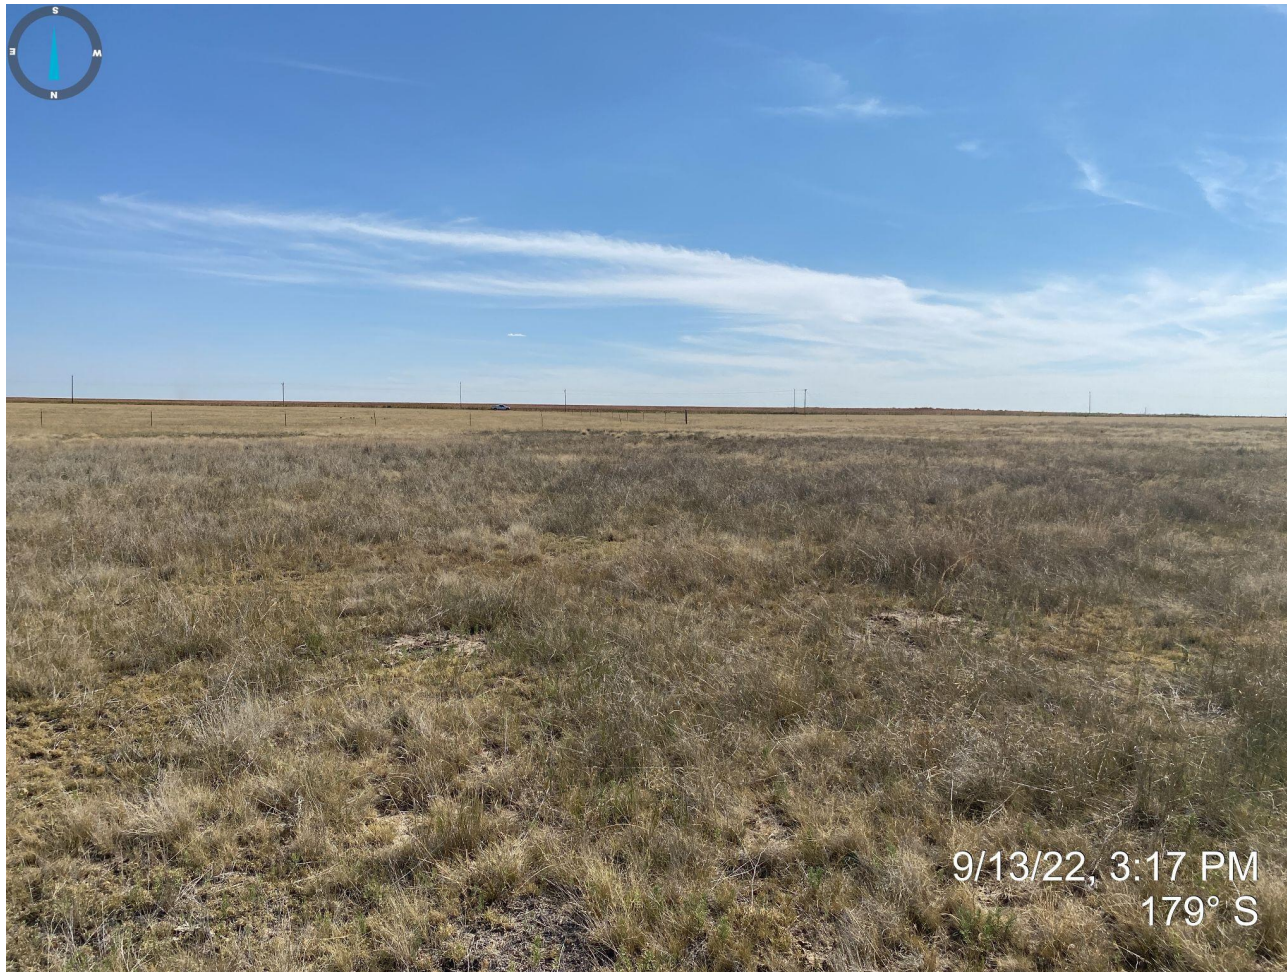
Photo 4. Facing south, see comments in photo 2.

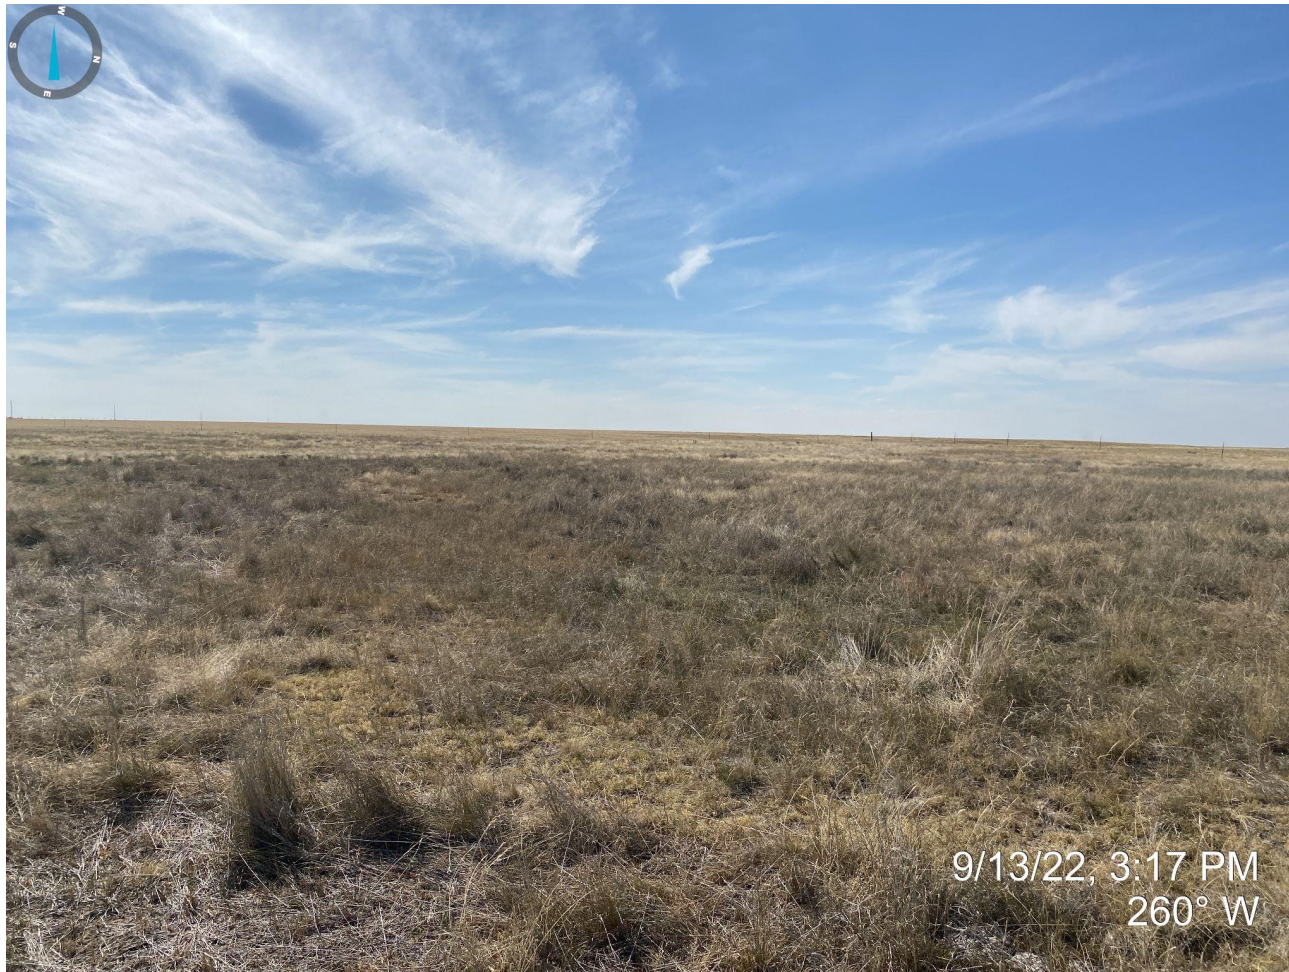
Photo 5. Facing west, see comments in photo 2.

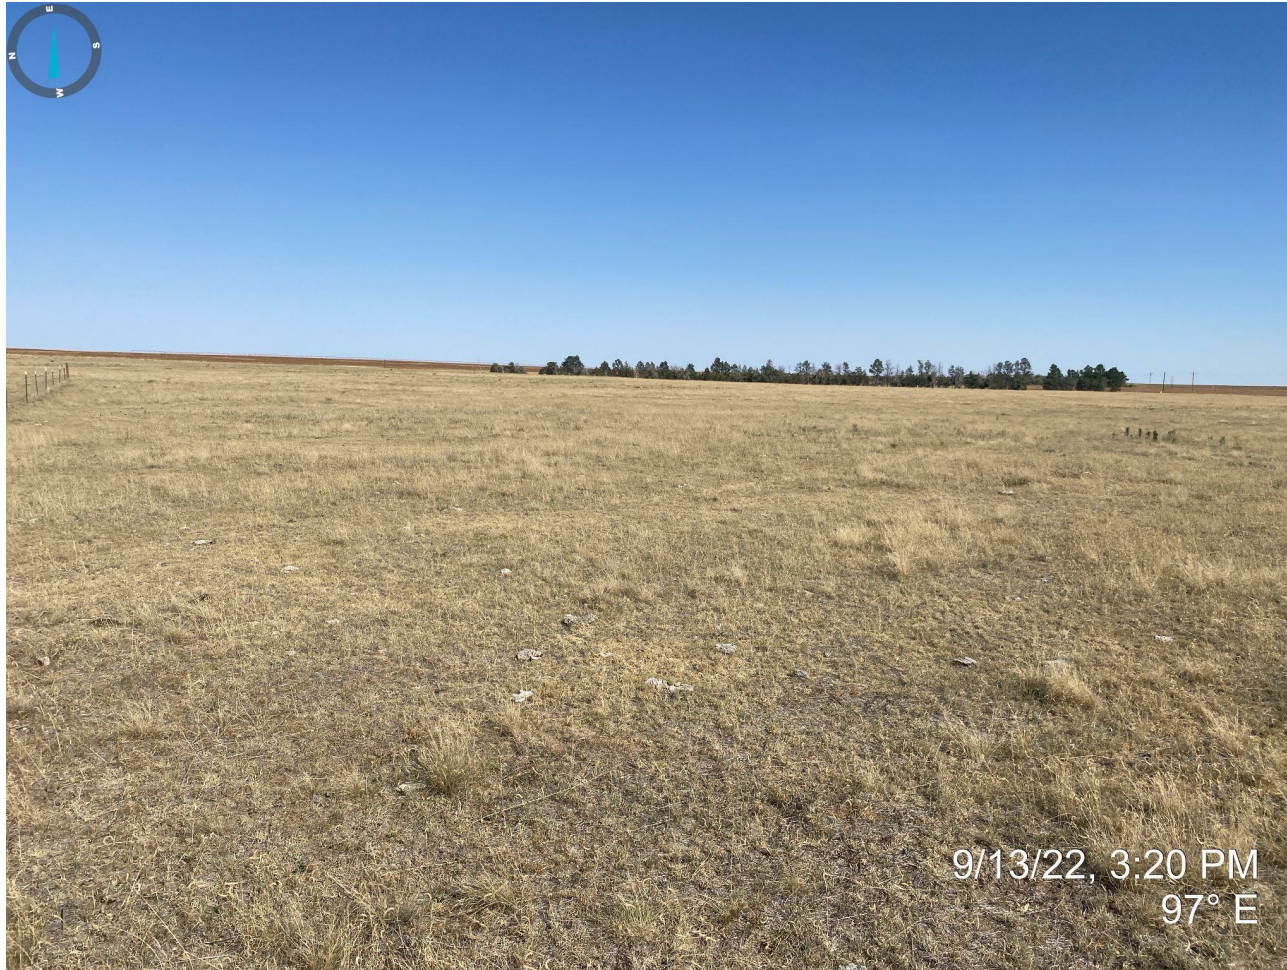
Photo 6. Reference area photo taken south and east of location, facing east. Photo illustrates reference area is predominantly buffalo grass and blue grama.
