# Inspection Photos and Issue Report

Operator: VISION ENERGY LLC - 10770

Location #312658

Mesa County, CO

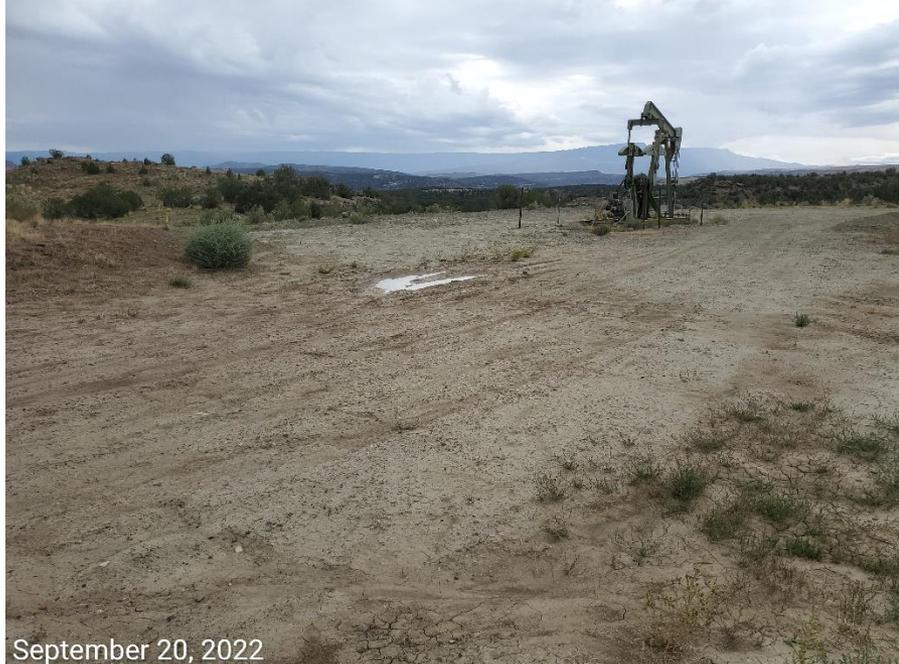
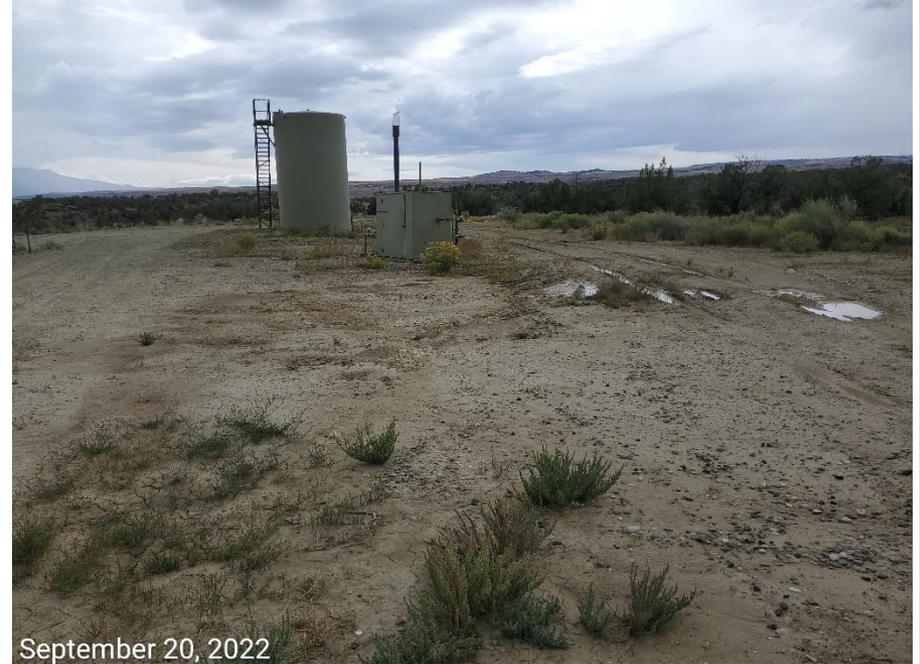
**Photo 1:** Photos taken from the north end of the Location, facing southeast and southwest. Photos provide overview of the Location.

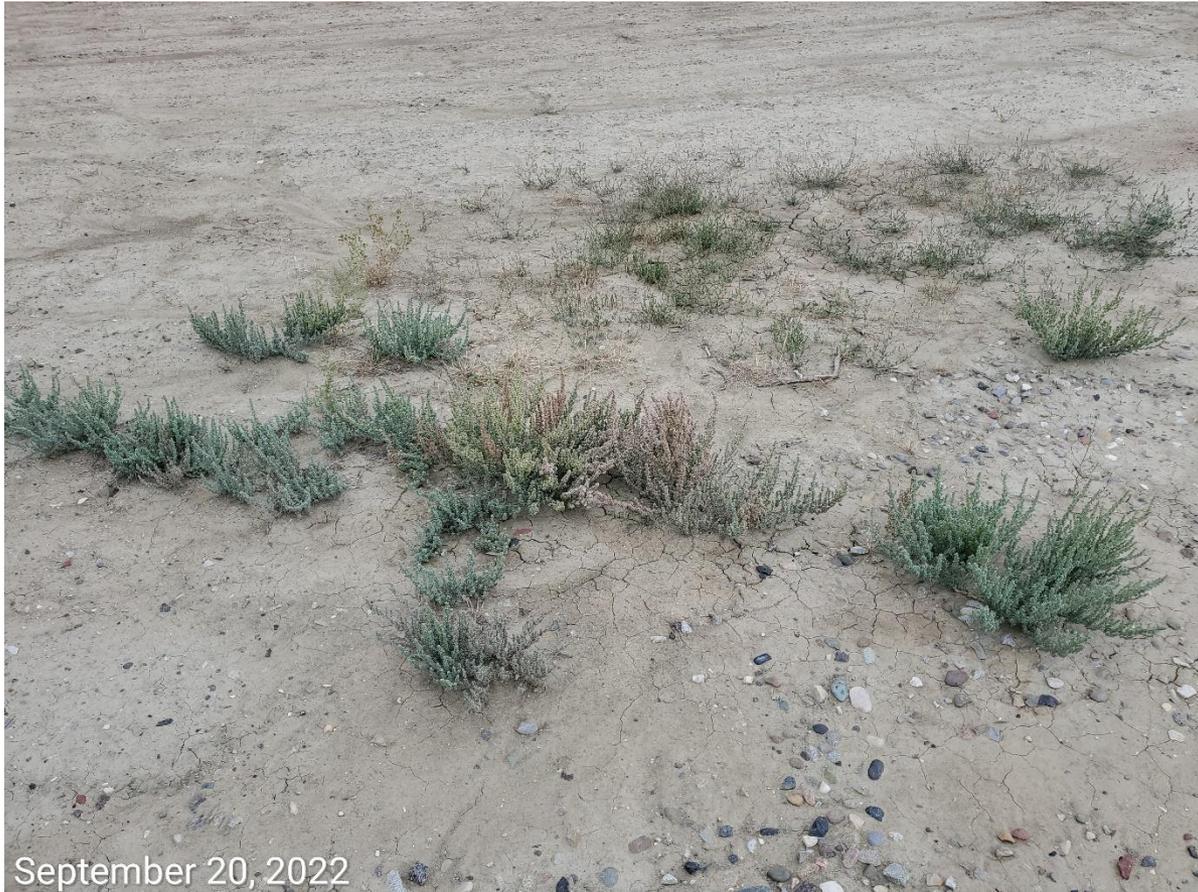
**Photo 2:** Photo example showing noxious weeds remain established on the Location.

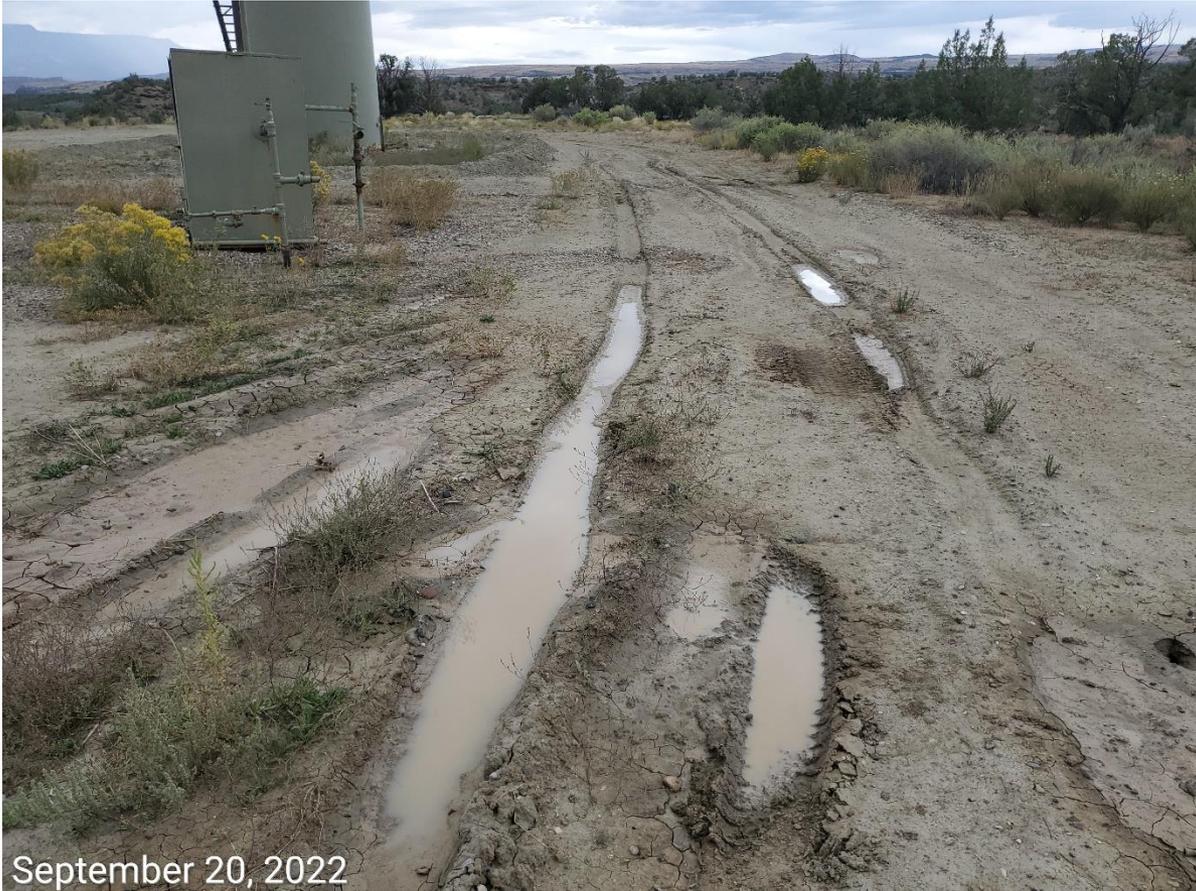
**Photo 3:** Photo example showing BMPs to stabilize the Location, and to minimize tracking and sediment transport remain missing or insufficient.

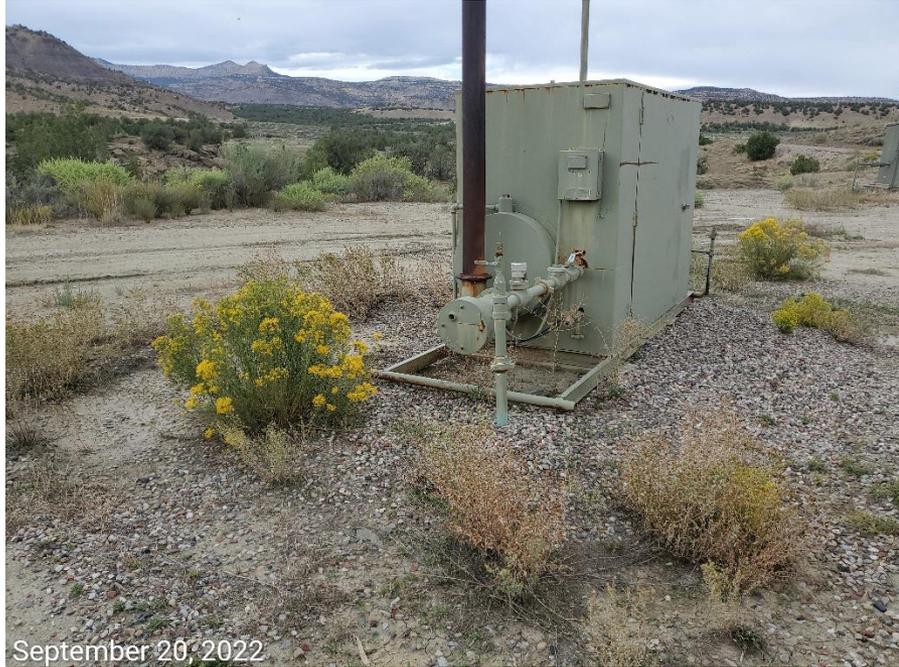
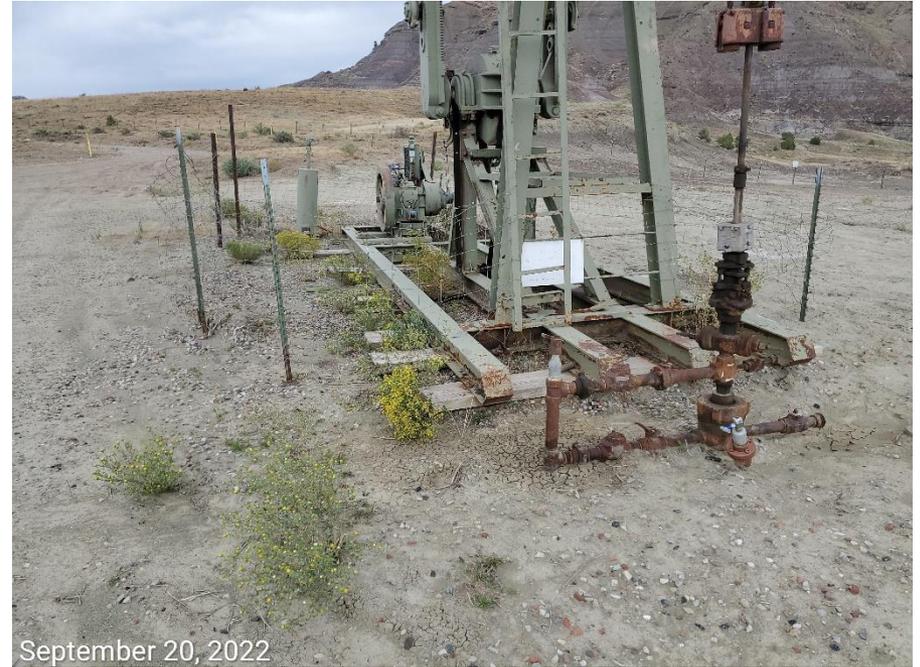
**Photo 4:** Photos examples showing vegetation remains established around production equipment. Photo right also shows sign at well remains inadequate.

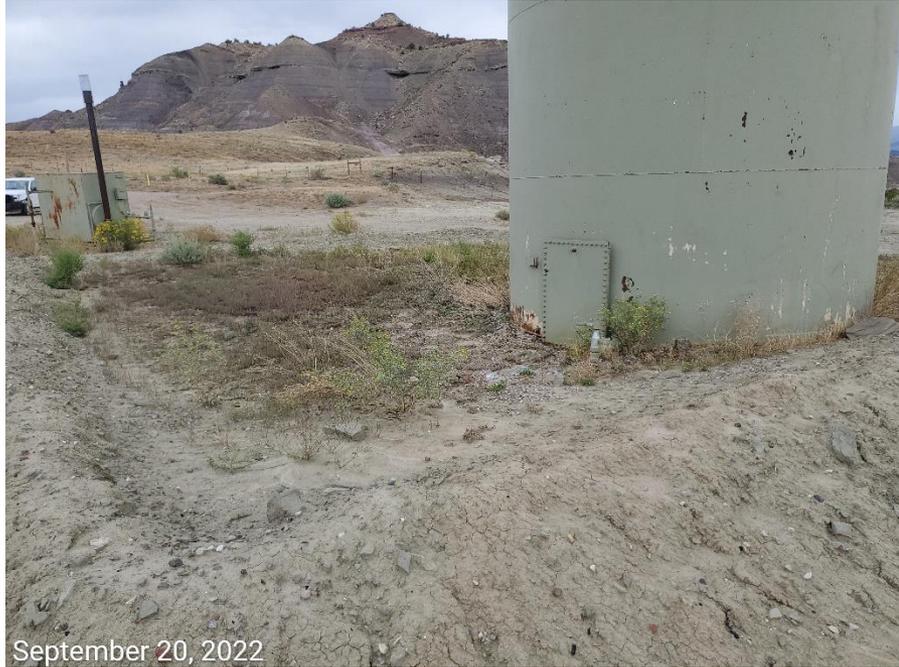
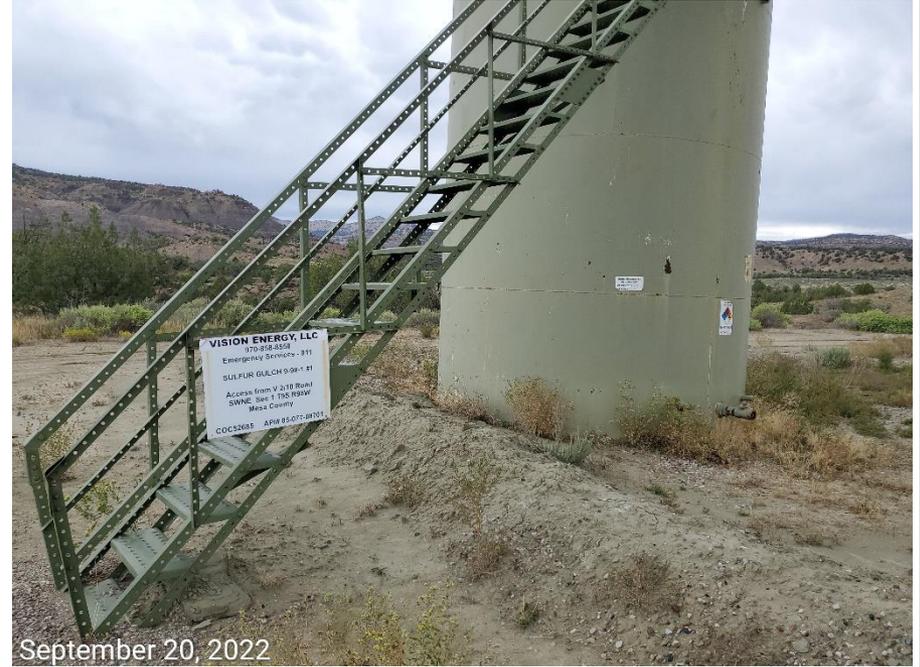
**Photo 5:** Photos examples showing areas vegetation remains established at the secondary containment BMP; secondary containment is not in proper functioning condition, or adequate in size to contain a spill from the tank. Vegetation within BMP compromises the impermeability of the containment.

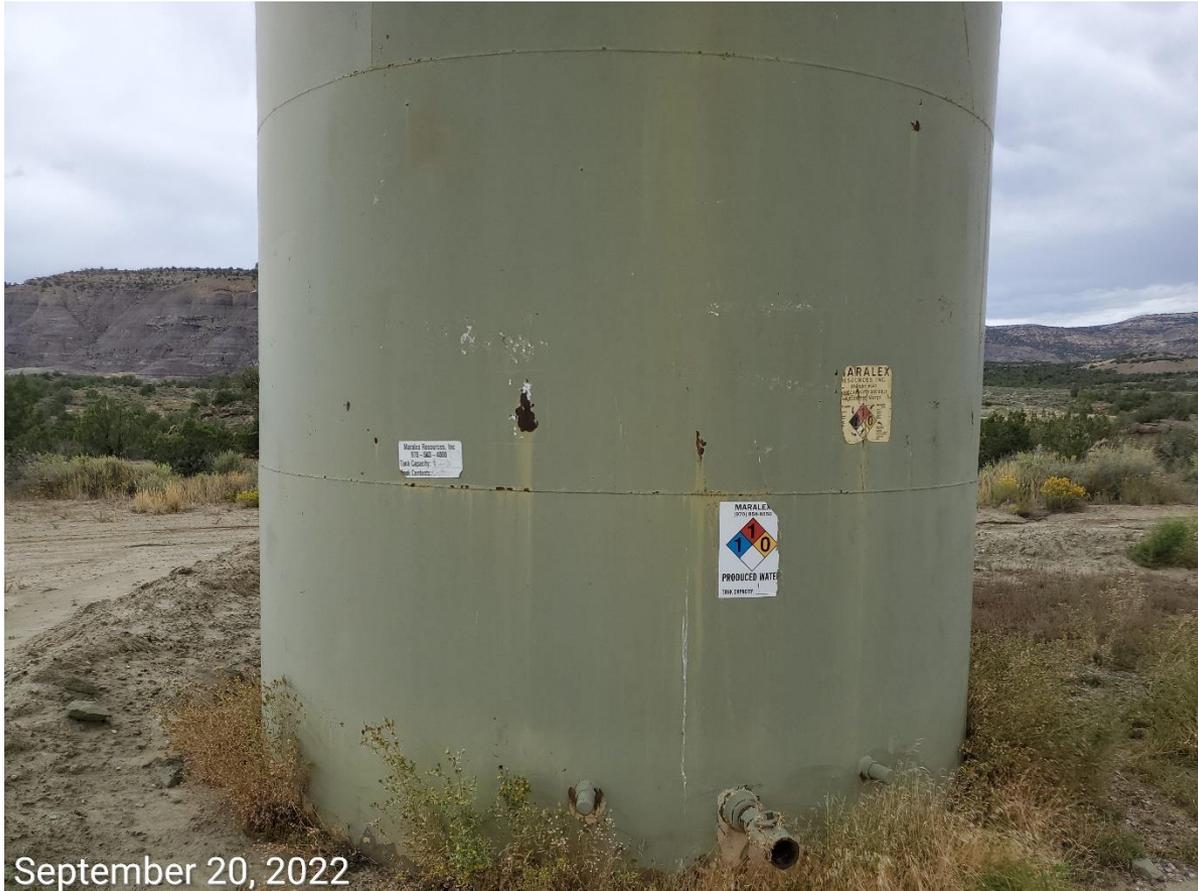
**Photo 6:** Labeling on tank does not comport with Rule 605.h

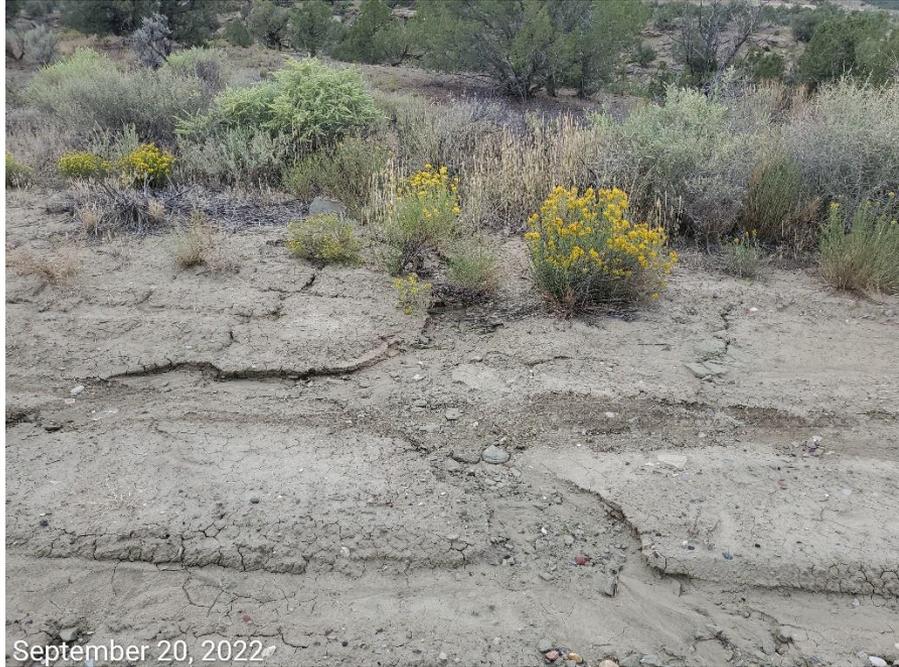
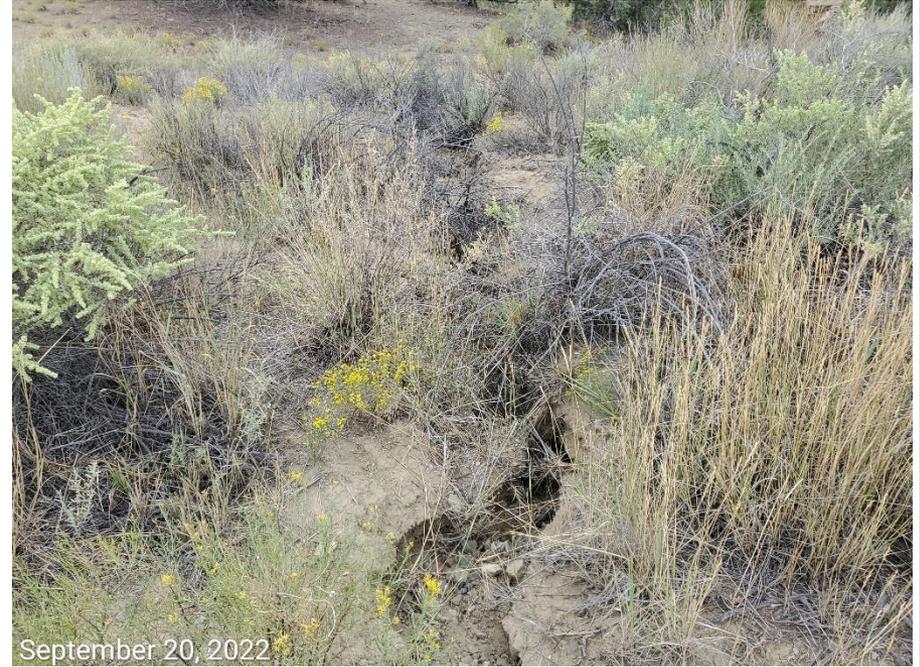
**Photo 7:** Photos taken from the west end of the Location. Photo shows stormwater runoff from the location has not been managed in a manner that minimizes erosion and degradation; gully erosion evident on offsite areas west of Location (photo right).

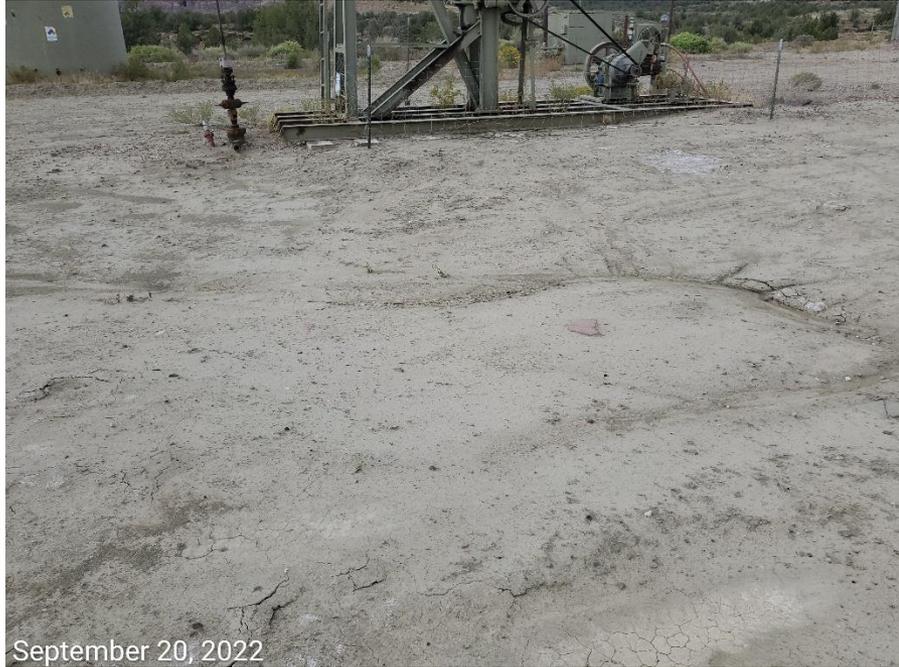
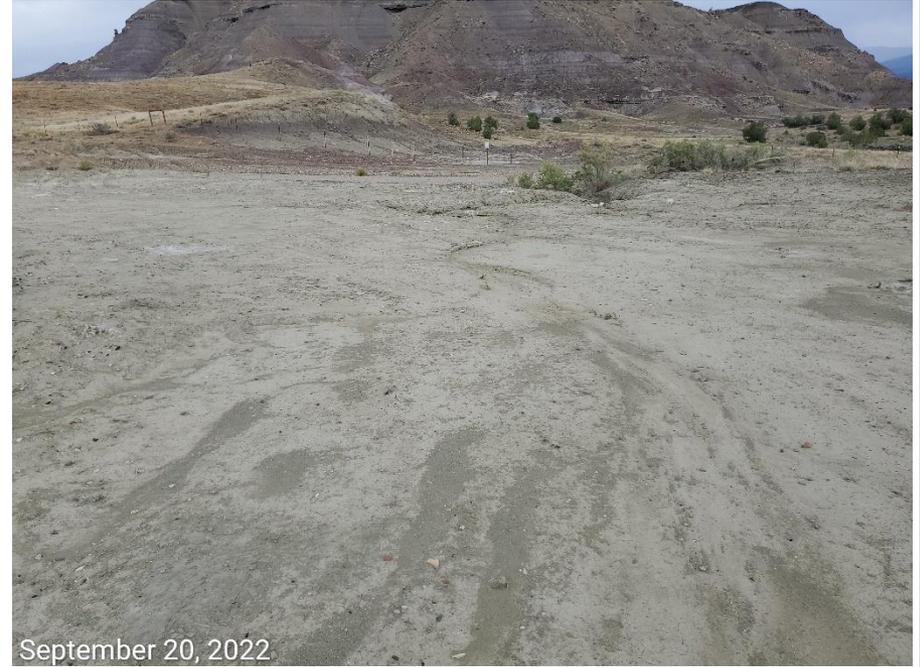
**Photo 8:** Photos 8-10 taken from the east end of the Location. Photos show stormwater and erosion control BMPs to stabilize the location and manage runoff remain missing or insufficient; erosion degradation has persisted.
