Final Reclamation and Stormwater Inspection

Operator: ENERGY QUEST II LLC - 10490

Location ID: 337062

Inspection Photos
Location Name: LIKE #3-16
Location ID: 337062

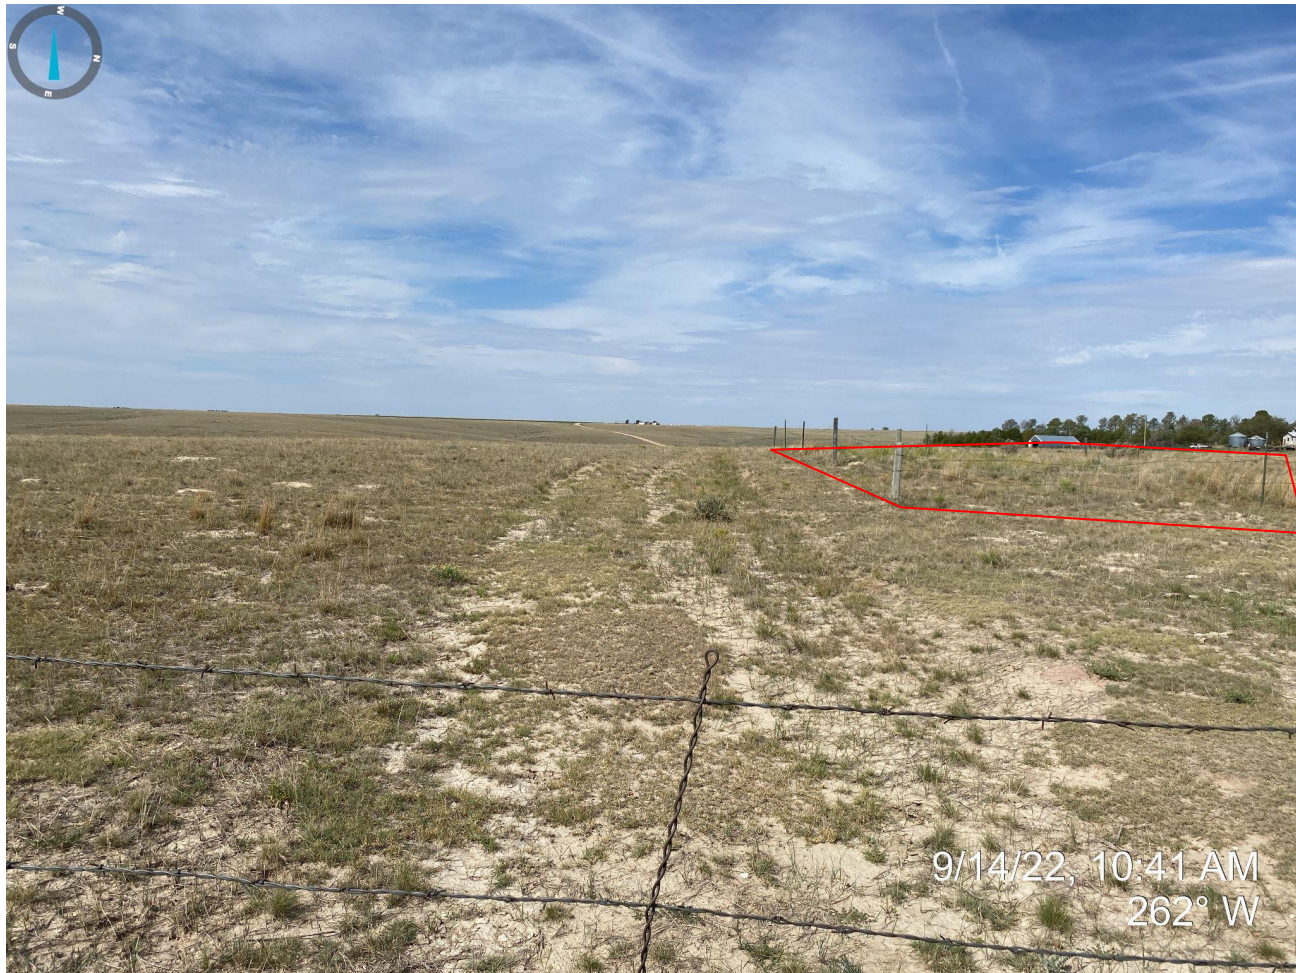
Photo 1. Taken from county road, facing west. Photo illustrates that access road has not been reclaimed and perimeter fencing is still installed (outlined in red); this is considered debris and needs to be disposed of properly.

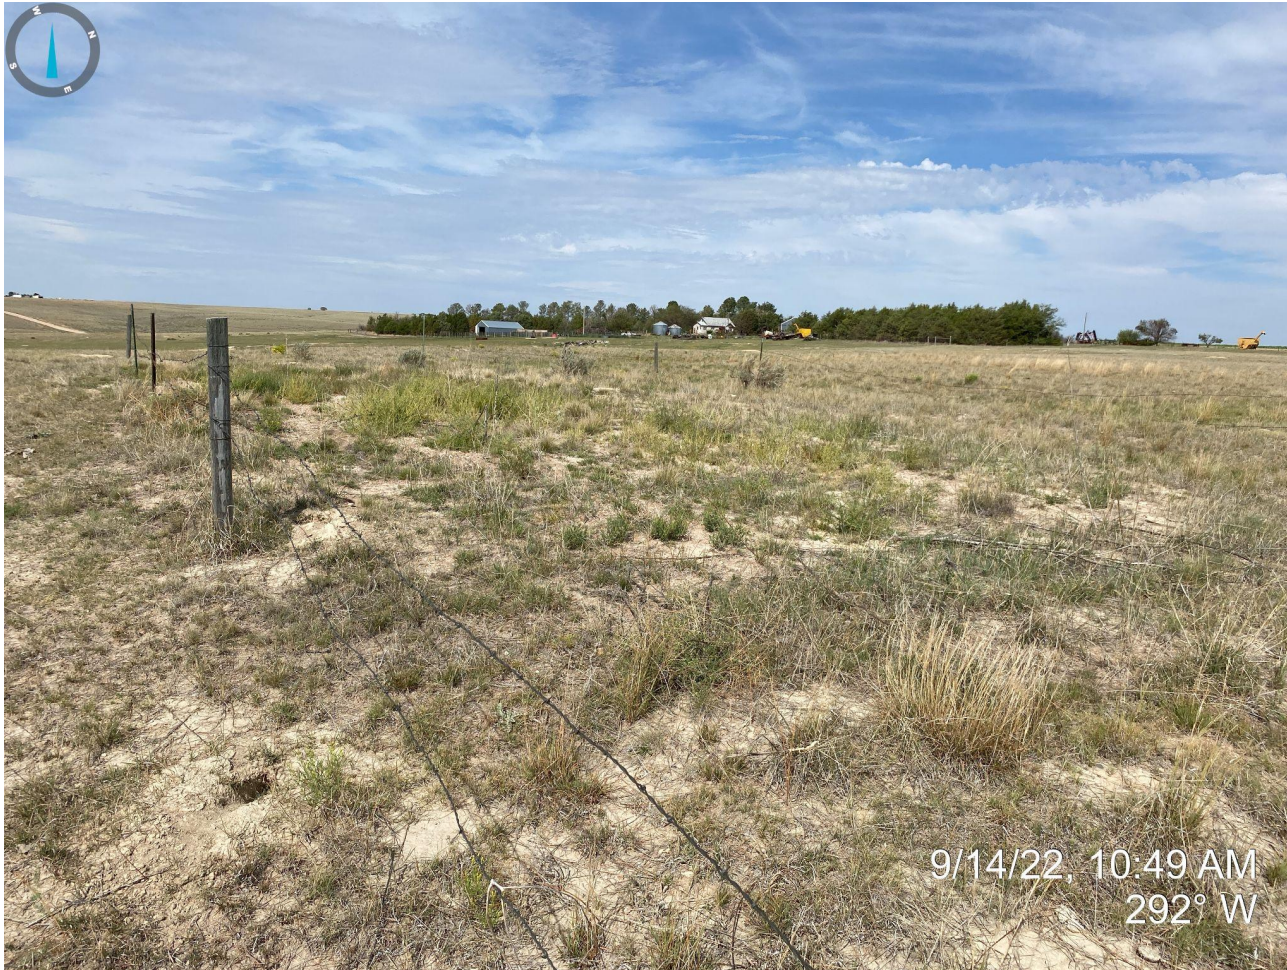
Photo 2. Facing west, see comments in photo 1.

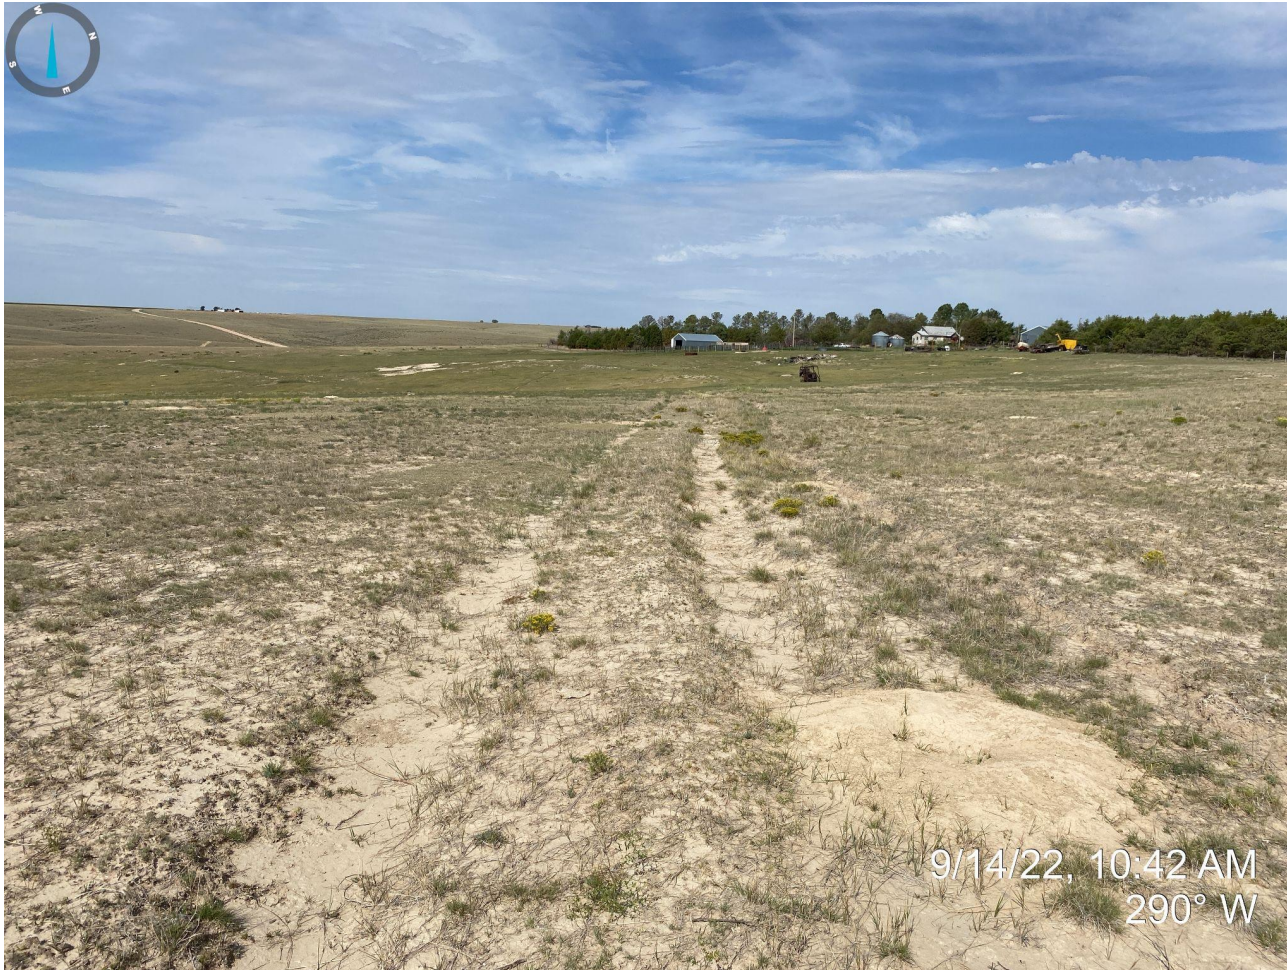
Photo 3. Access road facing west, see comments in photo 1.

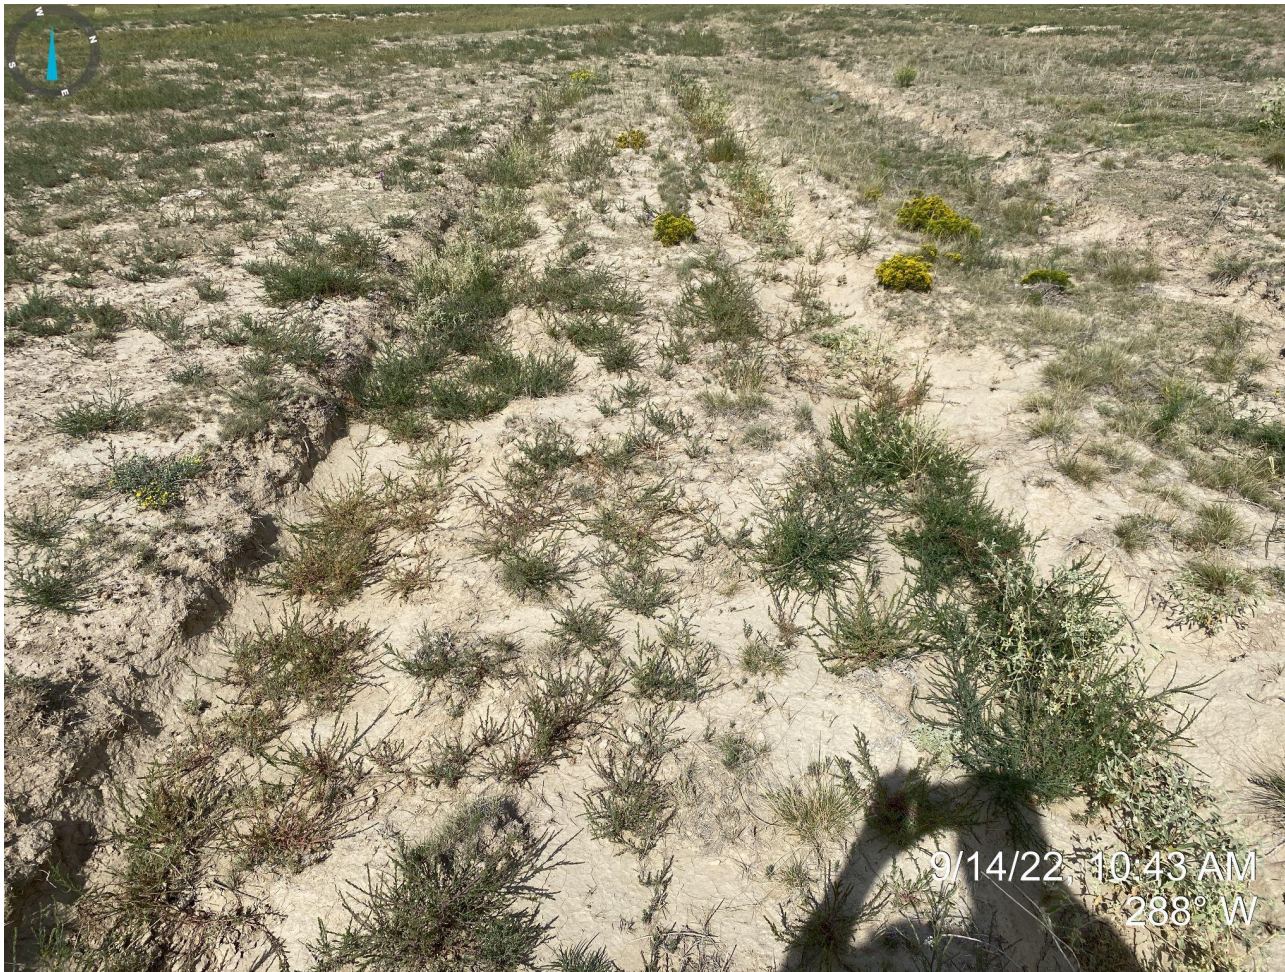
Photo 4. Close up photo showing access road has not been reclaimed with presence of rutting and annual weedy vegetation (predominantly russian thistle).

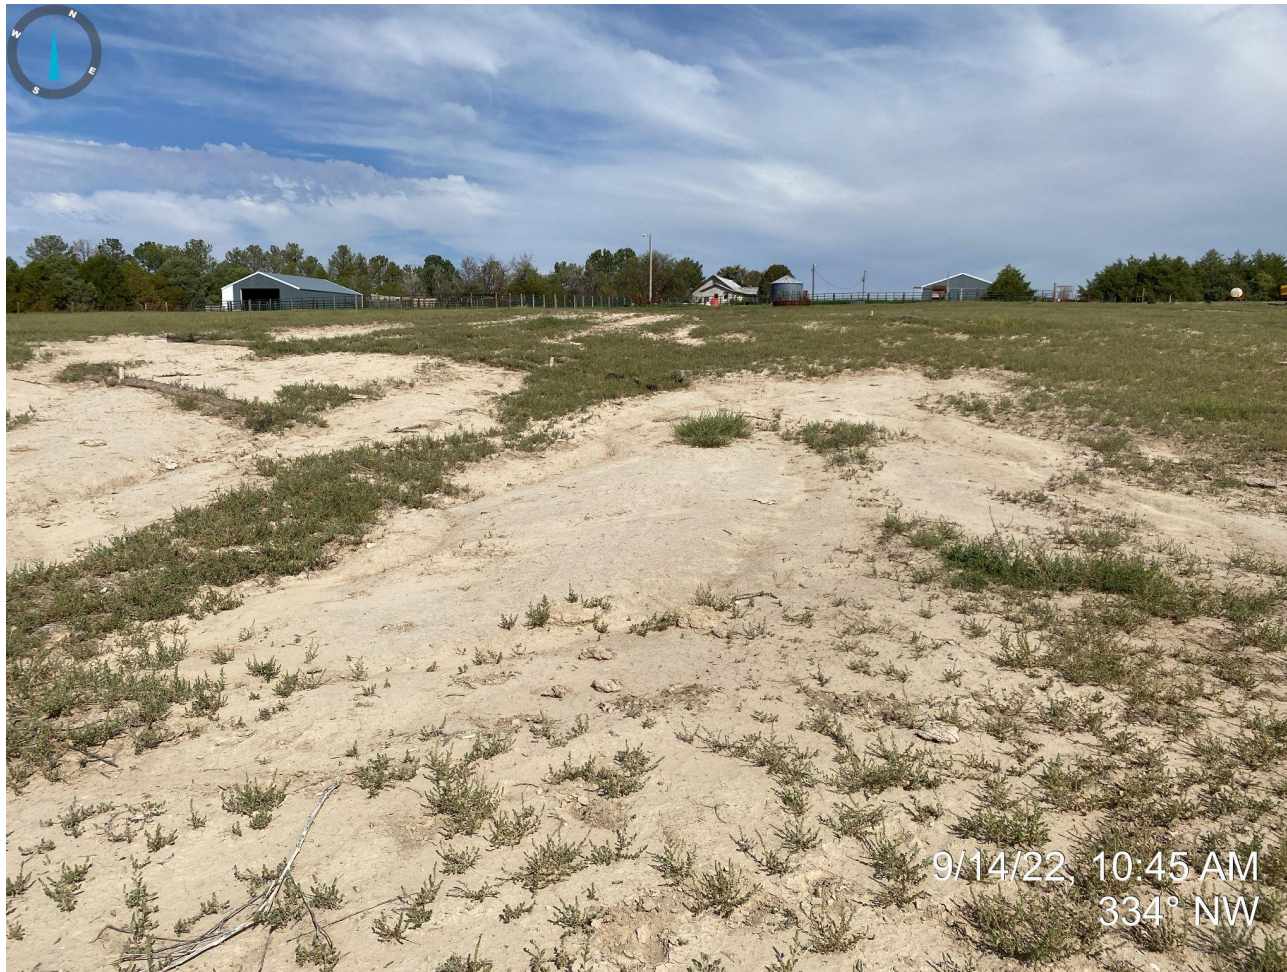
Photo 5. Taken from southern portion of location, facing northwest. Photo illustrates that location has not been reclaimed. Non-uniform vegetation cover resulting in bare soil, annual weedy vegetation (russian thistle and kochia) observed throughout the location, and rill/gully erosion resulting from unstabilized soil.

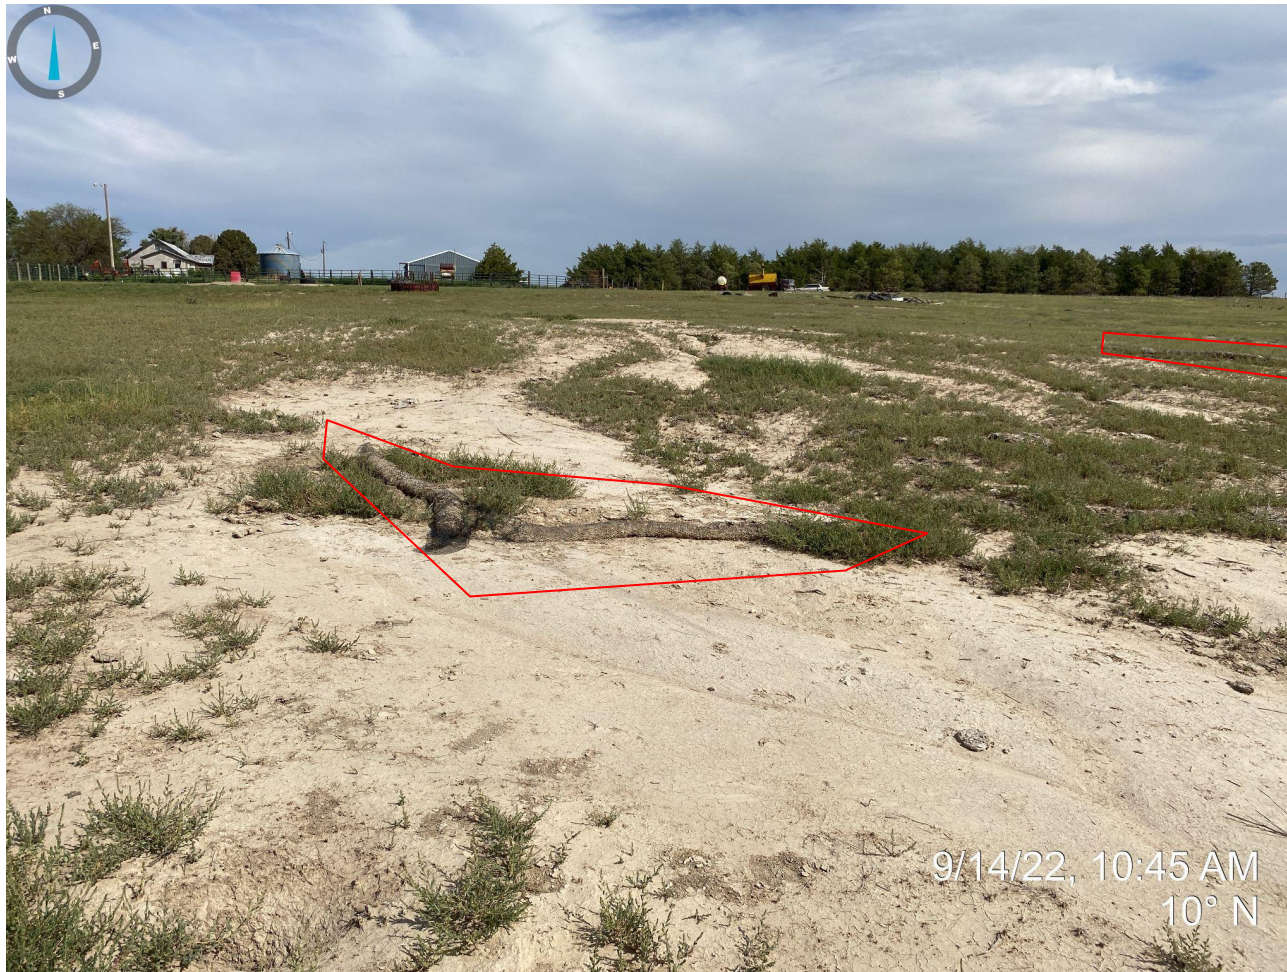
Photo 6. Facing north; degraded and/or improperly installed straw wattles outlined in red. These are considered debris and need to be disposed of properly.

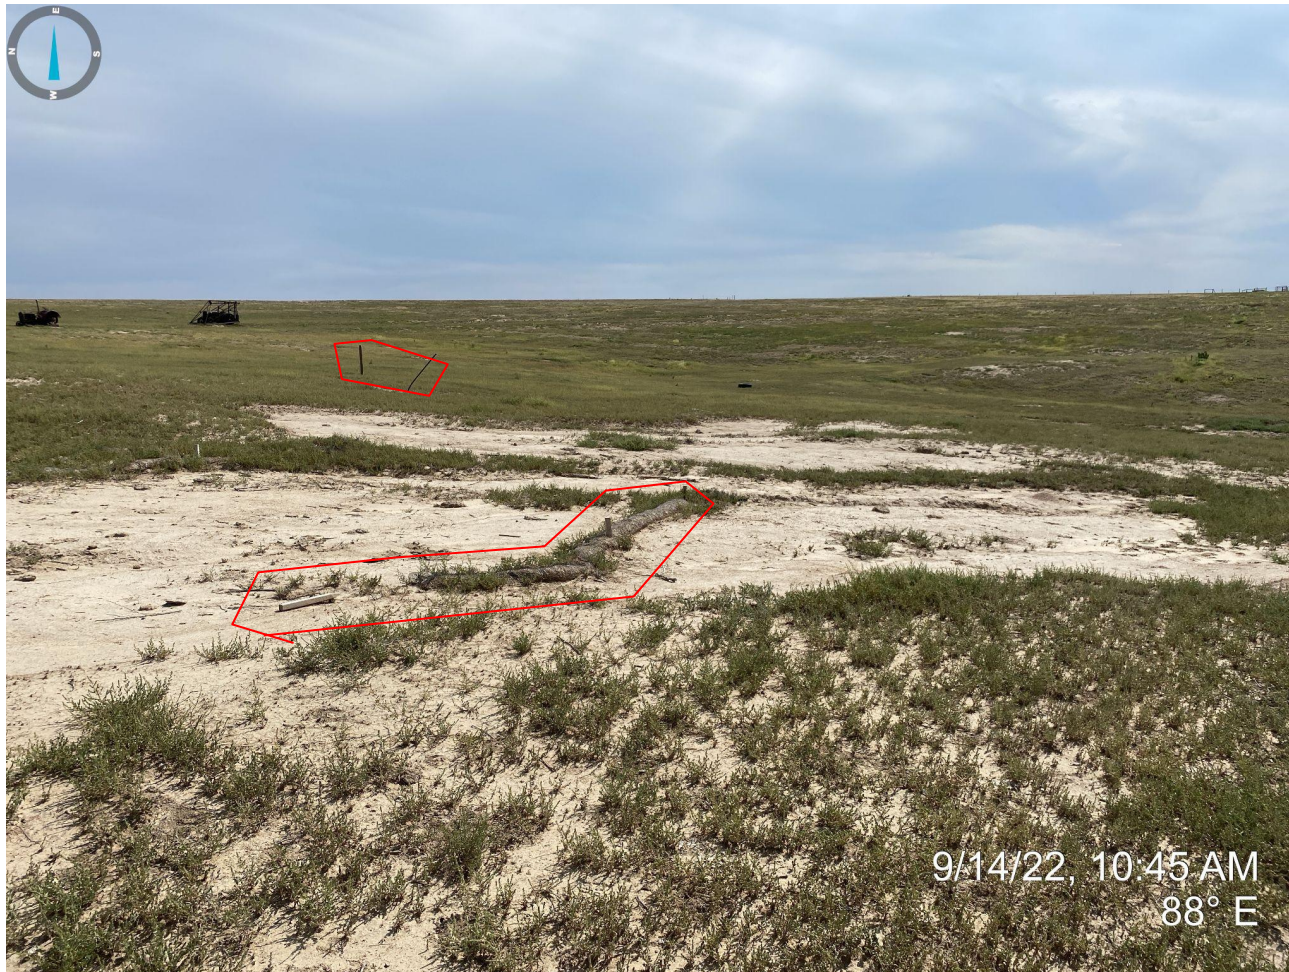
Photo 7. Facing east, see comments in photo 6.

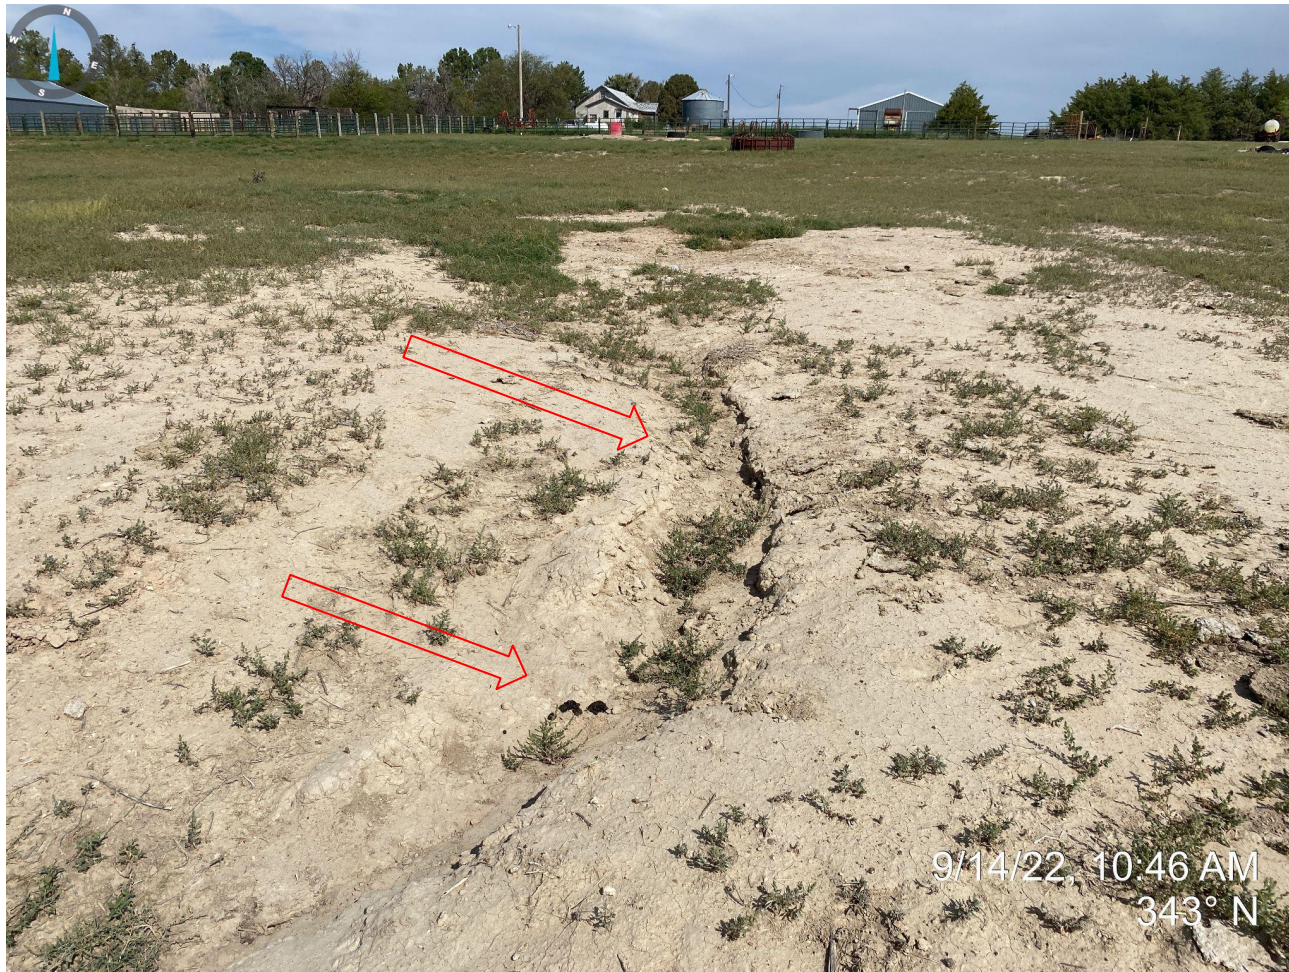
Photo 8. Close up photo of gully erosion on location.

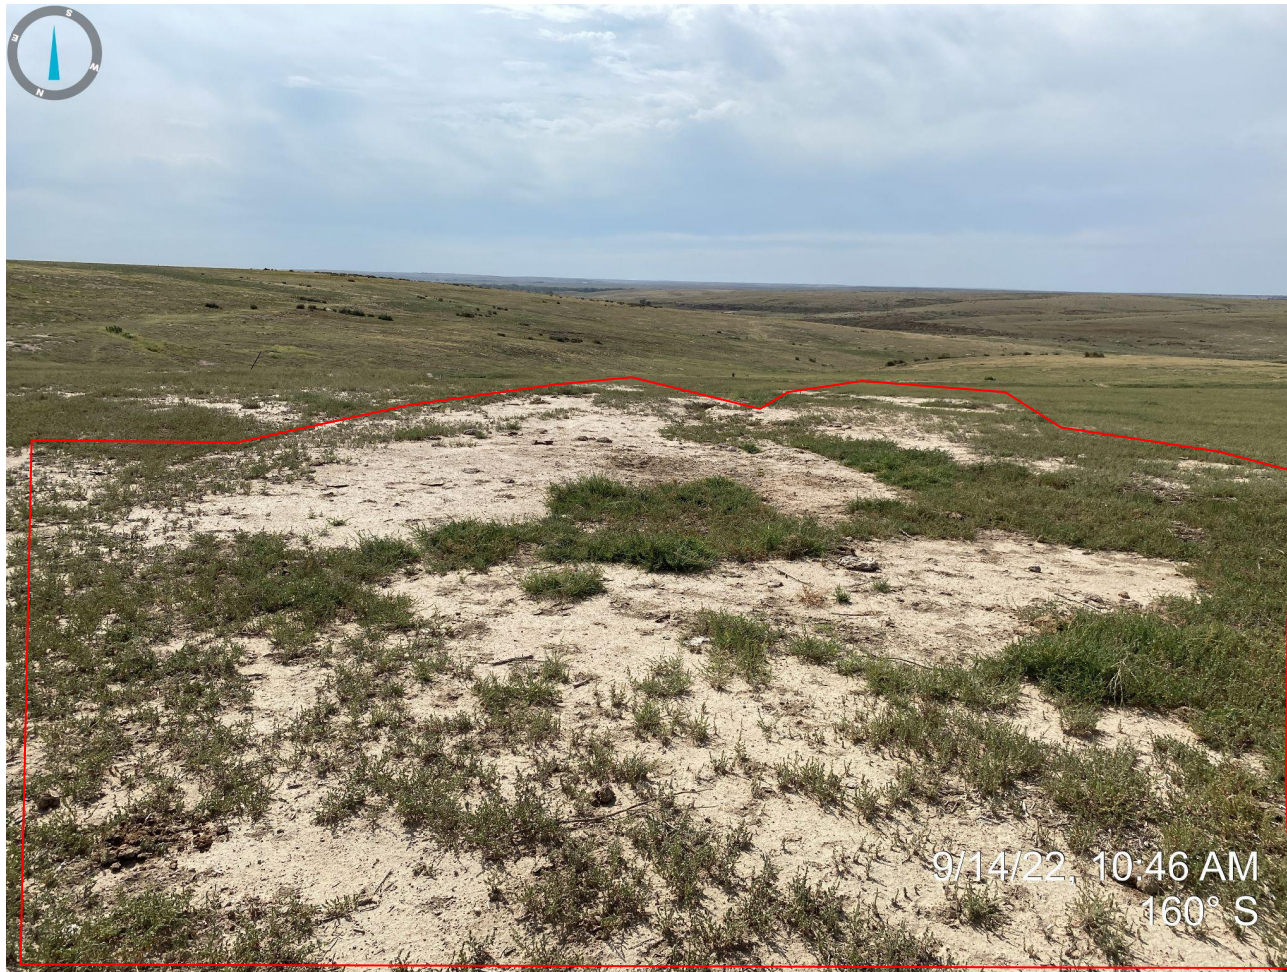
Photo 9. Taken from northern portion of location, facing south. Photo illustrates that location has not been reclaimed (outlined in red).
