Final Reclamation and Stormwater Inspection

Operator: ENERGY QUEST II LLC - 10490

Location ID: 337056

Inspection Photos
Location Name: LIKE #3-7
Location ID: 337056

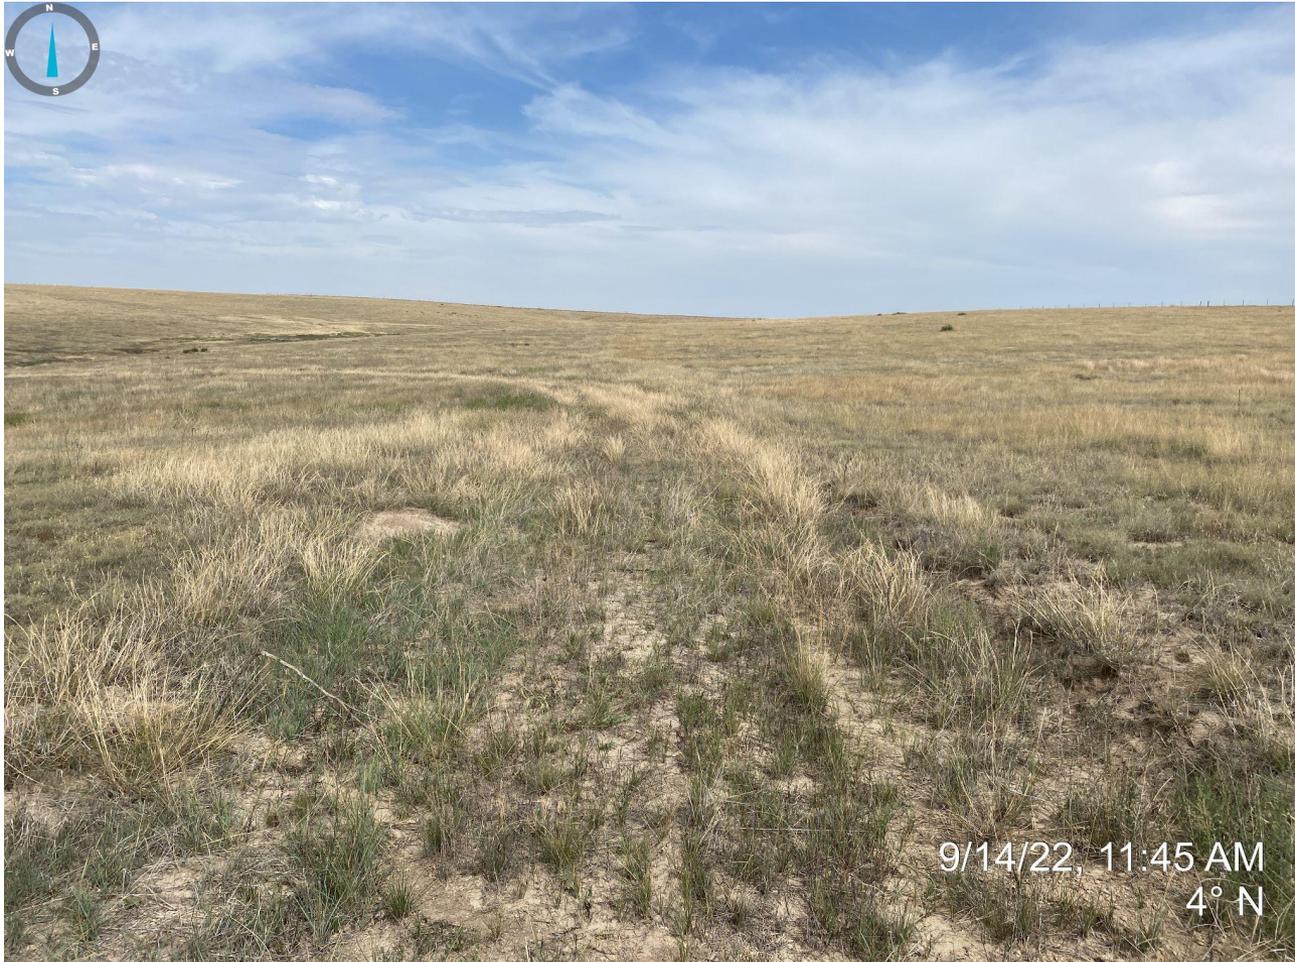
Photo 1. Taken from beginning of access road, southeast of location, facing north. Photo illustrates that the access road has not be contoured and regraded to reflect reference areas.

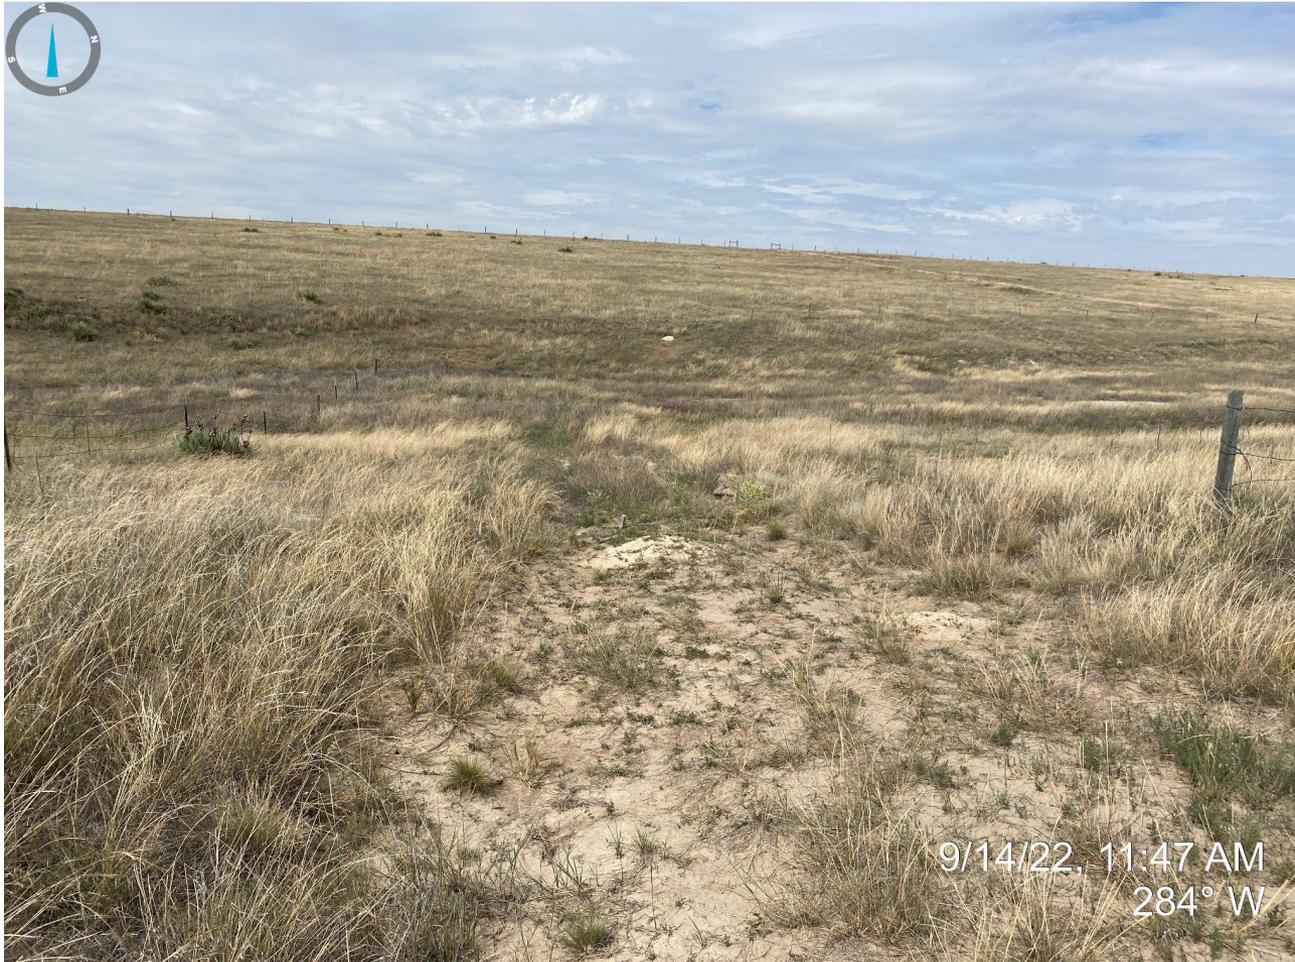
Photo 2. Taken from southeast portion of location and access road, facing west. See comments in photo 1.

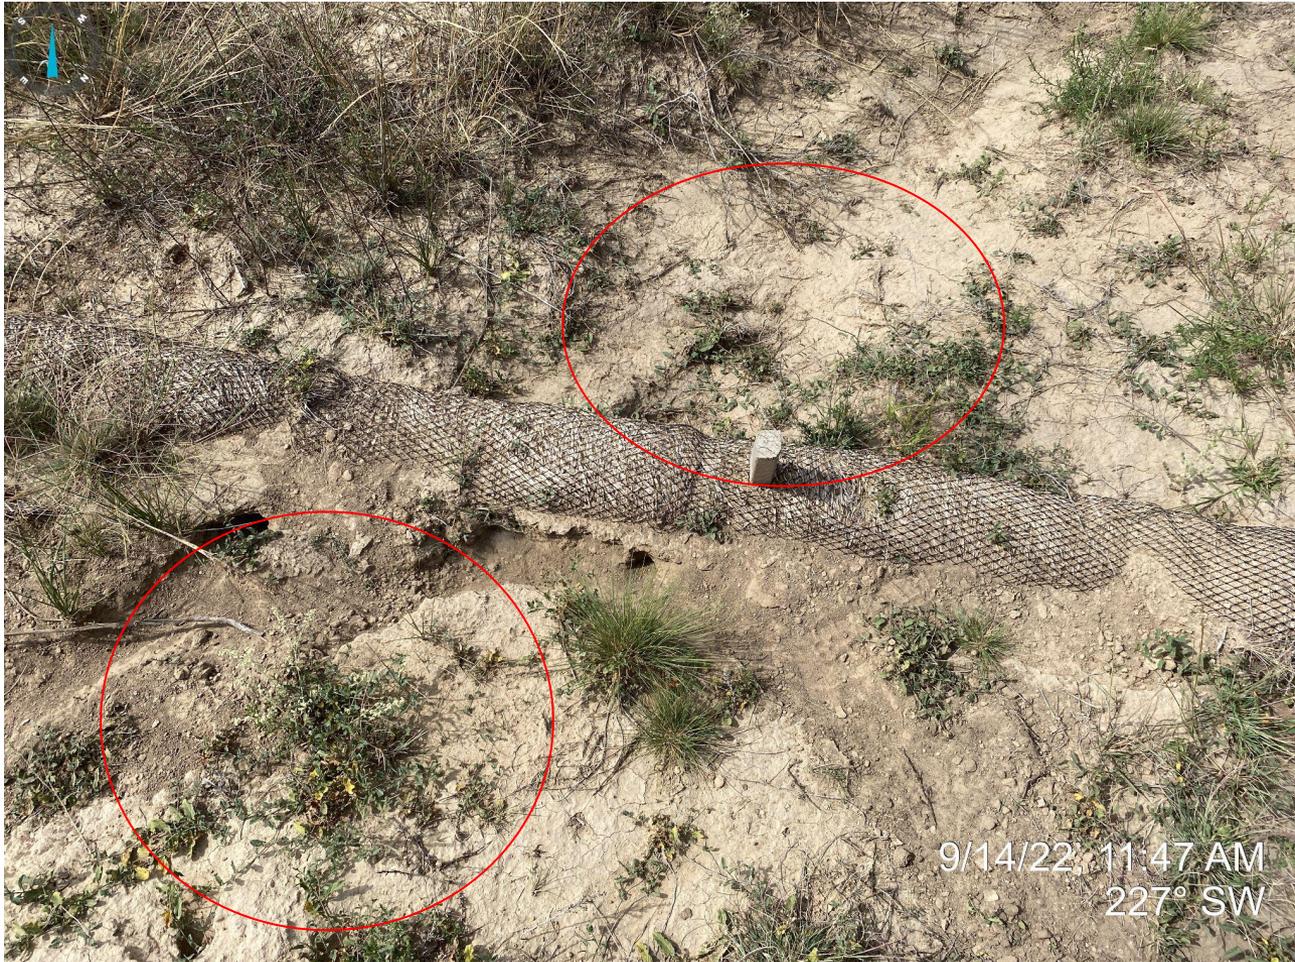
Photo 3. Close up photo of straw wattle, which is now considered debris and needs to be removed, and field bindweed (CO List C Noxious Weed) outlined in red.

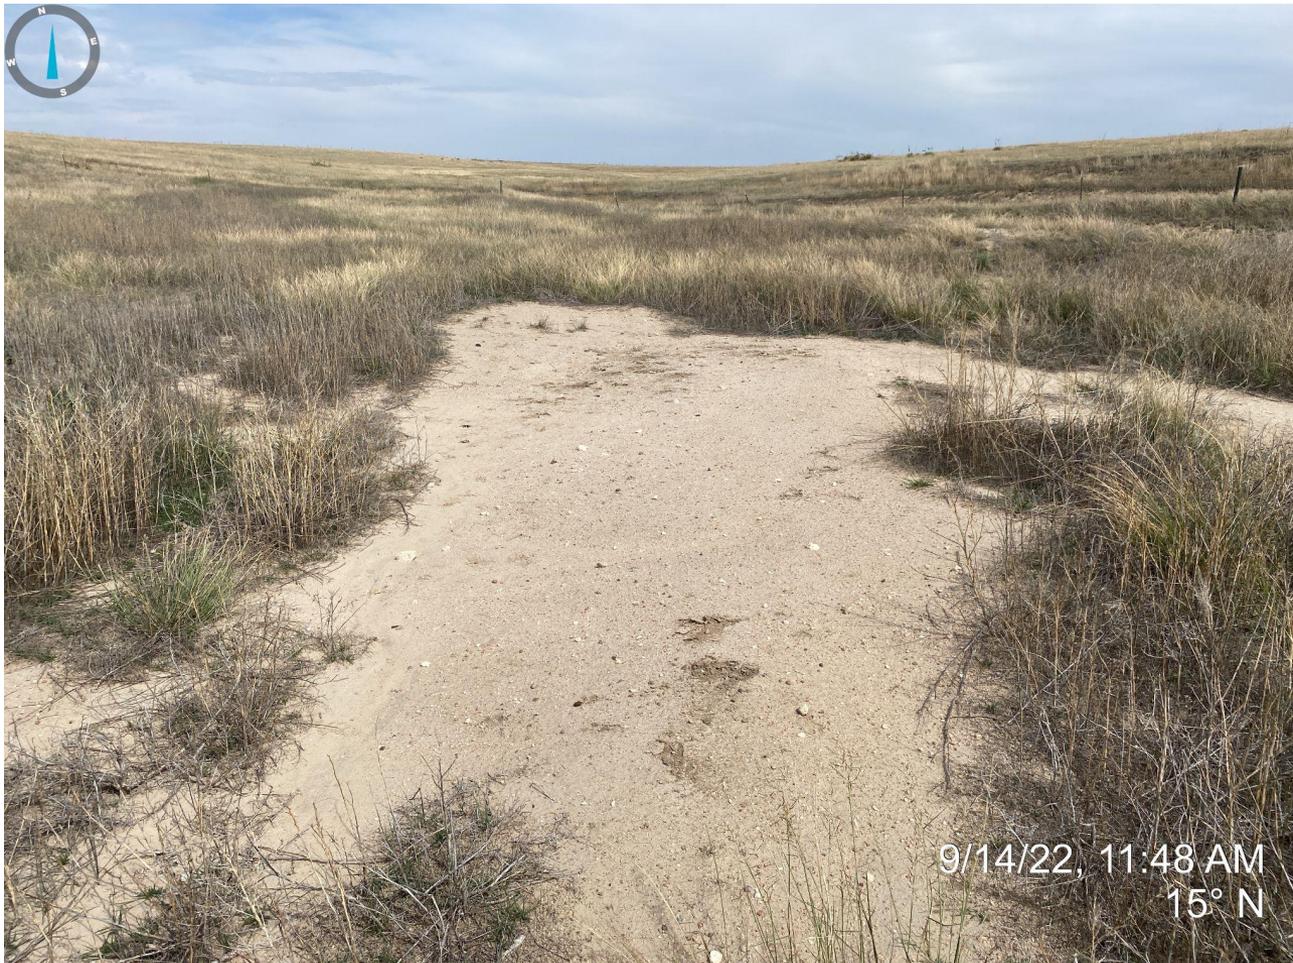
Photo 4. Taken from center portion of location, facing north. Photo illustrates location has not been reclaimed with lack of uniform vegetation cover (e.g. bare soil) and areas that have not been contoured and regraded to reflect reference areas.

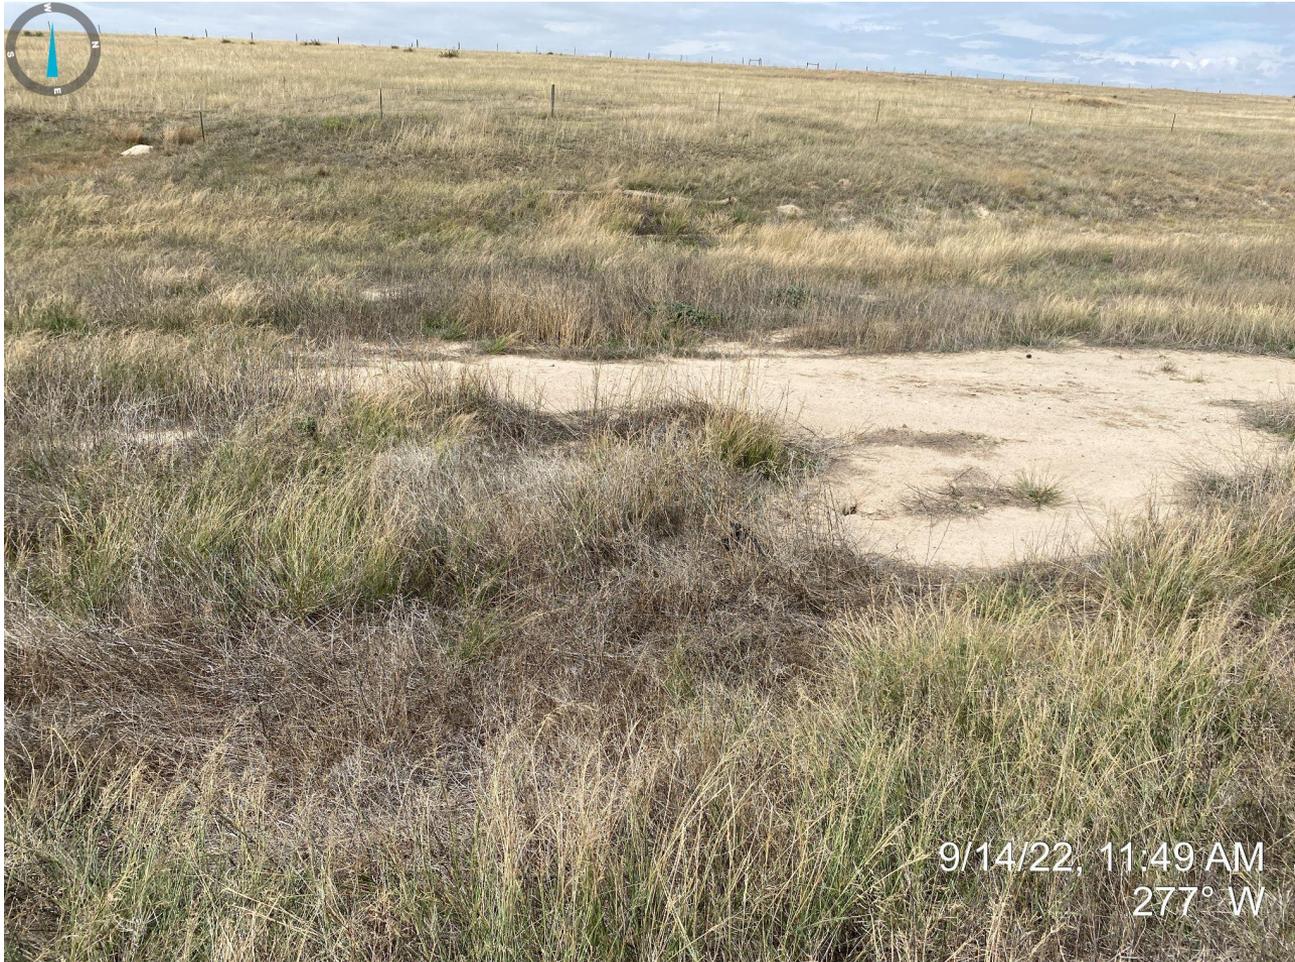
Photo 5. Facing west, see comments in photo 4.

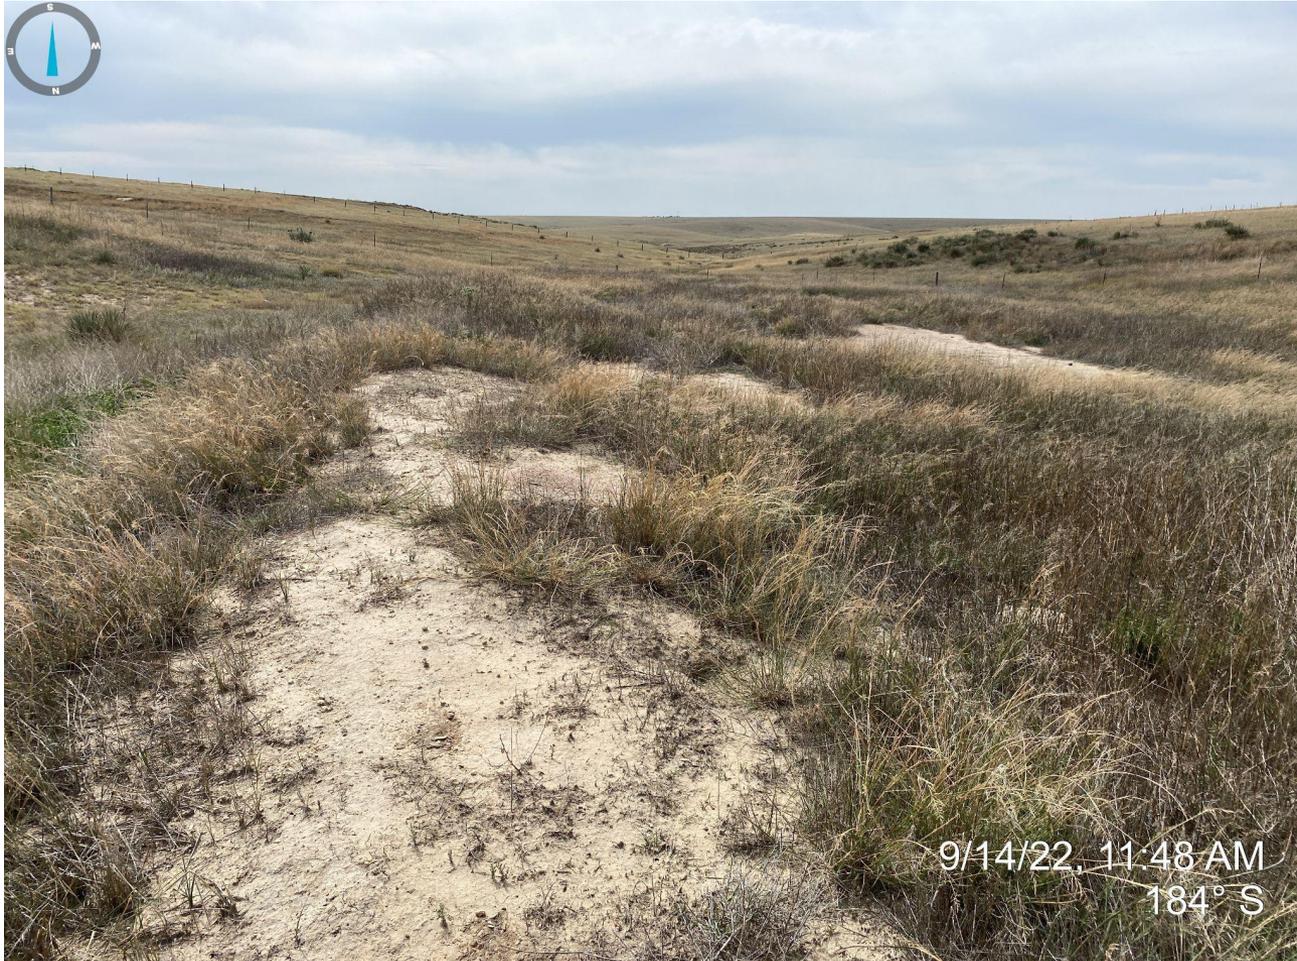
Photo 6. Facing south, see comments in photo 4.
