# Inspection Photos

Operator: Gulf Exploration LLC - #10728

Location Name: Eagle Hill 1-32 Pad

Inspection Document #: 702800728

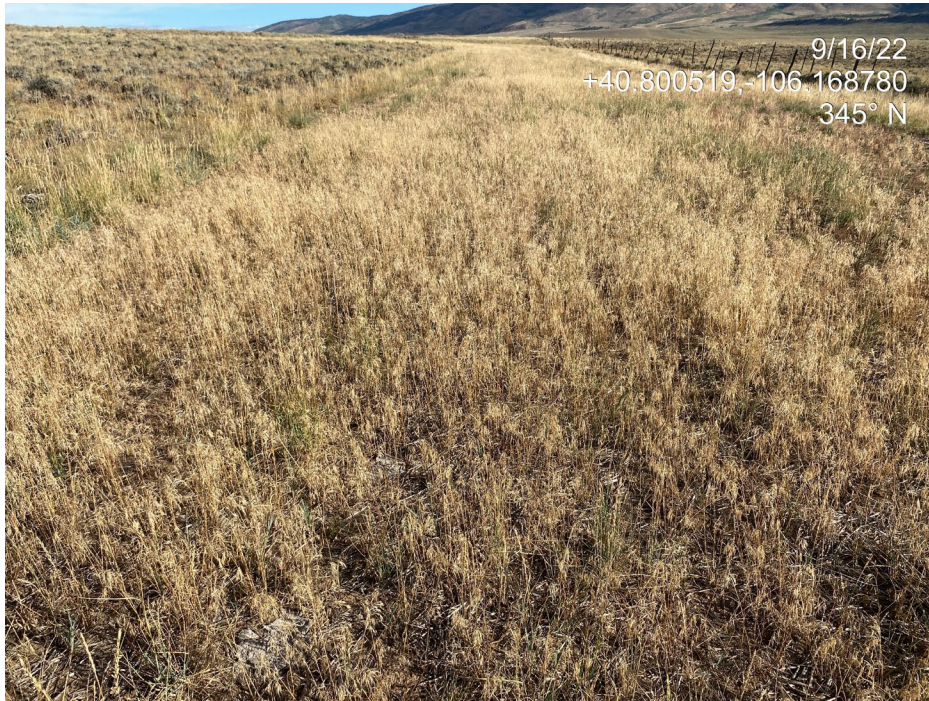
**Photo 1.** Photo shows the southern portion of the Location access road. The vegetation community is dominated by cheatgrass (List C Noxious Weed). Perennial grasses are subdominant.

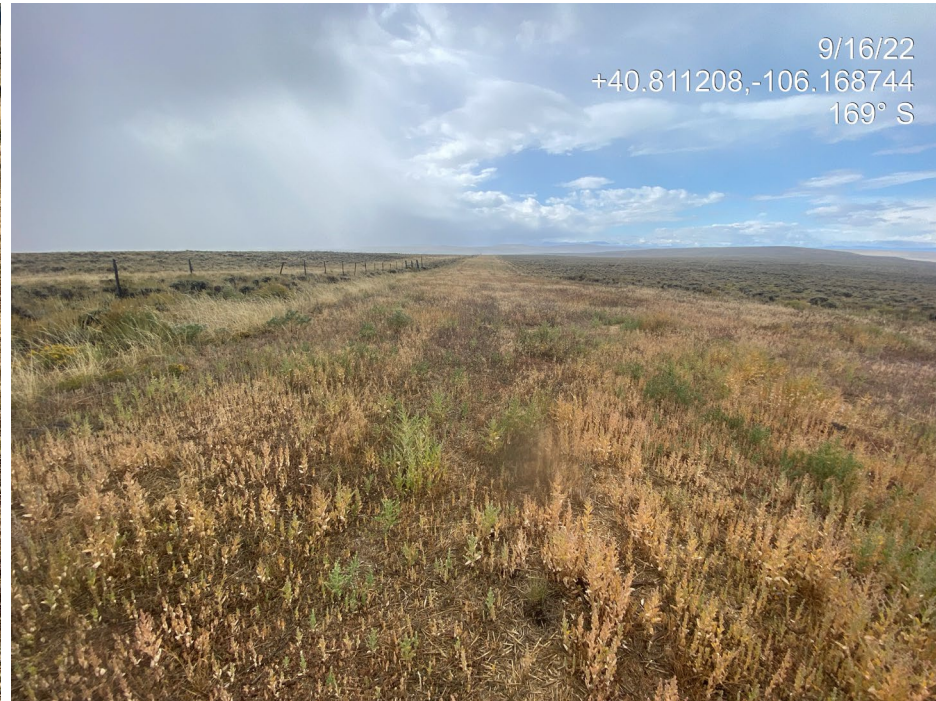
**Photo 2.** Photo shows the northern portion of the Location access road. The vegetation community is dominated by tumbling saltweed (annual, undesirable plant species/weed). Perennial grasses are sparse.

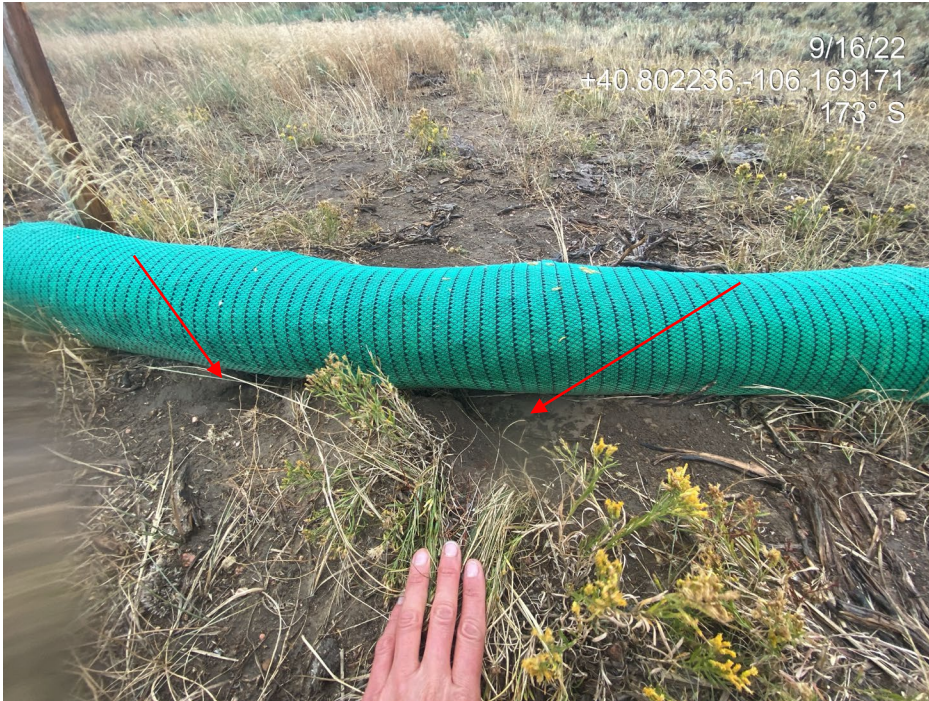
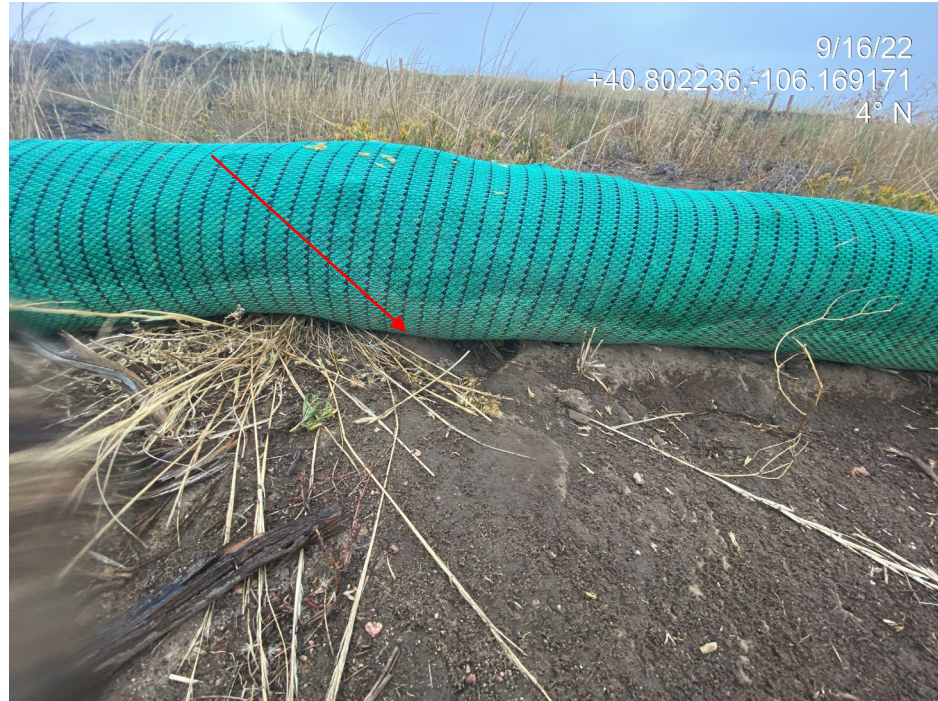
**Photo 3.** Photo taken from the location access road shows where water is beginning to undercut a wattle.

**Photo 4.** Refer to Photo 3 comment.

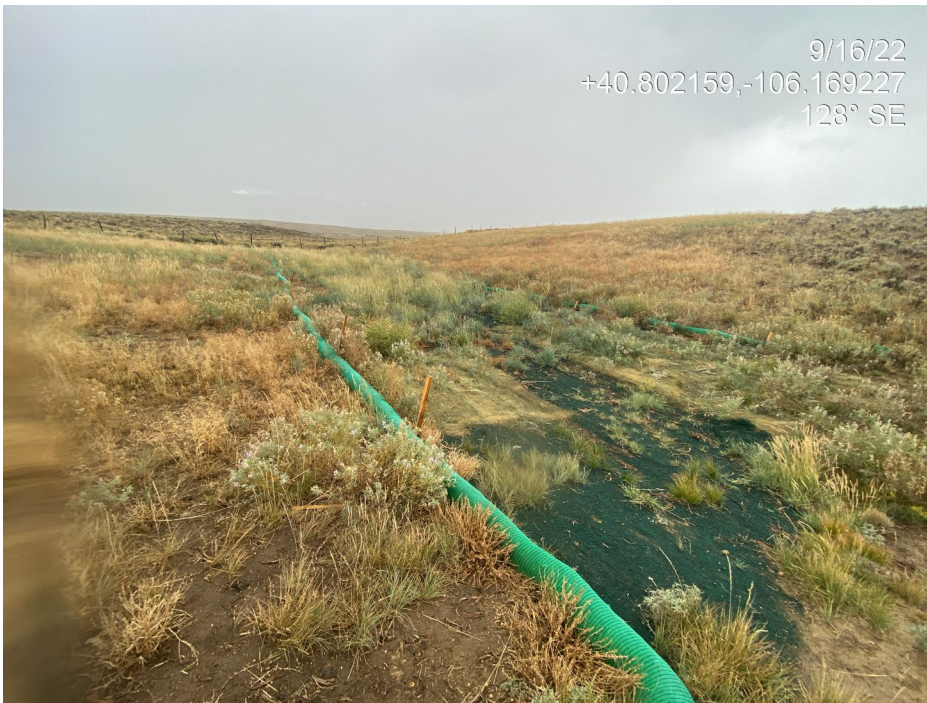
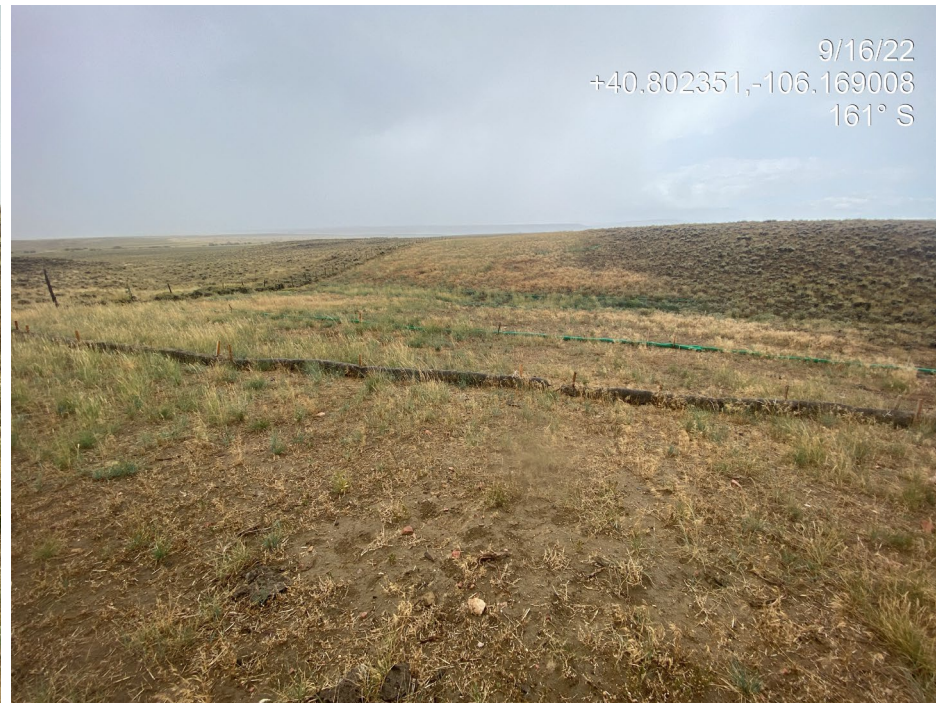
**Photo 5.** Photo taken from access road swale. Stormwater BMPs have been installed per good engineering practices. Photo also shows perennials (green plants) are well established on portions of the road and poorly established in other areas, where bare ground or cheatgrass (tan plants) dominate.

**Photo 6.** Refer to Photo 5 comment.

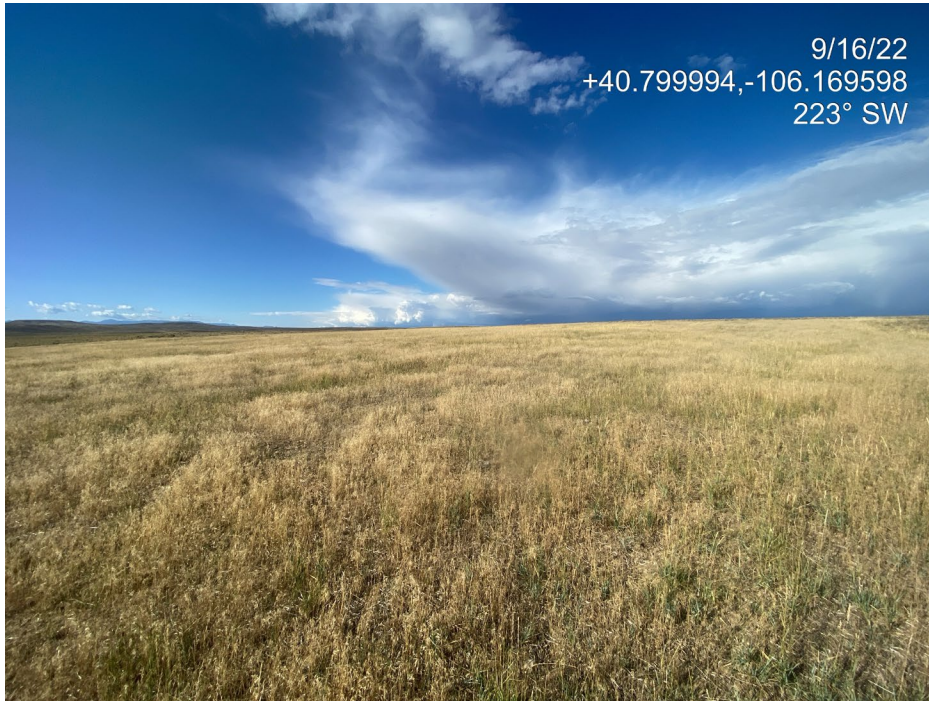
**Photo 7.** Photo taken from the east shows an overview of the reclaimed Location.

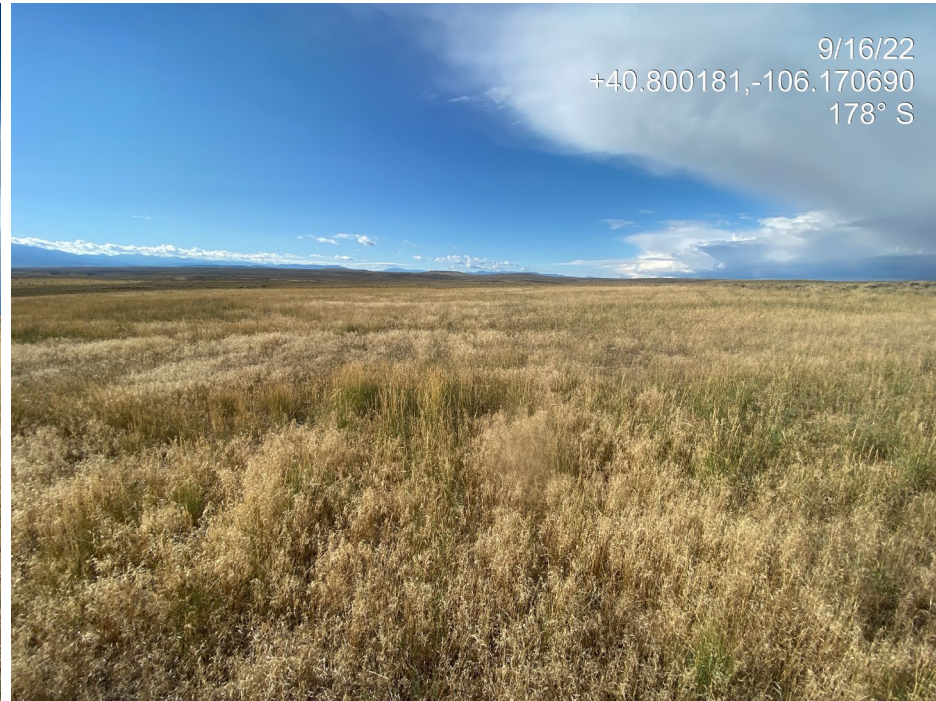
**Photo 8.** Photo taken from the northwest shows an overview of the reclaimed Location.

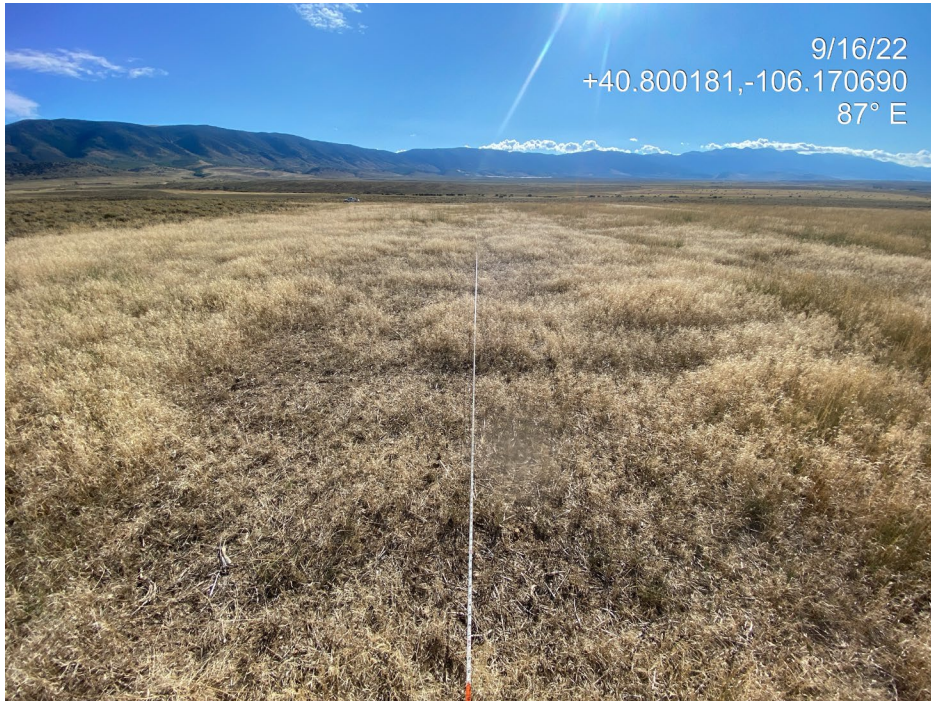
**Photo 9.** Photo taken from the northwest shows the start of the disturbed area vegetation monitoring transect.

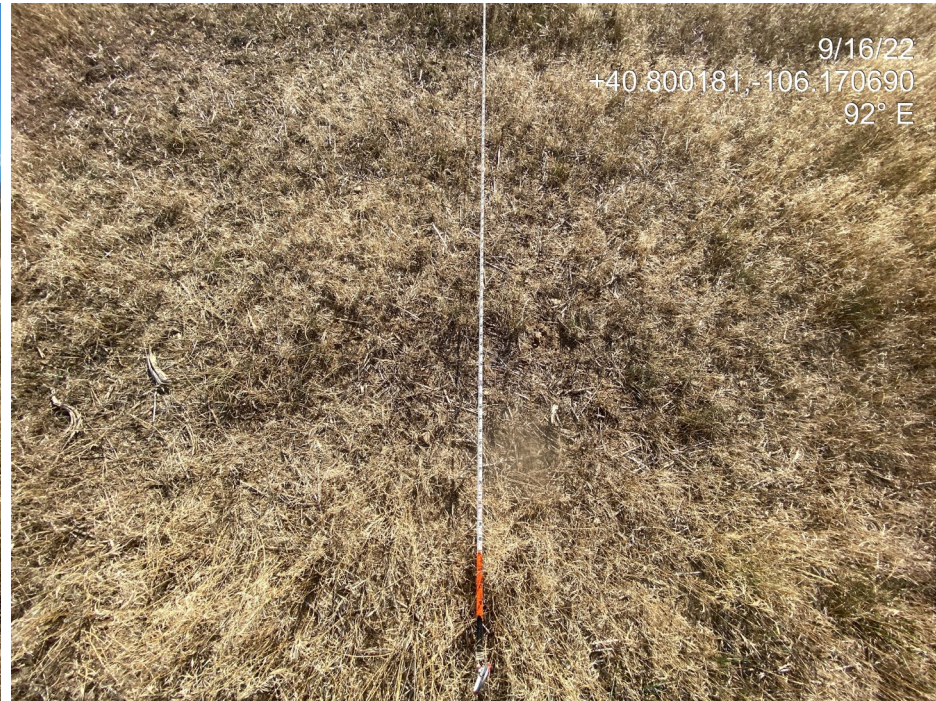
**Photo 10.** Photo taken from the northwest shows the ground surface at the start of the disturbed area vegetation monitoring transect.

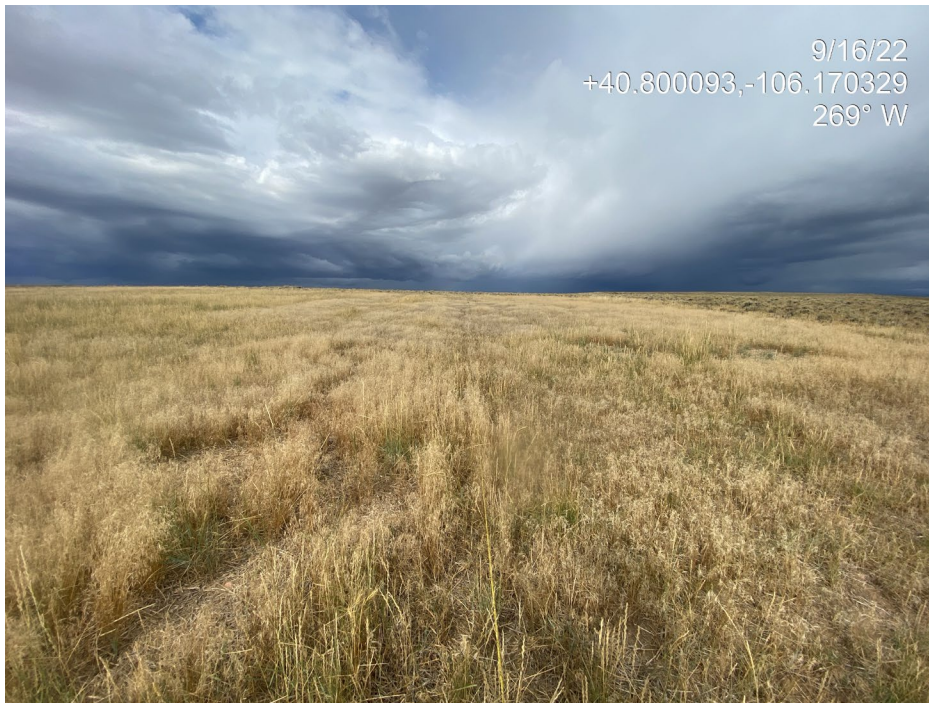
**Photo 11.** Photo taken from the north shows the end of the disturbed area vegetation monitoring transect.

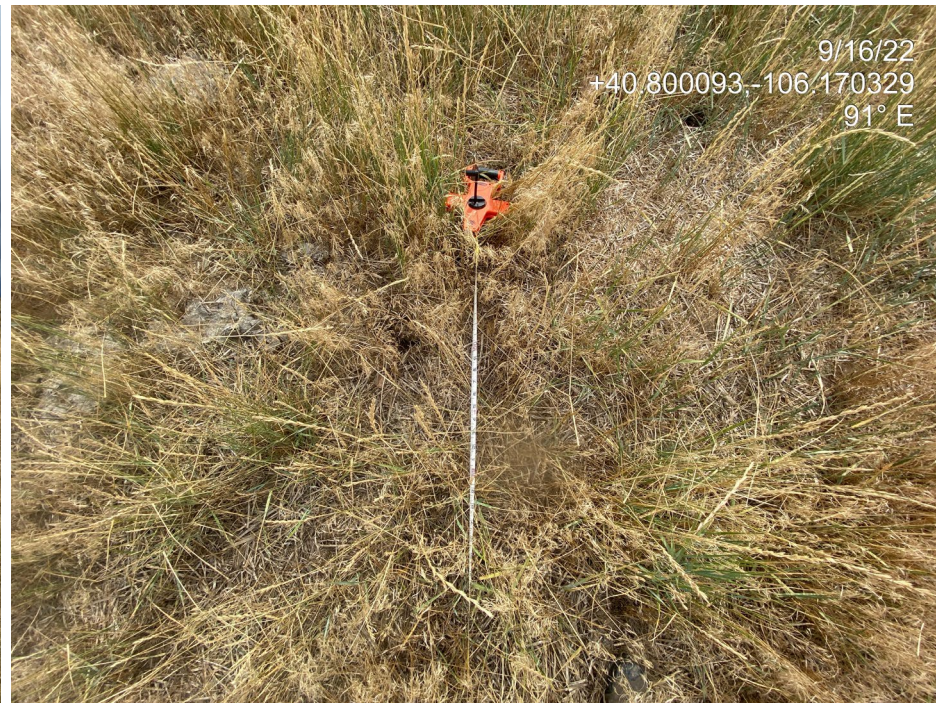
**Photo 12.** Photo taken from the north shows the ground surface at the end of the disturbed area vegetation monitoring transect.

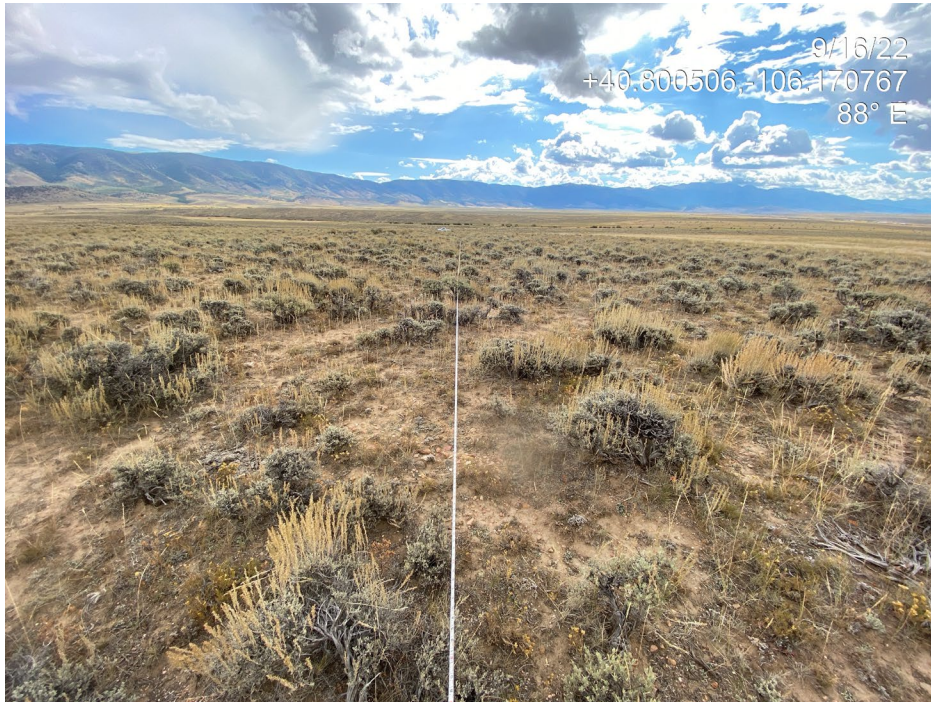
**Photo 13.** Photo taken to the north of the Location shows the start of the reference area vegetation monitoring transect.

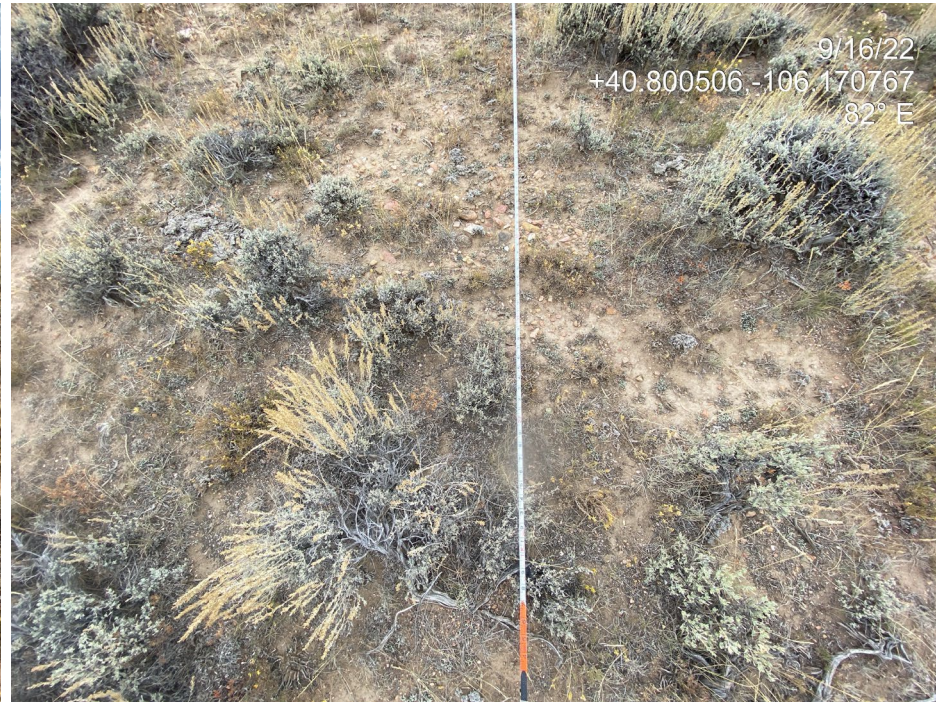
**Photo 14.** Photo taken to the north of the Location shows the ground surface at the start of the reference area vegetation monitoring transect.

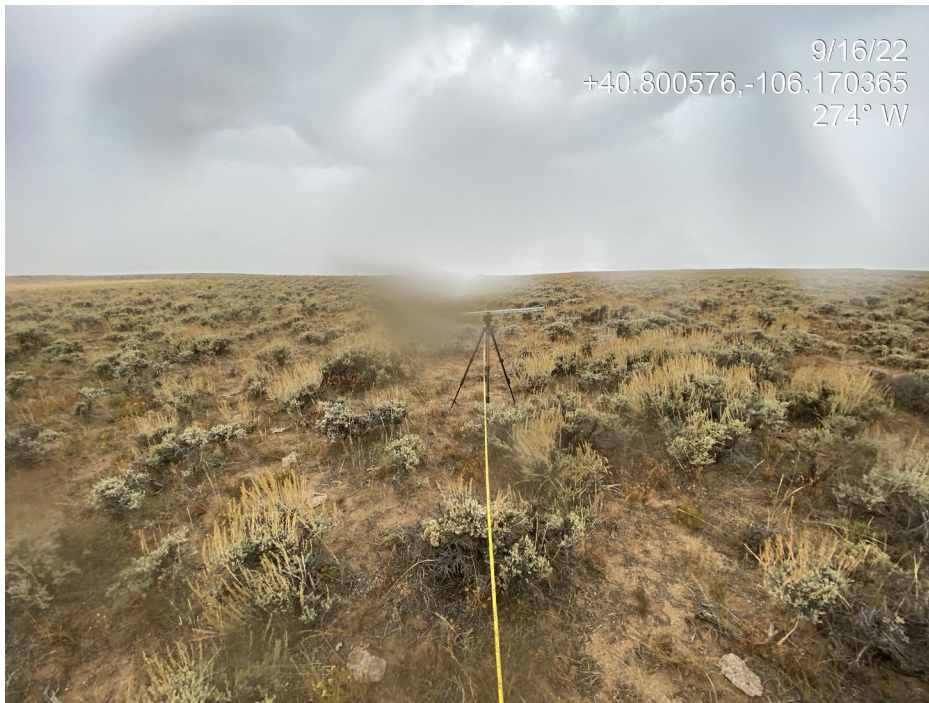
**Photo 15.** Photo taken to the north of the Location shows the end of the reference area vegetation monitoring transect.

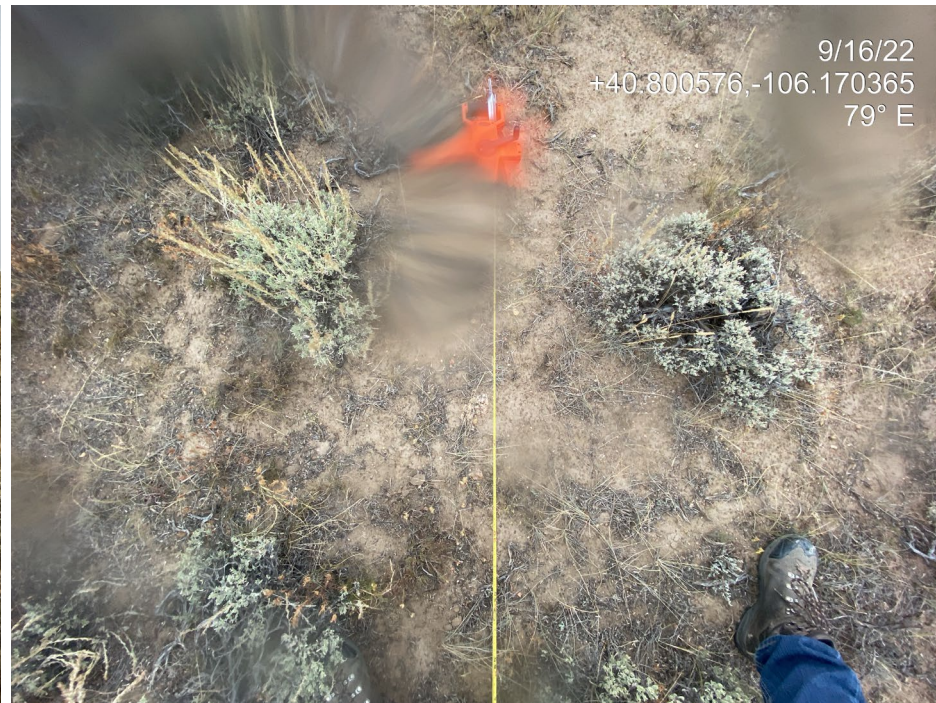
**Photo 16.** Photo taken to the north of the Location shows the ground surface at the end of the reference area vegetation monitoring transect.
