# Inspection Photos and Issue Report

Operator: CAERUS PICEANCE LLC - 10456

Location #445862

COGCC

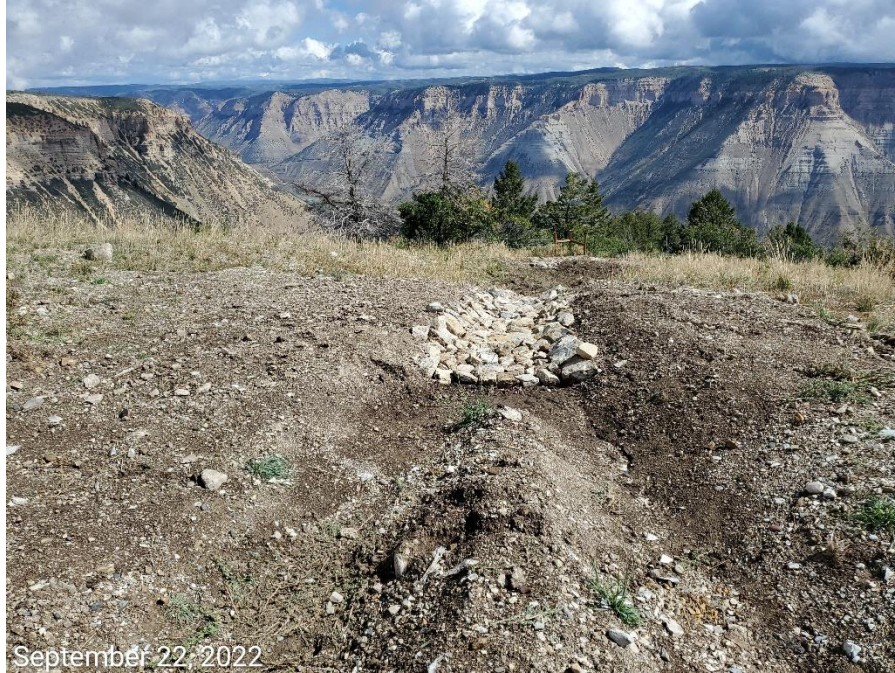
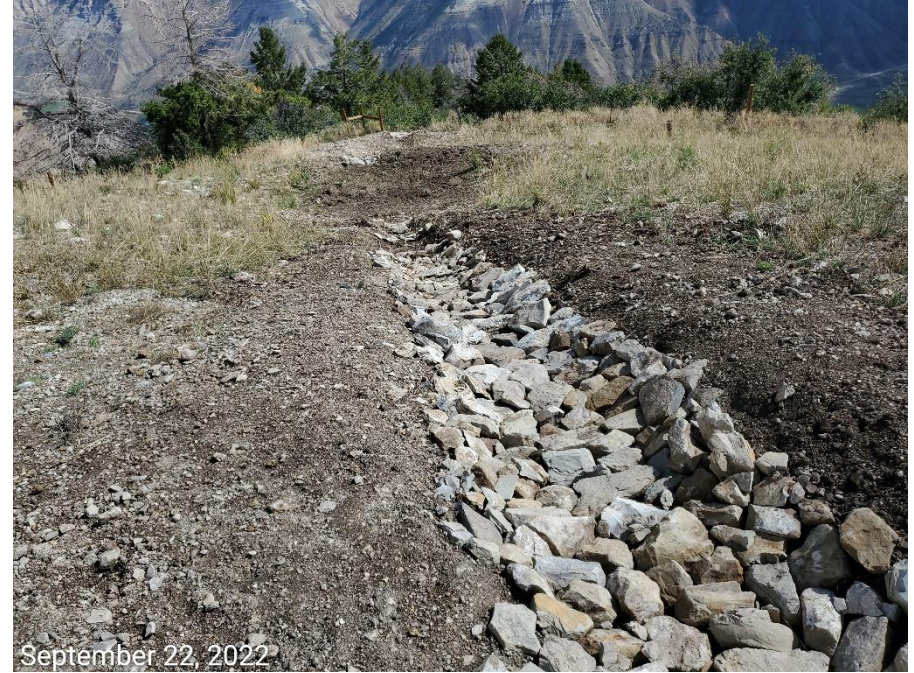
**Photo 1:** Photos taken from the sediment trap on the north end of the Location. Though work to maintain sediment trap has been conducted, work has not been conducted in accordance with good engineering practices; geotextile lining has not been installed at the inlets/outlets with the rip-rap material.

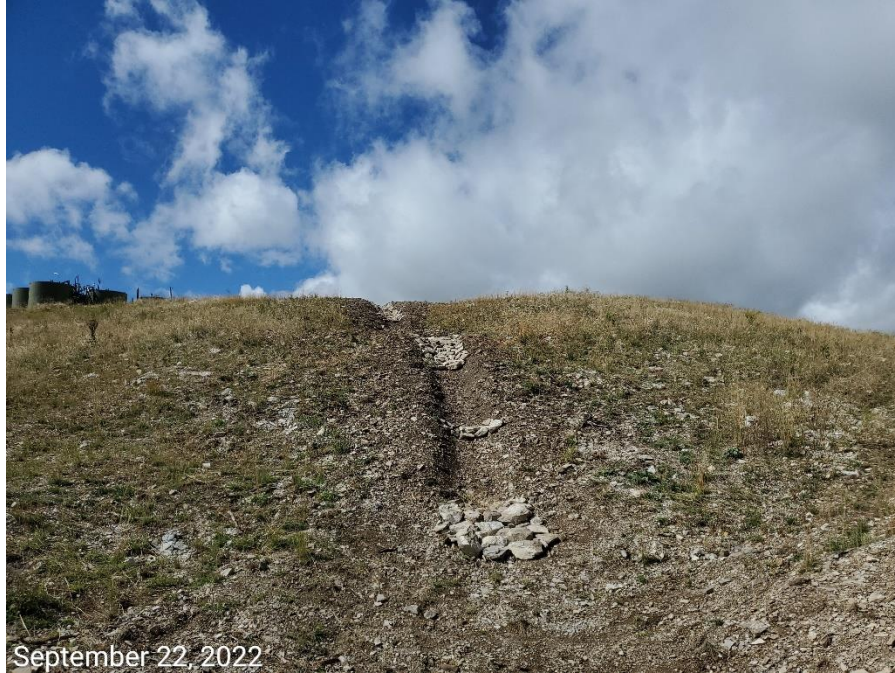
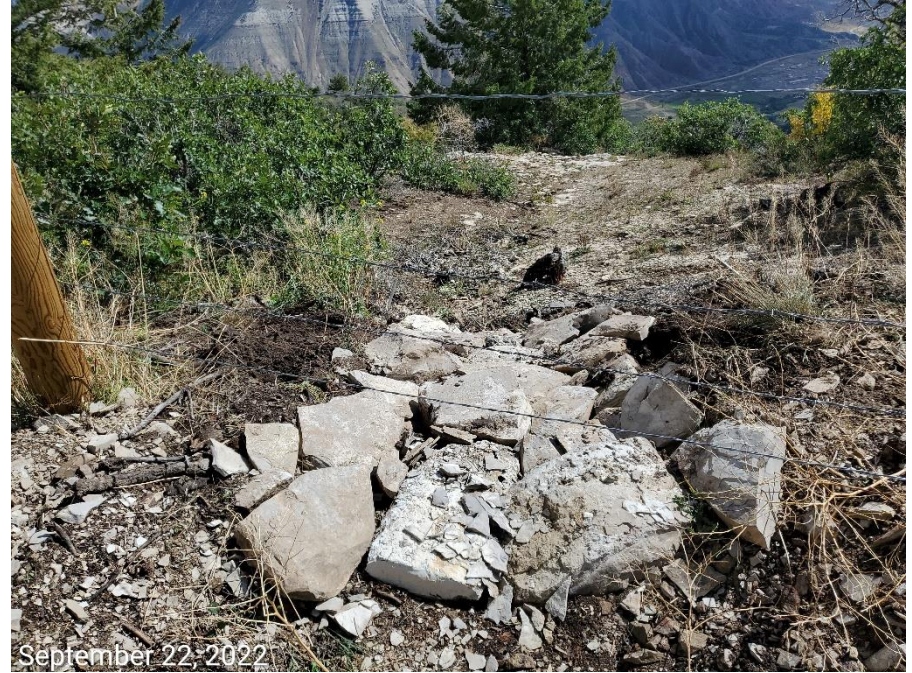
**Photo 2:** Photos taken from the sediment trap on the north end of the Location. Though work to maintain sediment trap has been conducted, work has not been conducted in accordance with good engineering practices; geotextile lining has not been installed at the inlets/outlets with the rip-rap material.
