Inspection Photos and Issue Report

9/22/2022

Operator: CAERUS PICEANCE LLC - 10456

Location #441653

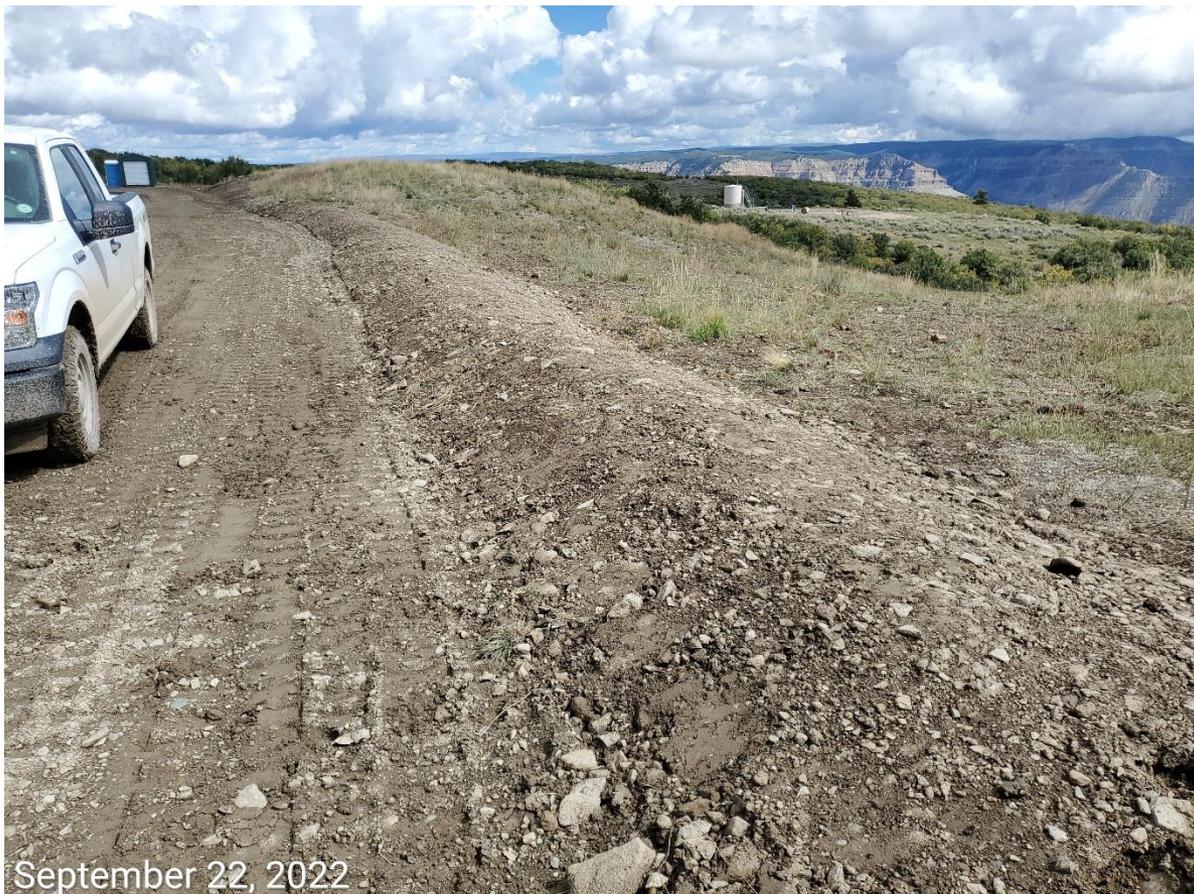
Photo 2: Photo taken from east end of the working pad. Photo shows Operator has installed a berm to prevent stormwater runoff from discharge to the eastern interim areas of the Location.

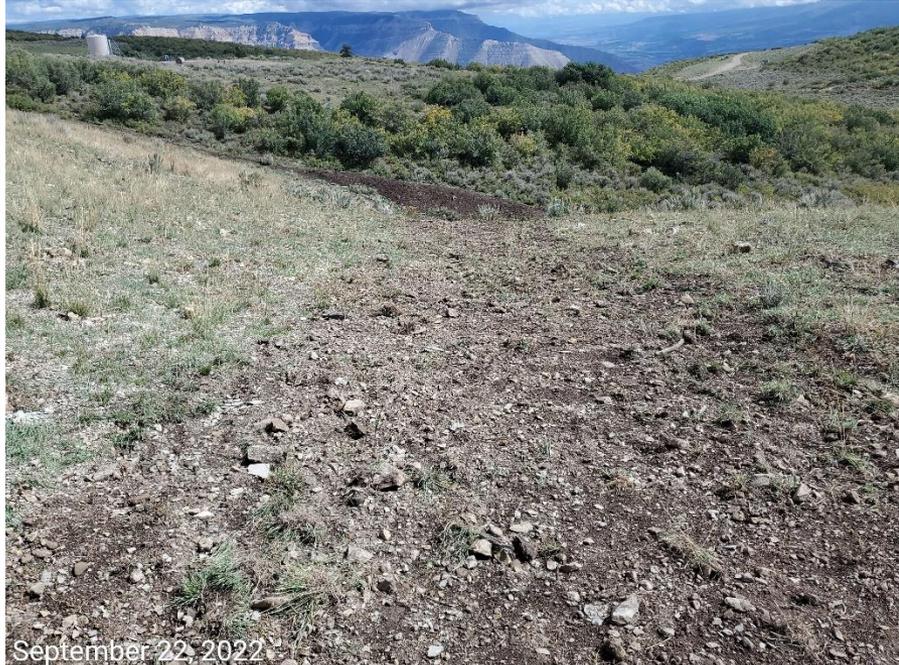
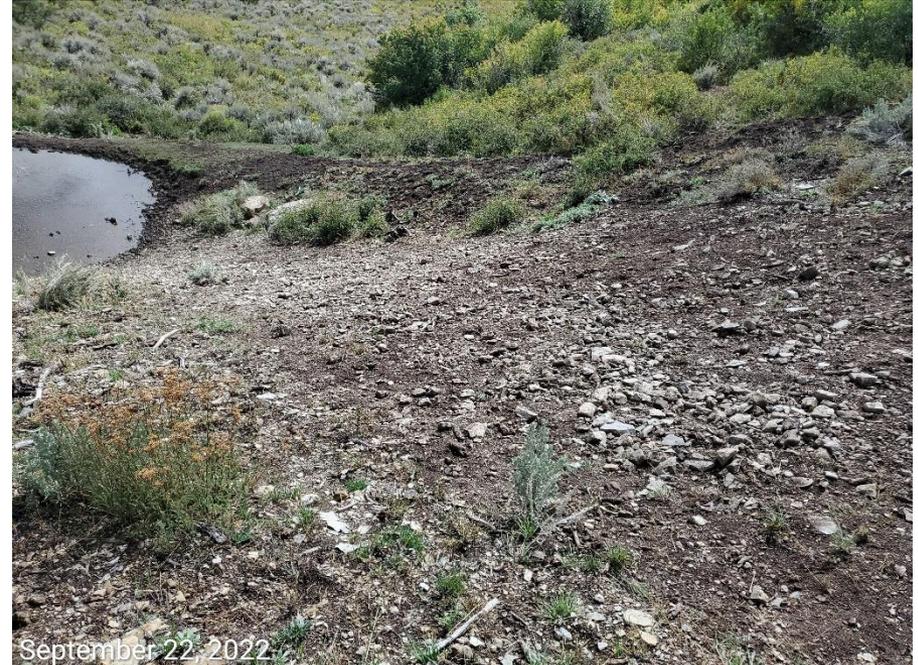
Photo 2: Photos taken from the eastern interim areas of the Location. Photo shows gully erosion has been repaired. BMPs to stabilize the soils on the slope are missing or insufficient.

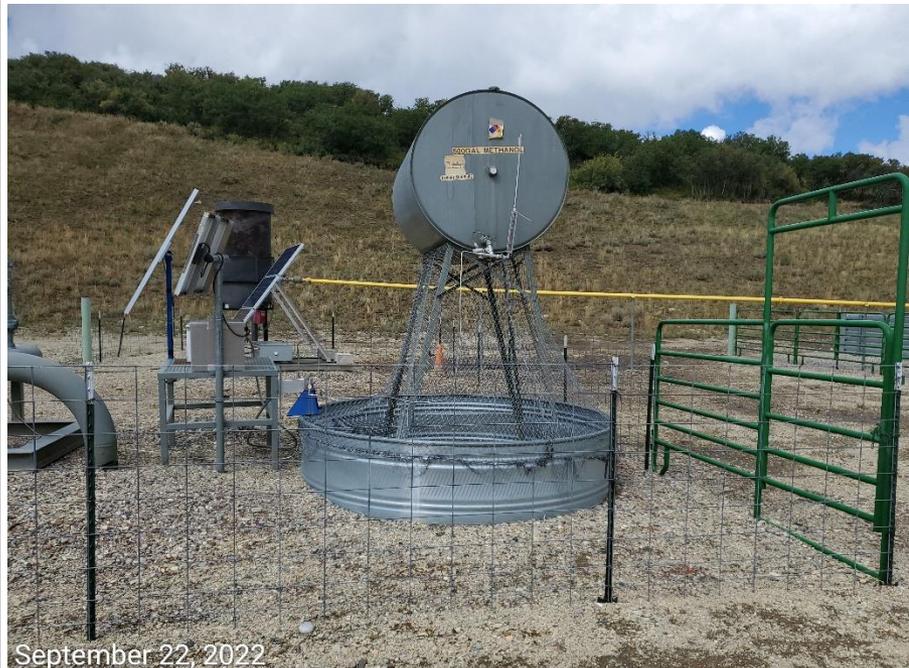
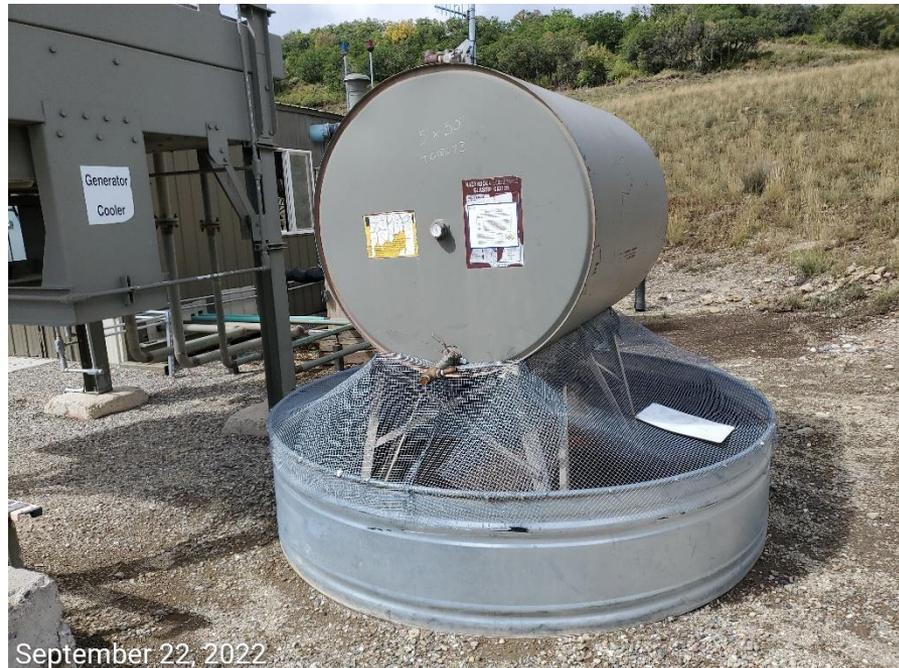
Photo 3: Photos show wildlife protection BMPs have been implemented at tanks.

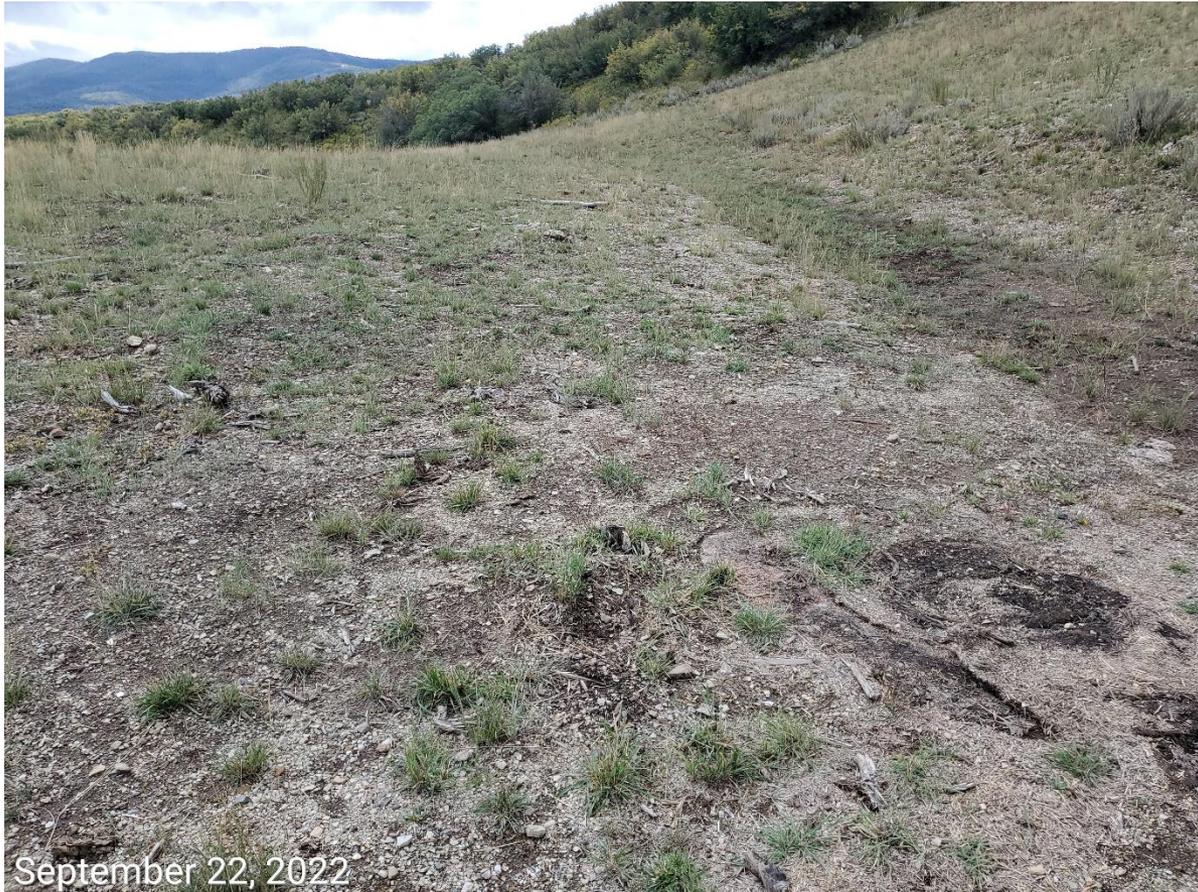
Photo 4: Photo shows trash/debris has been removed from the southern end of the Location.
