Final Reclamation and Stormwater Inspection

Operator: GREAT WESTERN OPERATING COMPANY -
10110

Location ID: 320486

Inspection Photos
Location Name:HRS STATE #6-16
Location ID: 320486

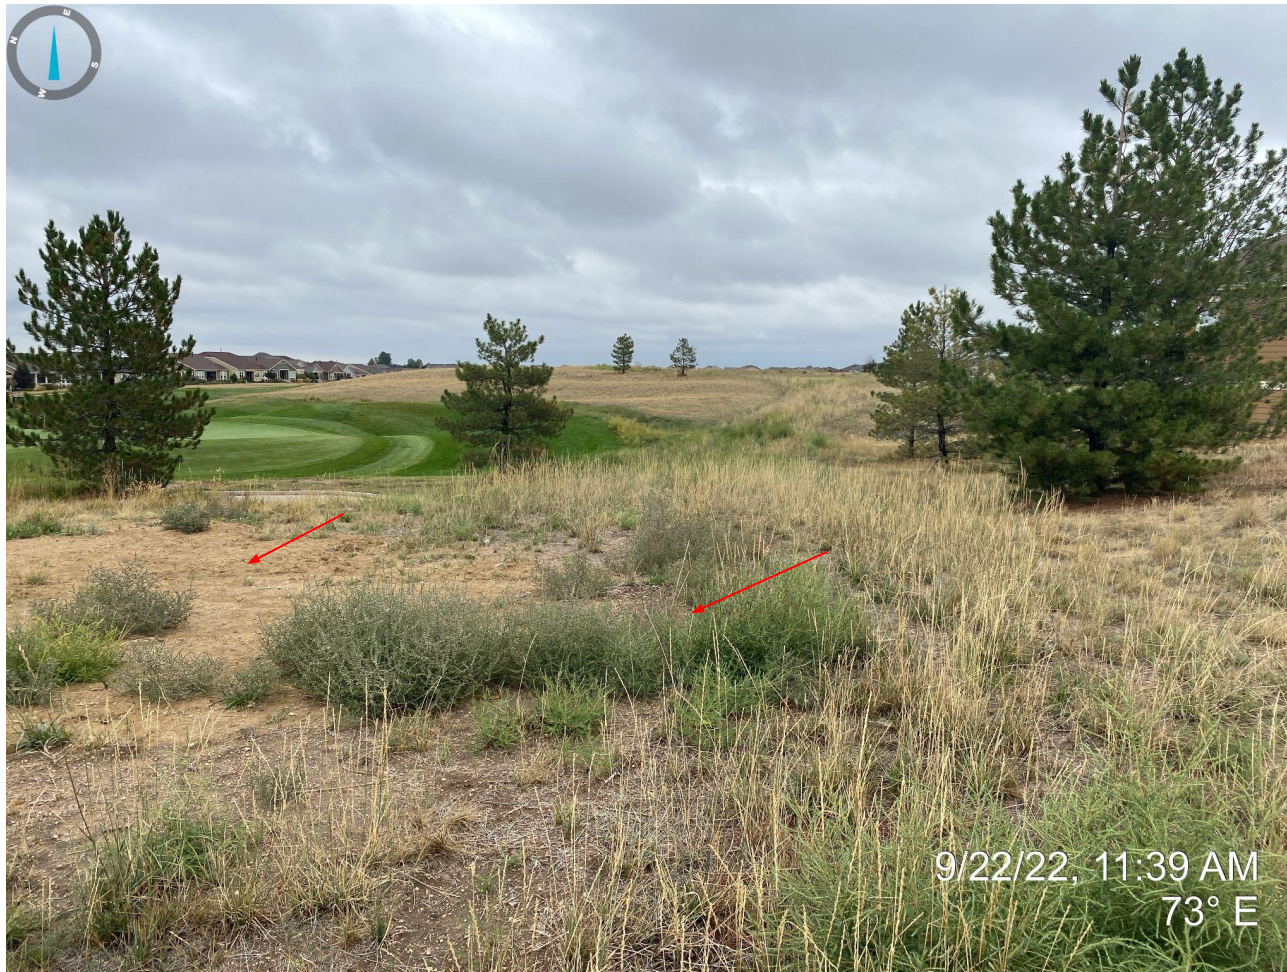
Photo 1. Taken west of location, facing east. Photo illustrates that some reclamation work has been conducted with evidence of western wheatgrass in drill rows. Also pictured are some areas of bare soil and annual weedy vegetation, e.g. russian thistle.

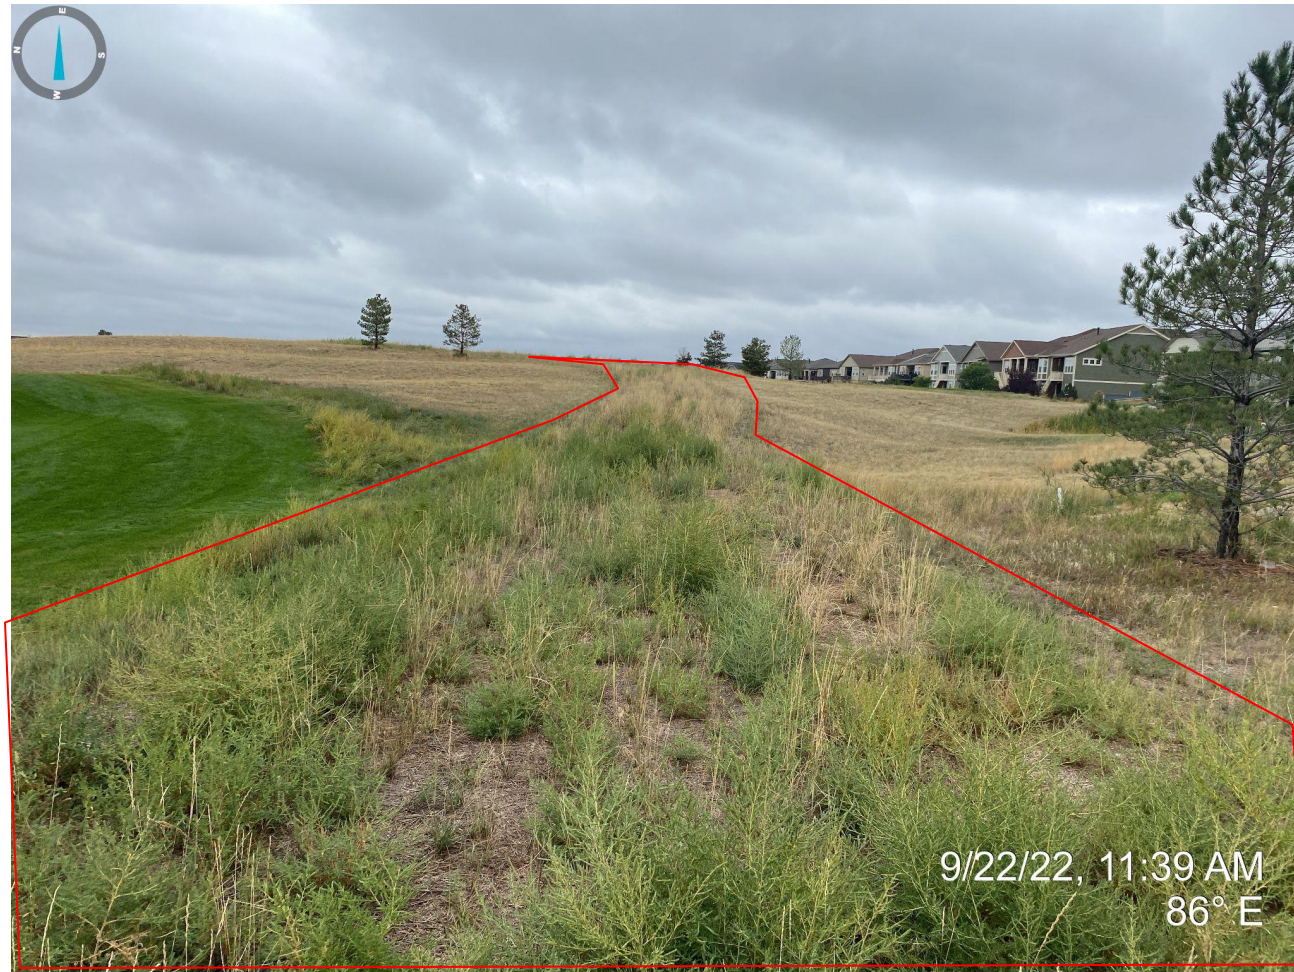
Photo 2. Taken west of location, facing east. Photo illustrates access road that does not appear to have been reclaimed (visible crown to the road) and annual weedy vegetation, e.g. russian thistle.

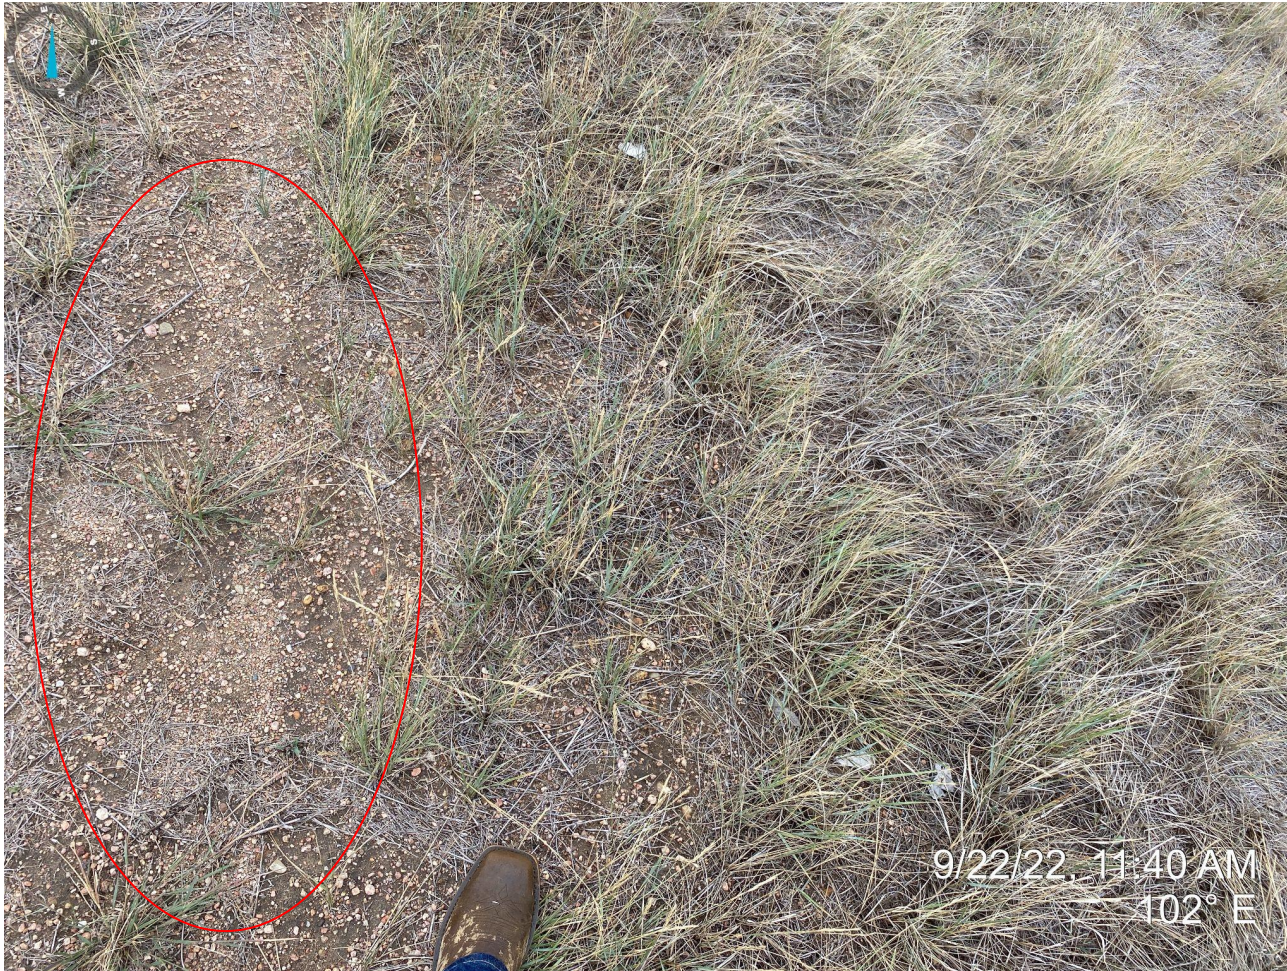
Photo 3. Close up photo taken of access road, illustrating the presence of gravel.

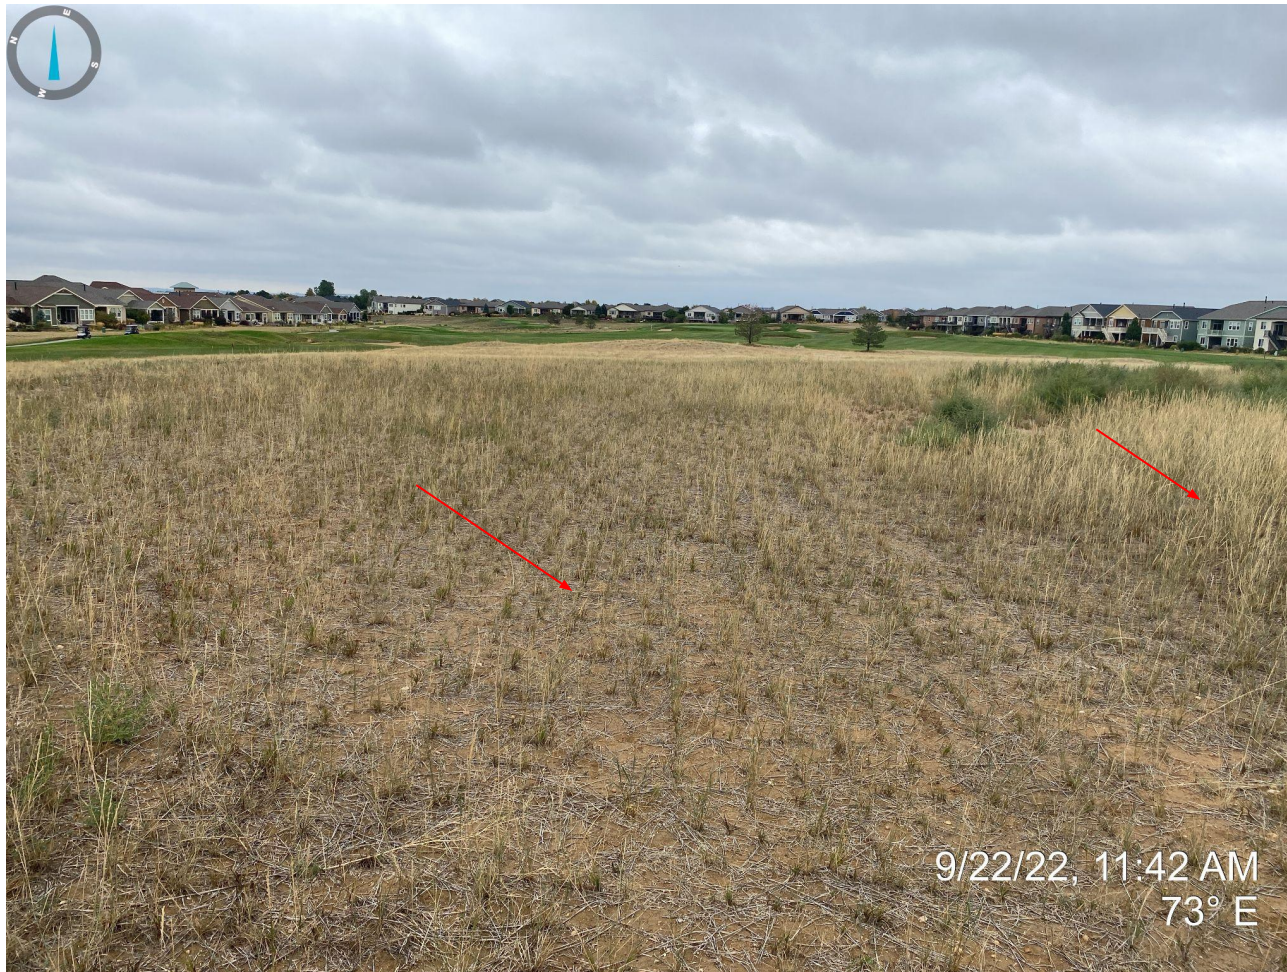
Photo 4. Taken from northwestern portion of location, facing east. Photo illustrates some revegetation efforts have been conducted as evidenced by drill rows. Variable vegetation height possibly a result of compaction issues.

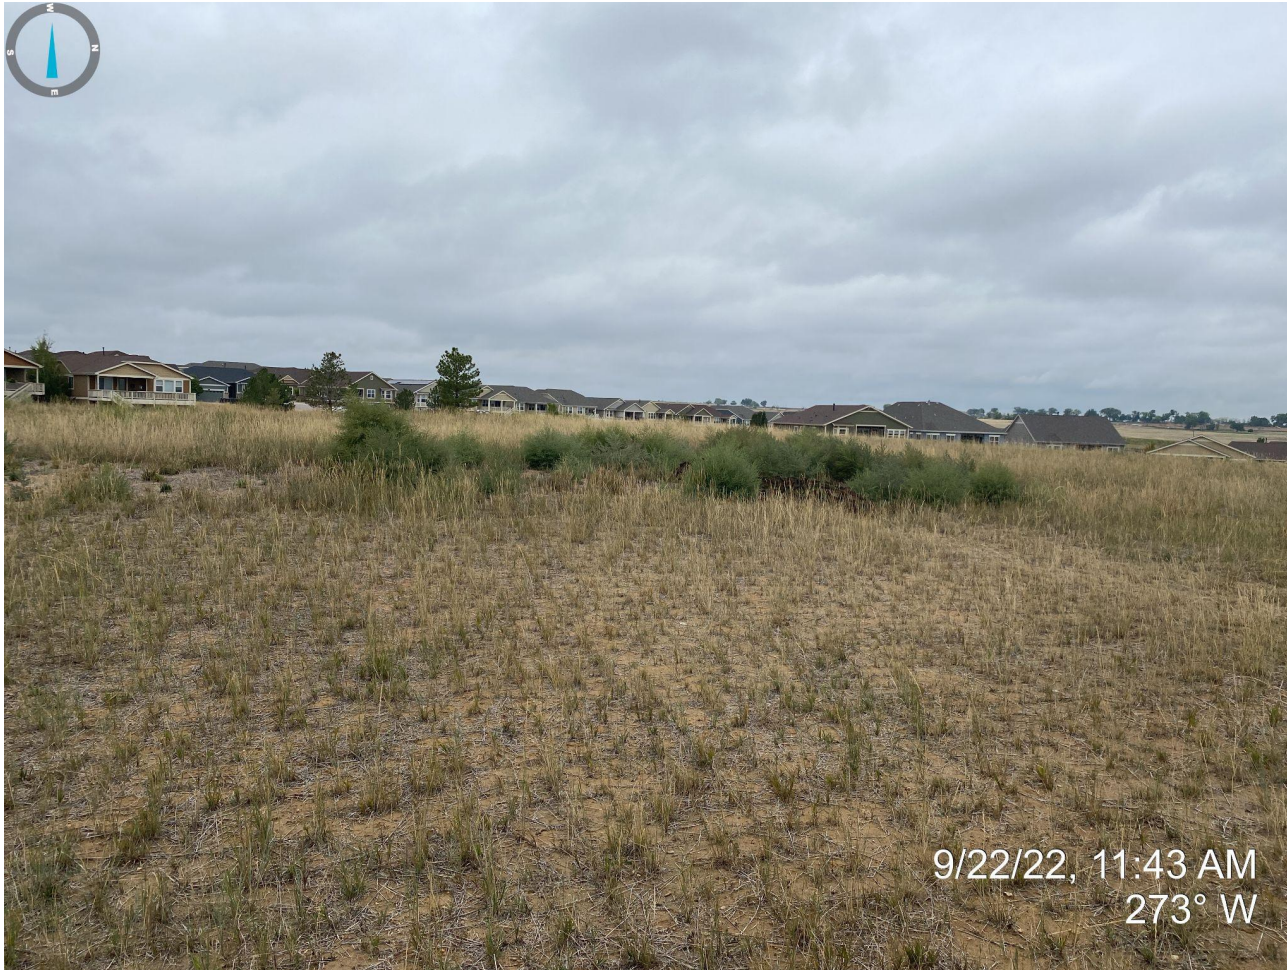
Photo 5. Facing west, see comments in photo 4.

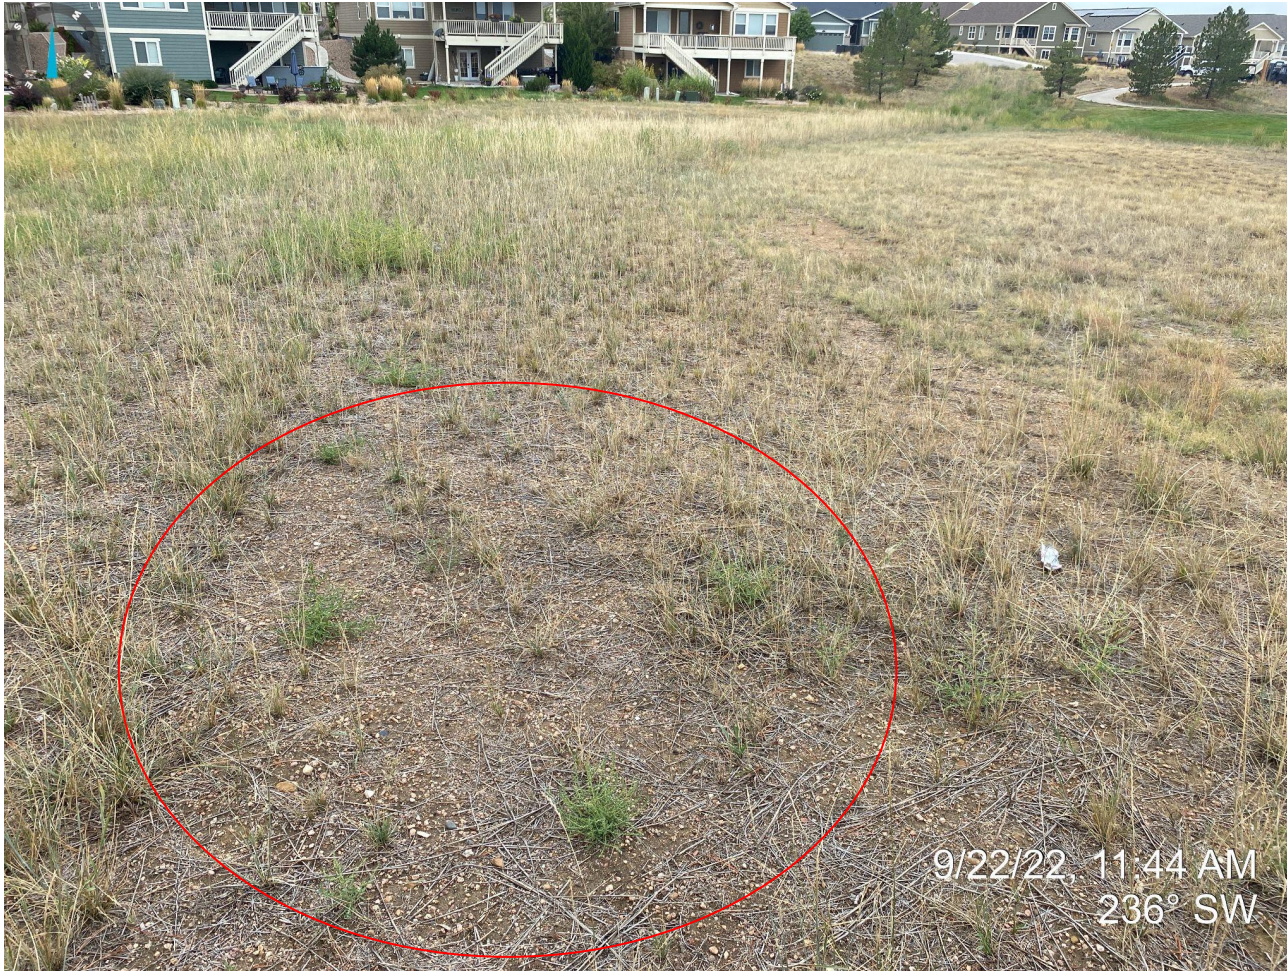
Photo 6. Taken from western portion of location, facing southwest. Photo illustrates presence of gravel and areas of non-uniform vegetation cover possibly resulting from compaction issues.

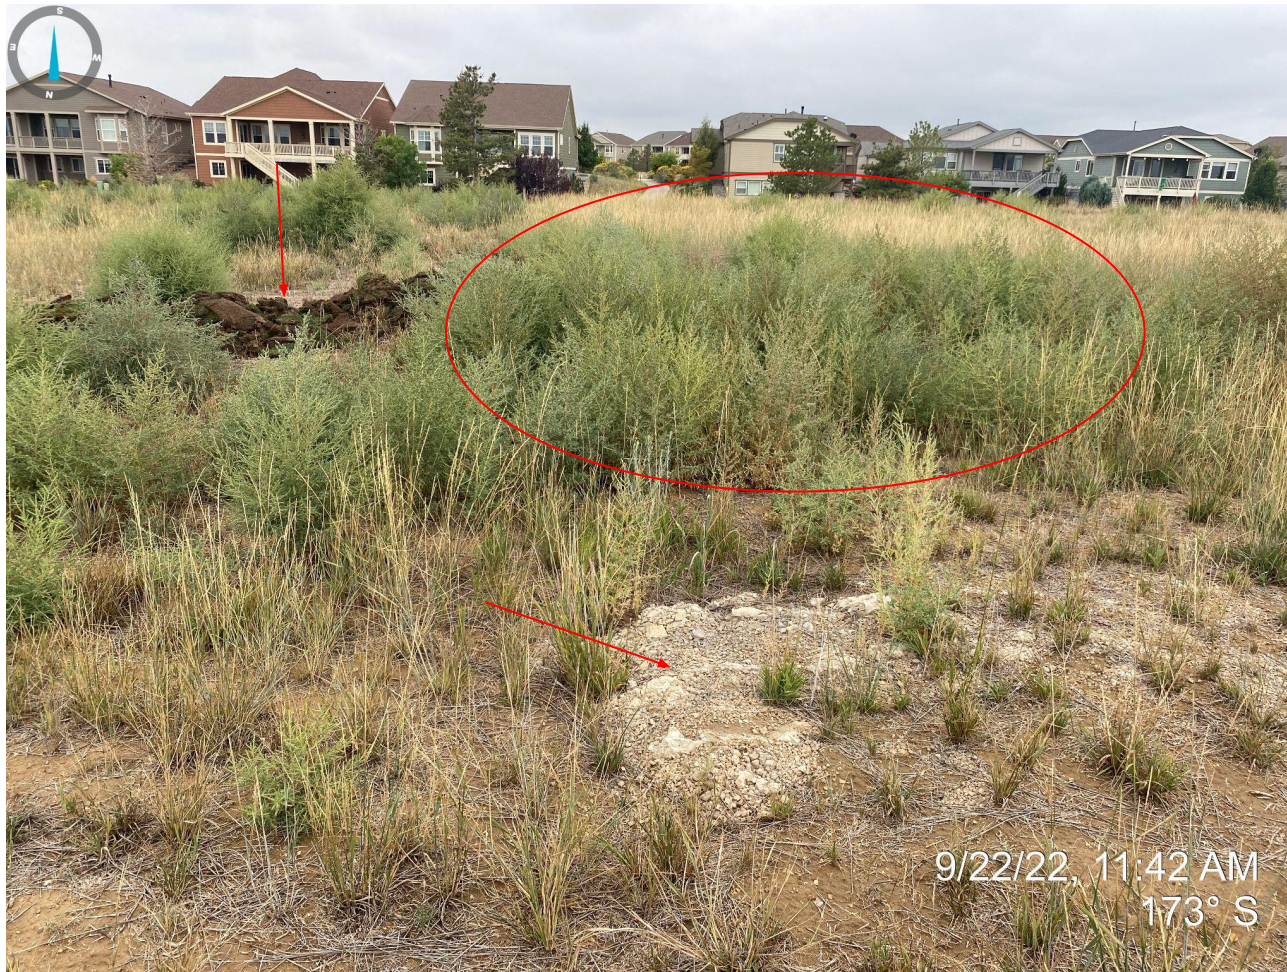
Photo 7. Taken from eastern portion of location, facing south. Photo illustrates debris and annual weedy vegetation, predominantly russian thistle.

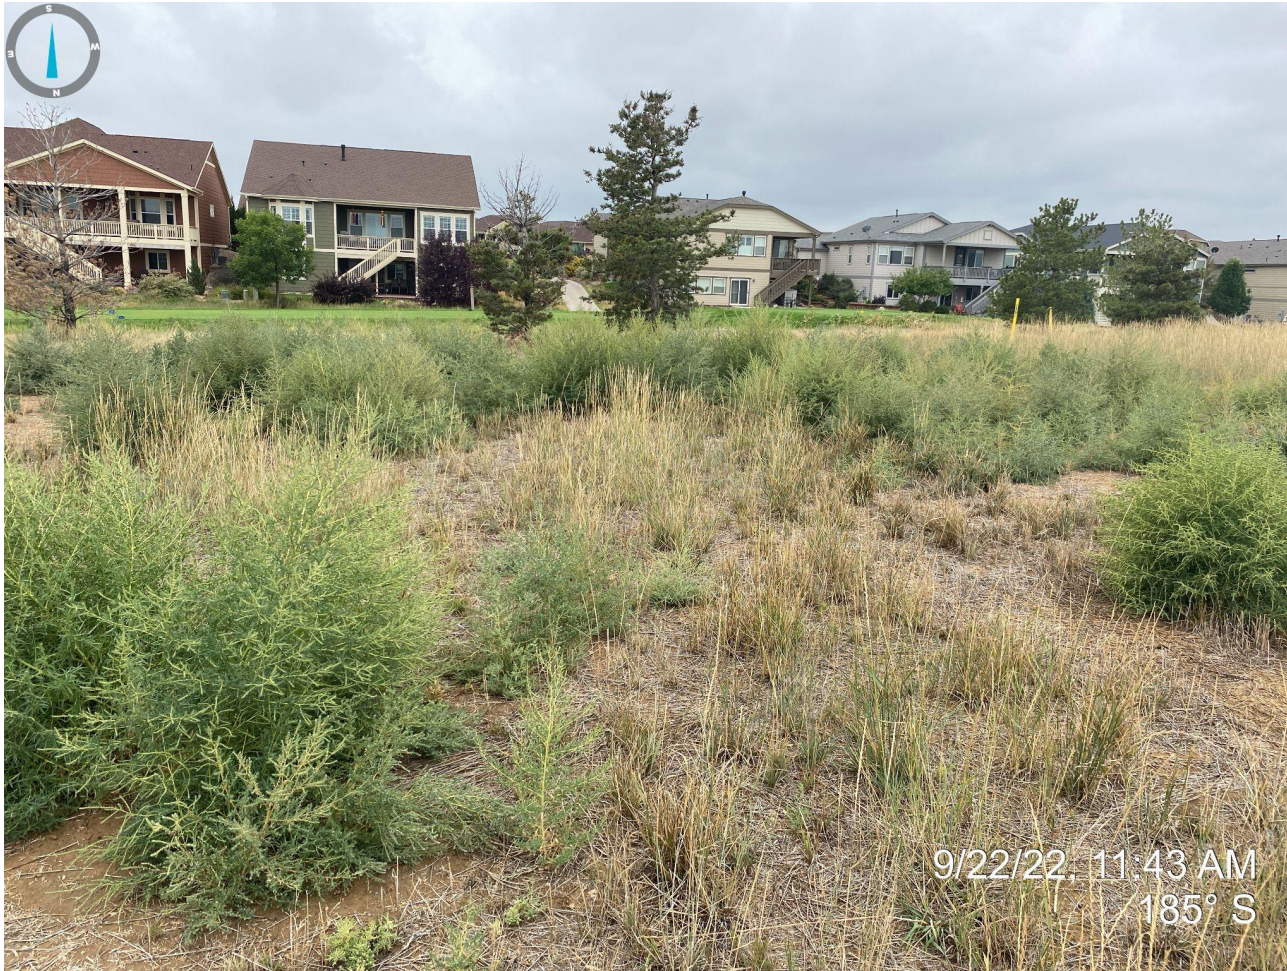
Photo 8. Taken from eastern portion of location, facing south. Photo illustrates annual weedy vegetation, predominantly russian thistle.

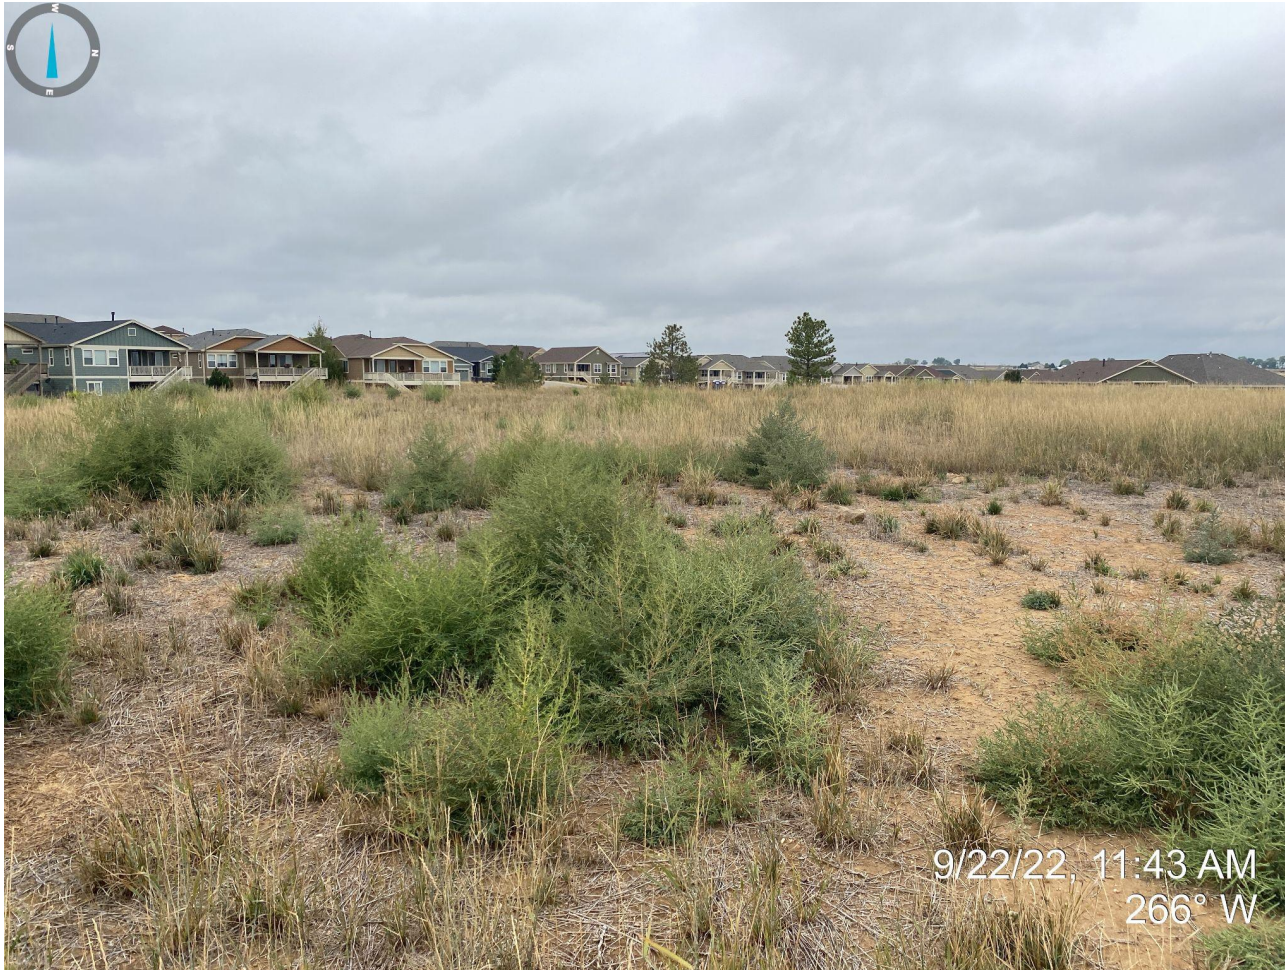
Photo 9. Taken from southeastern portion of location, facing west. Photo illustrates areas of non-uniform vegetation cover resulting in bare soil, possibly a result of compaction issues. Also pictured, annual weedy vegetation.
