# Final Reclamation and Stormwater Inspection

Operator: GREAT WESTERN OPERATING COMPANY LLC - 10110

Location ID: 320446

Inspection Photos  
Location Name: JOHN H EHLER "A" #1  
Location ID: 320446

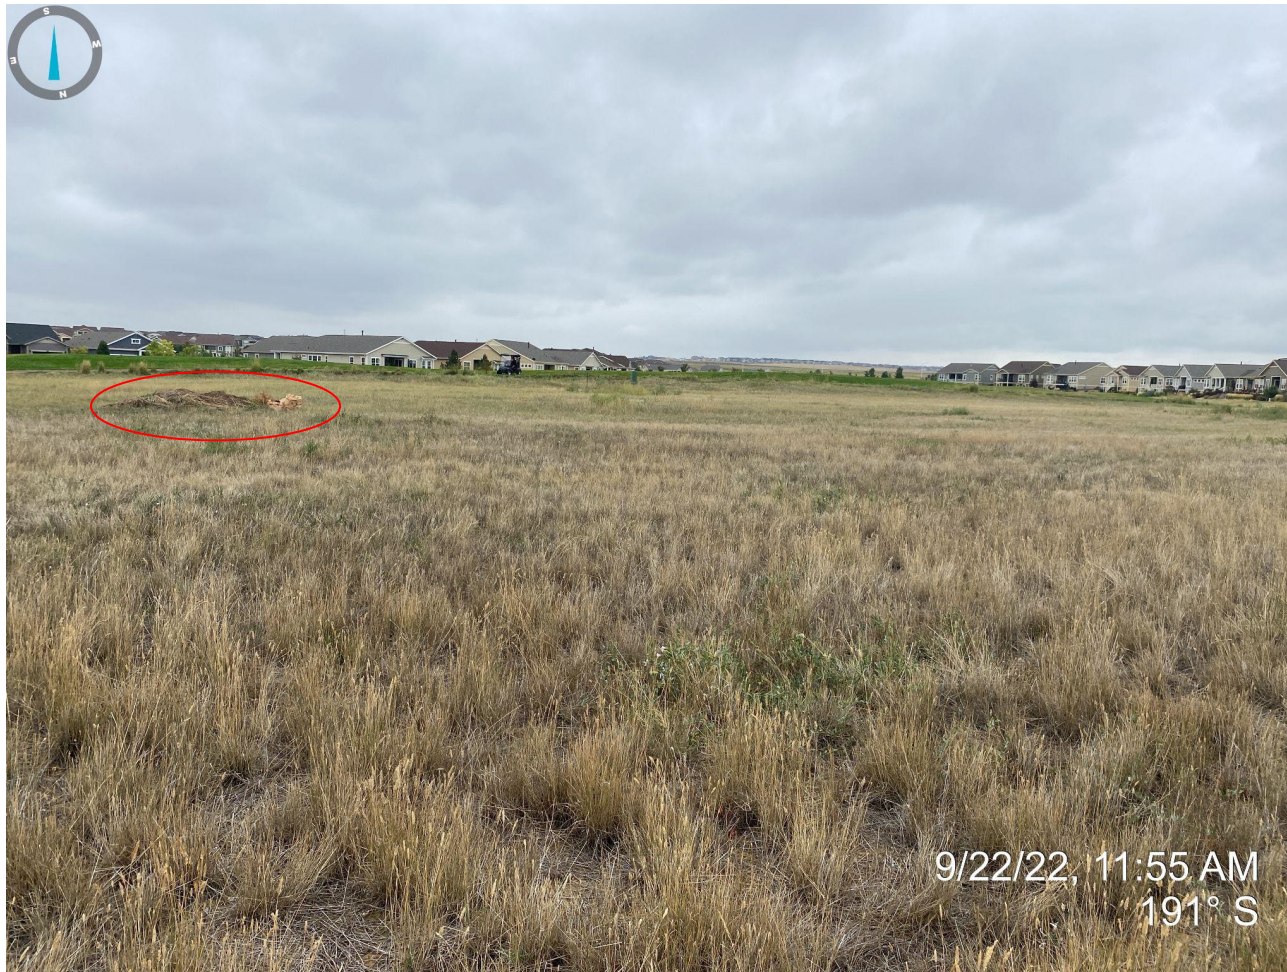
**Photo 1.** Taken northwest of location, facing south. Debris observed on location (outlined in red) that needs to be properly disposed of.

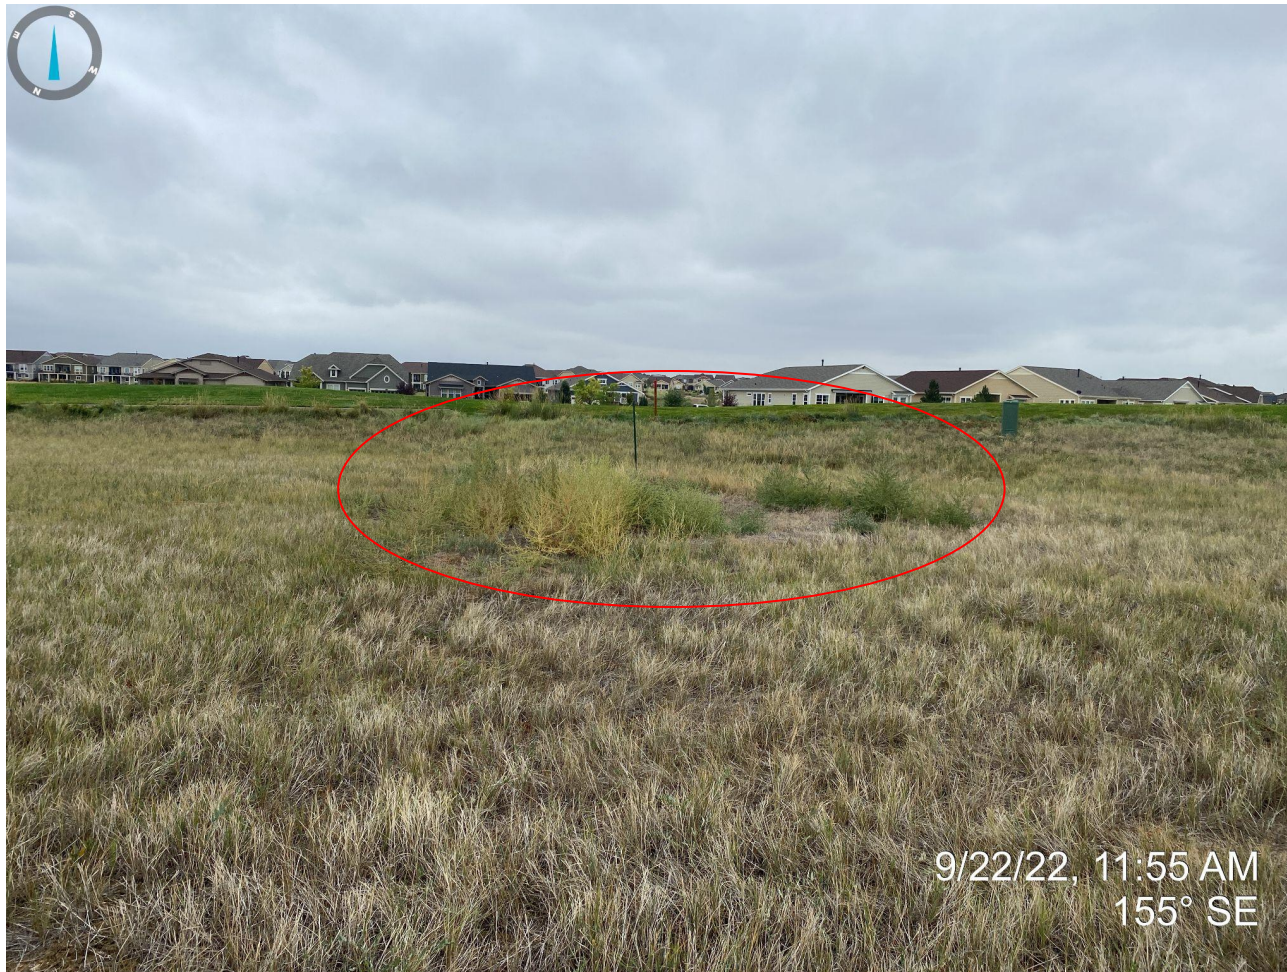
**Photo 2.** Taken near well location, facing southeast. Red outline illustrates weedy annual vegetation (russian thistle).

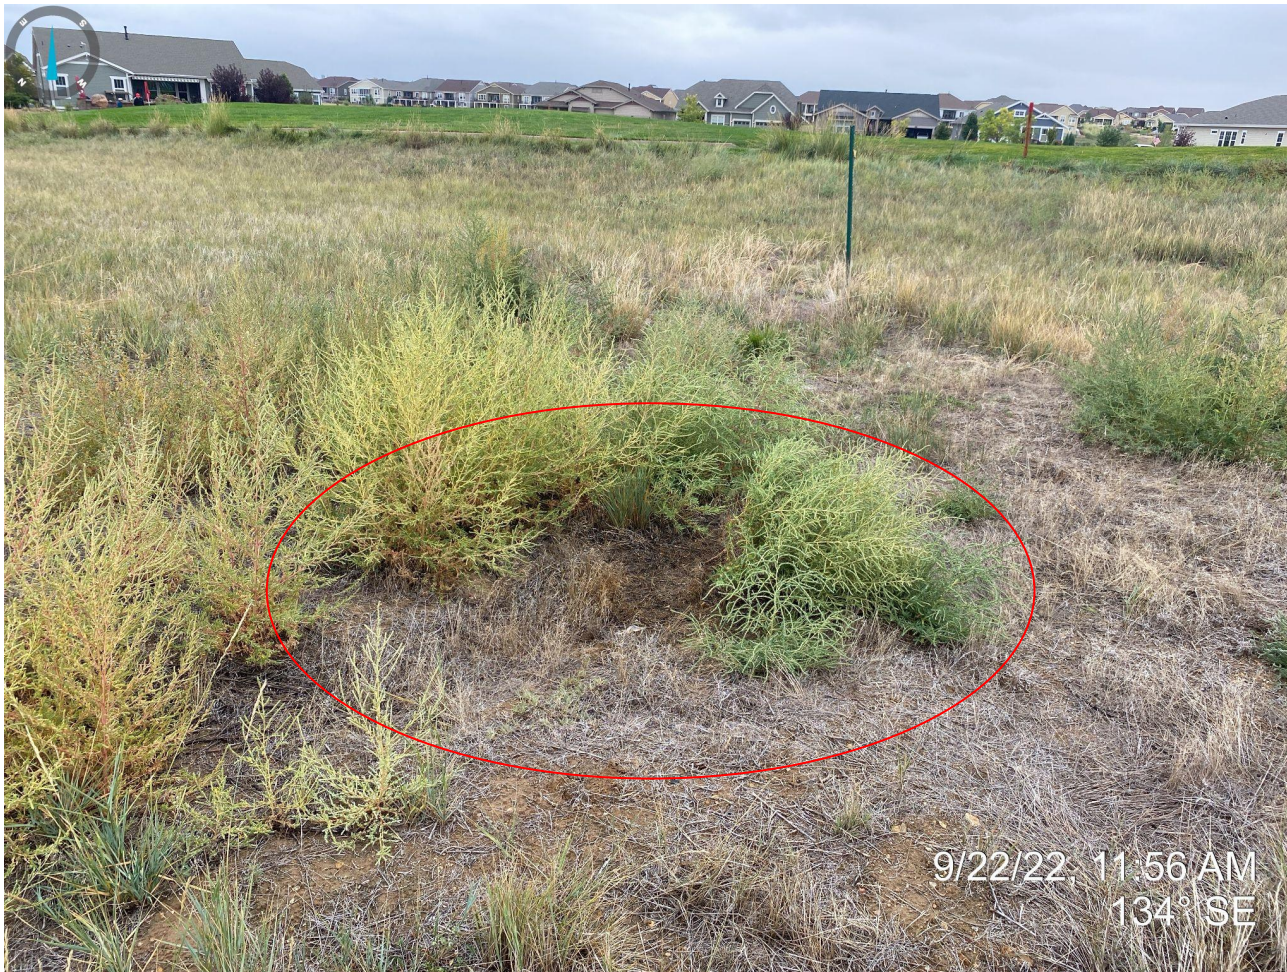
**Photo 3.** Close up photo of well location, facing southeast. Photo illustrates weedy annual vegetation (russian thistle) and subsidence, approximately 6" below surface grade (outlined in red).

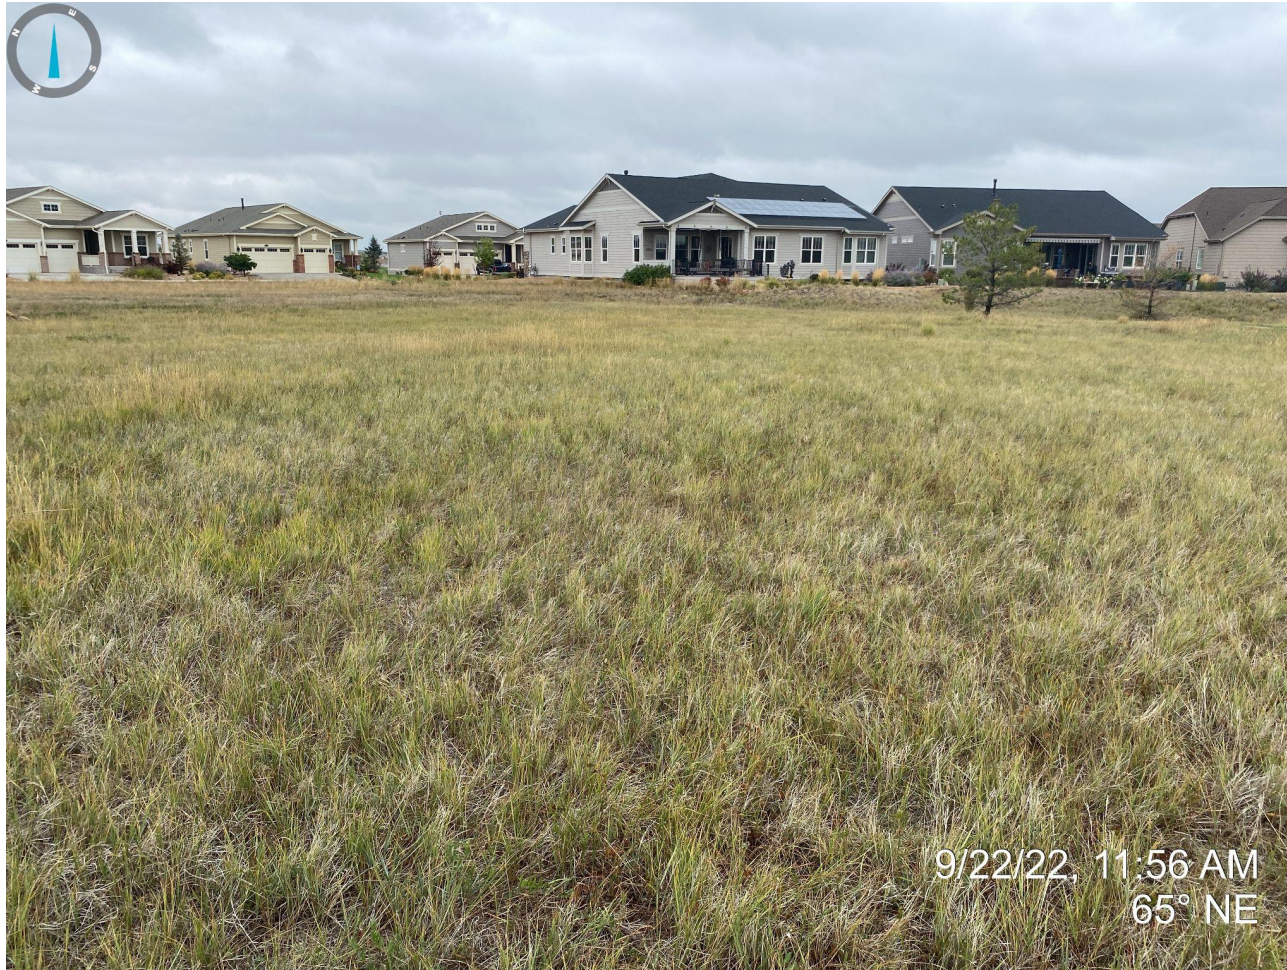
**Photo 4.** Taken west of location, facing northeast. Photo illustrates approximate access road location that appears to have been reclaimed and is reflective of reference areas.
