# Final Reclamation and Stormwater Inspection

Location ID: 319816

Inspection Document #: 696105462

Inspection Photos  
Location Name: WIERMAN #2  
Location ID: 319816

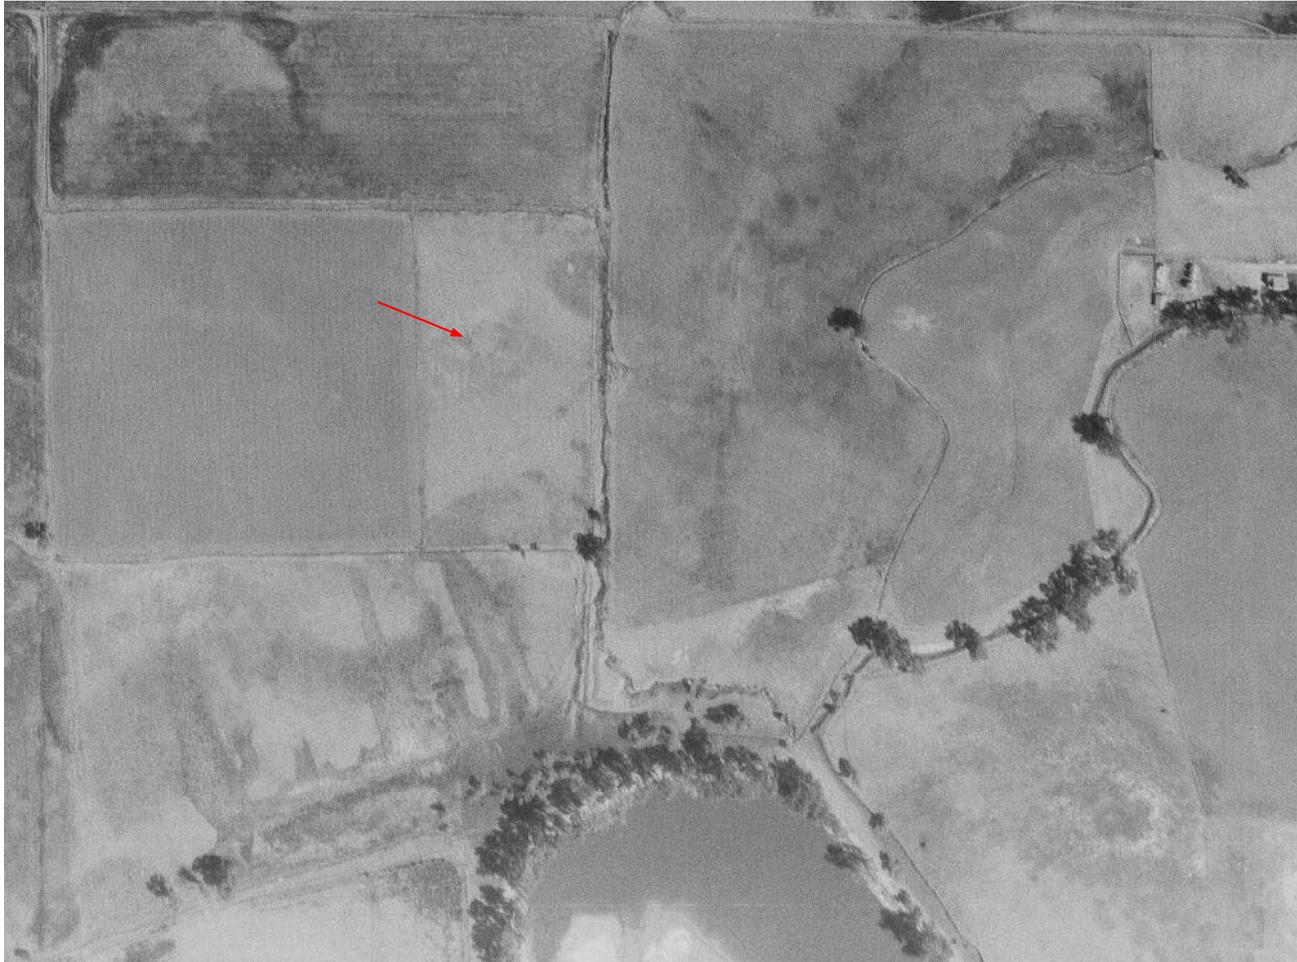
**Photo 1.** Historical imagery taken circa 1963. Red arrow indicates approximate well location. Minimal disturbance documented from this photo.

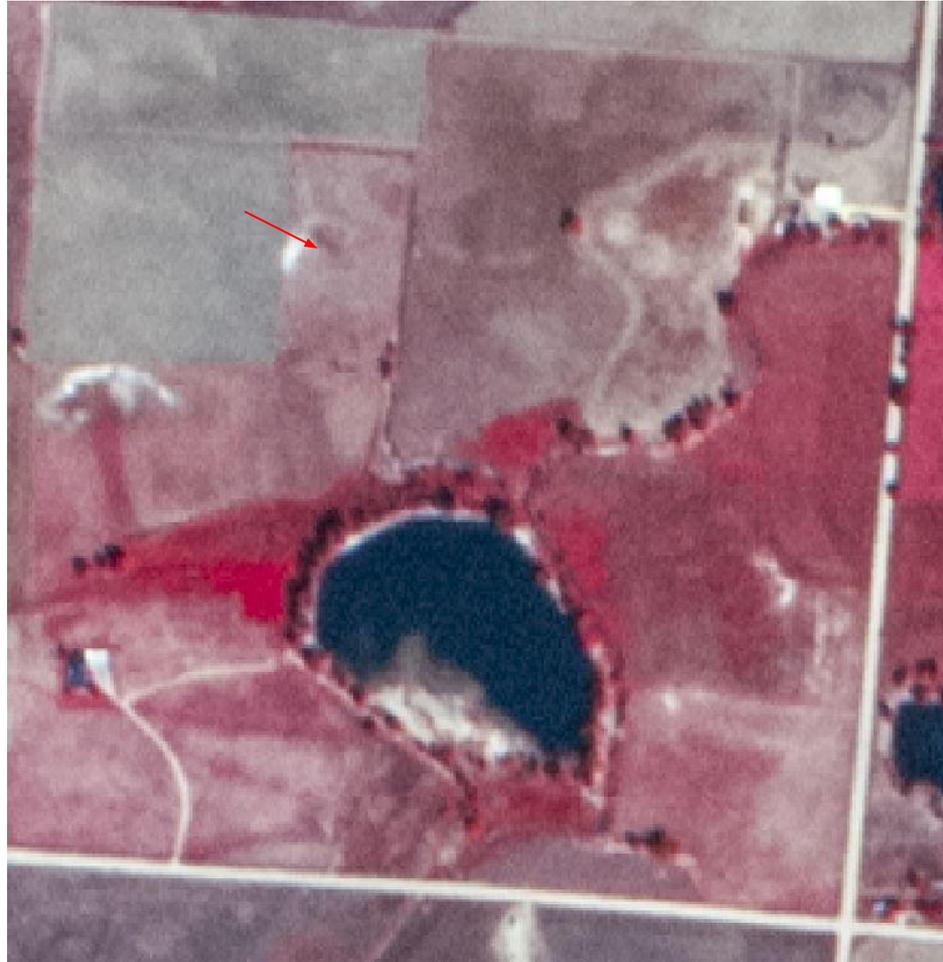
**Photo 2.** Historical imagery taken circa 1972. See comments in photo 1.

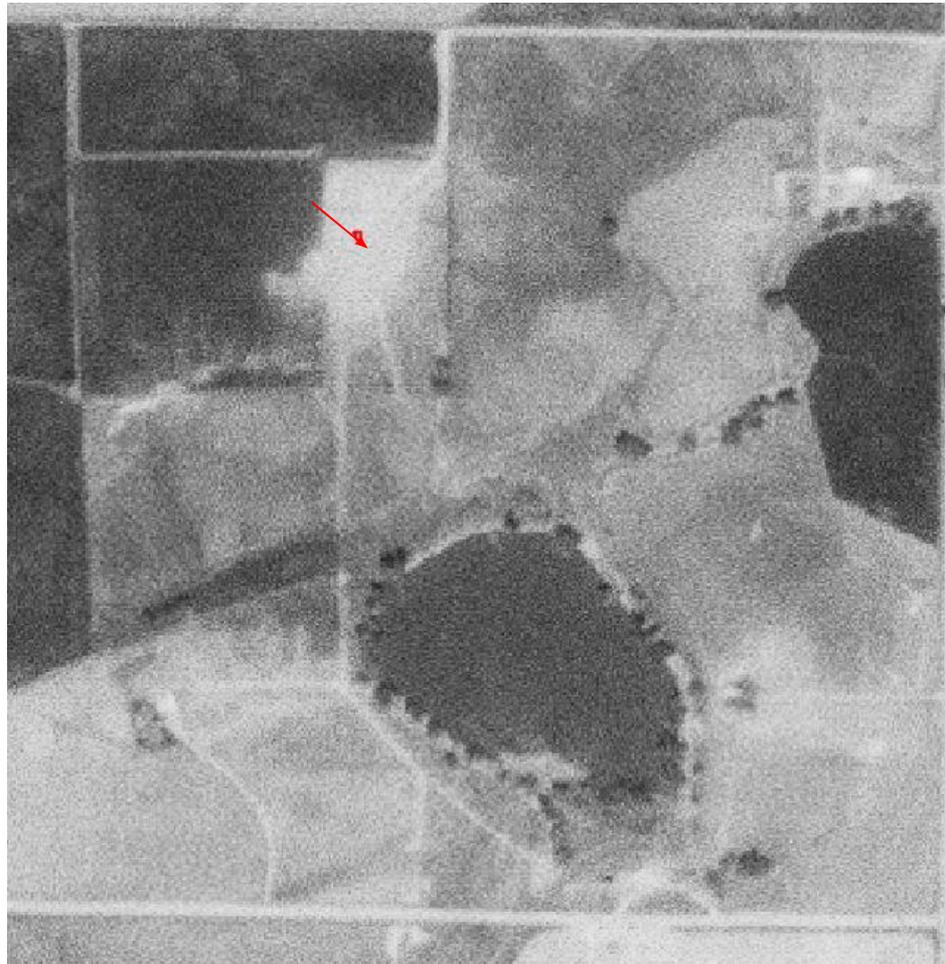
**Photo 3.** Historical imagery taken circa 1975. Image illustrates oil and gas operations under construction based on spud and completion dates (01/09/1975 and 05/26/1975, respectively) from scout card with larger surface disturbance. Red arrow indicates approximate well location.

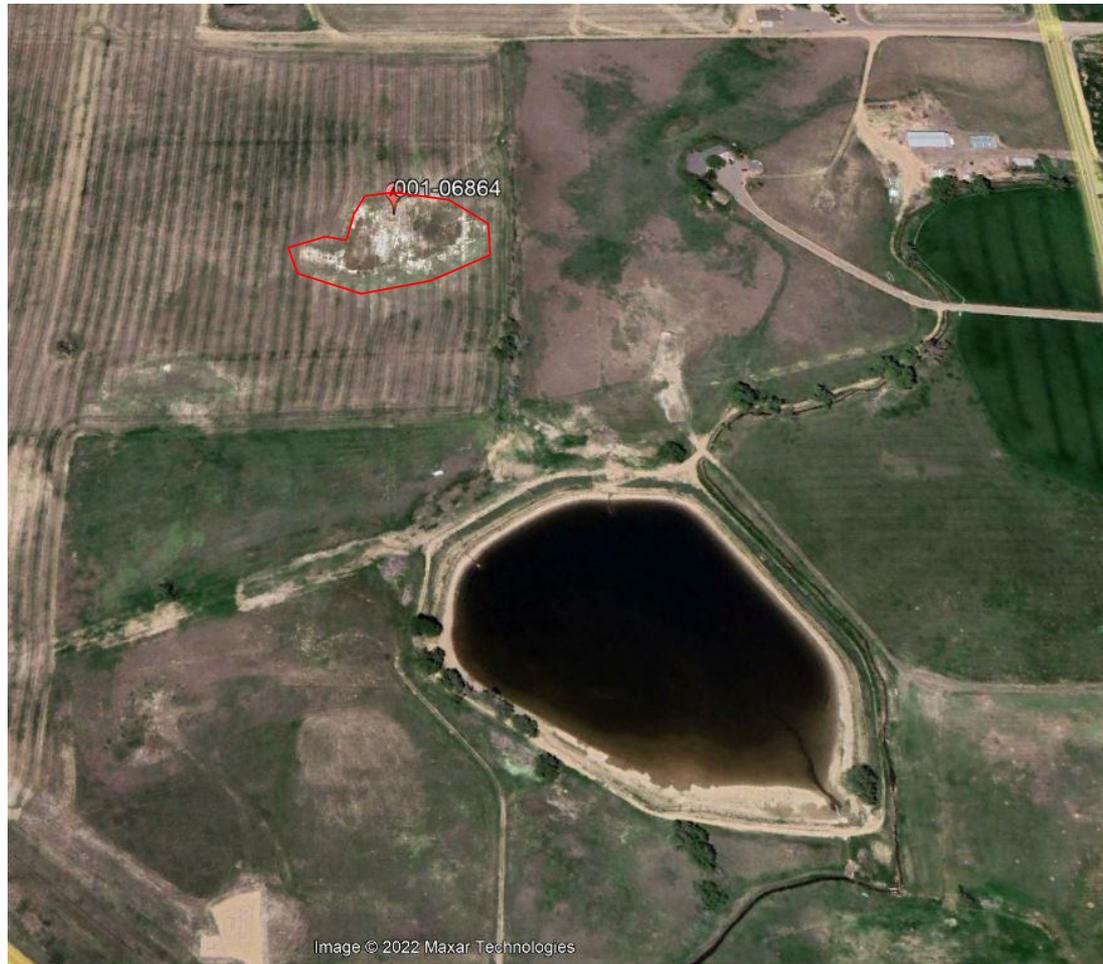
**Photo 4.** Google Earth imagery from circa 2021 illustrates surface disturbance, outlined in red polygon.

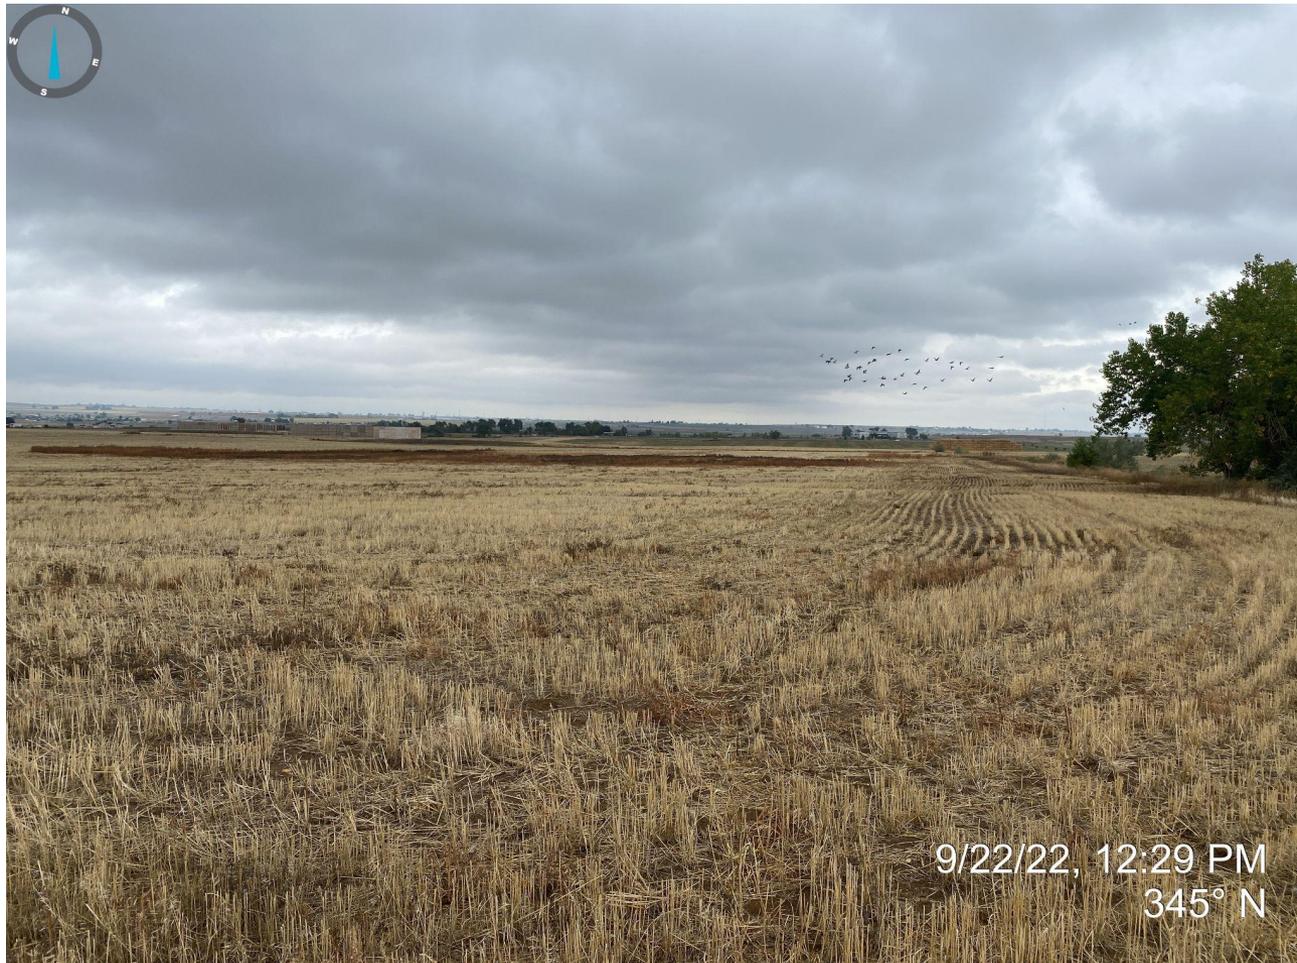
**Photo 5.** Taken south of location, facing north. Photo illustrates reference area (e.g. wheat stubble).

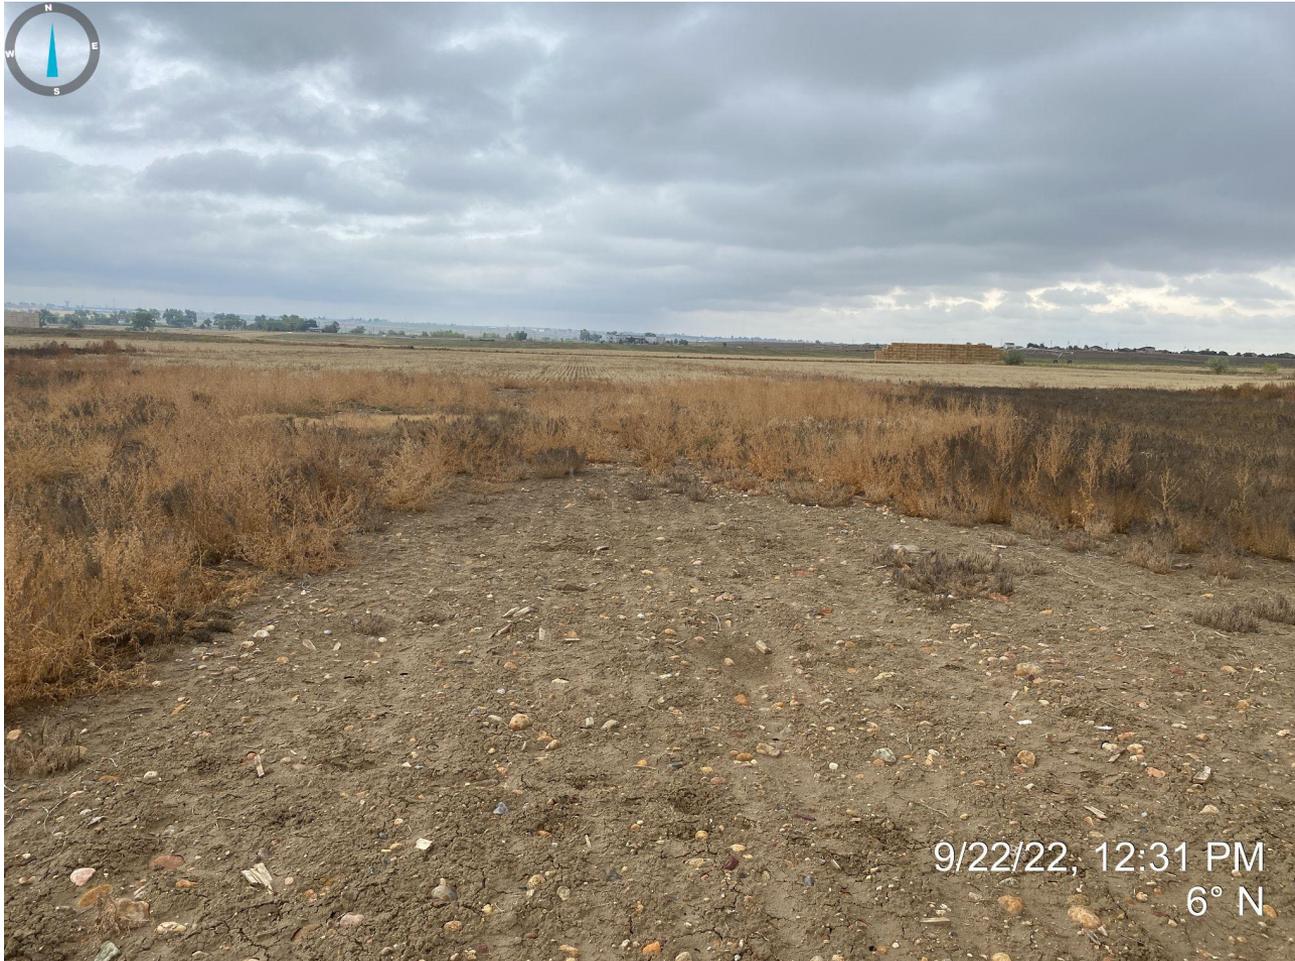
**Photo 6.** Taken near well location, facing north. Photo illustrates non-uniform vegetation cover resulting in bare soil and annual weedy vegetation observed, e.g. russian thistle and kochia.

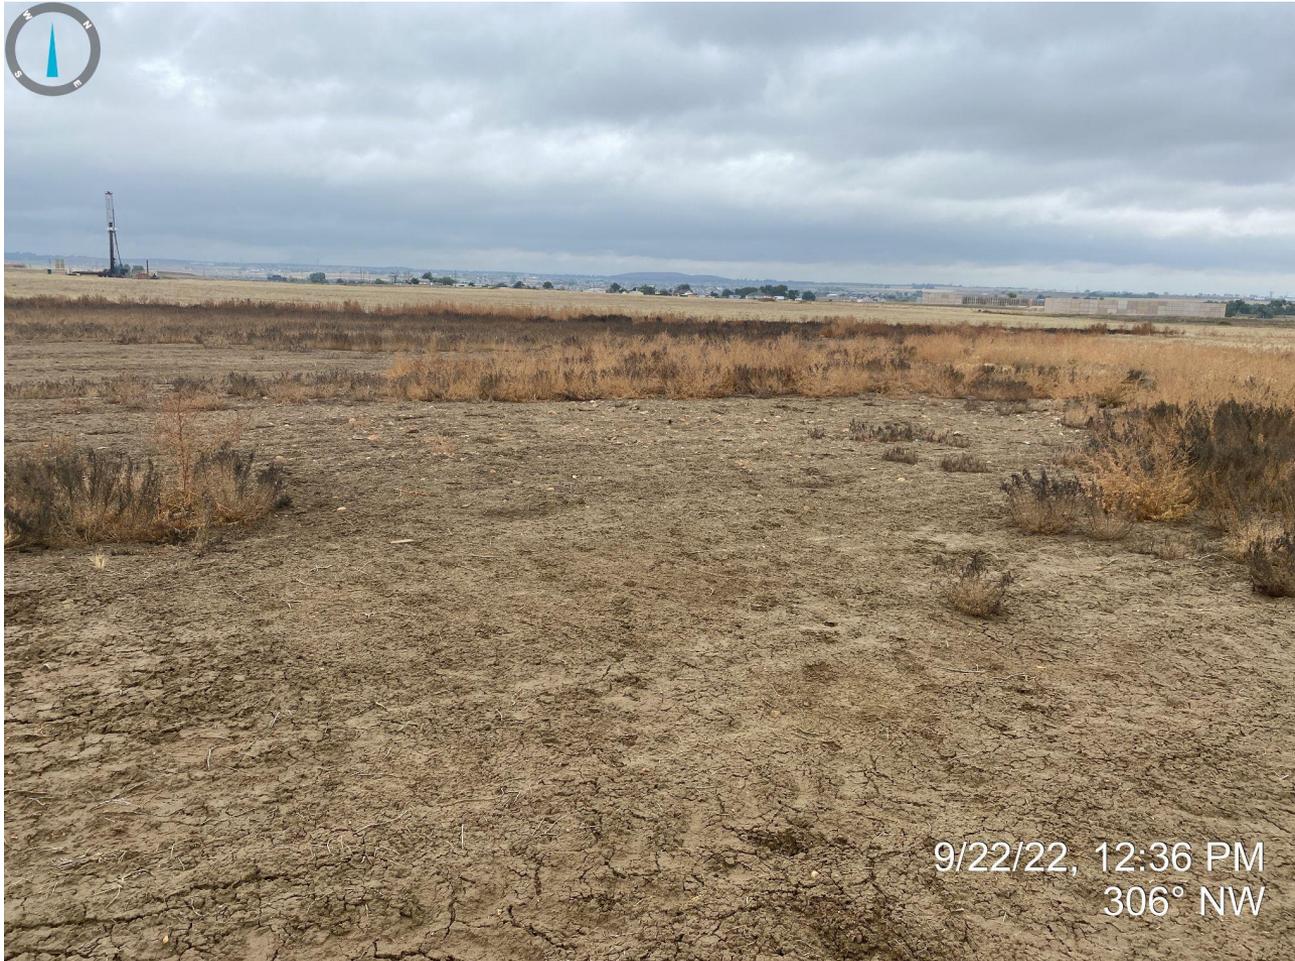
**Photo 7.** Taken from eastern portion of location, facing northwest. See comments in photo 6.

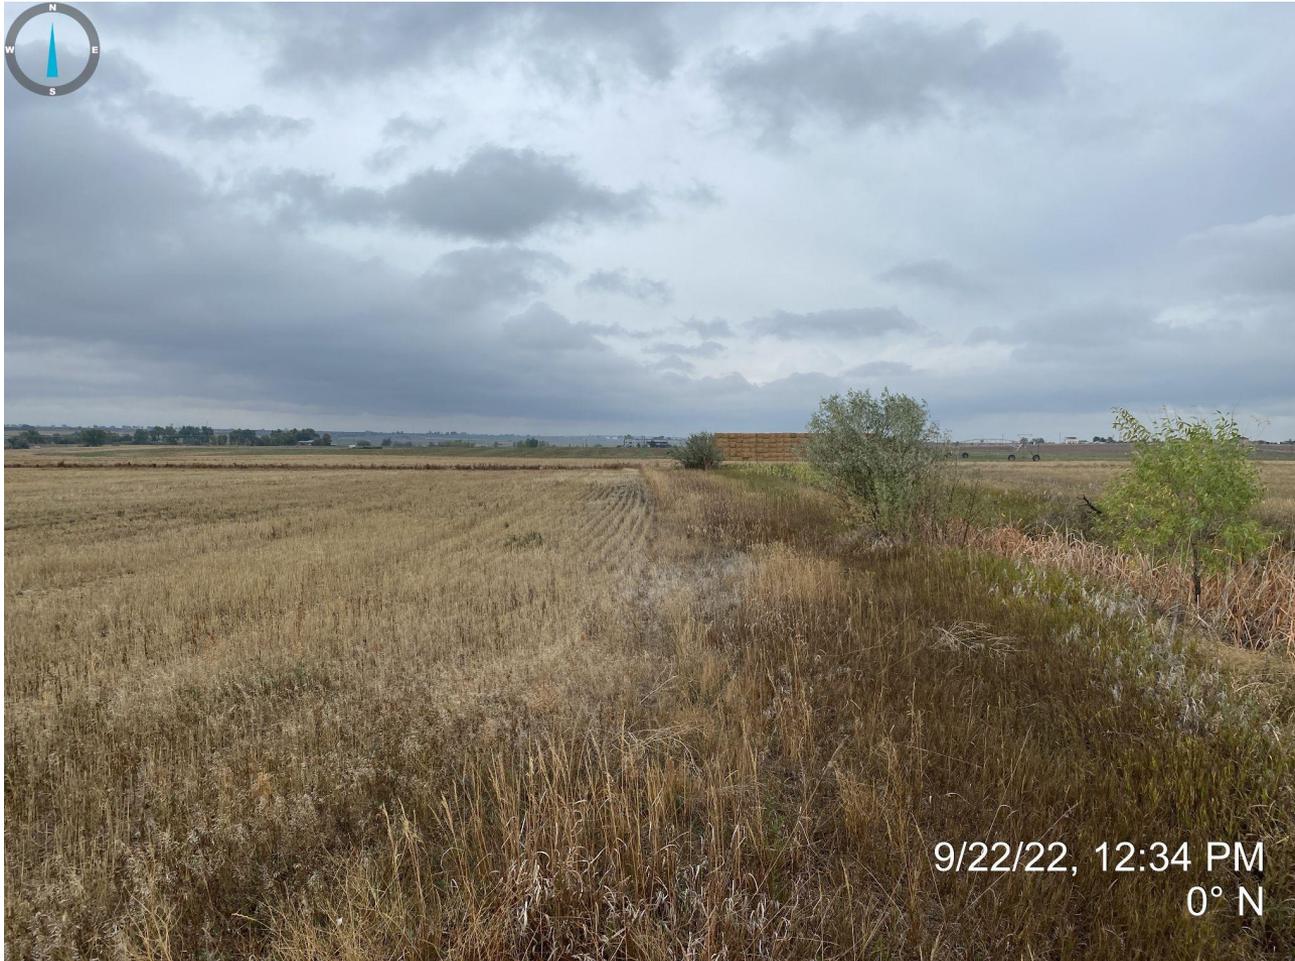
**Photo 8.** Taken east of location and south of former access road, facing north. Photo illustrates access road appears to meet final reclamation standards and is reflective of reference area crop, e.g. wheat stubble).
