Inspection Photos and Issue Report

9/29/2022

Operator: TEP ROCKY MOUNTAIN LLC #
96850

Location #436652
Rio Blanco County, CO

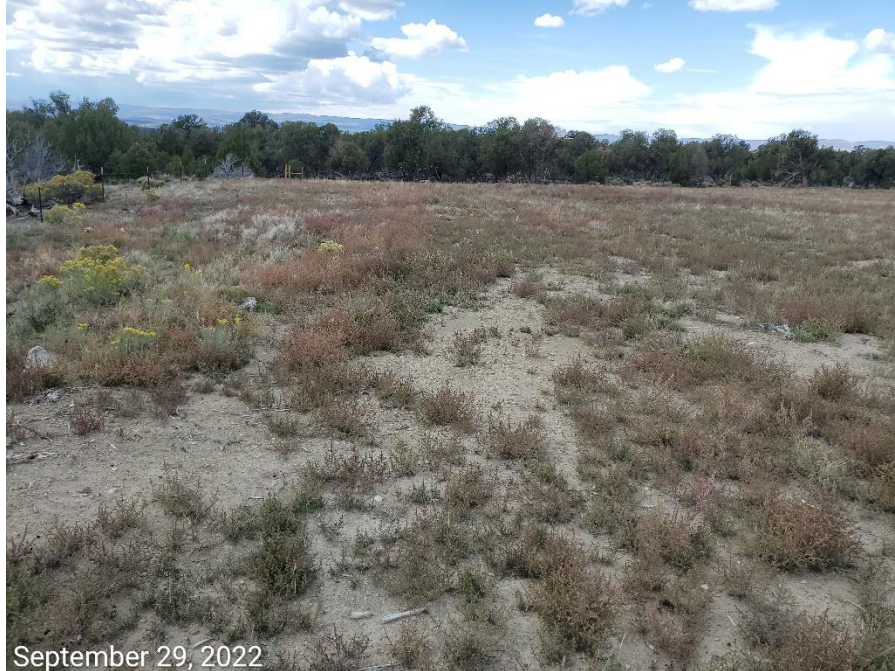
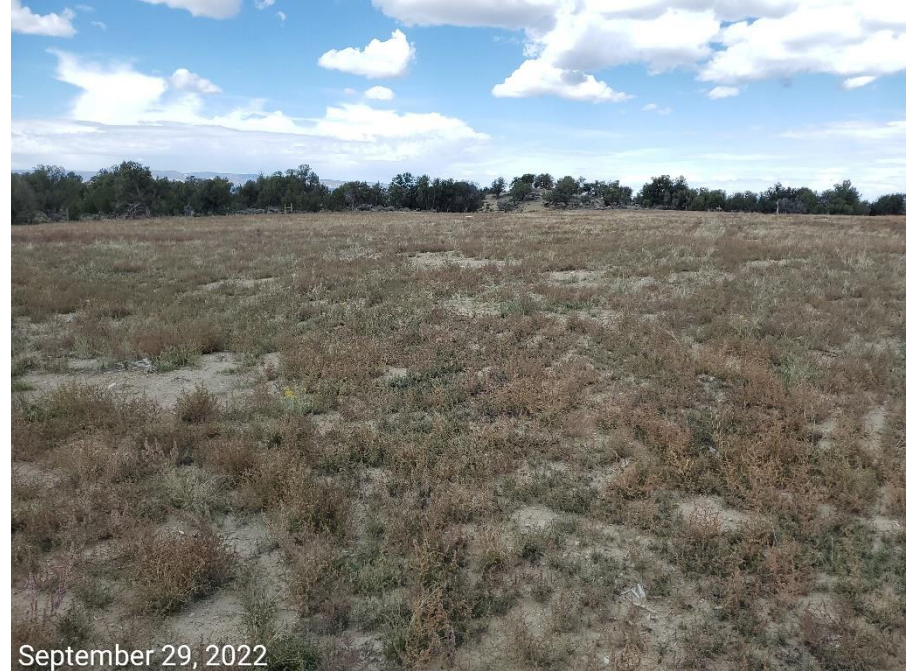
Photo 1: Photos 1-2 taken from the south end of the Location. Photos provide an overview of the Location from west, northwest, northeast to east. Photos also show vegetation on the Location is predominantly Undesirable and Weedy Plant species such as Russian thistle and Halogeton. Though desirable plant establishment was observed, perennial revegetation is sparse throughout the Location and not uniform.

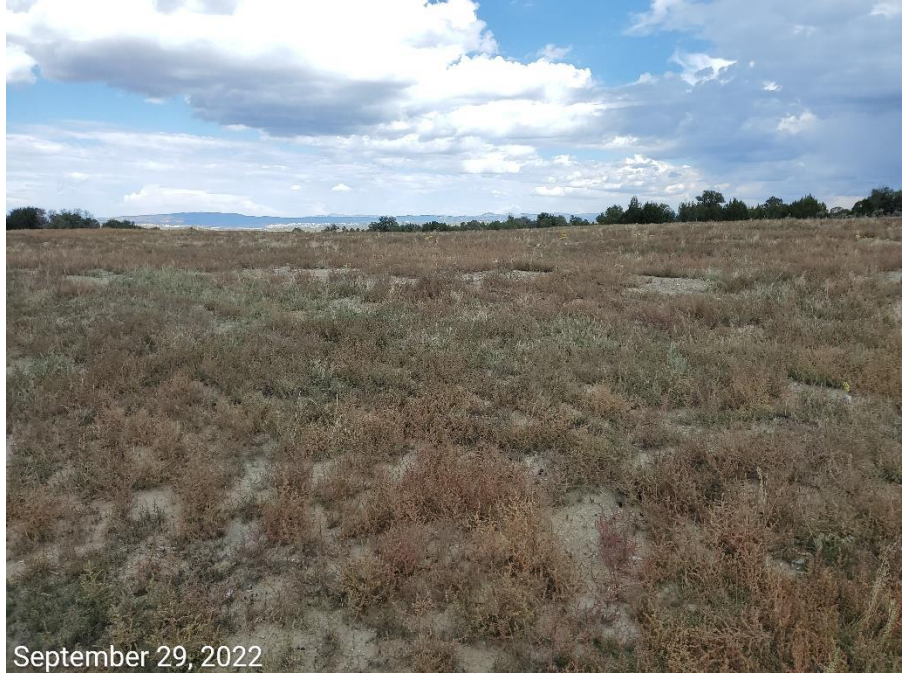
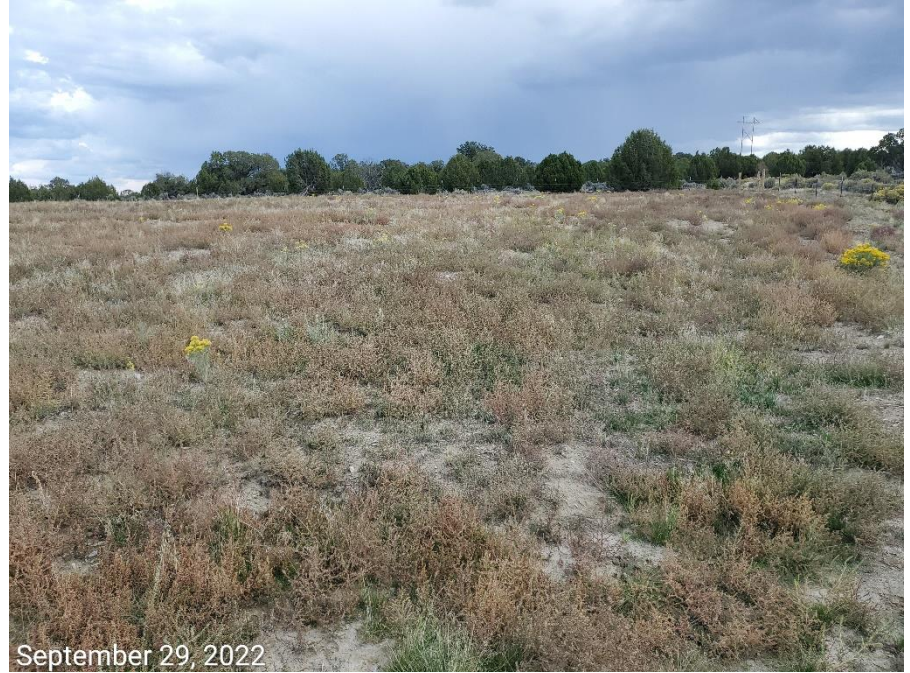
Photo 2: See comments under photo 1.

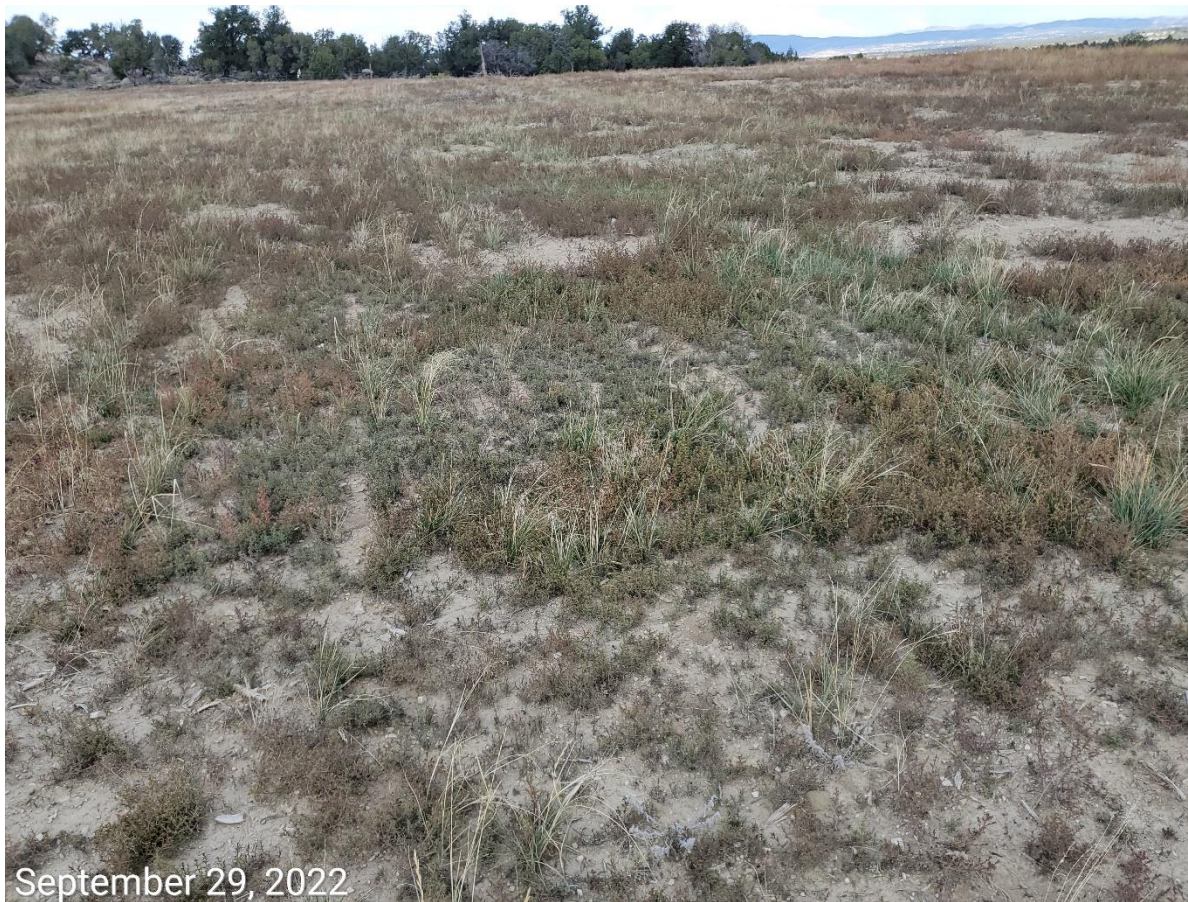
Photo 3: Photo example showing areas where desirable plant establishment was observed, however perennial revegetation is sparse throughout the Location and not uniform. Location predominantly Undesirable Plant Species.

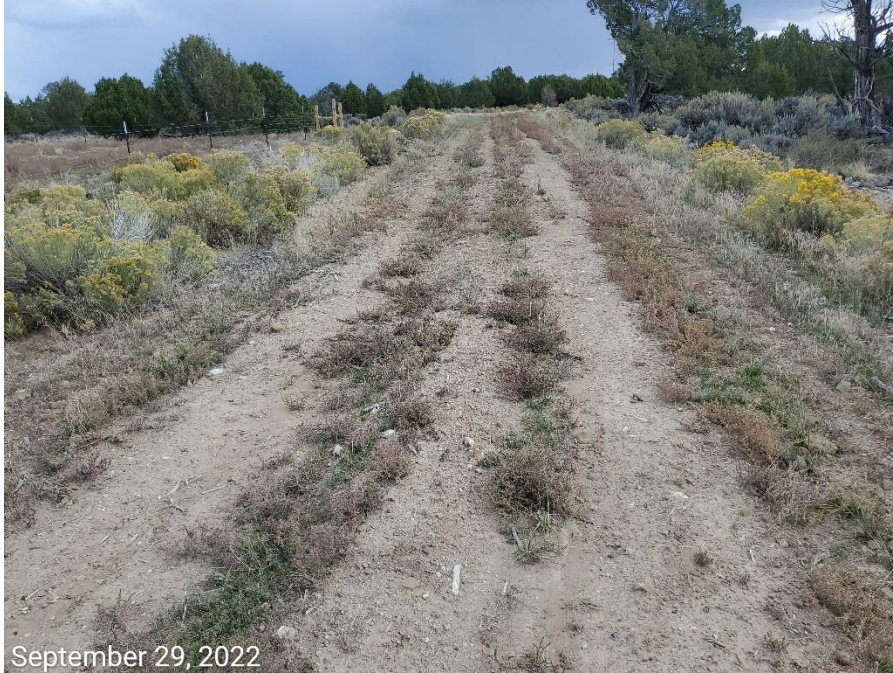
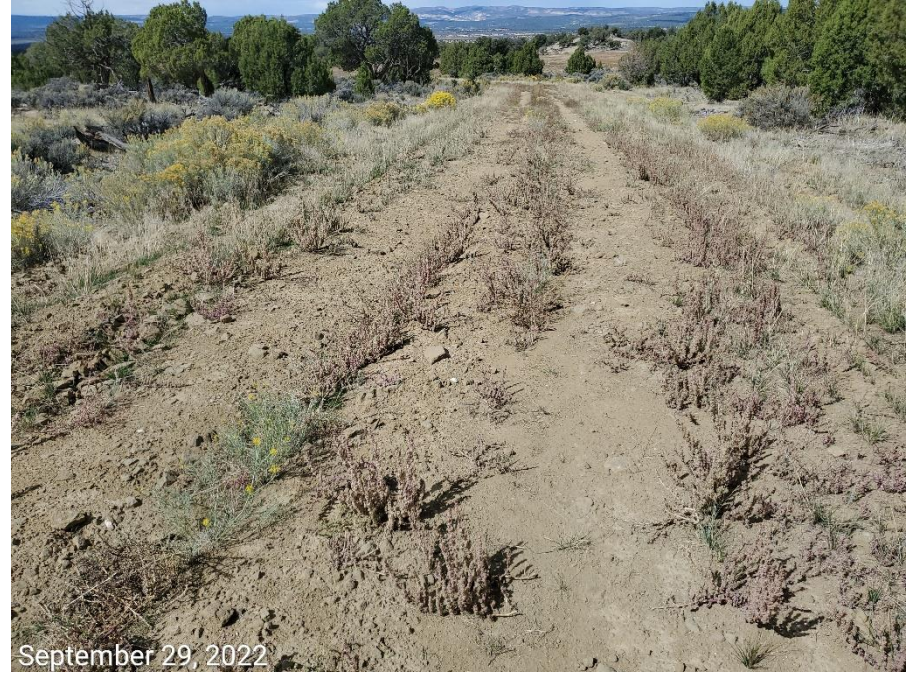
Photo 4: Photo example showing access roads. Compaction concerns appear to remain; desirable plant establishment is not progressing towards 1004 standards. Vegetation observed on road predominantly Russian thistle and Halogeton.
