Final Reclamation Inspection

Operator: GREAT WESTERN OPERATING COMPANY LLC- #10110

Location ID: 323392

Inspection Photos
Location Name: PIERCE UNIT-KENNEDY #3
Location ID: 323392

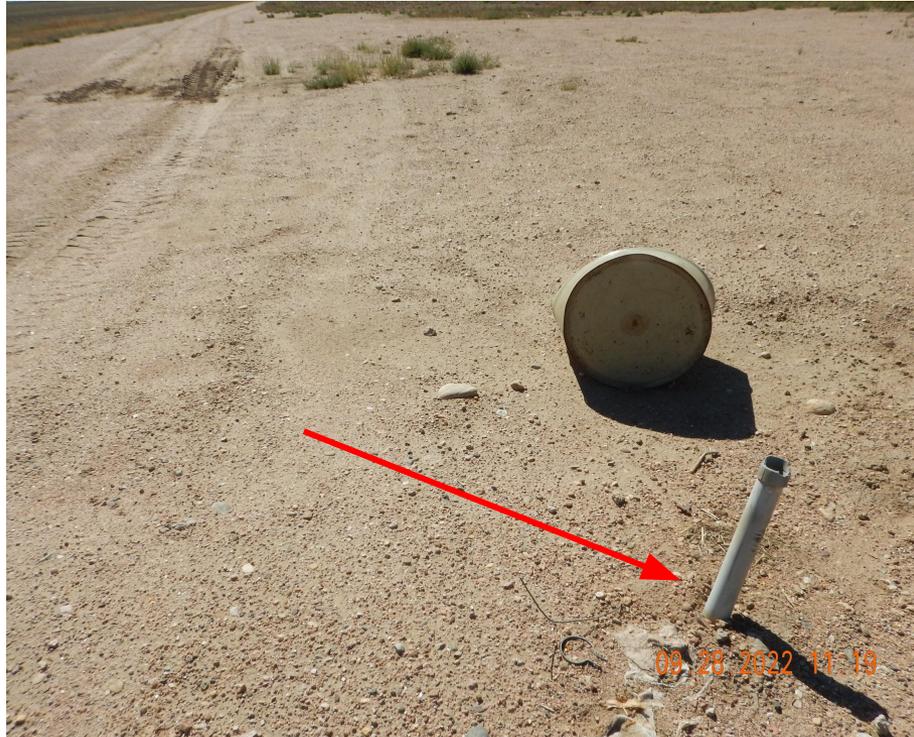
Photo 1. Photo taken from the location, facing South. Photo illustrates not all equipment has been removed.

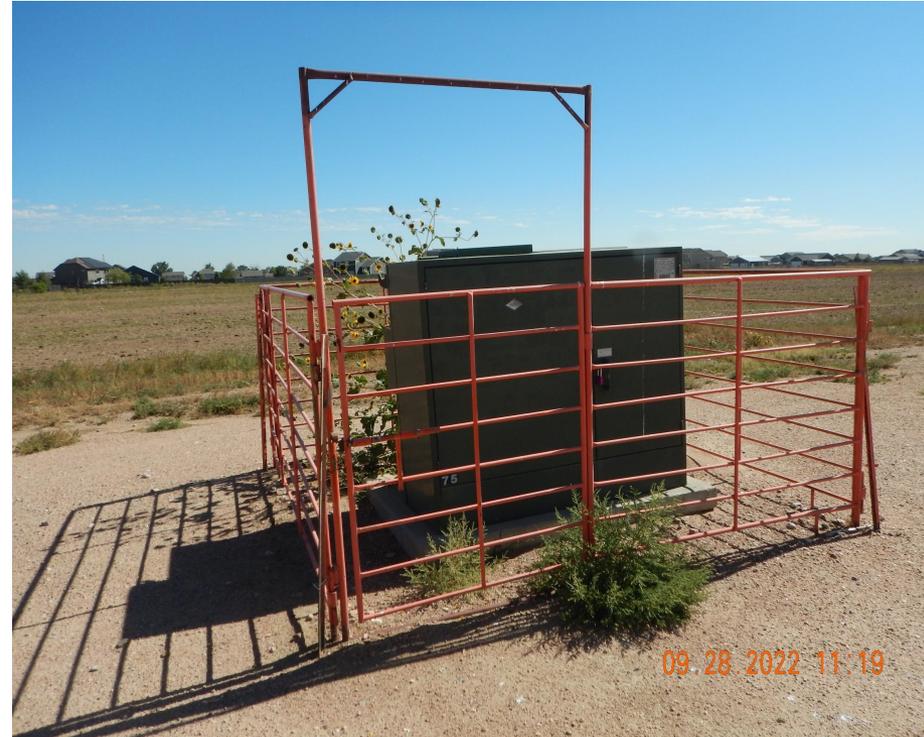
Photo 2. Photo taken from location, facing East. It is unclear whether this was used for oil and gas operations. If it was, it shall be removed per Rule 1004.a.

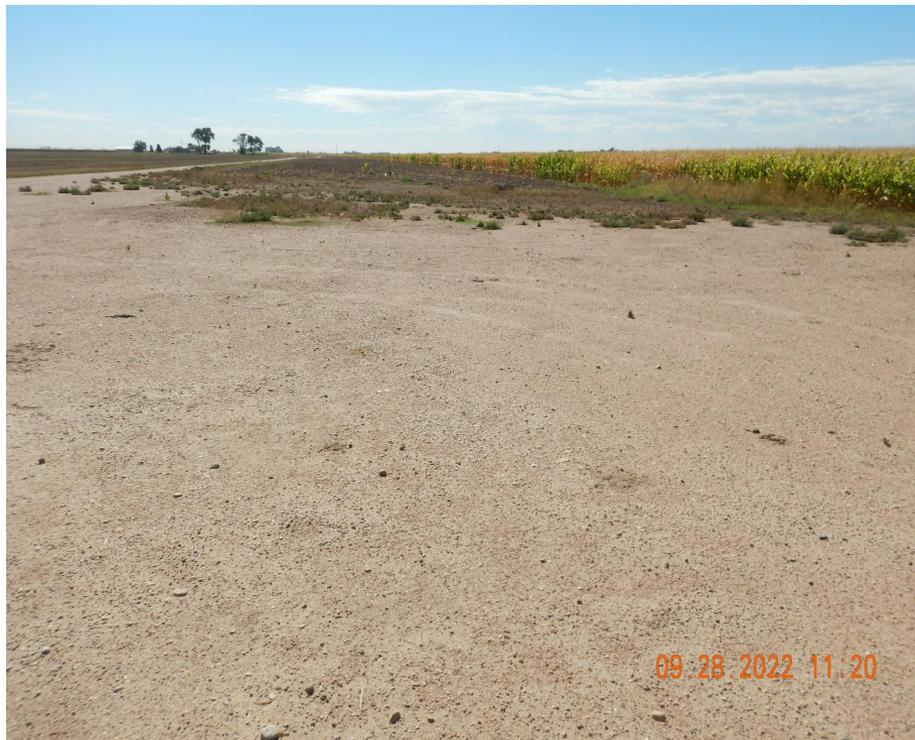
Photo 3. Photo taken from the western location, facing South. Photo illustrates final reclamation activities have not been completed.

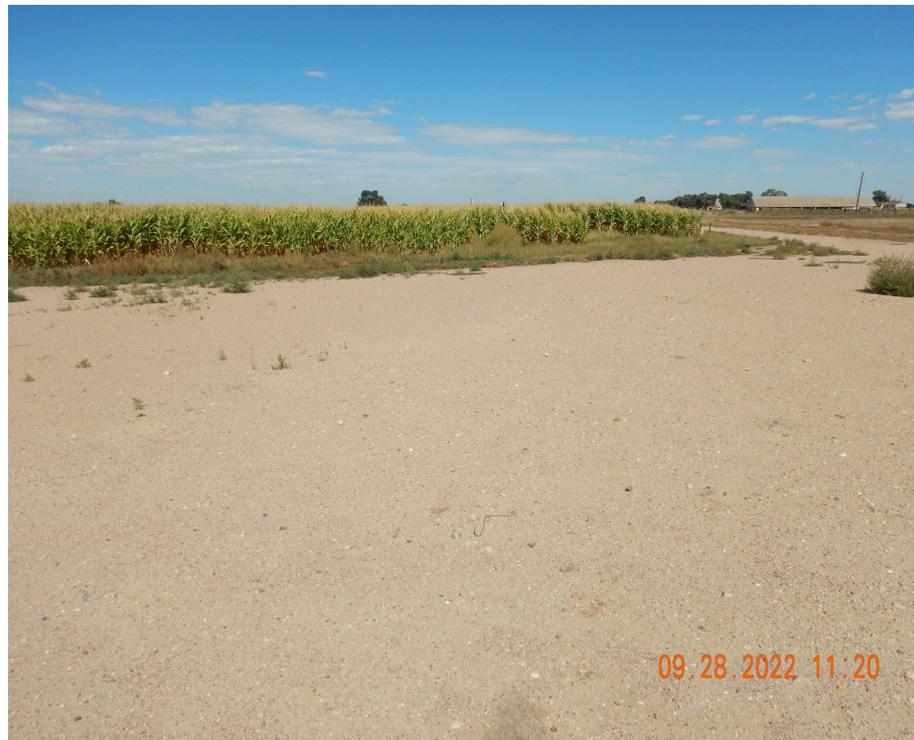
Photo 4. Photo taken from the western location, facing North. See comments under Photo 3.
