REPORT OF WORK COMPLETED

Project Name: Mesa 22 Tank Failure
COGCC Location ID#: 335506
COGCC Spill/Release Point ID#: 482841
Legal Description: SWNE Sec. 25 T6S-R97W 6th P.M. Garfield County, CO
Location (Lat/Long): 39.495860, -108.166172

Mesa 22 Tank Failure ROWC

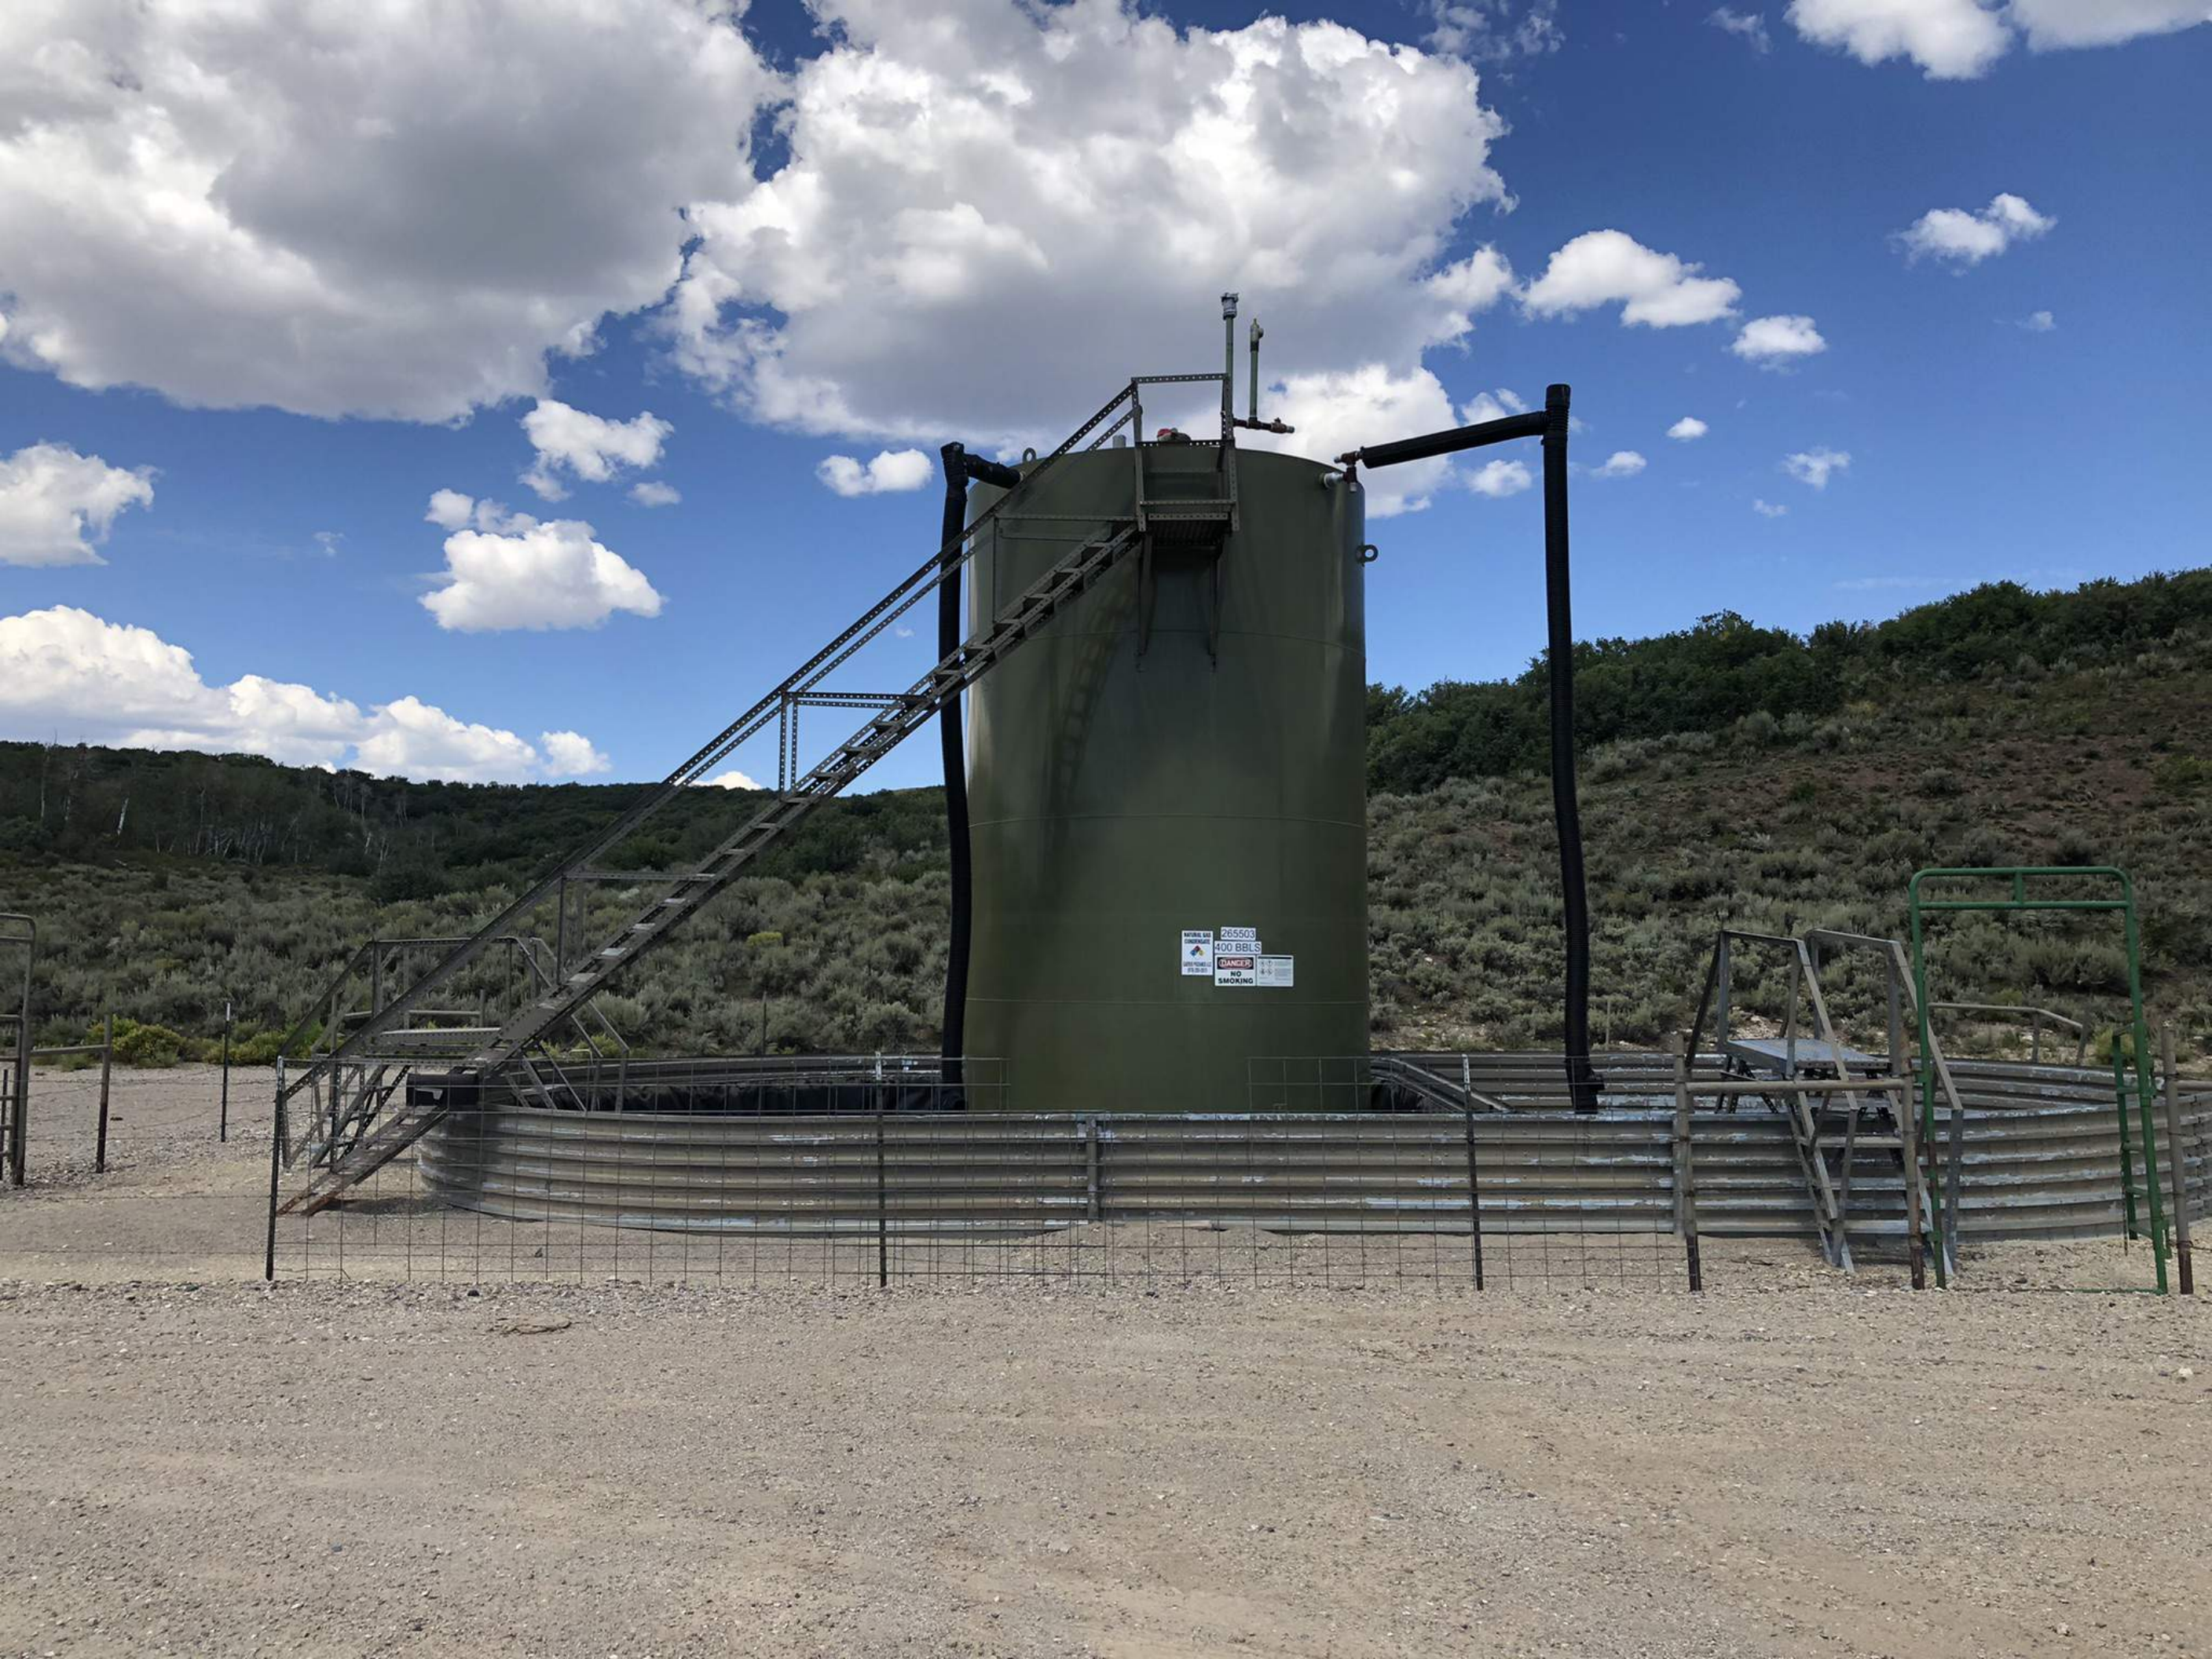
Point of
Release

As reported to the Colorado Oil and Gas Conservation Commission (COGCC) in Form 19 (Doc# 403148904), the release was discovered on August 26, 2022 when a water hauler observed a pinhole leak in the side of a production tank that resulted in accumulation of production fluids within the lined secondary containment. The production fluids were immediately recovered from the containment and production was shut-in. Caerus has determined that the incident was caused by corrosion of the interior of the tank. The tank is being evaluated and will either be repaired or replaced. A supplemental Form 19 (Doc# 403152602) was submitted on August 31, 2022.

Based on the spill response and liner inspection, all production fluid has been recovered and there are no apparent pathways for production fluid to leave the secondary containment. CEPC recommends removal of remaining stained gravel and concludes that a no further action request to the COGCC is warranted.

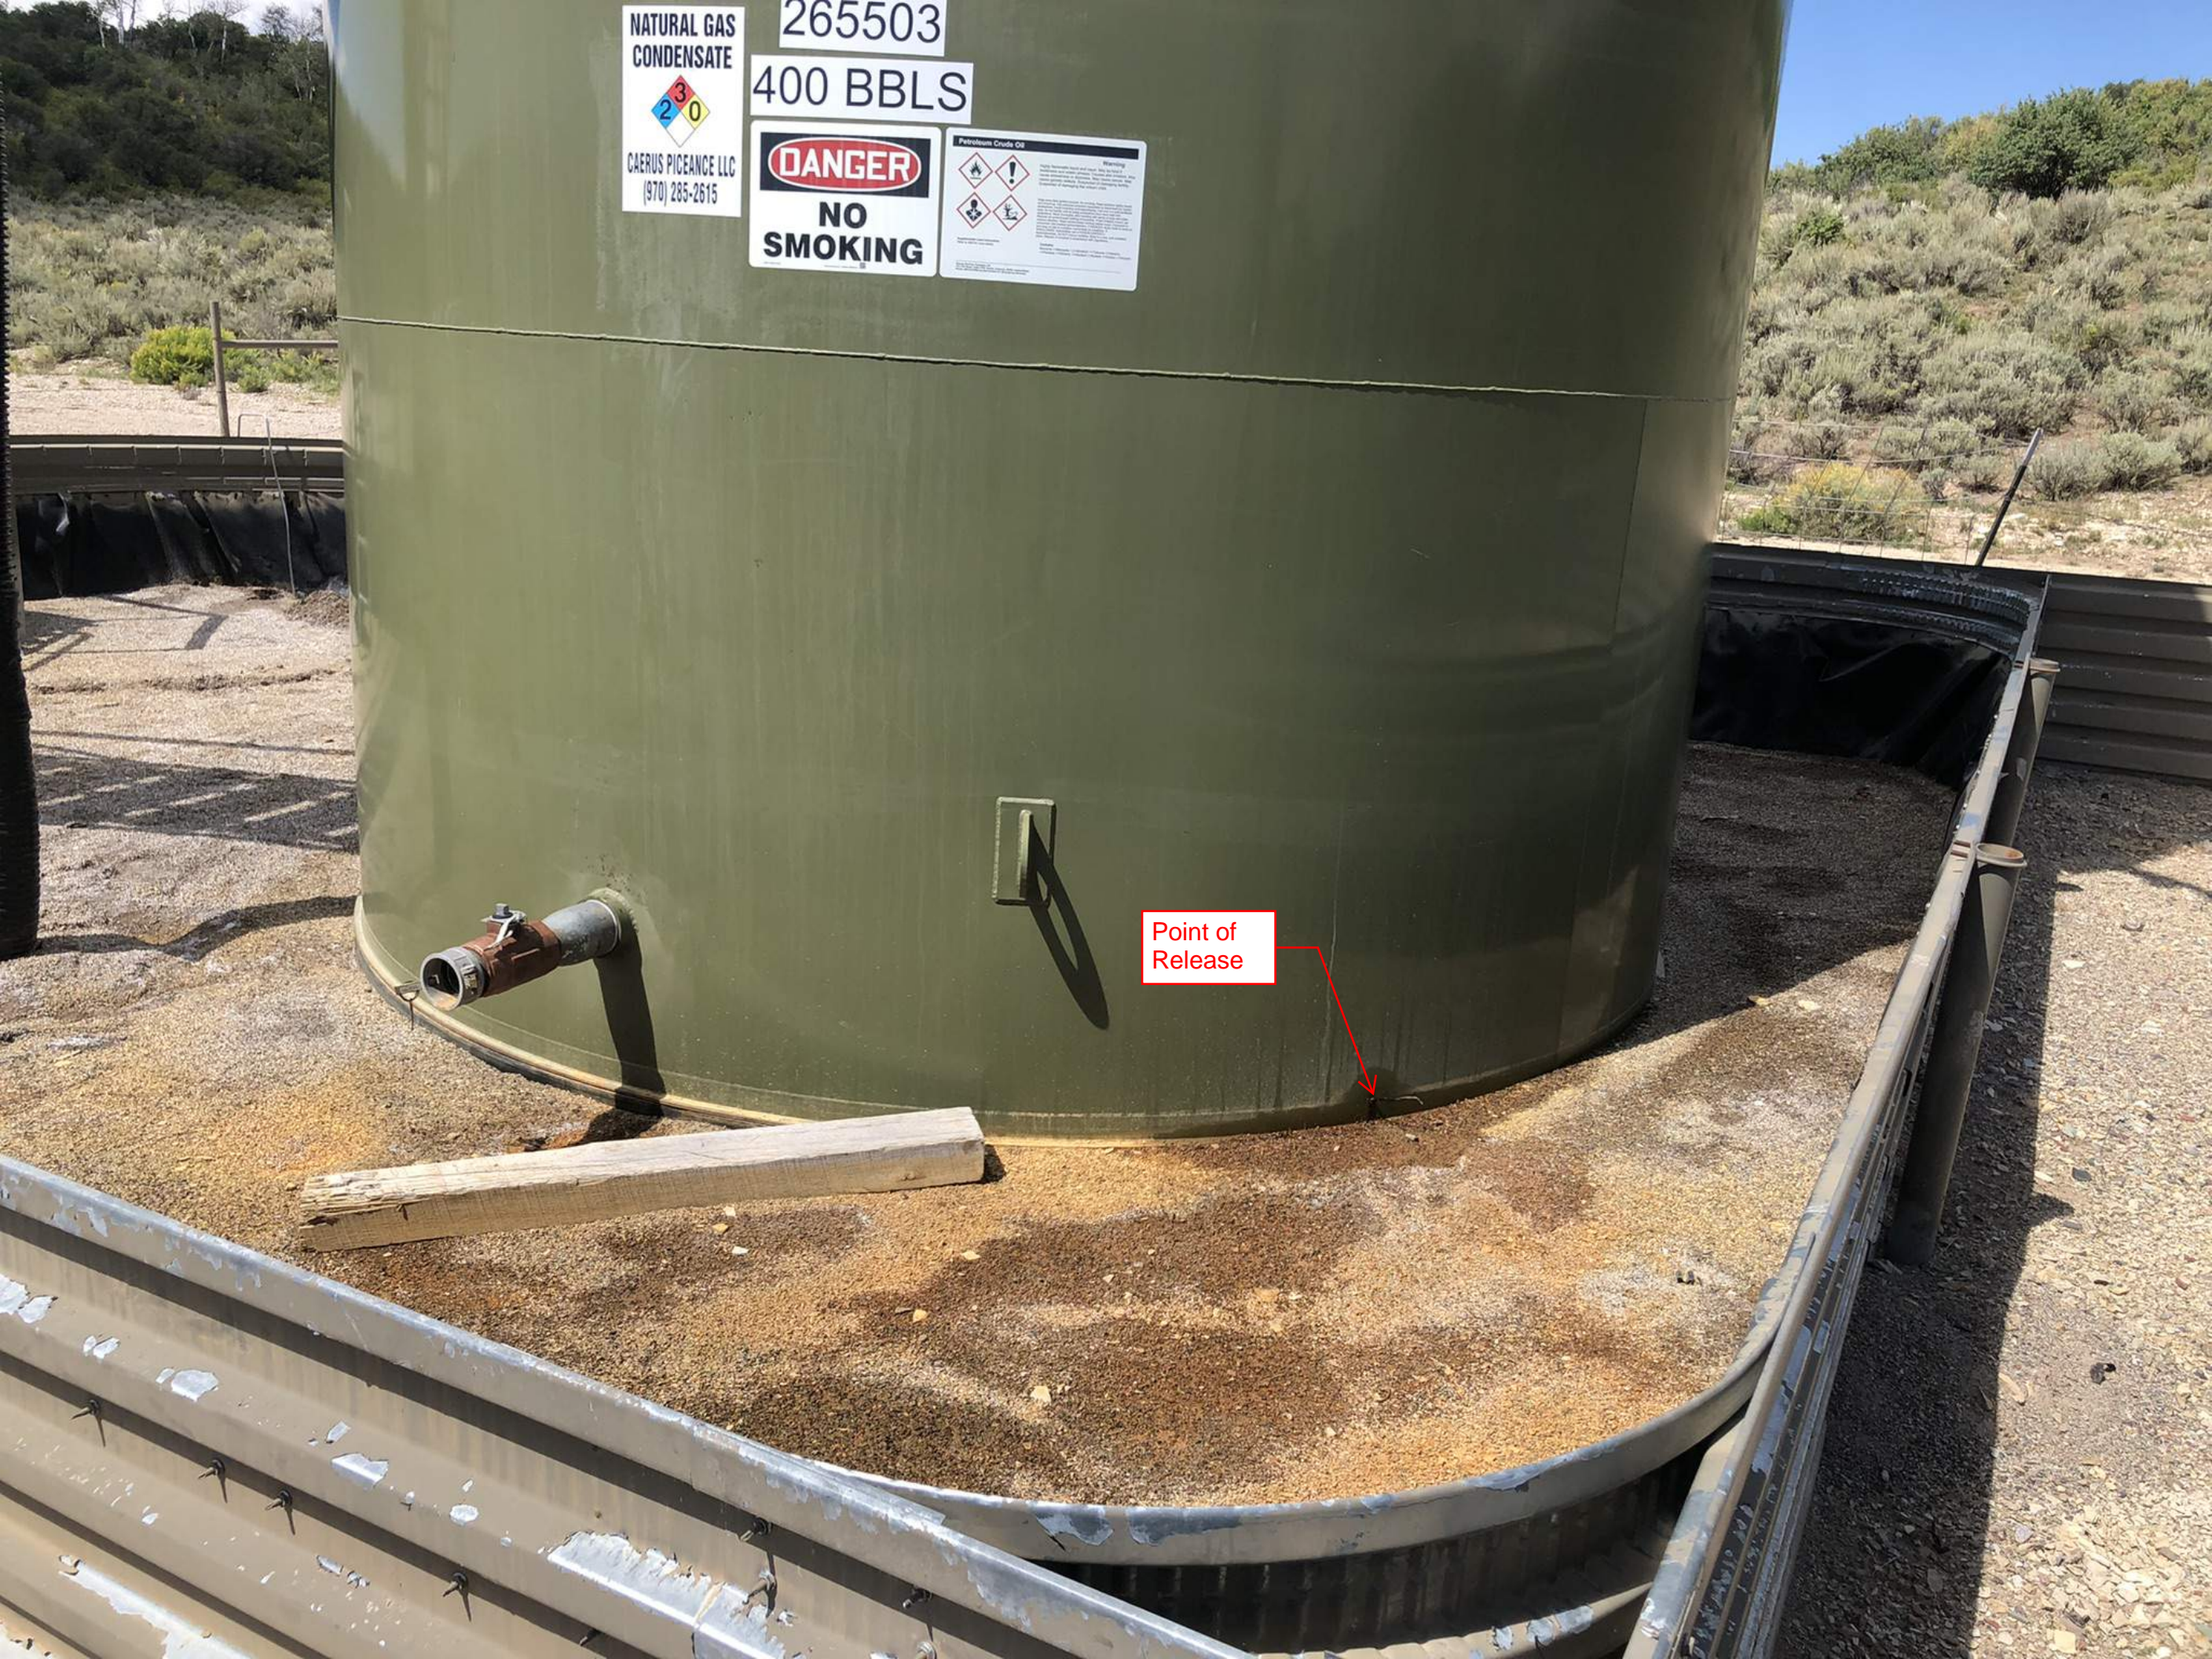
CEPC was contracted to conduct a liner inspection at the Site on August 31, 2022. Field observations indicated the containment is in good condition and no signs of damage to the liner were present throughout the entire containment. Additionally, no indications of impacts were observed outside the containment area.

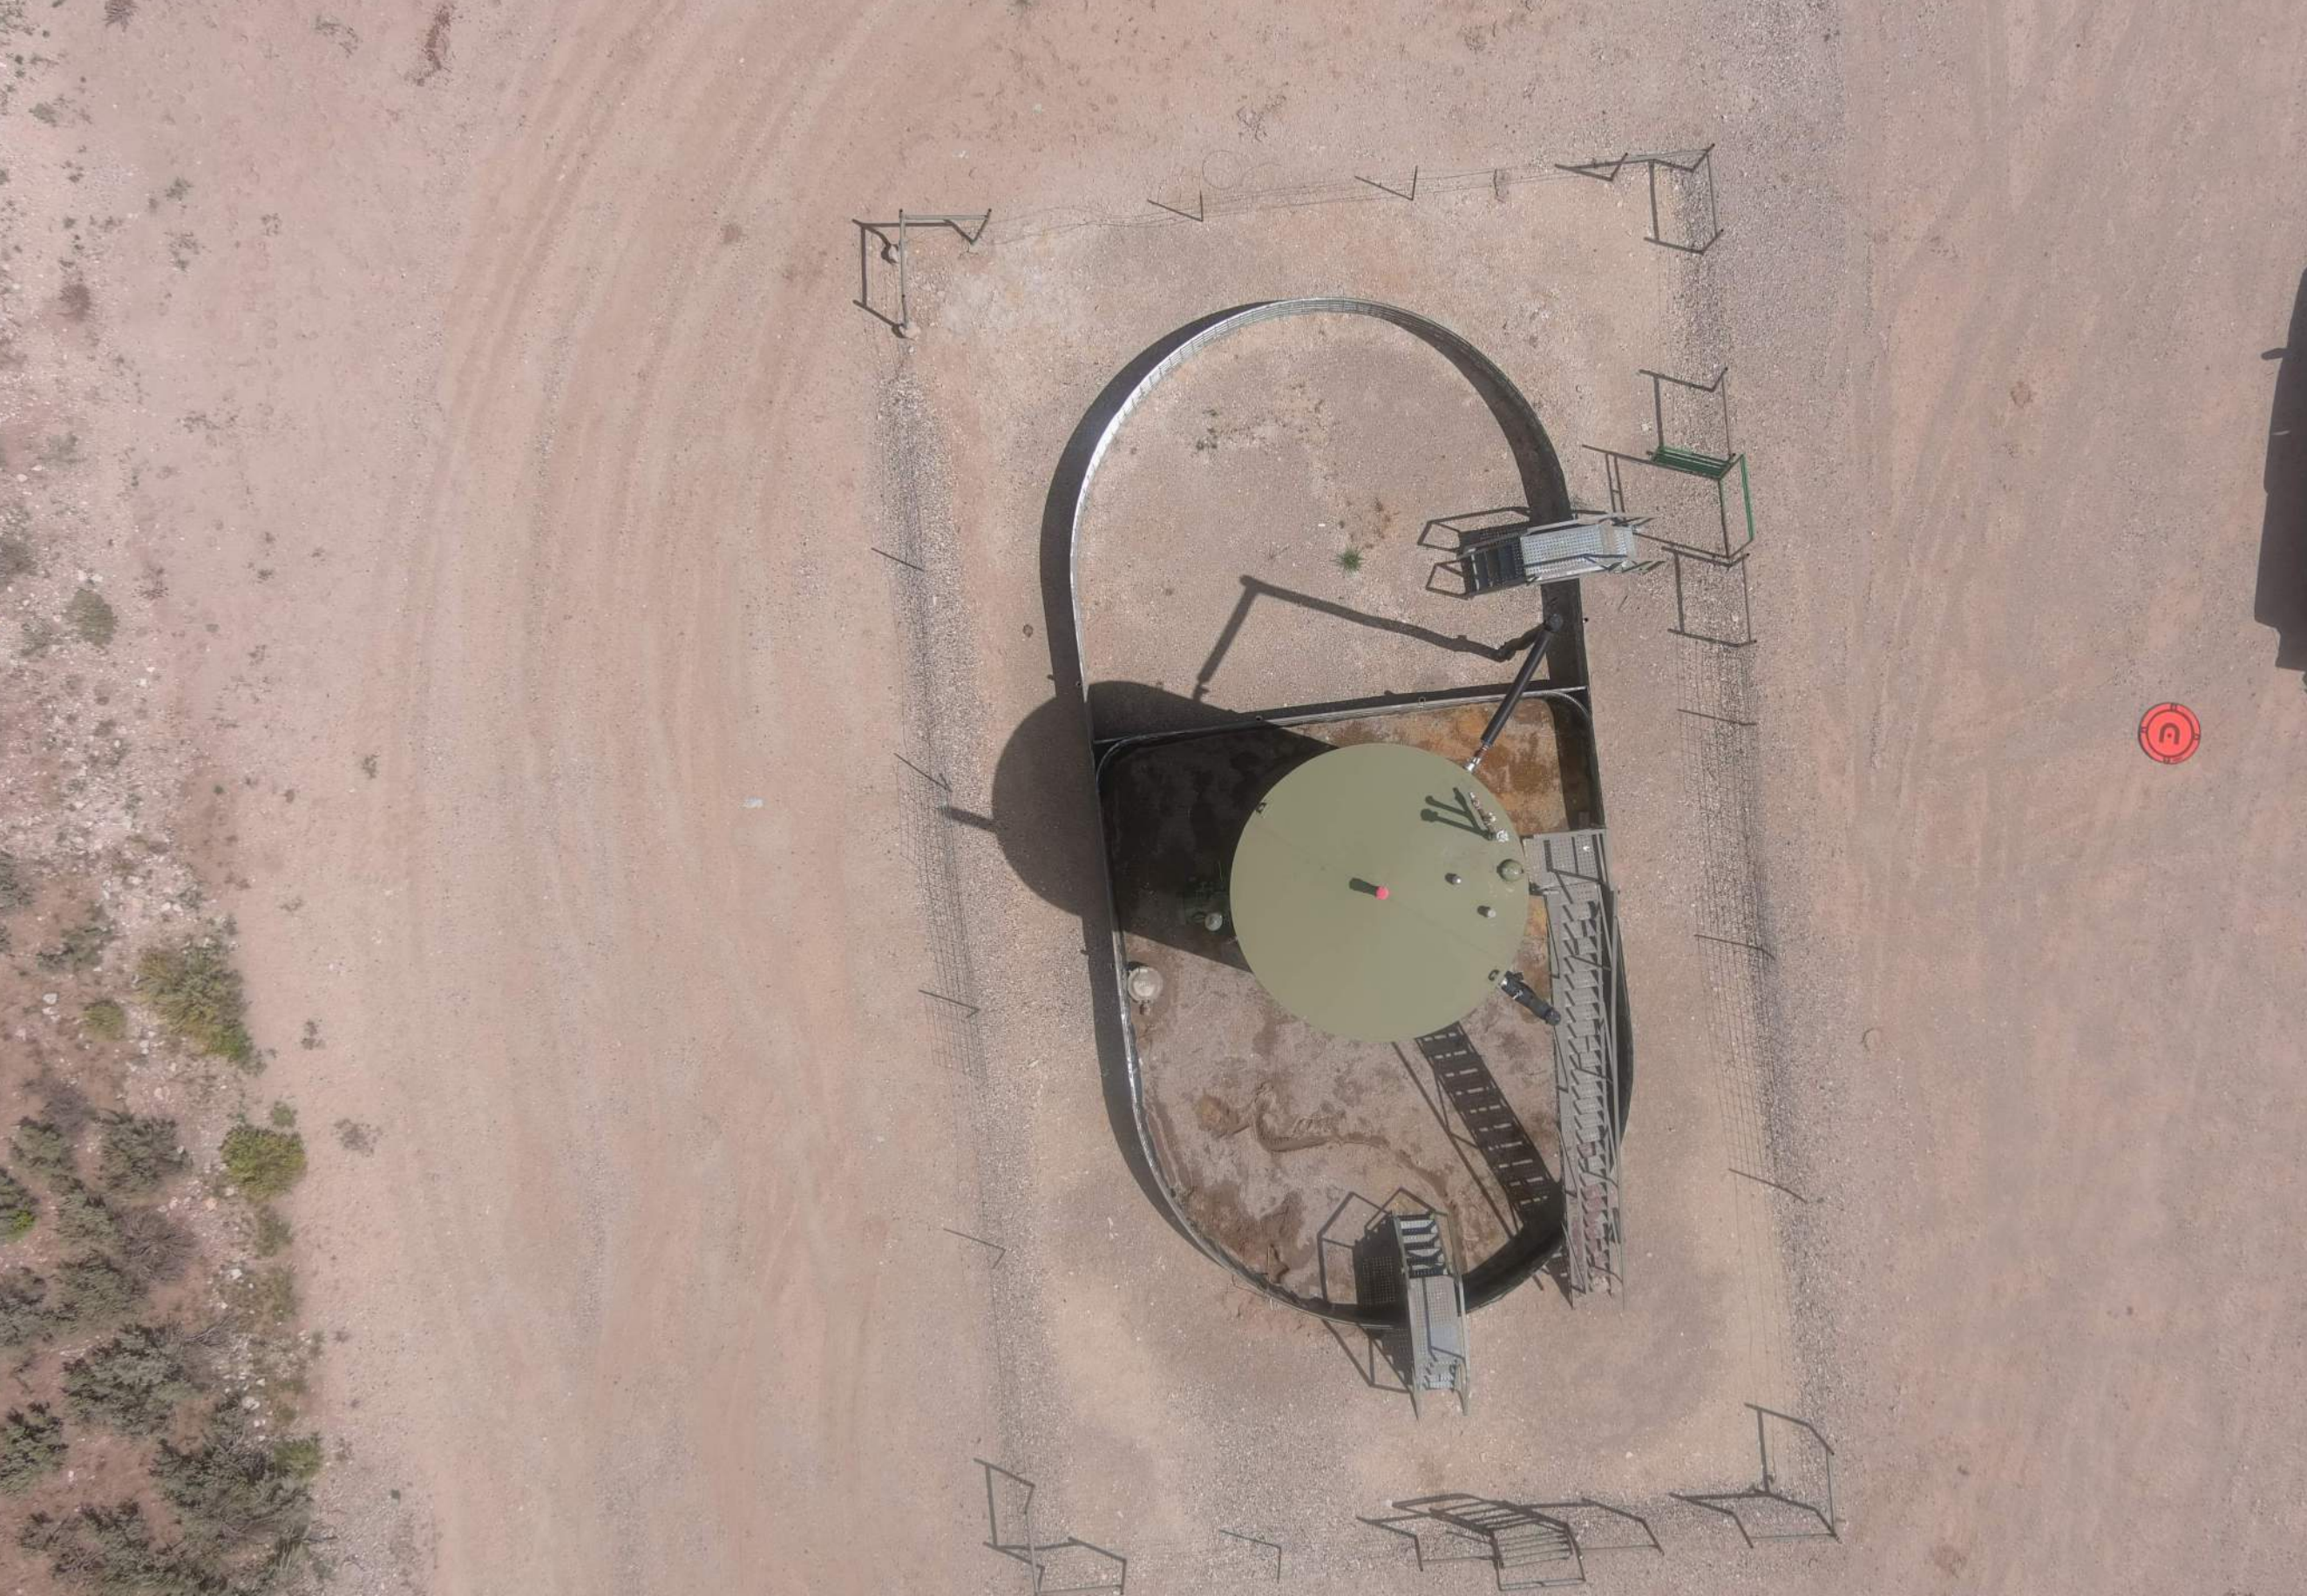
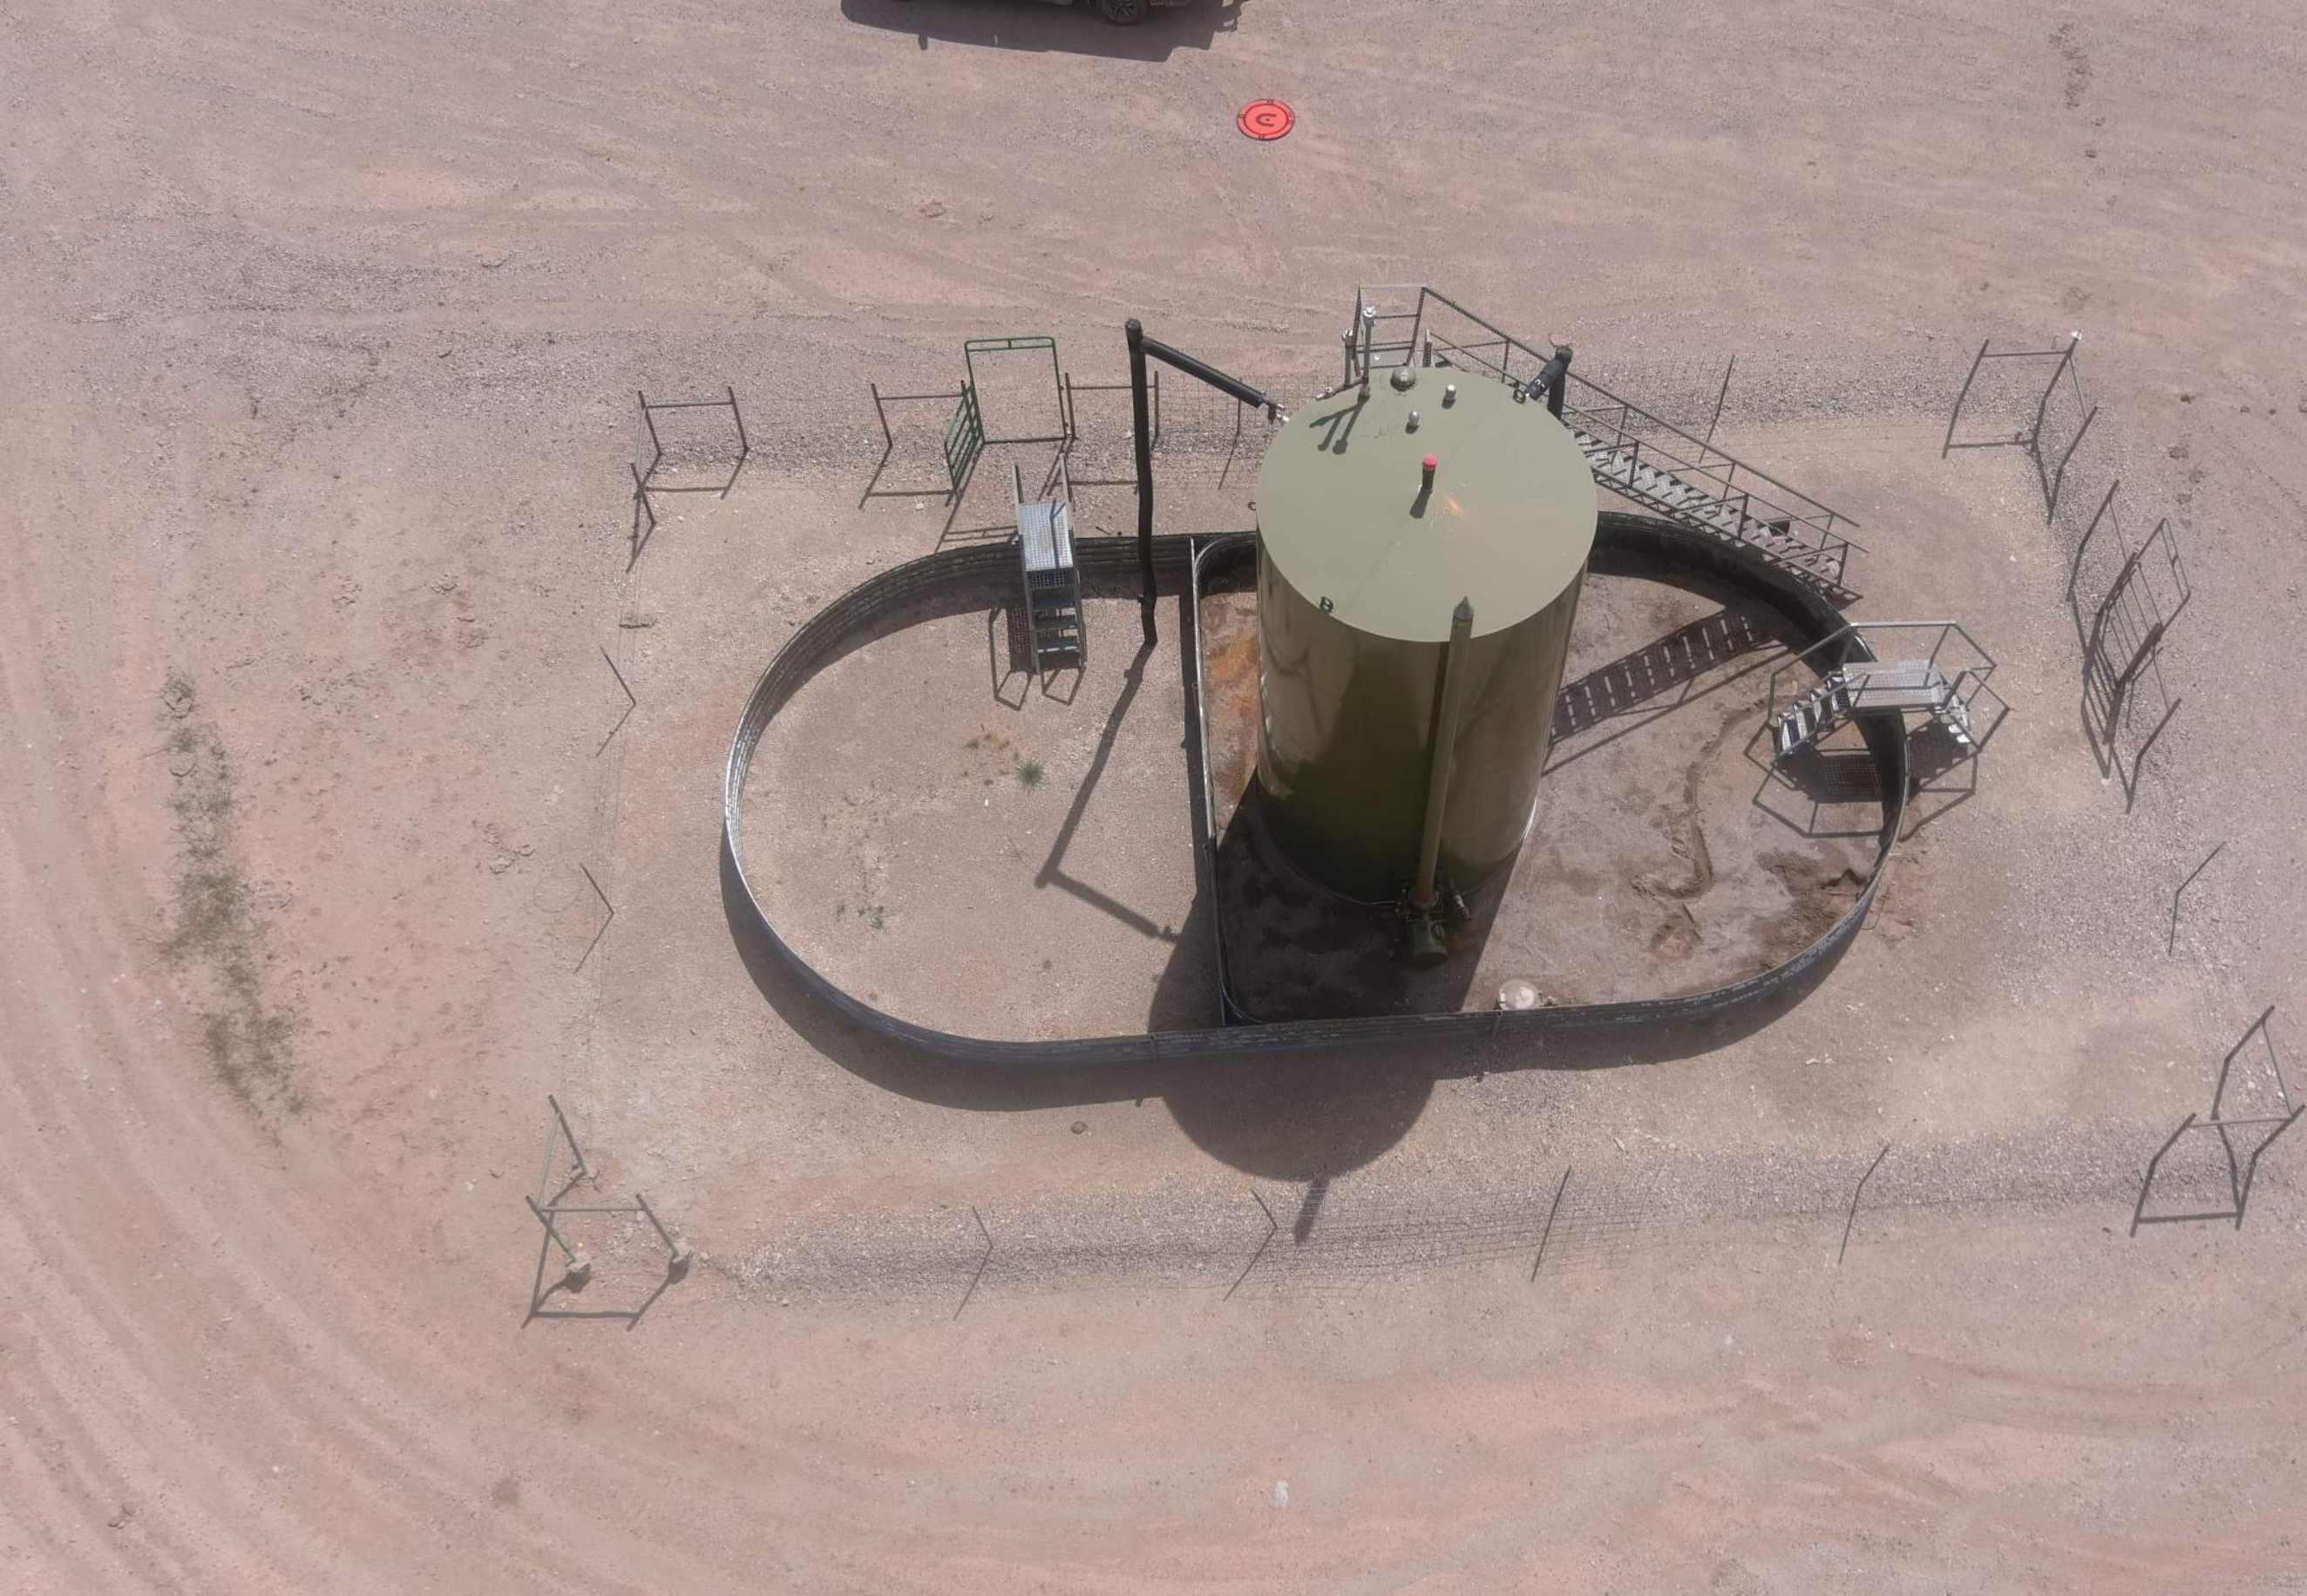
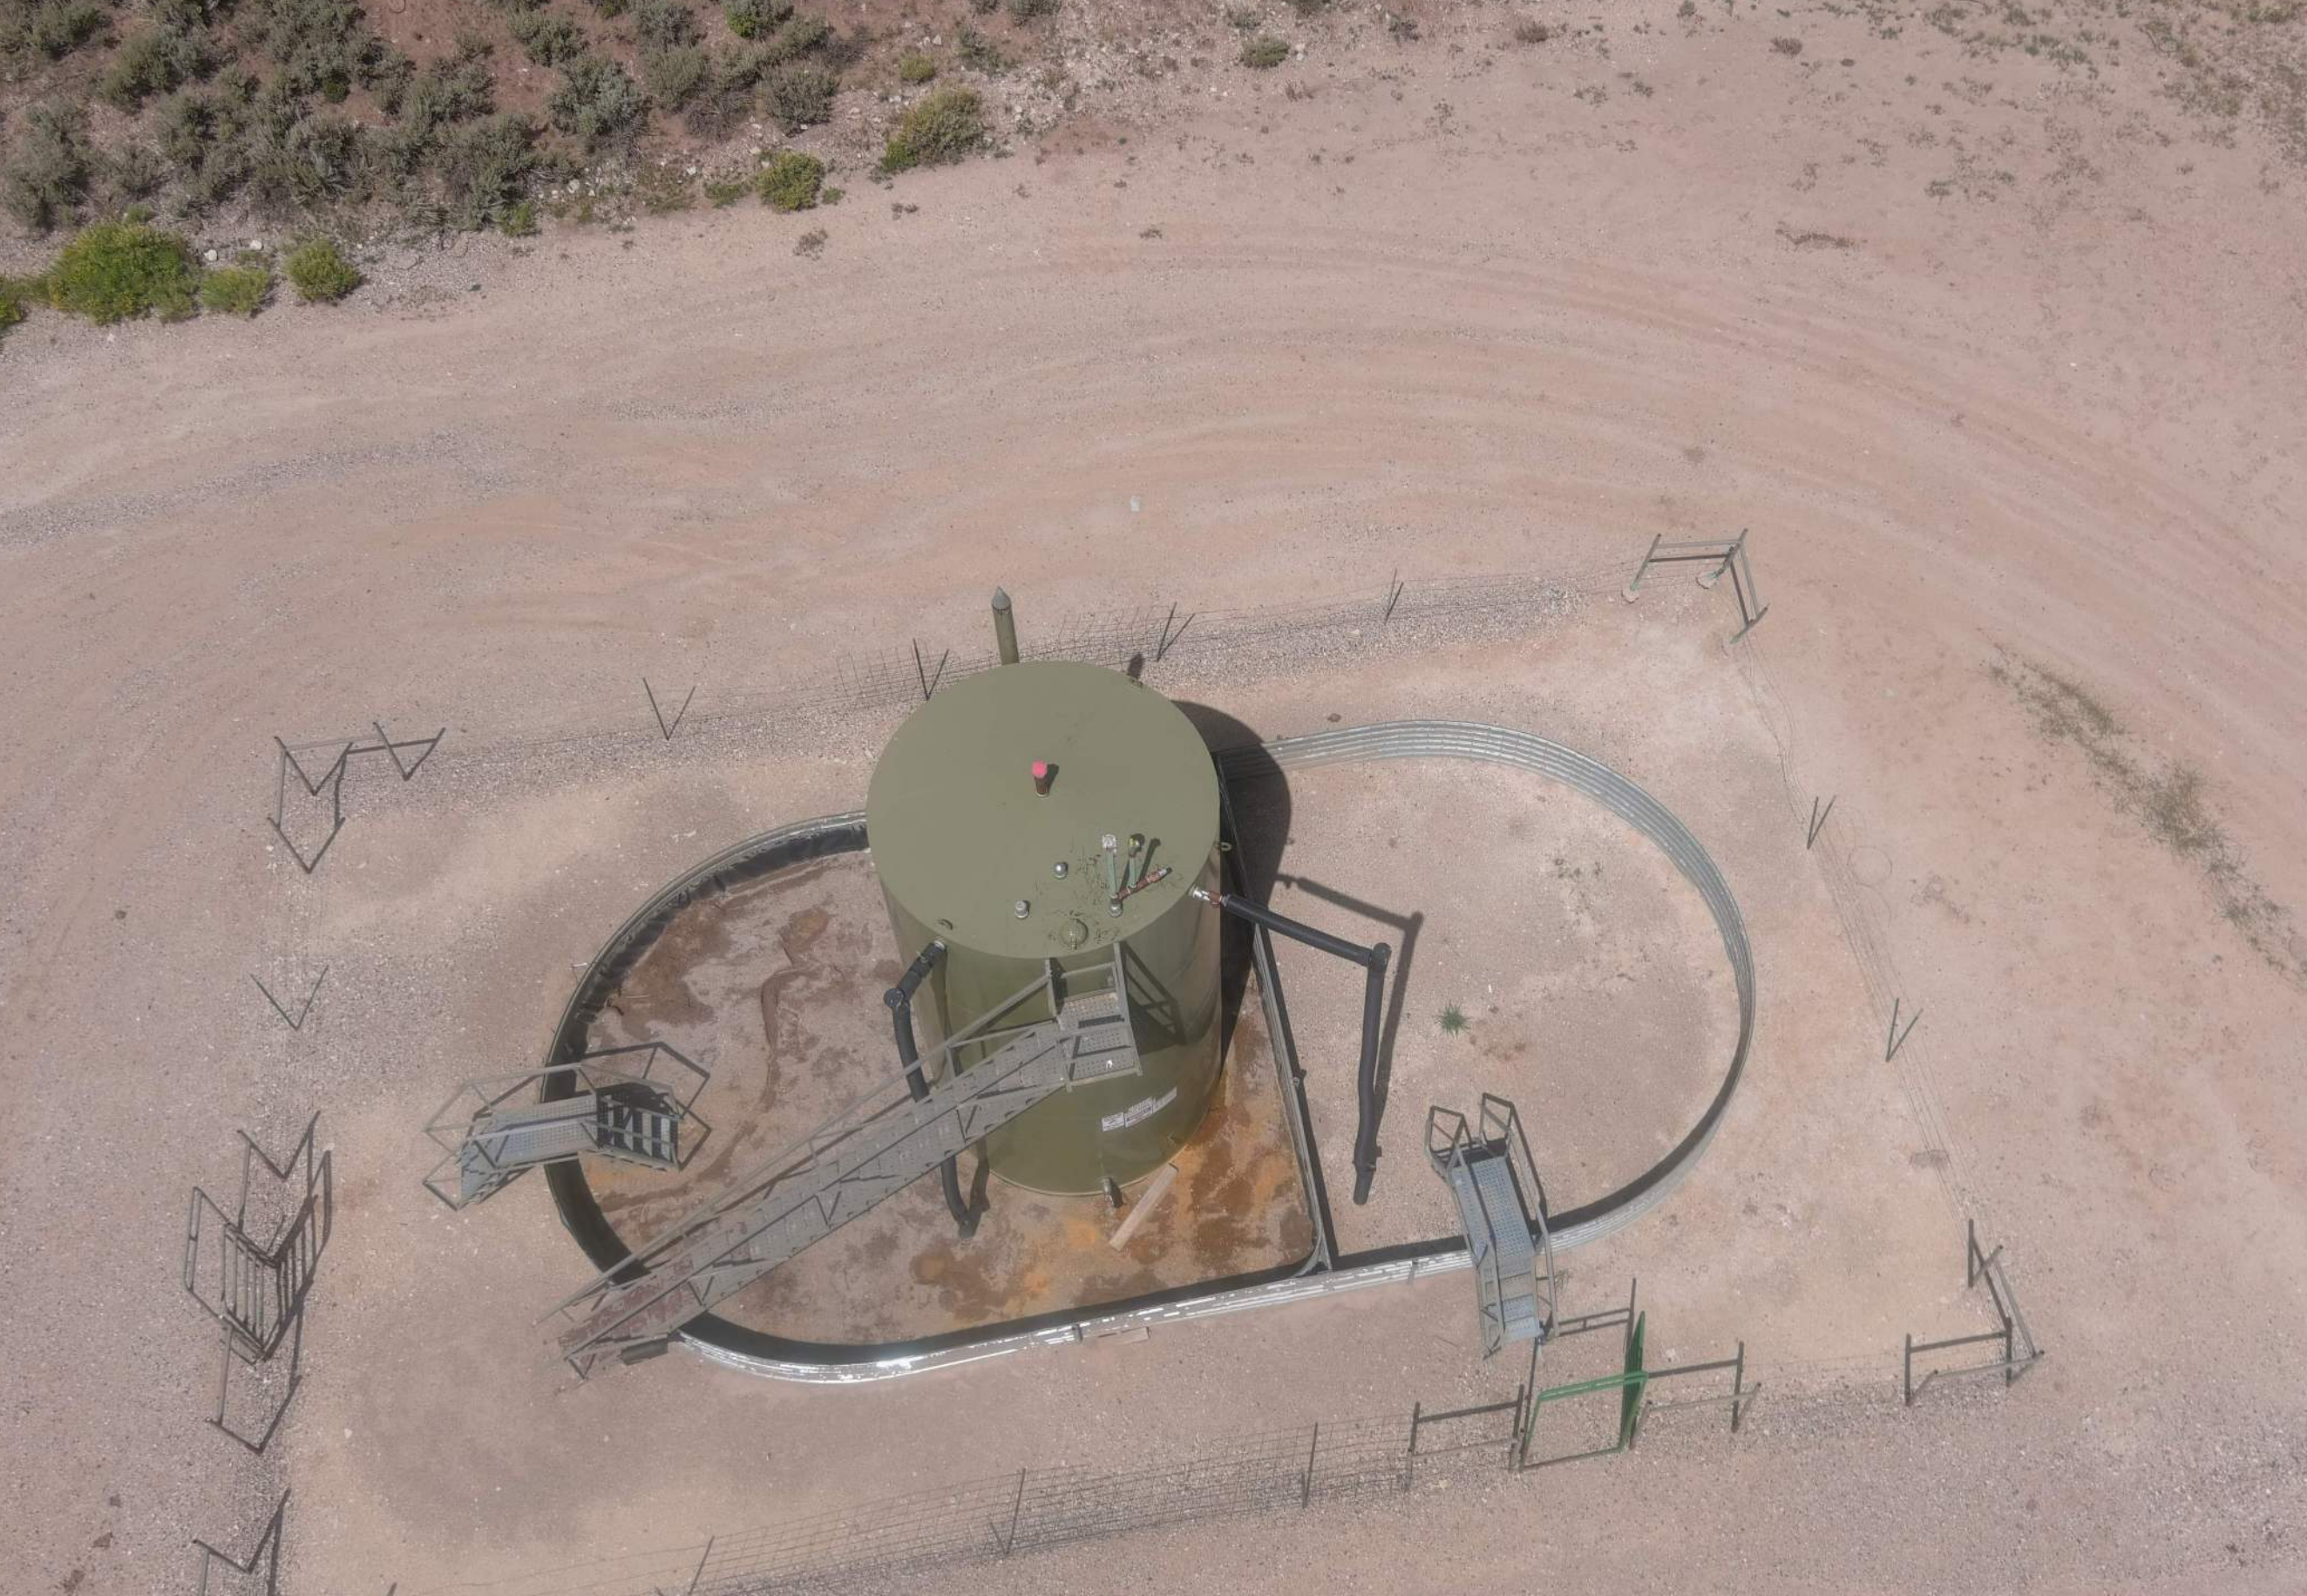
Location Mesa 22

- No observable staining outside of containment

- strong odor present / staining within containment
