Final Reclamation Inspection

Operator: PDC ENERGY INC - 69175

Location ID: 323641

Inspection Photos
Location Name: McCarty 28-6
Location ID: 323641

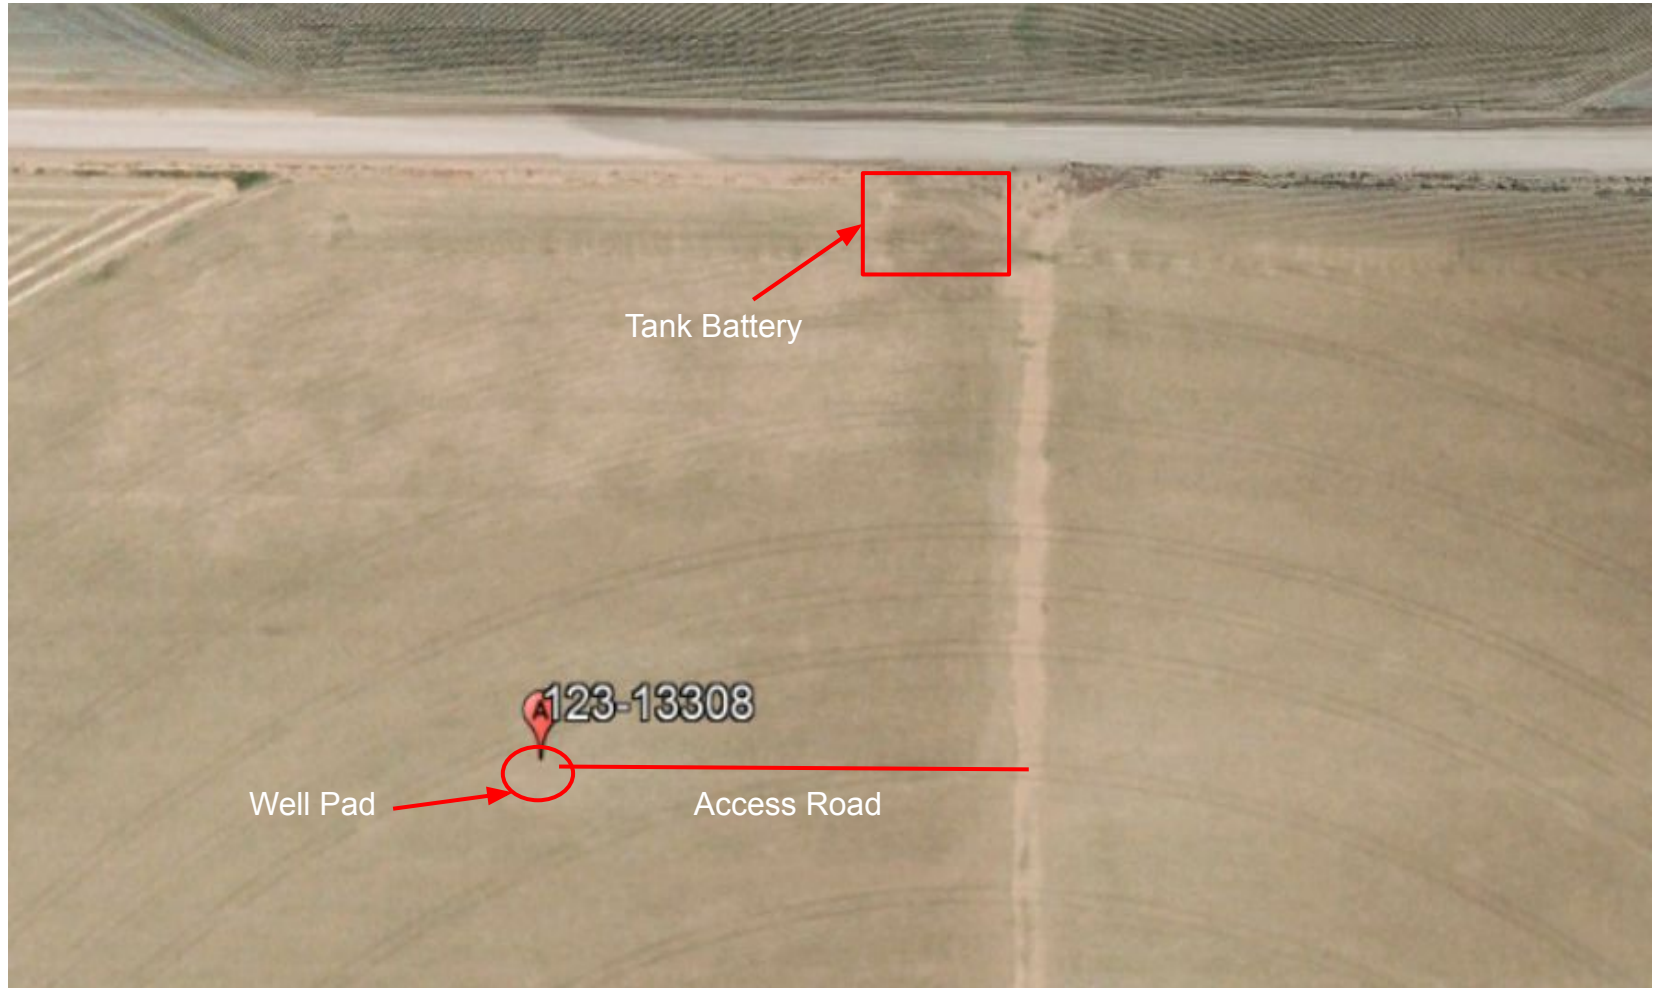
Photo 1. 2021 aerial imagery of the well pad, access road and tank battery.

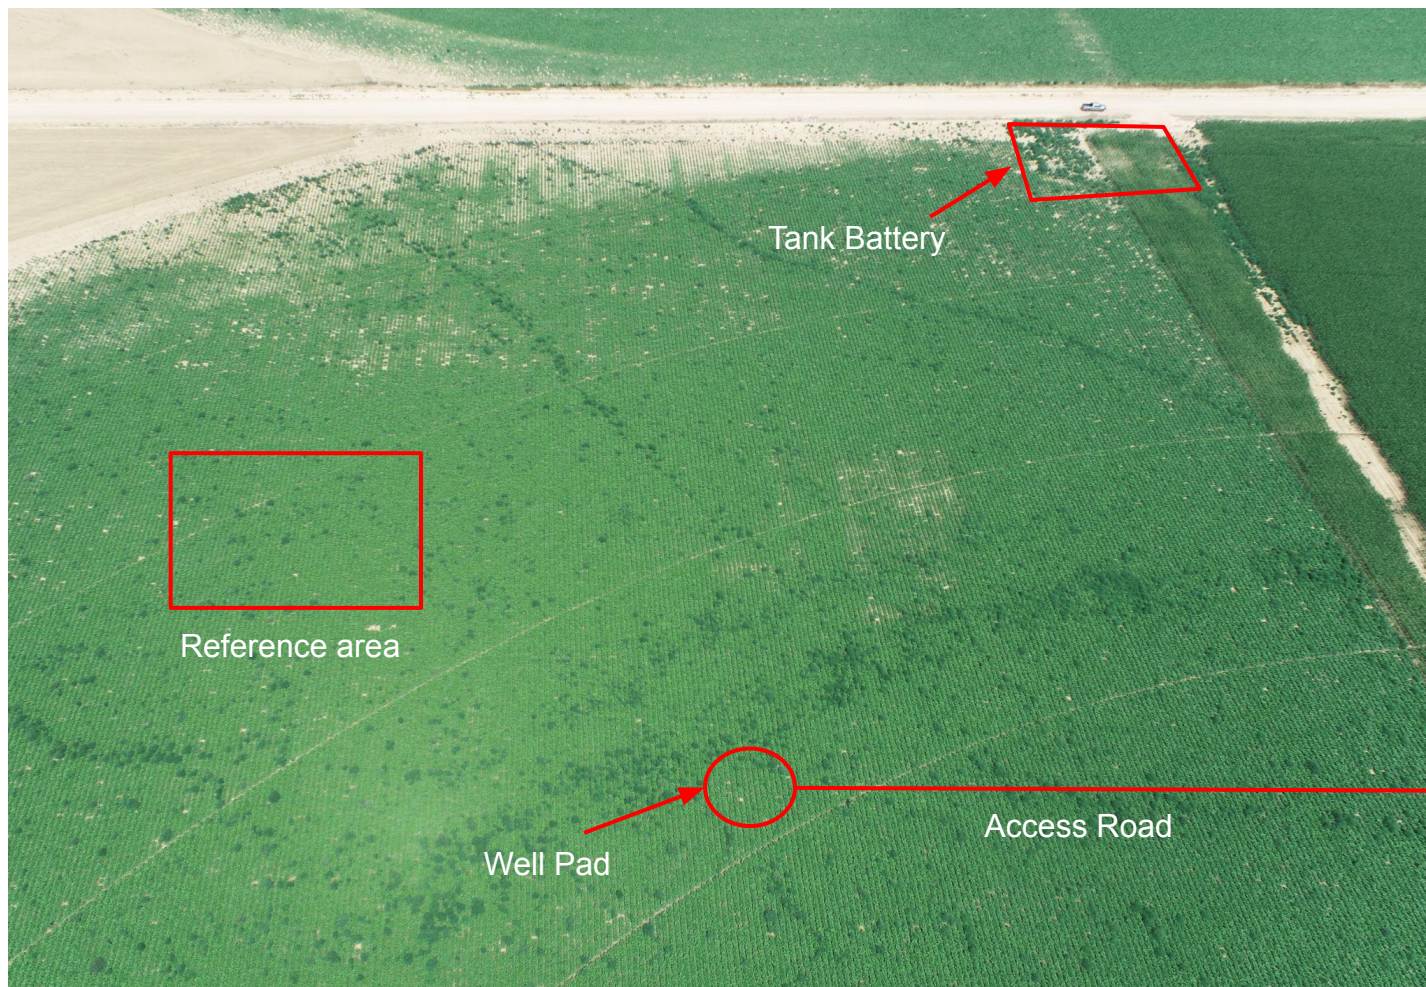
Photo 2. Overview photo of the well pad, access road, tank battery and reference area taken with a drone. Note: well pad and access road appear consistent with the adjacent reference area. Well pad falls within a crop field with kochia interspersed.

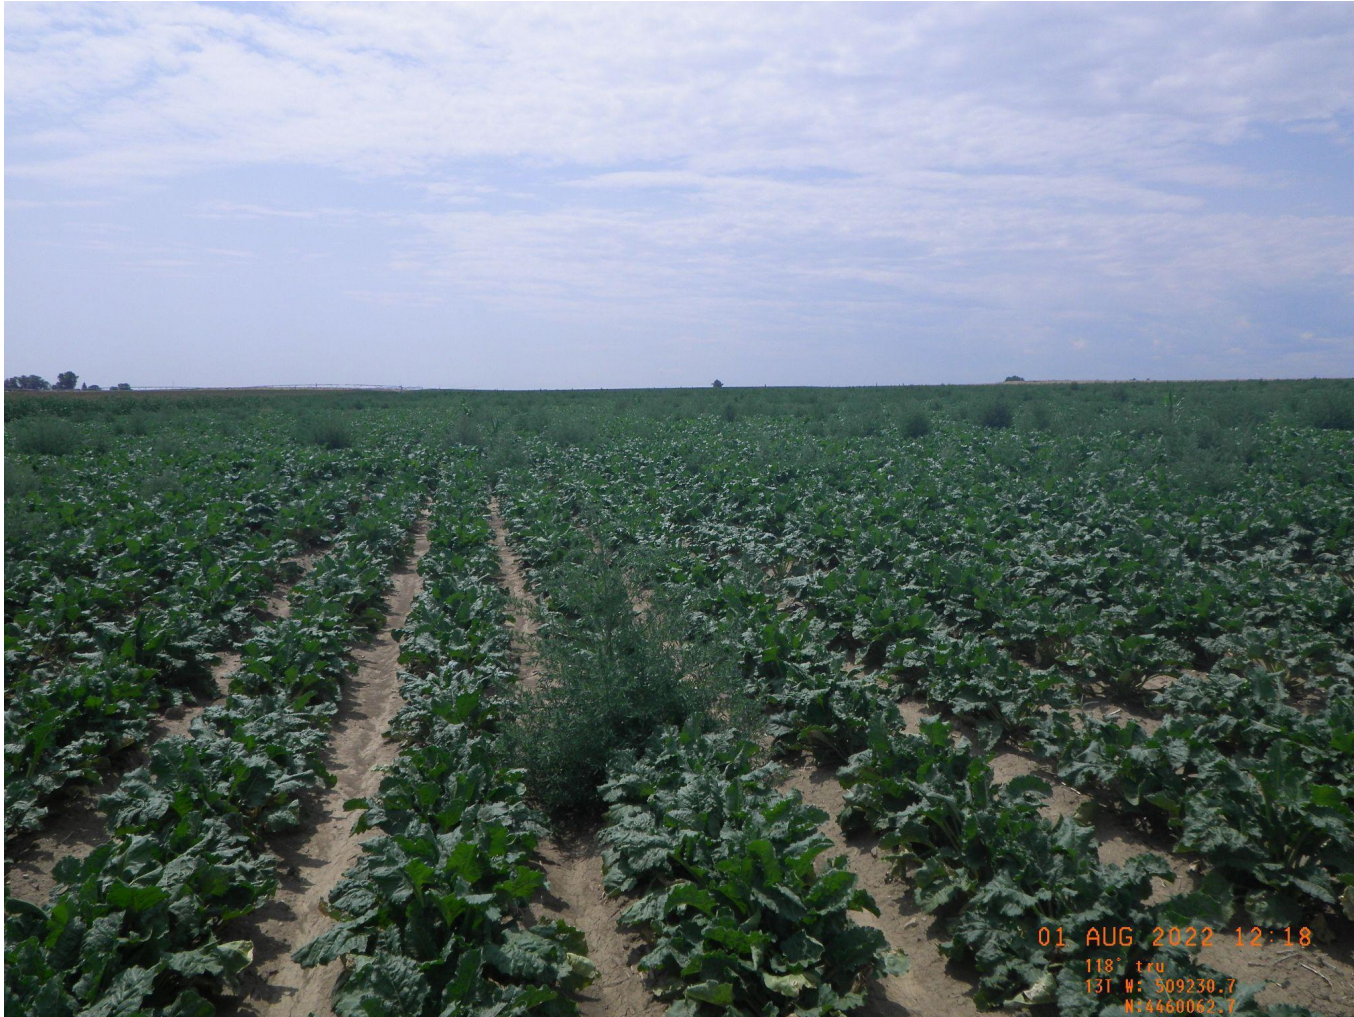
Photo 3. Overview photo of well pad crop field.

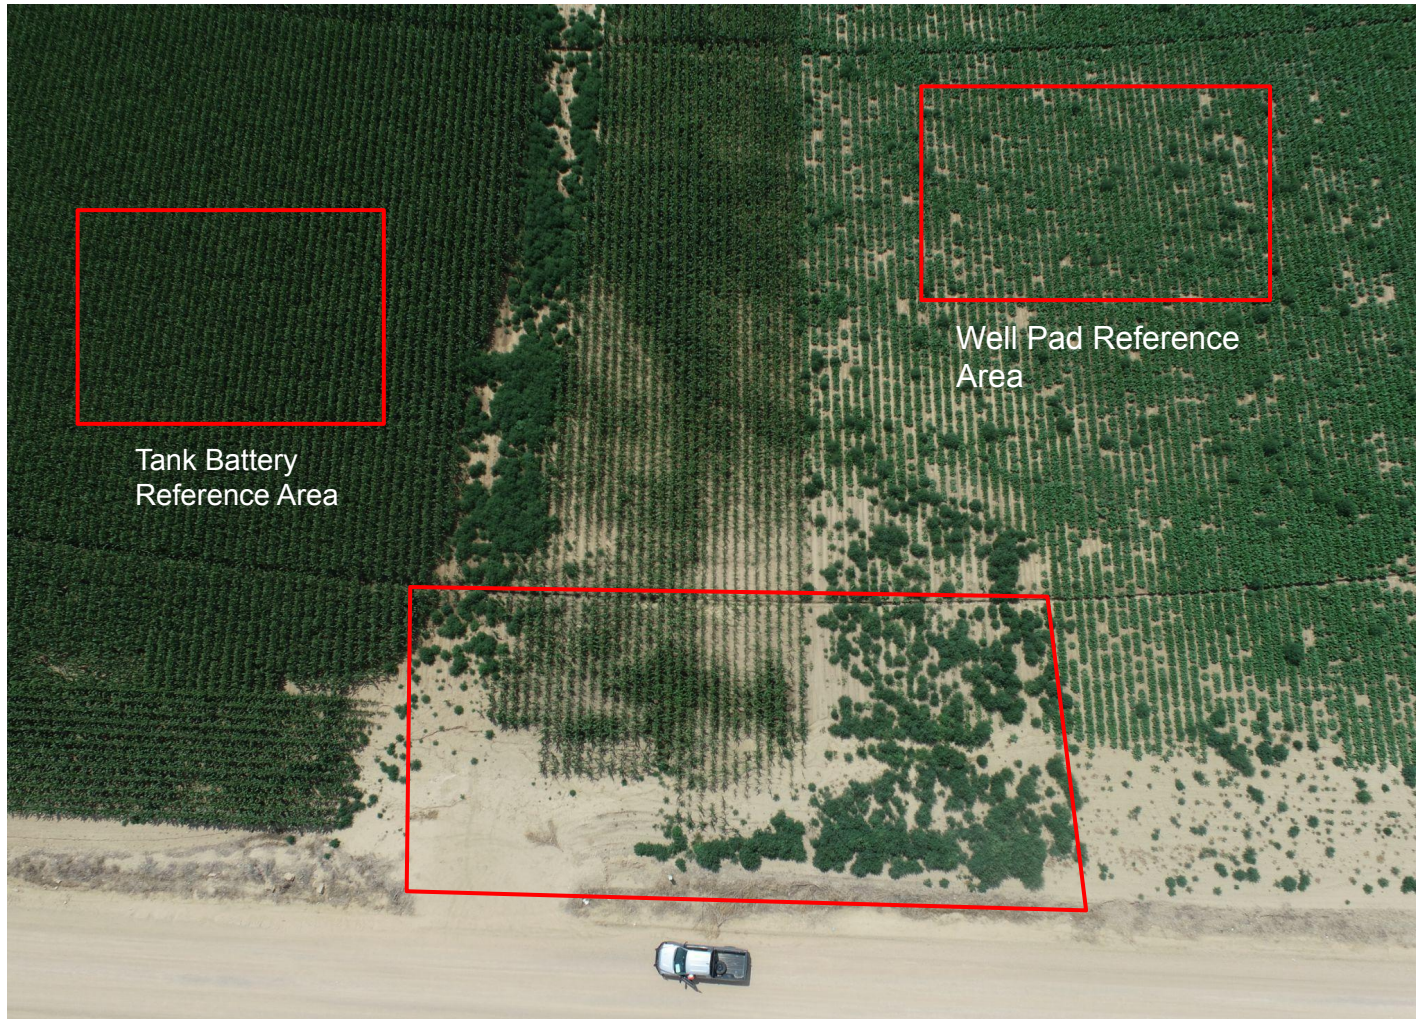
Photo 4. Overview photo of the tank battery and reference areas taken with a drone from northern edge facing south. Note: eastern edge of the tank battery has been planted with corn while the western edge is dominated by kochia. Corn section of tank battery appears stunted and kochia on western edge appears to be at a higher density than adjacent field.

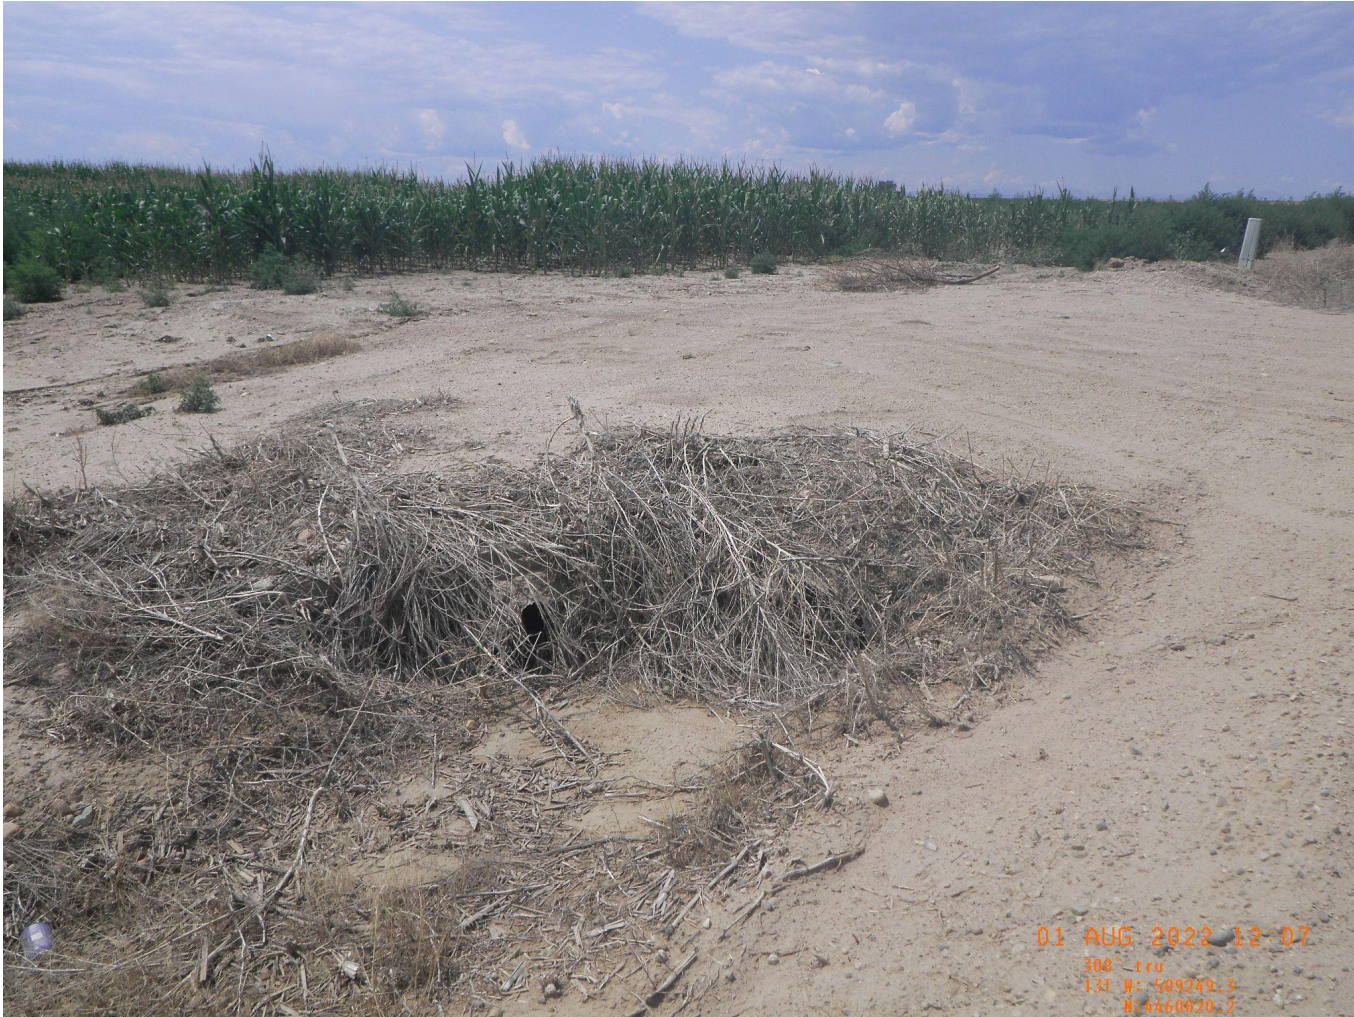
Photo 5. Photo of the access point and culvert located at the northern edge of the tank battery. Access and culvert fall under variance doc #220200025.
