Final Reclamation Inspection

Operator: PDC ENERGY INC - 69175

Location ID: 322556

Inspection Photos
Location Name: Koehler Frank 13-27
Location ID: 322556

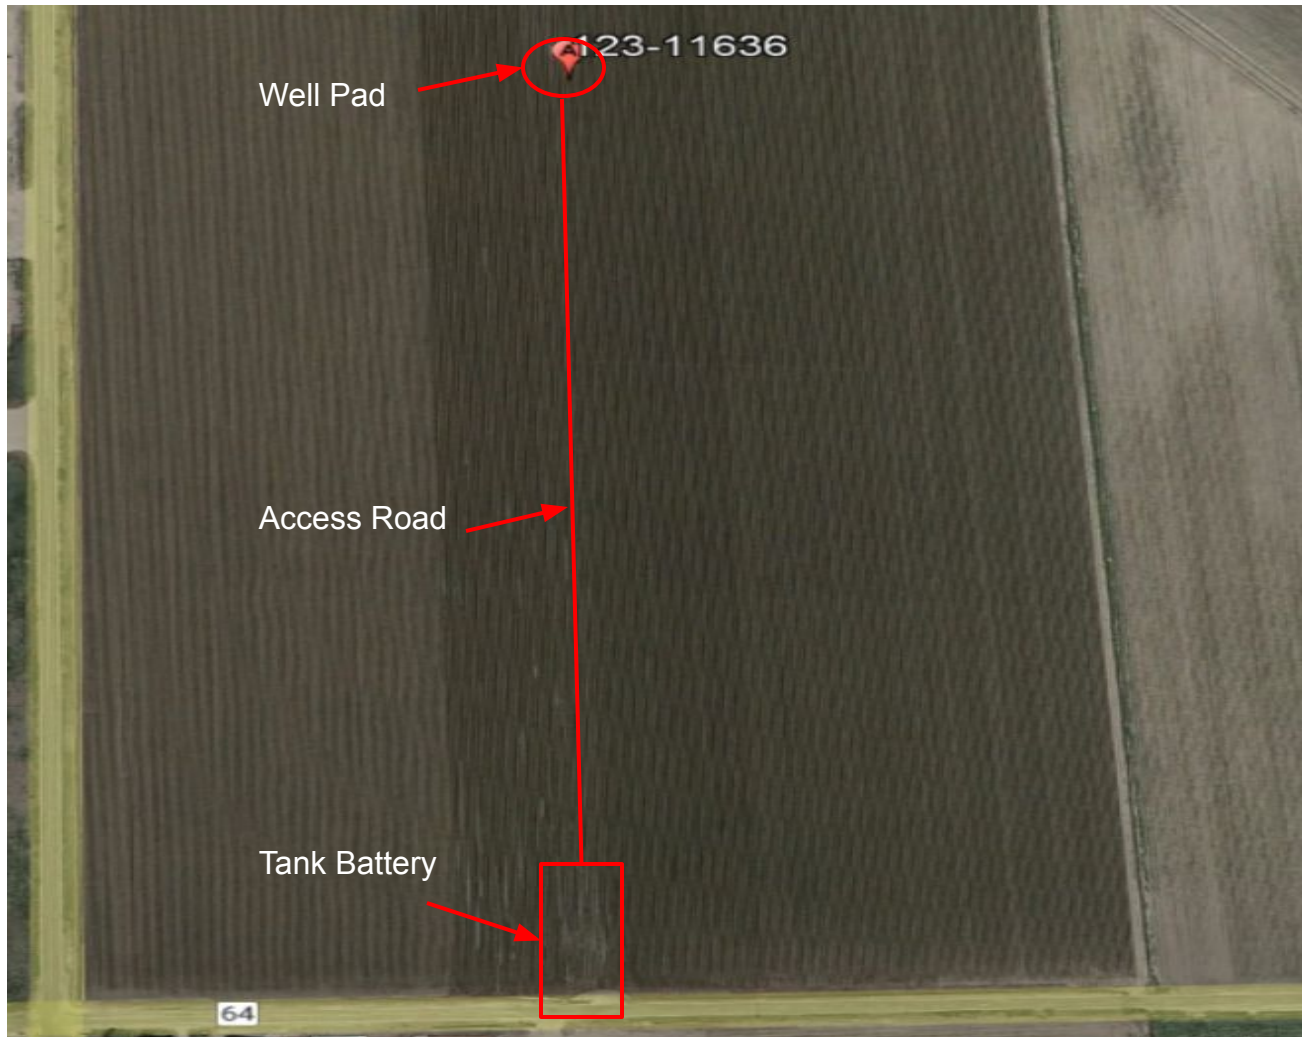
Photo 1. 2021 aerial imagery of the well pad, tank battery and access road.

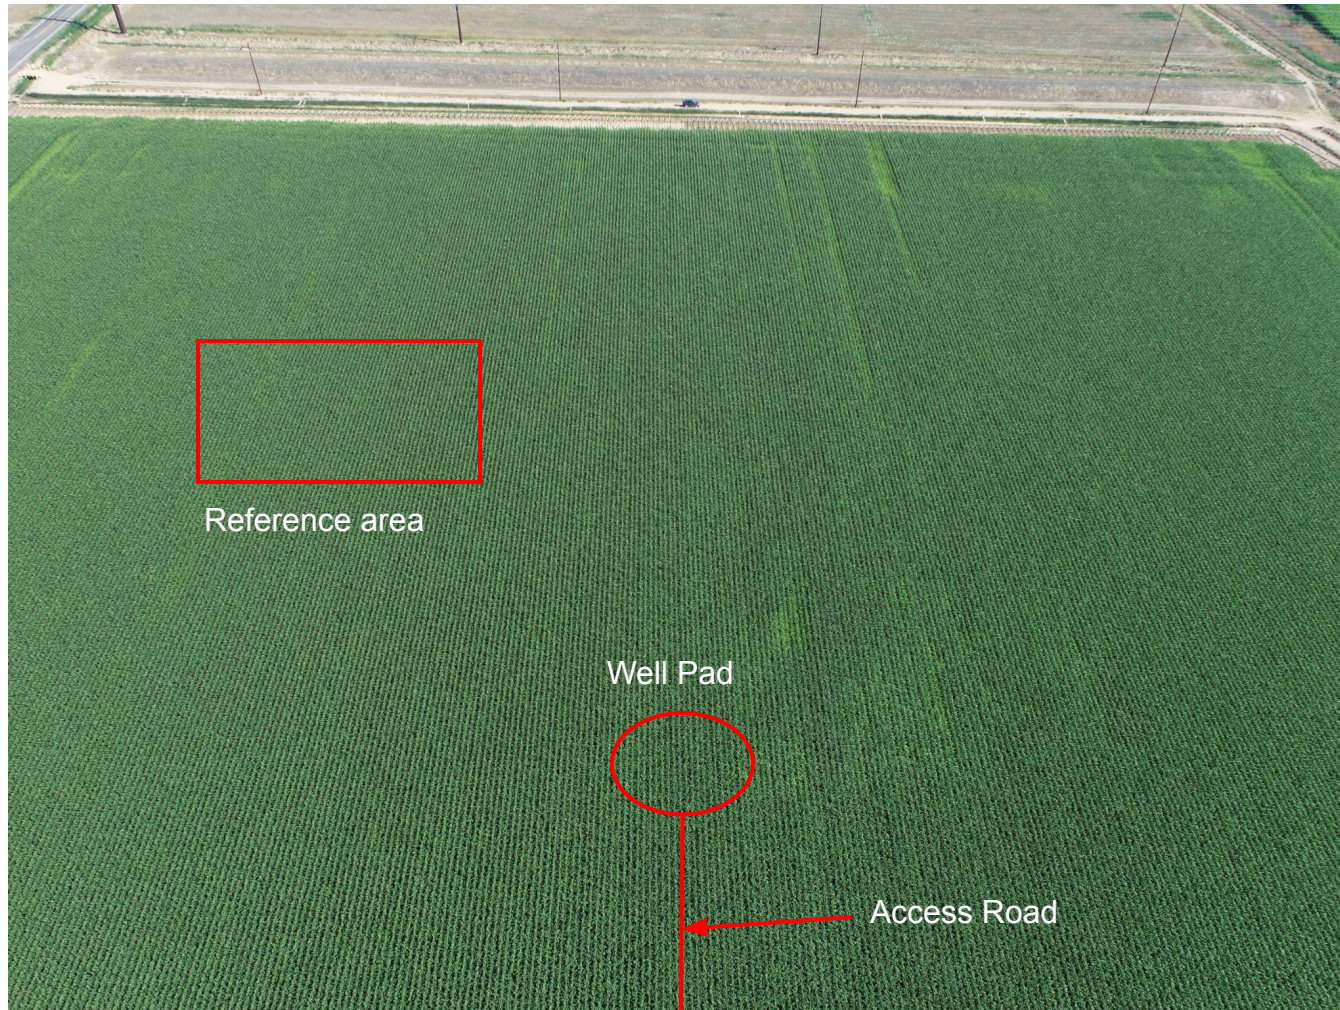
Photo 2. Overview photo of the well pad, access road and reference area taken from the southern edge facing north using a drone. Note: well pad and access road appear consistent with adjacent crop reference area.

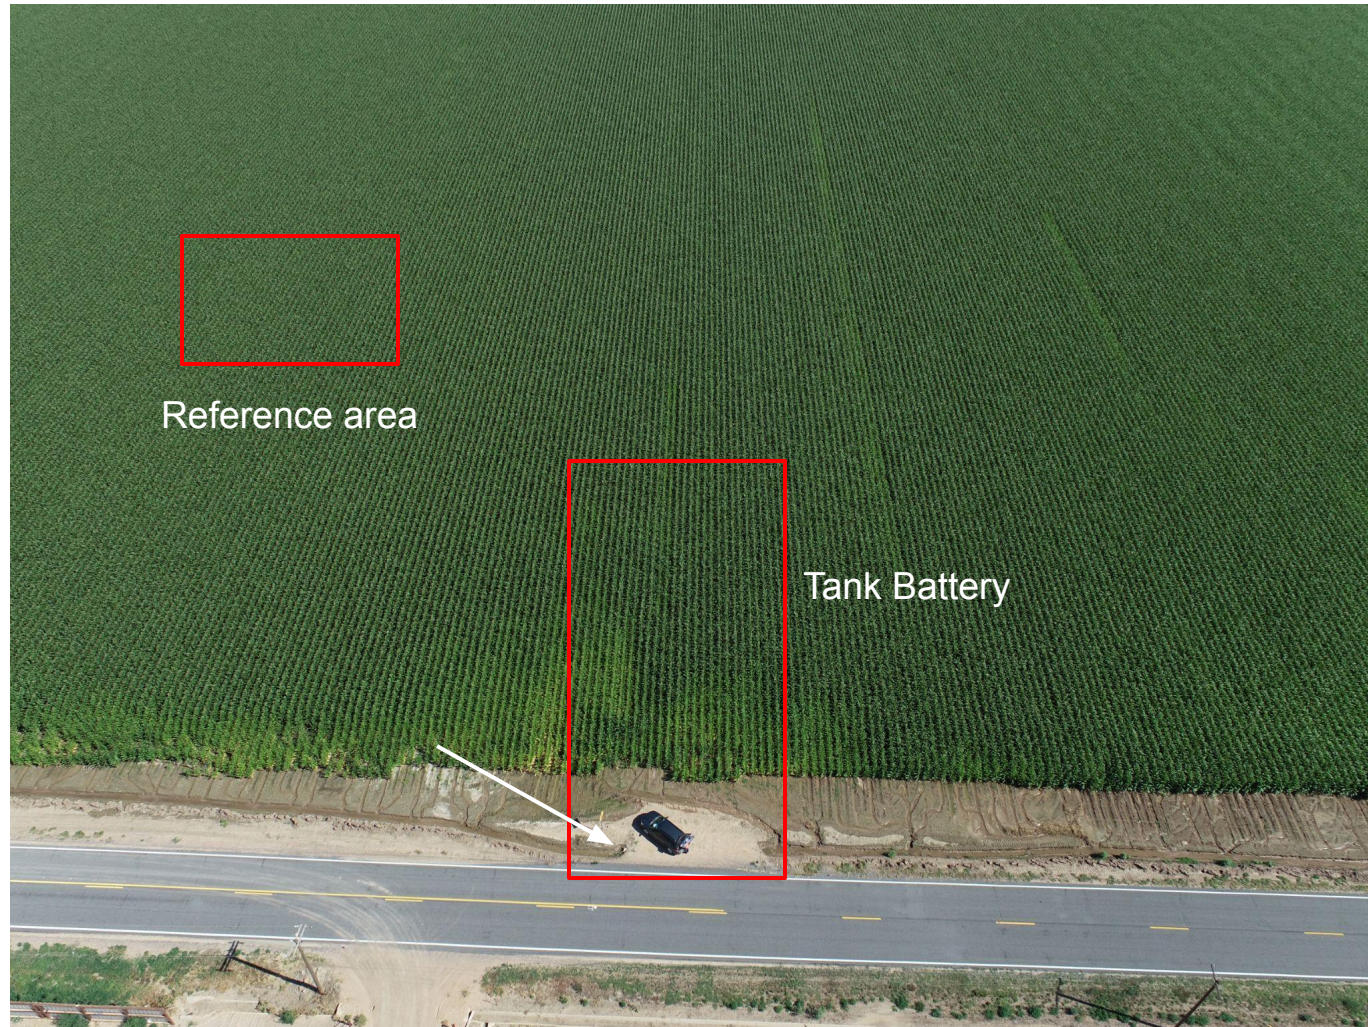
Photo 3. Overview photo of the tank battery and reference area. Note: tank battery access remains with a culvert indicated by white arrow (see photo 4). Remaining tank battery disturbance appears consistent with adjacent crop reference area.

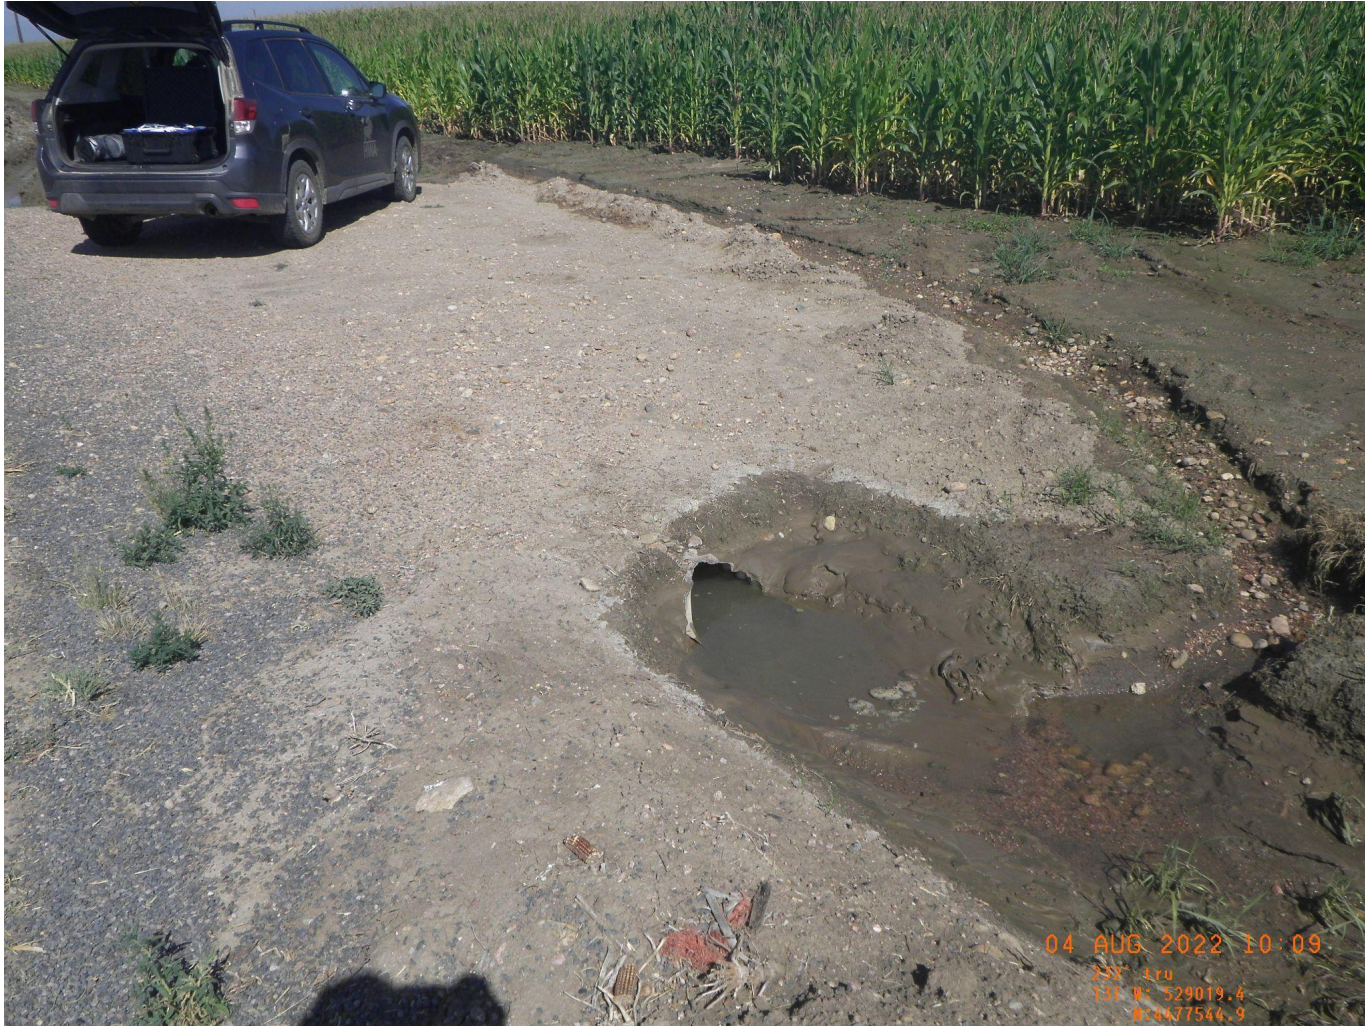
Photo 3. Ground photo of the tank battery access point and culvert that remain on site.
