Inspection Photos

API: 011-06072

Operator: STRACHAN EXPLORATION INC

Inspection Date: 10/11/2022

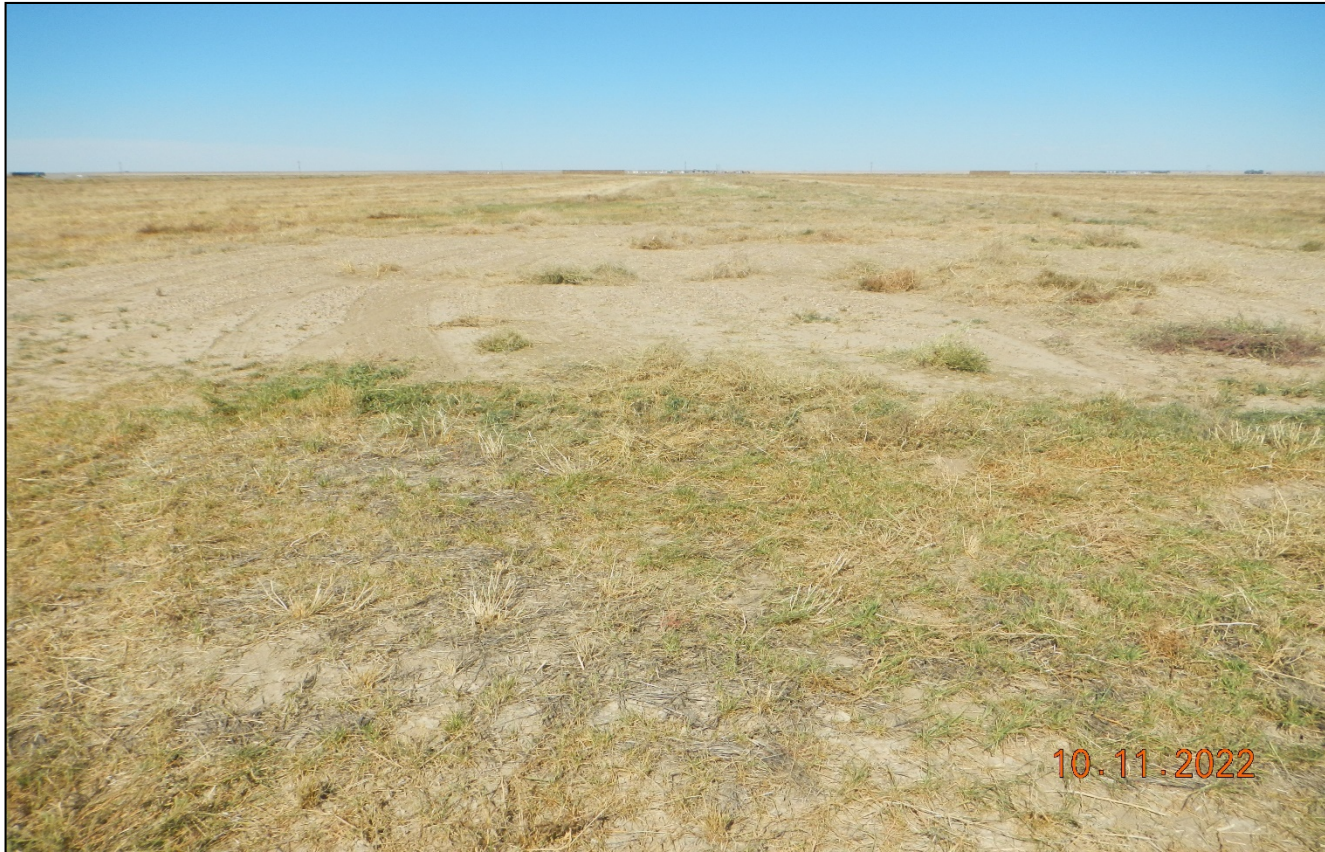
Photo 1. Facing north toward the location. There is an area approximately 150'x100' with no vegetation growth. The surrounding field does not have a crop planted but has vegetation growth. There are likely soil issues that is impact growth of vegetation.

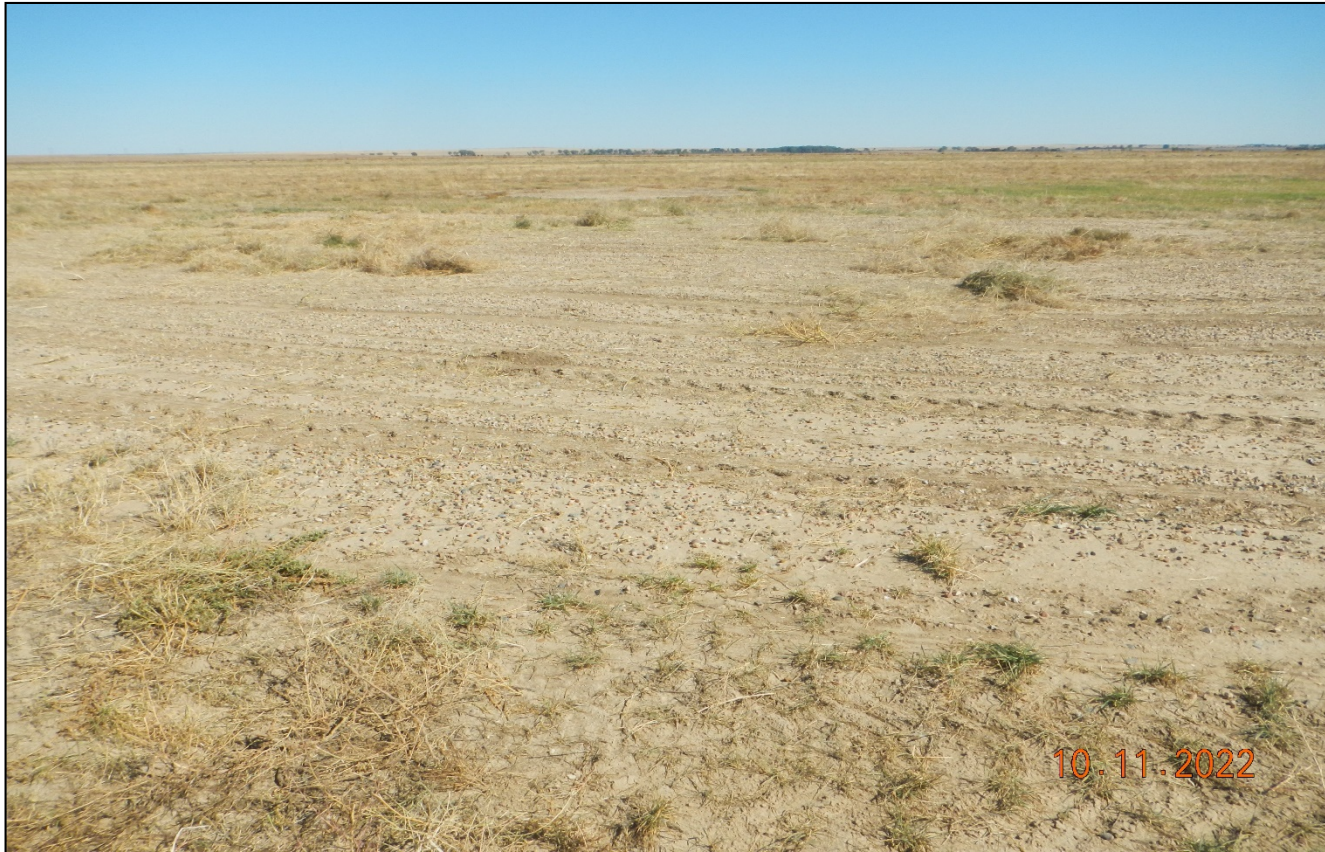
Photo 2. Facing north at the location. There is an area approximately 150'x100' with no vegetation growth. The surrounding field does not have a crop planted but has vegetation growth. Previous corrective action was not completed.

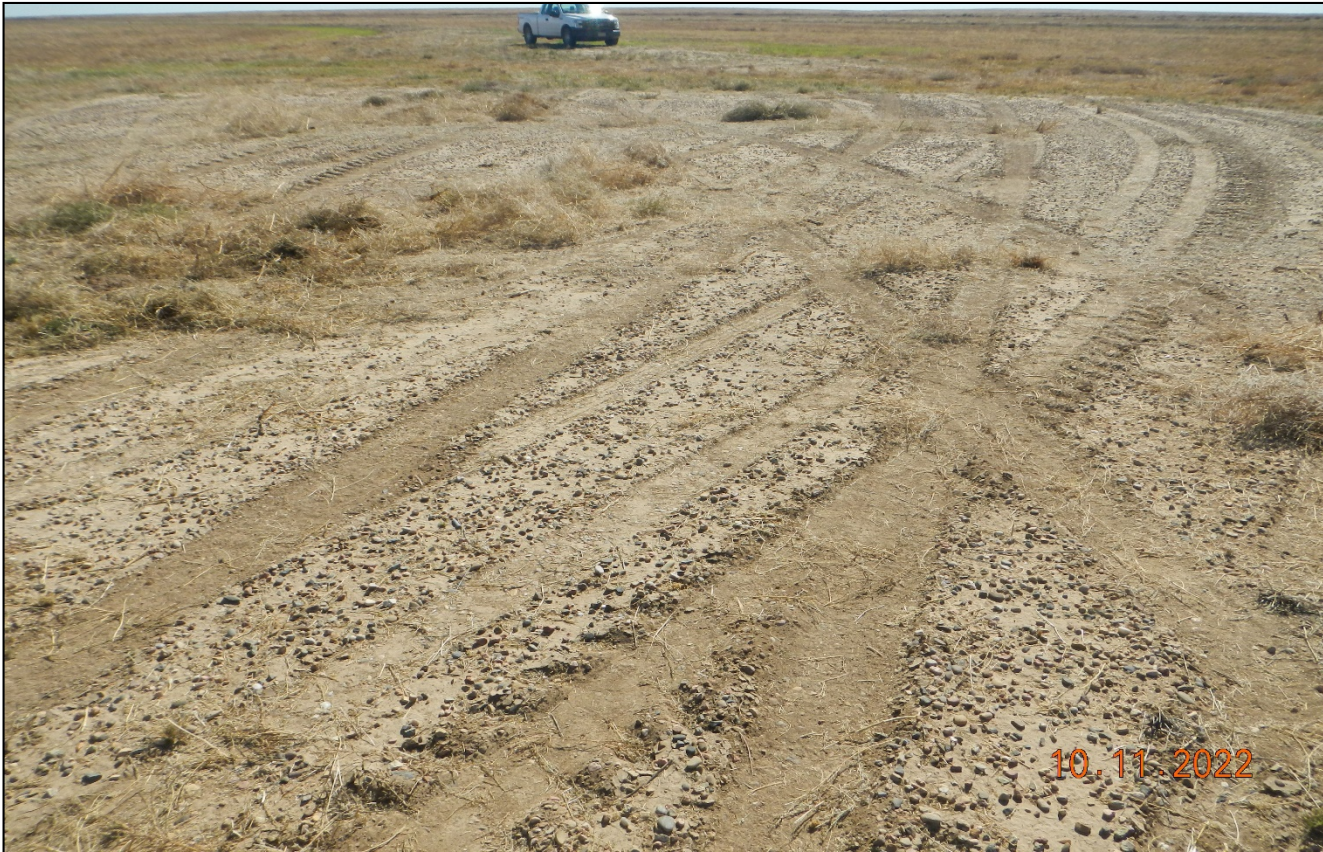
Photo 3. Facing south at the location shows no vegetation growth at the former well site. There are likely soil issues that impact growth of vegetation.

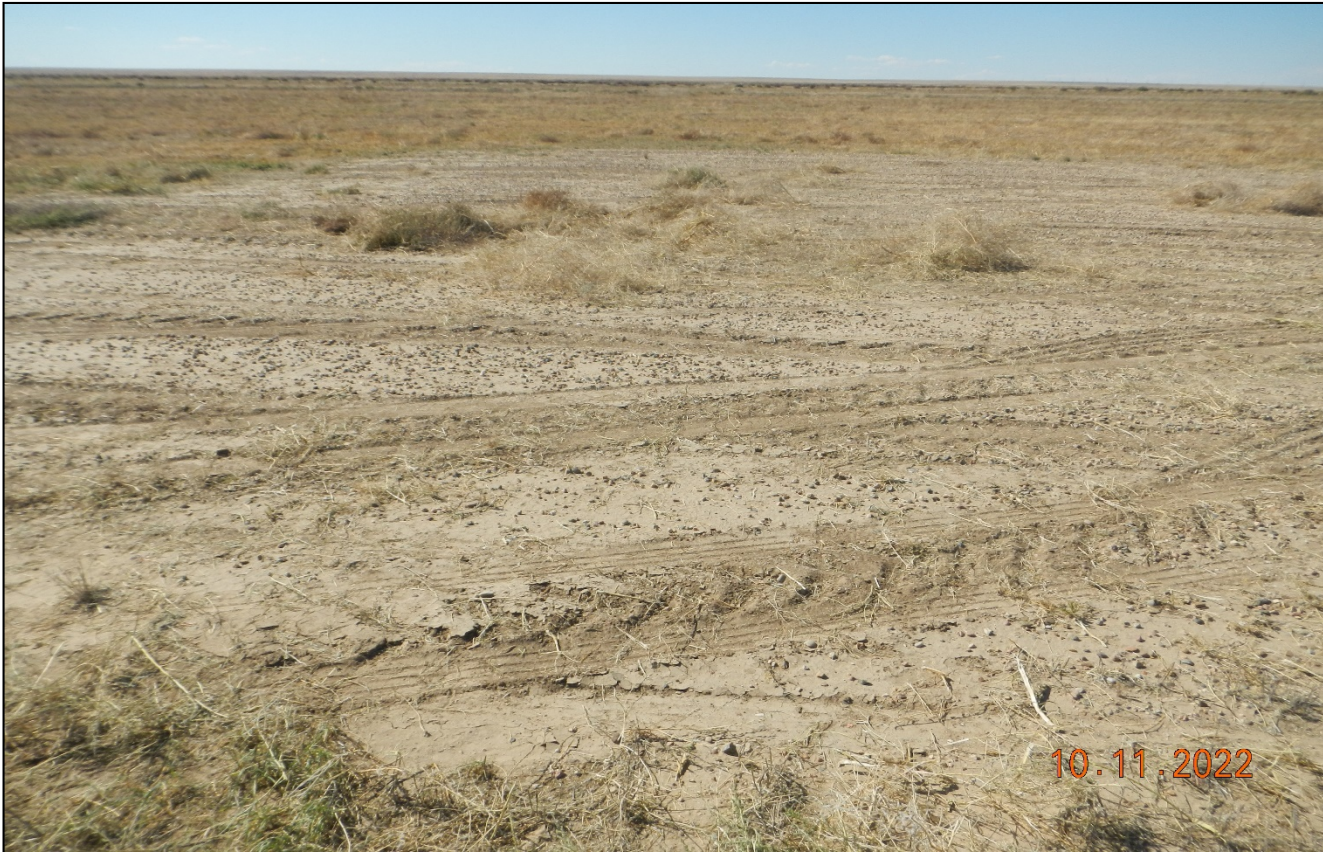
Photo 4. Facing west at the location. There is an area approximately 150'x100' with no vegetation growth. The surrounding field does not have a crop planted but has vegetation growth. Previous corrective action was not completed.

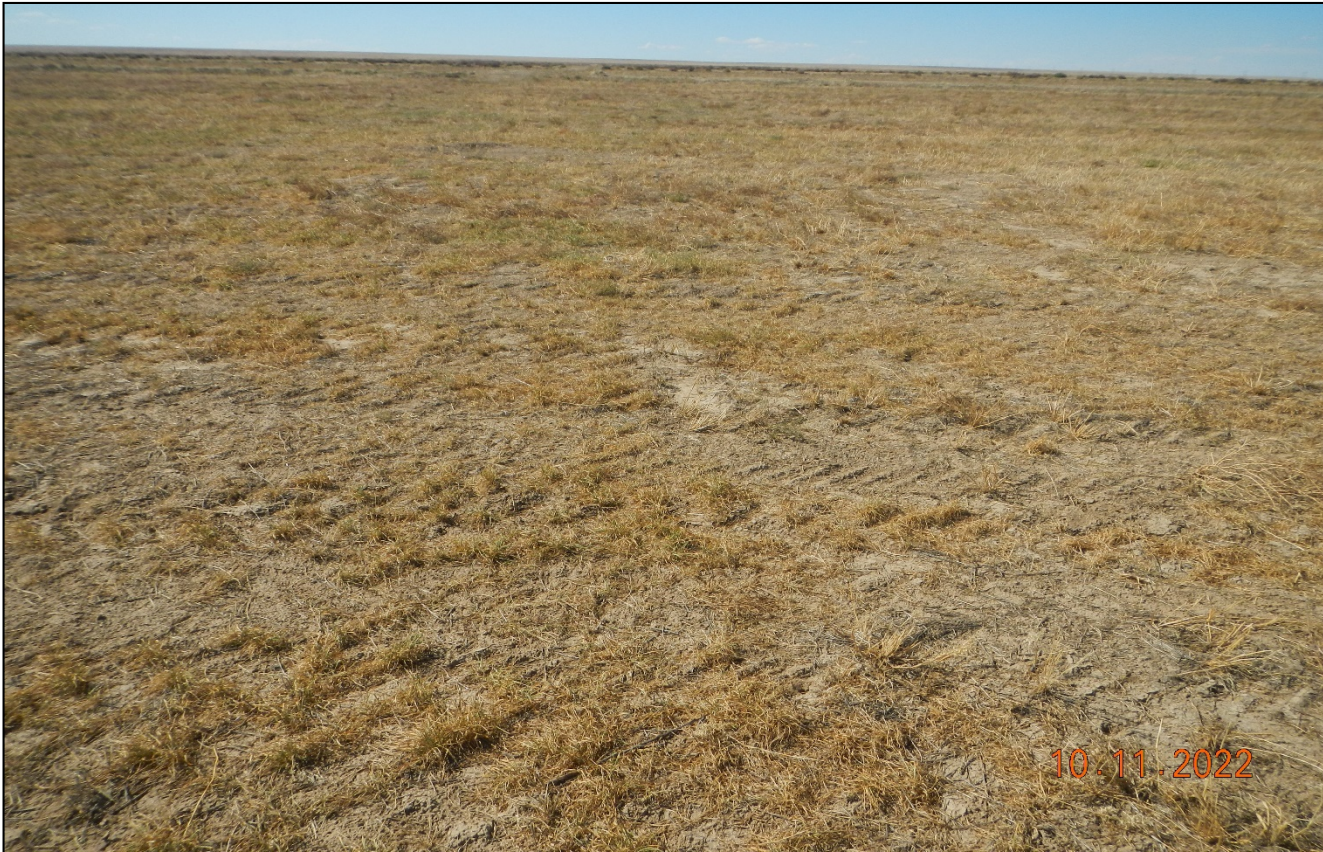
Photo 5. Facing west at the surrounding undisturbed area which shows vegetation cover compared to the location which has no vegetation growth.
