# Inspection Photos

API: 011-06046

Operator: STRACHAN EXPLORATION INC

Inspection Date: 10/11/2022

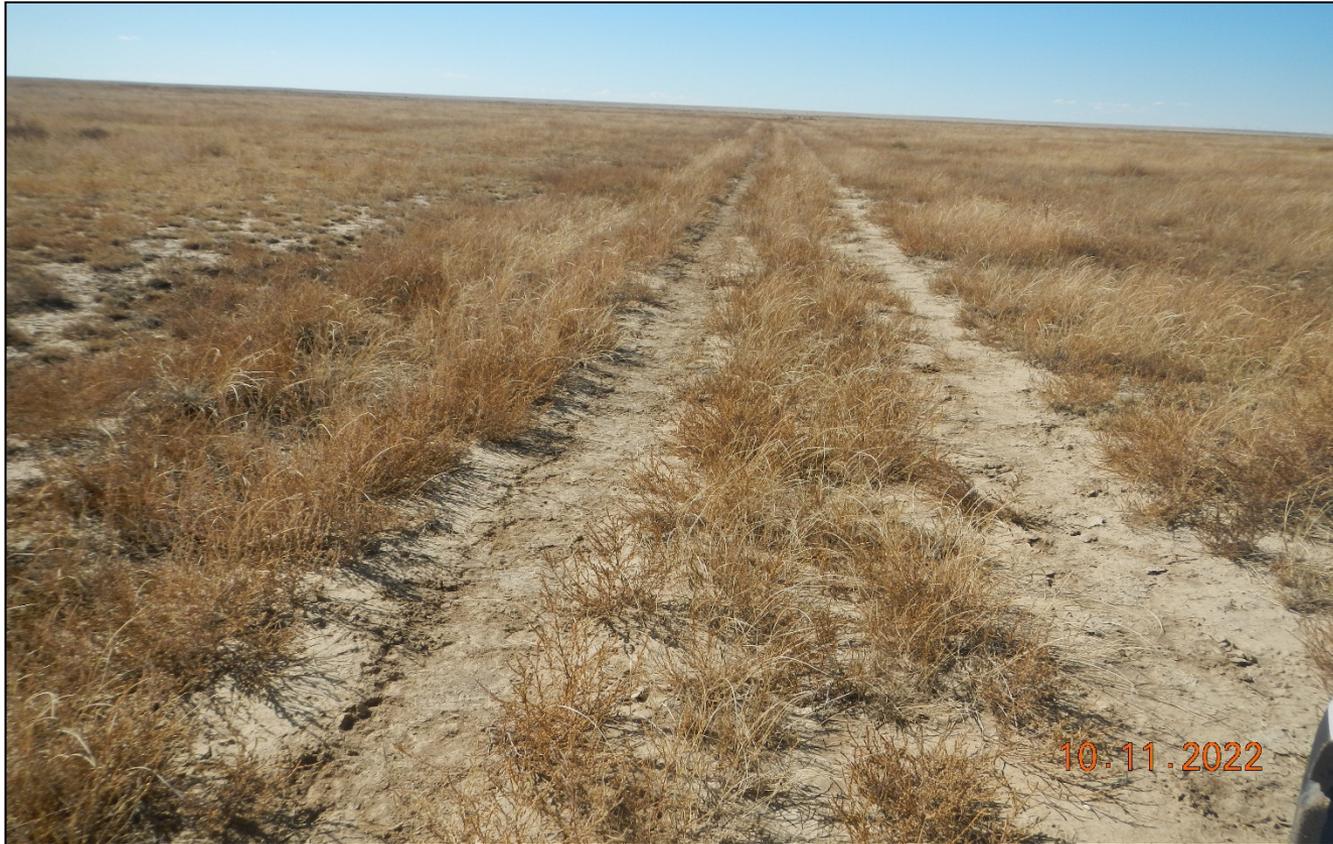
**Photo 1.** Facing west along the access road. The access road has not been reclaimed. There is pipe risers associated with the former well site that have not been removed.

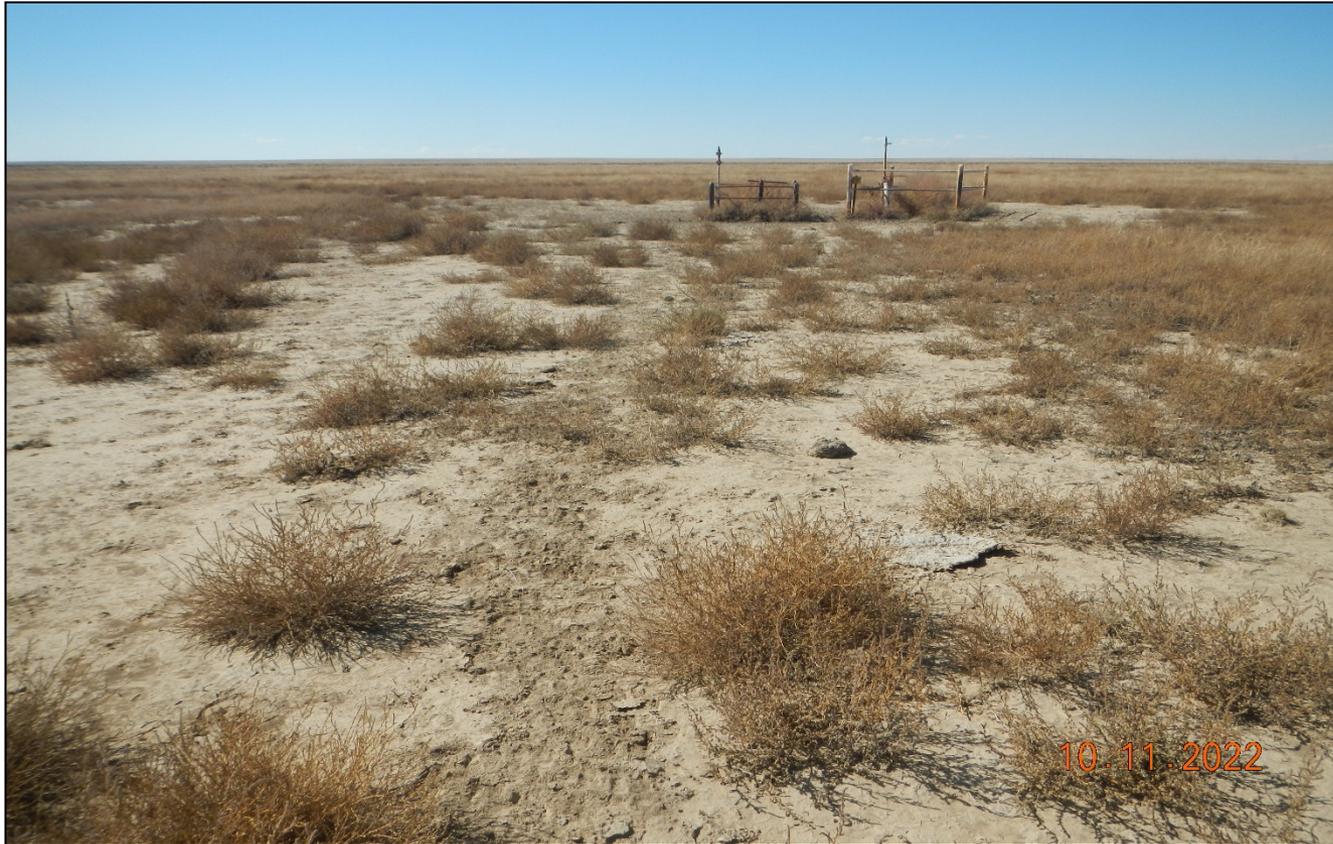
**Photo 2.** Facing west toward the location which has not been reclaimed. There are undesirable weeds throughout the location and areas bare vegetation. There is equipment that remains at the north side of the location. Previous corrective action was not completed.

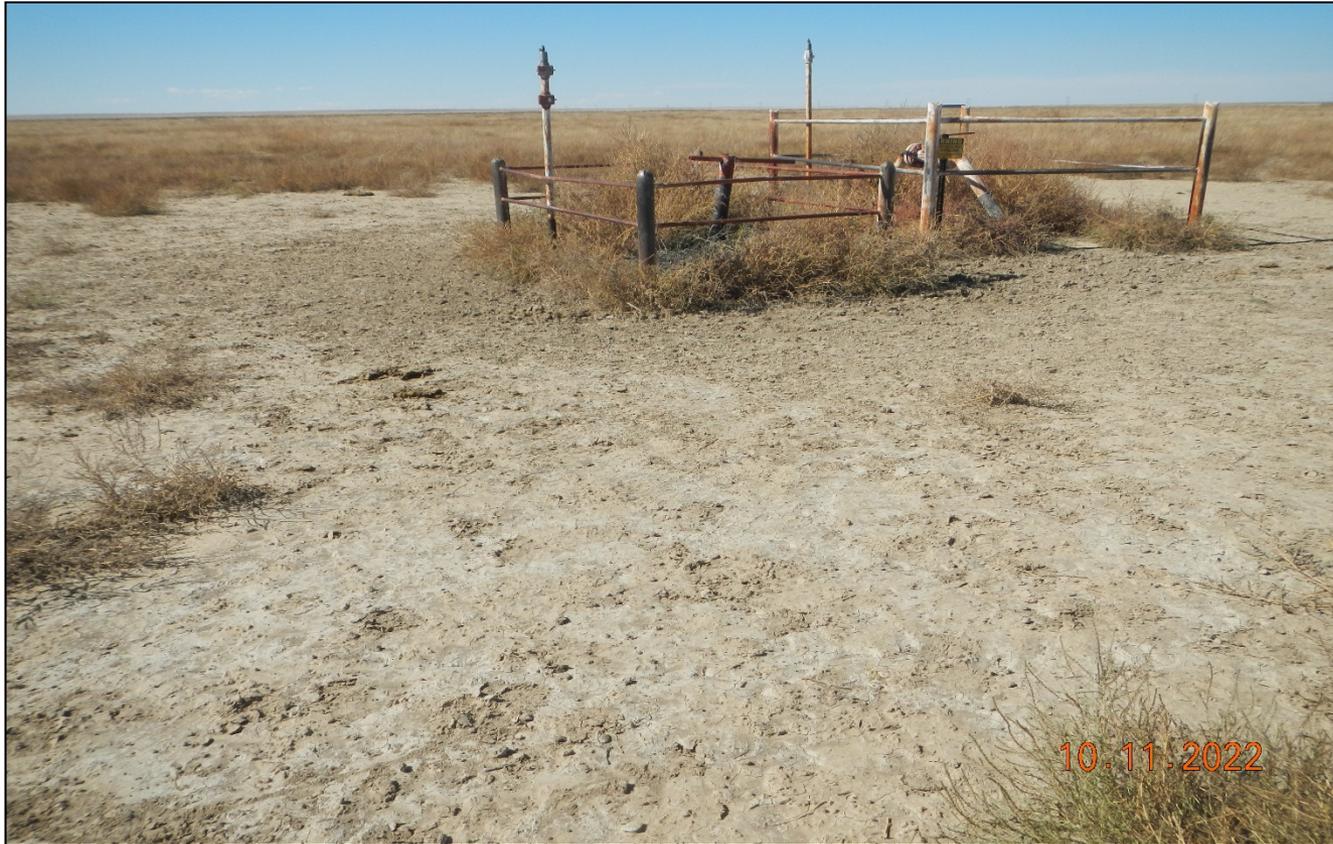
**Photo 3.** There are pipe risers associated with the former well site that have not been removed. Previous corrective action was not completed.

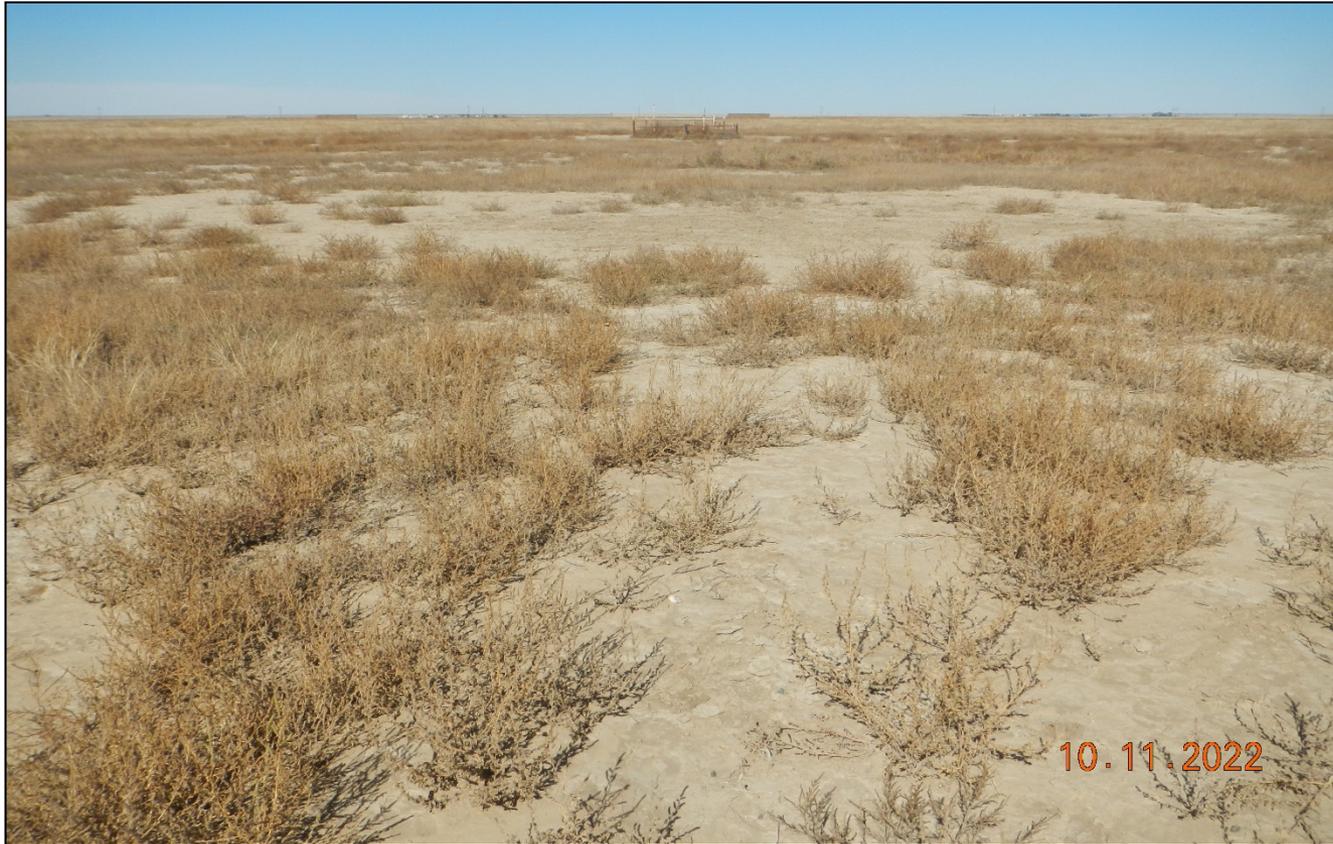
**Photo 4.** South side of the location facing north. There are undesirable weeds throughout the location and areas bare vegetation. Reclamation has no been completed.

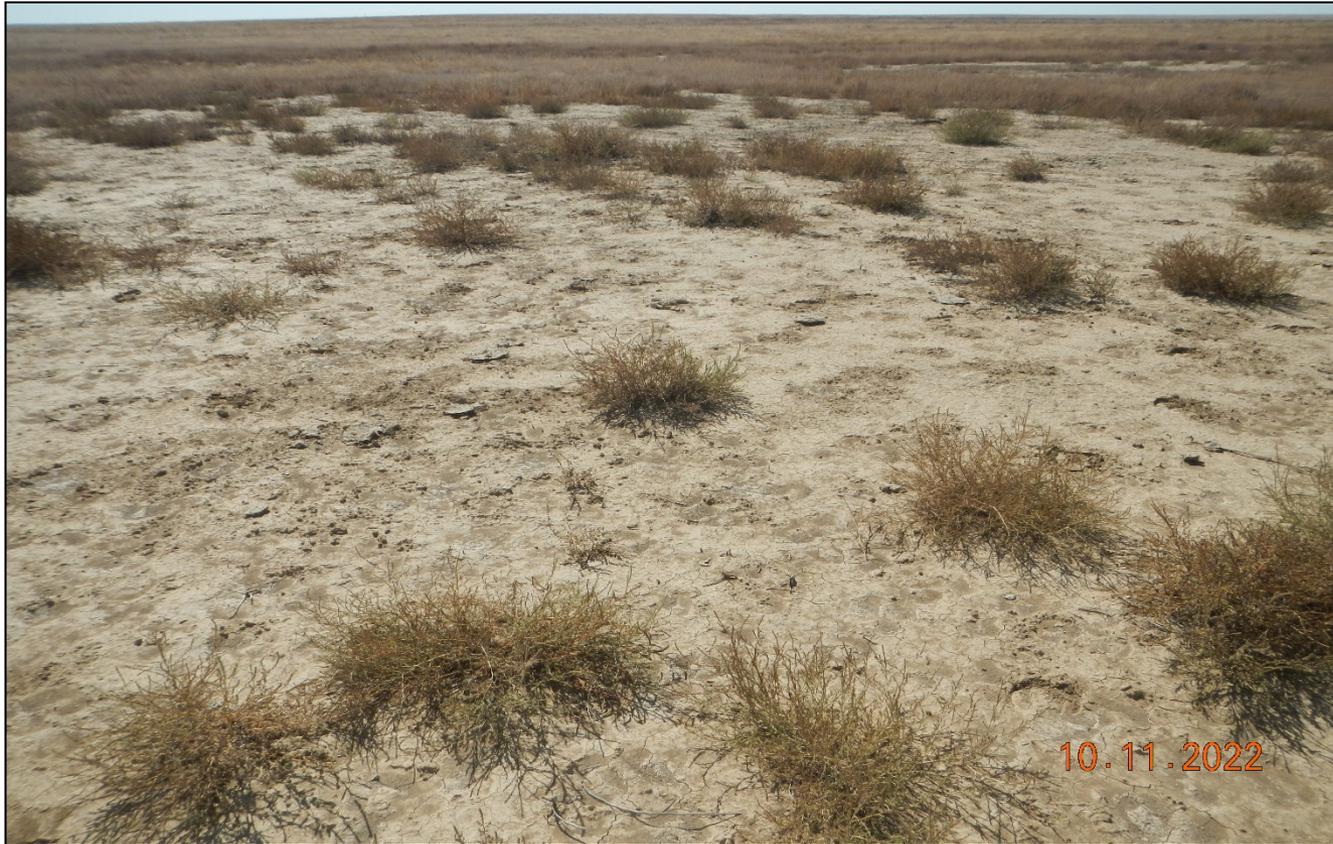
**Photo 5.** Facing west at the location which consists of undesirable weeds and areas with no vegetation. Reclamation has not been completed.

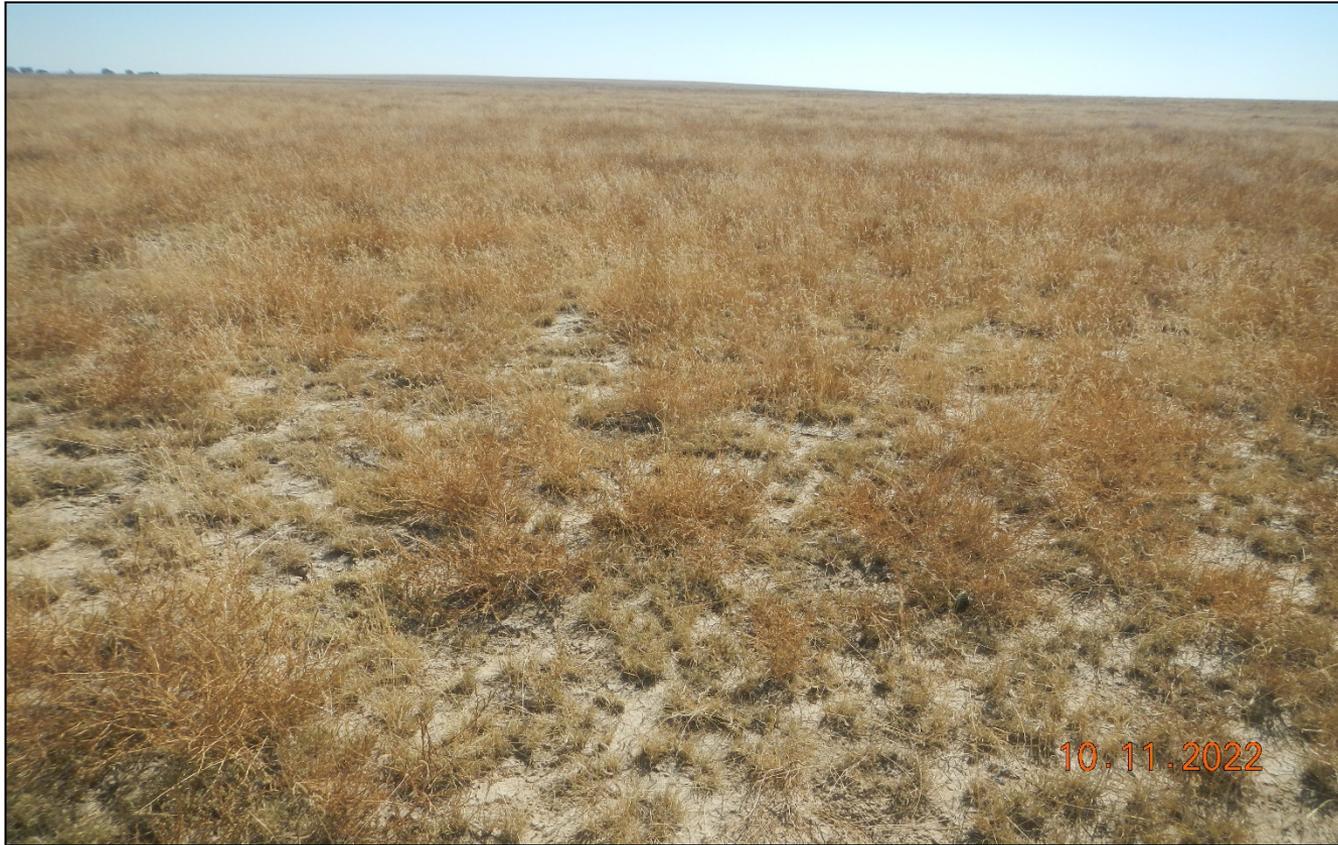
**Photo 6.** Facing south at the surrounding undisturbed reference area which shows a uniform vegetation cover consisting of Blue grama, Sand dropseed, Prairie threeawn among other species.
