Inspection Photos

API: 011-06099

Operator: PONCHO PRODUCTION COMPANY

Inspection Date: 10/11/2022

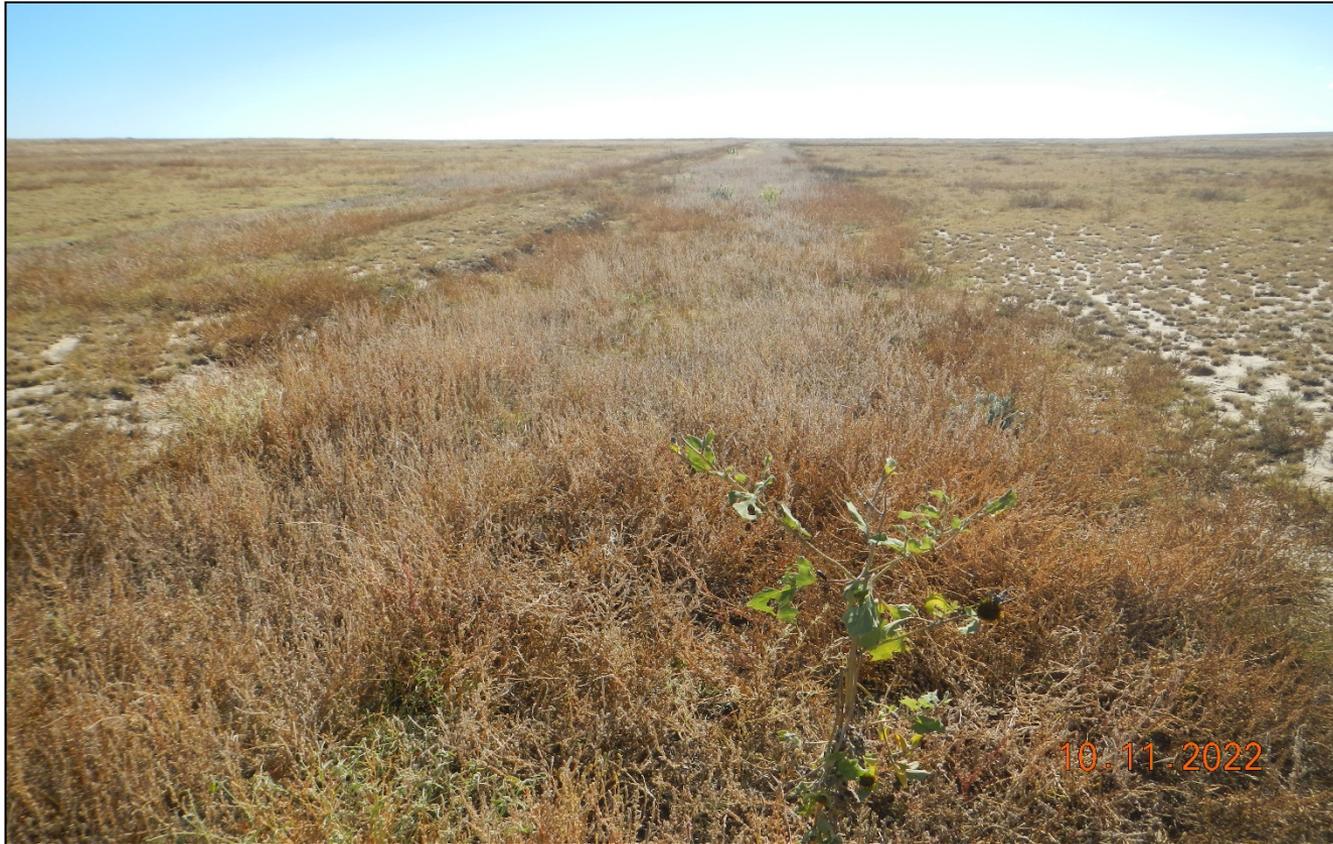
Photo 1. Facing southwest along the former access road. The road has not been reclaimed and consists of undesirable weed such as Kochia and Russian thistle.

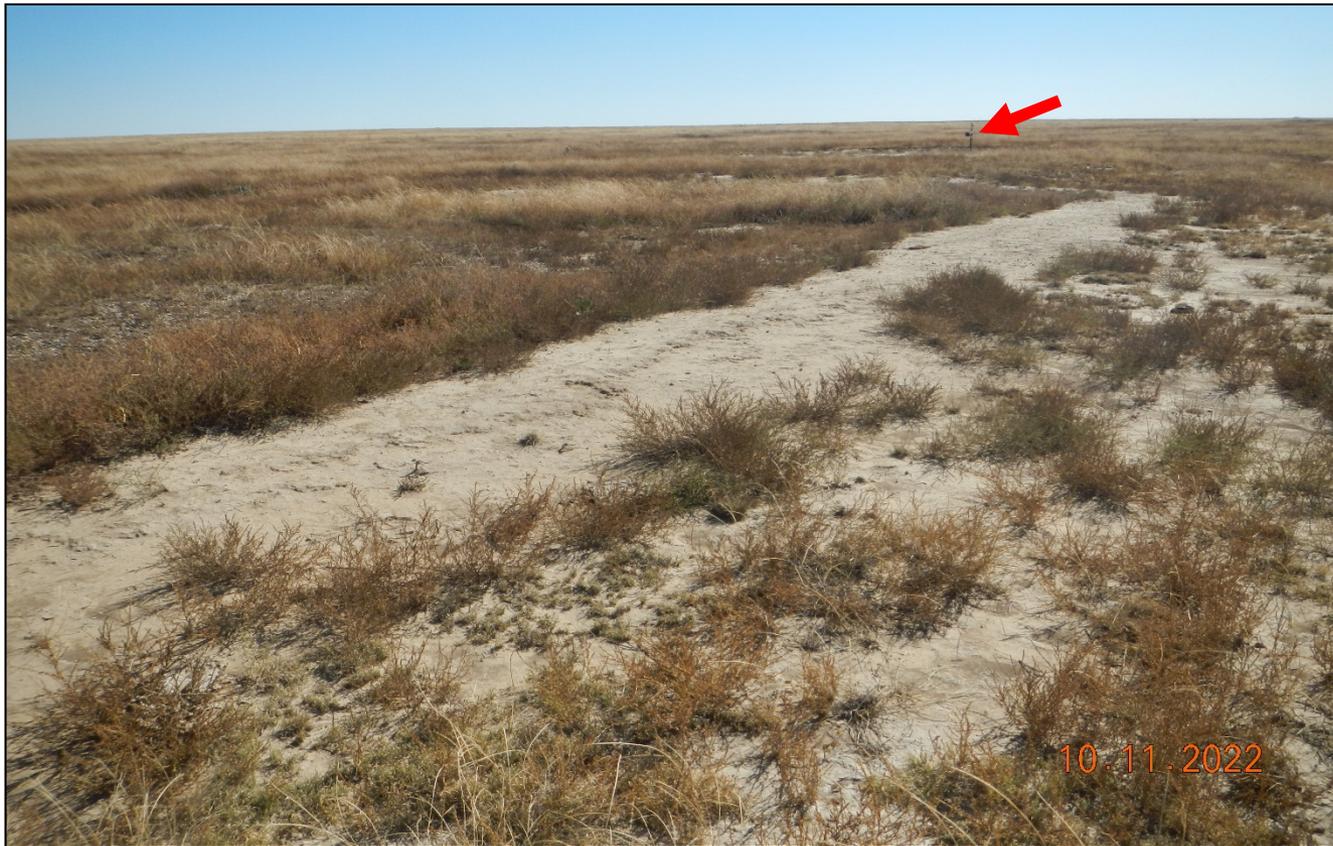
Photo 2. Facing south toward the location which has not been reclaimed. There are undesirable weeds throughout the location and areas bare vegetation. There is equipment that remains at the south side of the location shown at red arrow.

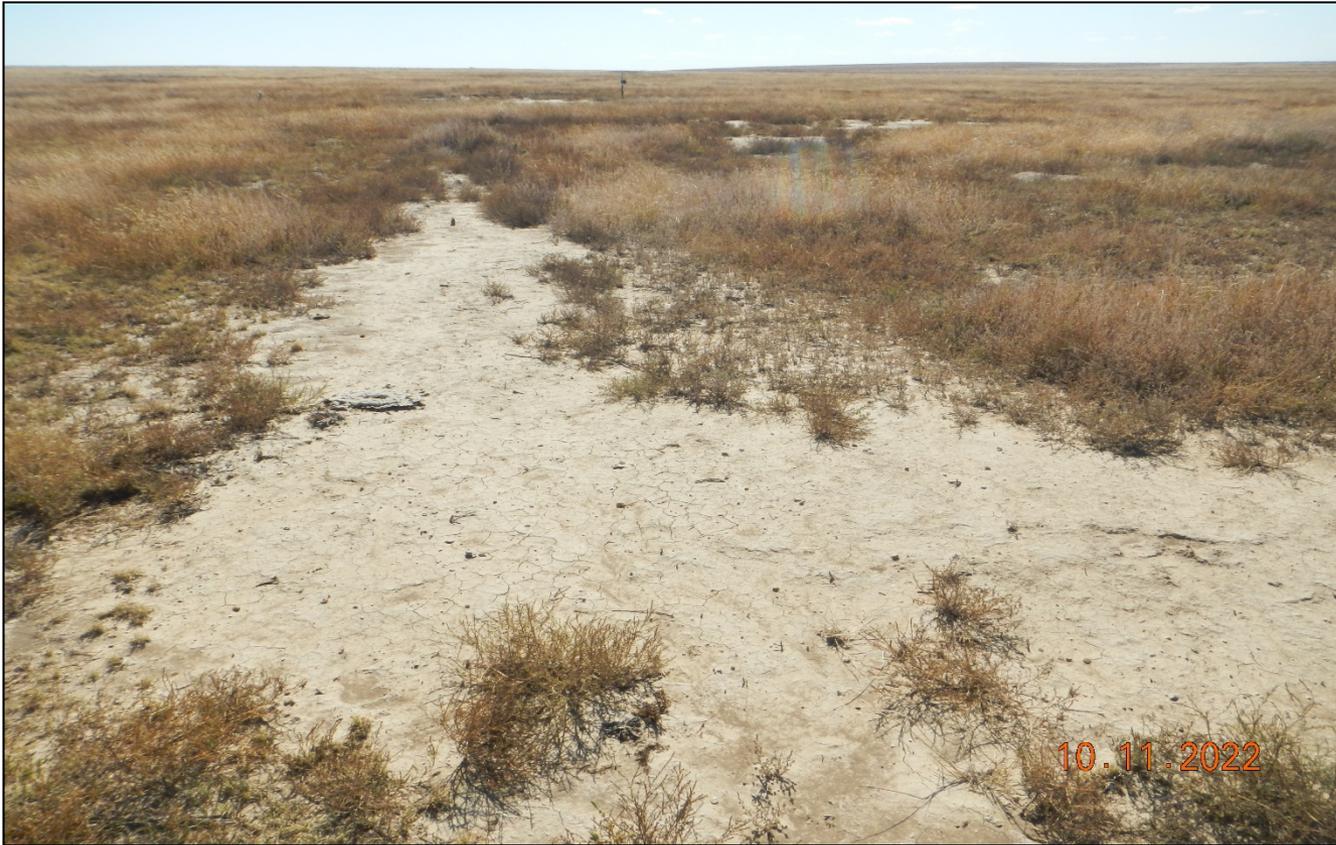
Photo 3. Facing southwest. This area appears to be the former tank battery site. There are likely soil issues preventing vegetation growth within this area.

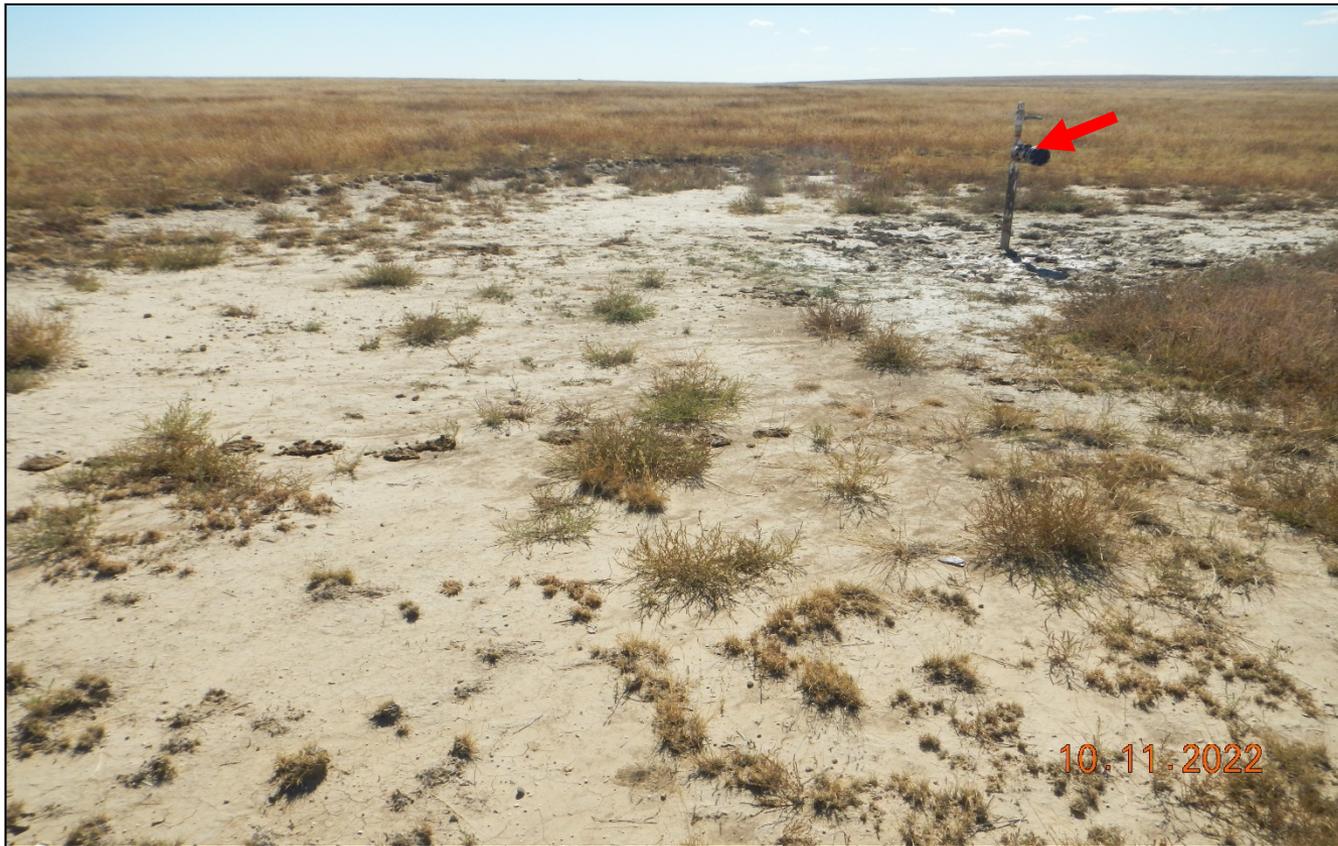
Photo 4. Facing southwest at the south side of the location. There is an abandoned pipe riser that has not been removed shown at red arrow.

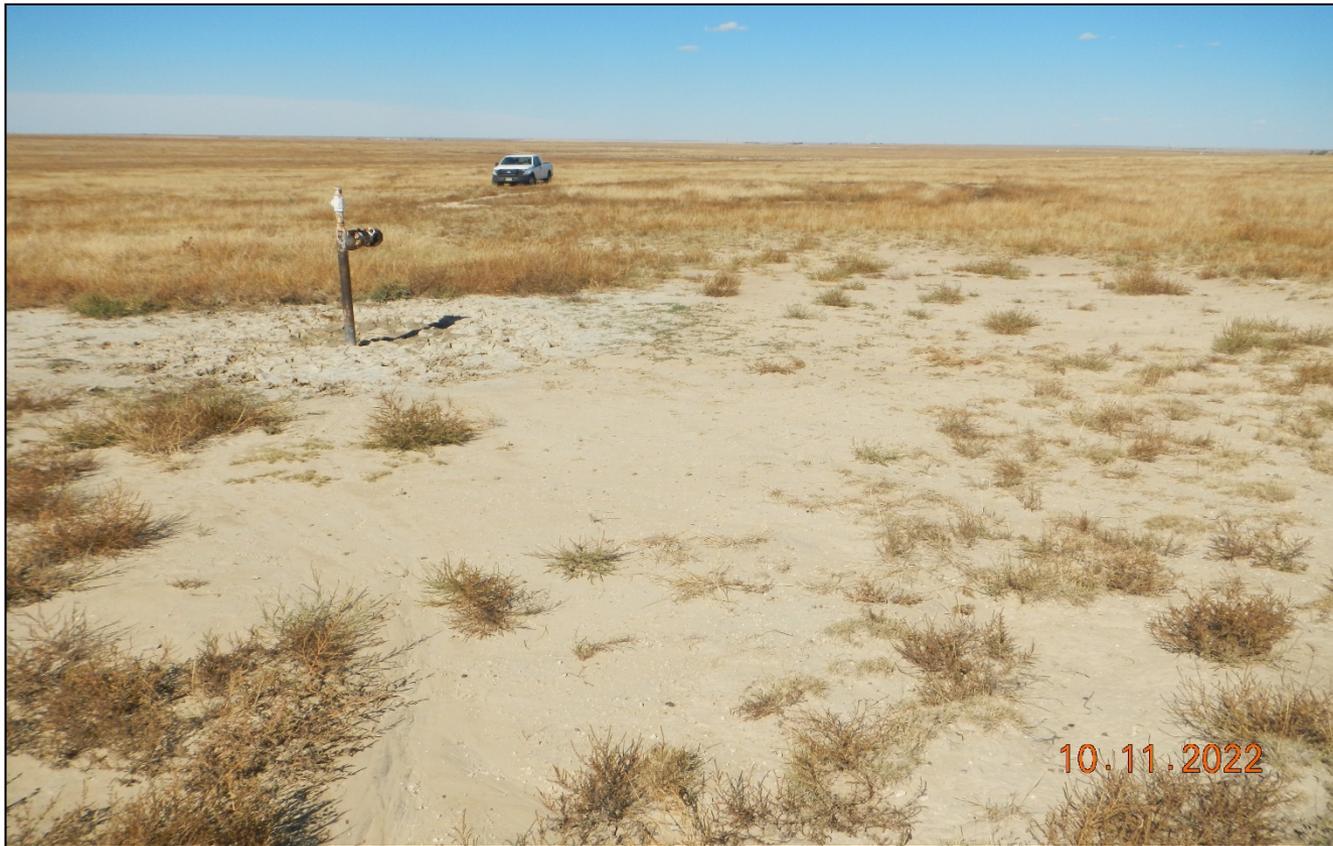
Photo 5. South side of the location facing north. There are areas with no vegetation growth and the abandoned pipe riser remains.

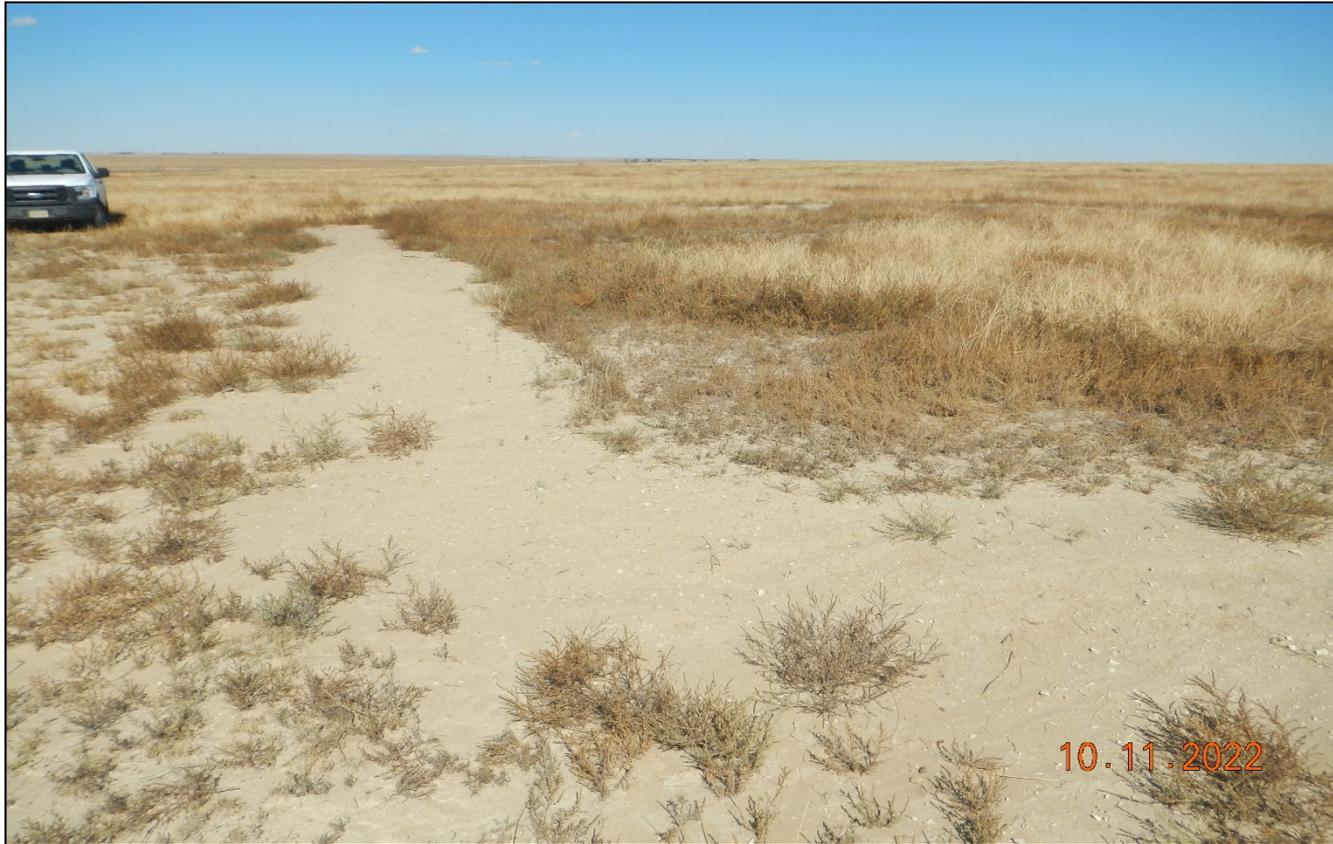
Photo 6. Facing northeast. This area appears to be the former tank battery site. There are likely soil issues preventing vegetation growth within this area.

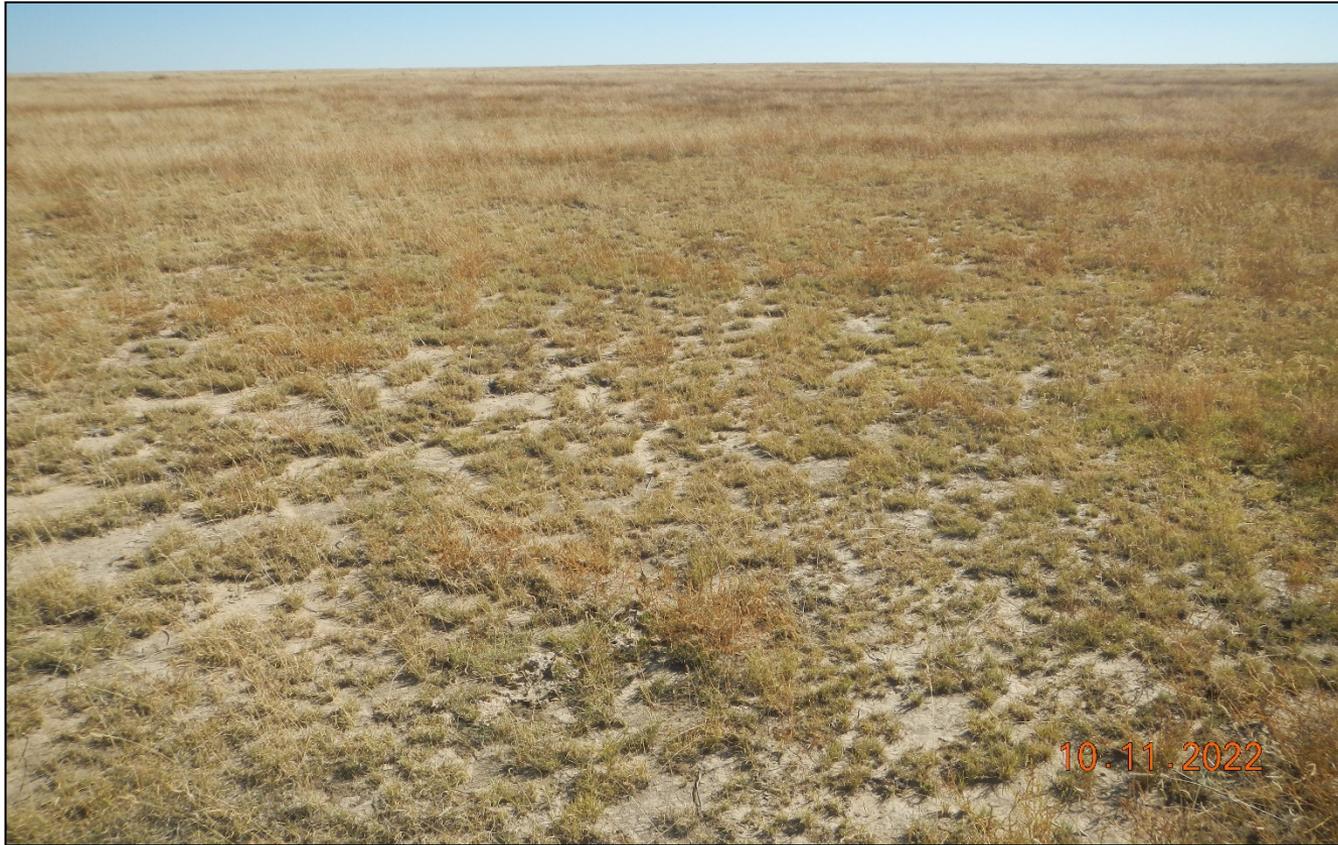
Photo 7. Facing southeast at the surrounding undisturbed reference area which shows a uniform vegetation cover consisting of Blue grama, Sand dropseed, Prairie threeawn among other species.
