Inspection Photos

Location Name: CADDIS FEDERAL-611N91W/9NWSE

Inspection Document #: 702800825

Anna O'Malley
Reclamation Specialist, COGCC

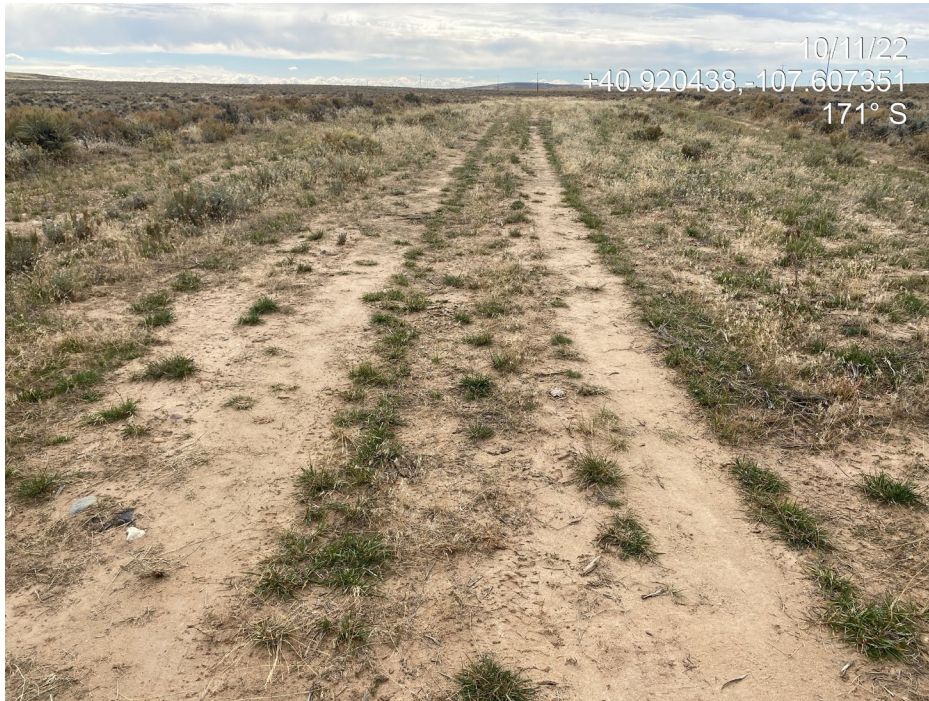
Photo 1. Photo taken from the Location entrance shows the access road is bare and compacted in tracks. Vehicles are utilizing the road, potentially compromising revegetation.

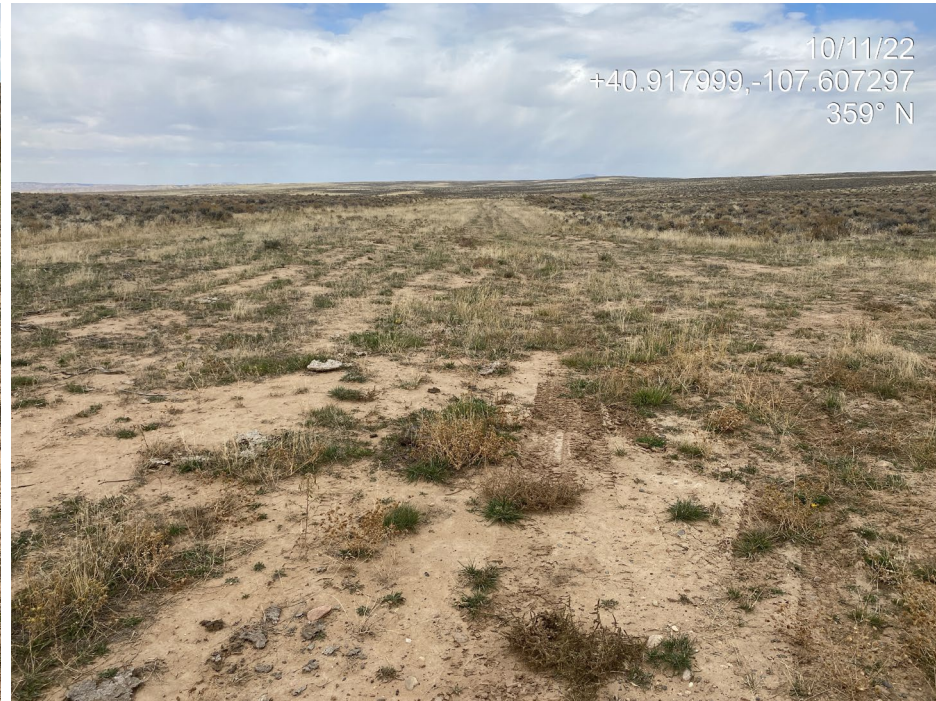
Photo 2. Photo taken to the south shows the start of the access road. Portions of the road are revegetated, however, perennial cover is not uniform. Bare ground and annual weeds are common and vehicles are utilizing the road causing compaction and potentially compromising revegetation.

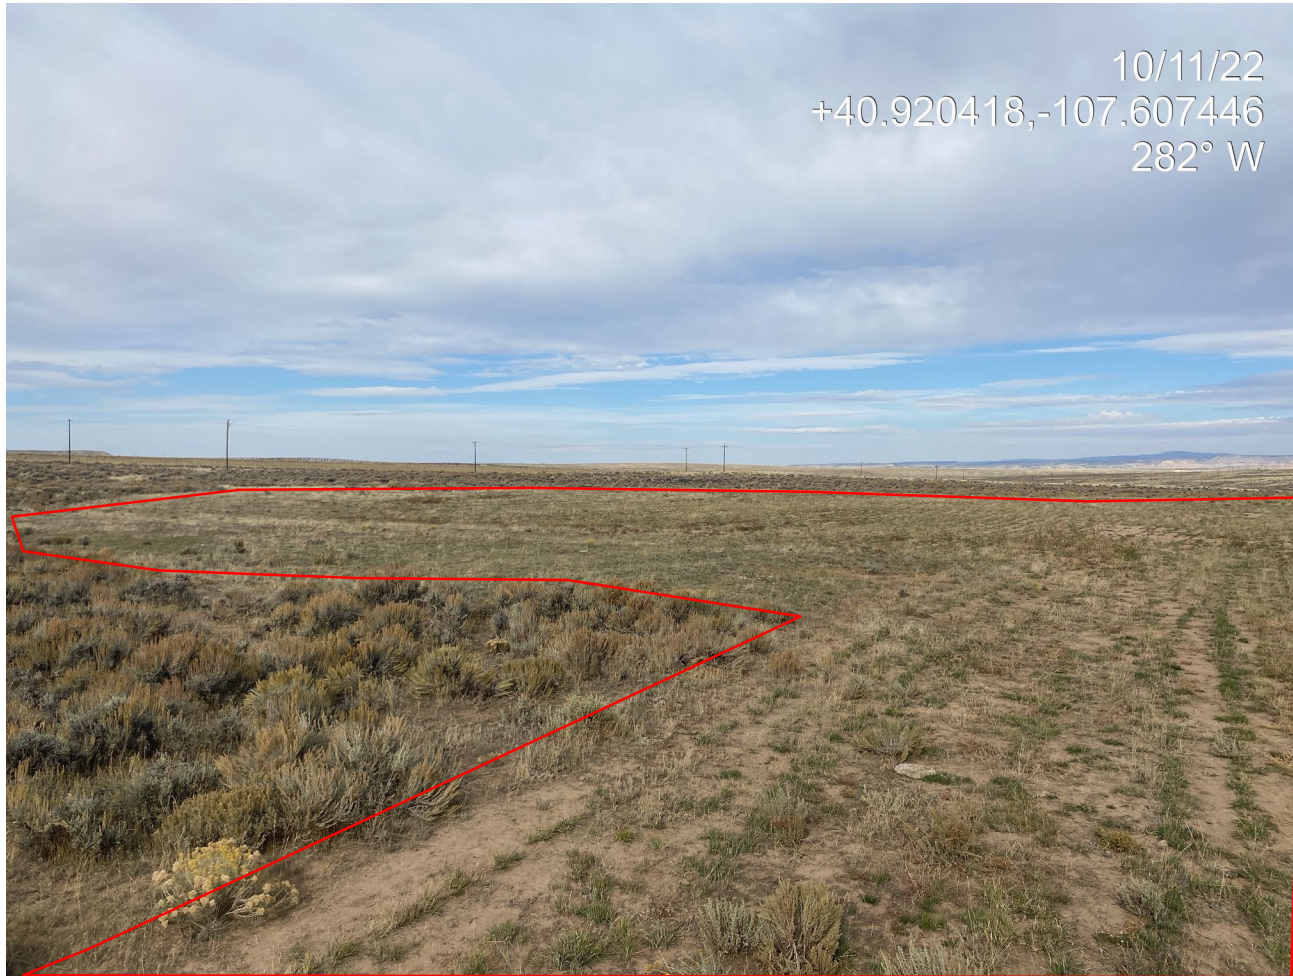
Photo 3. Photo taken from the location entrance shows an overview of the reclaimed location.

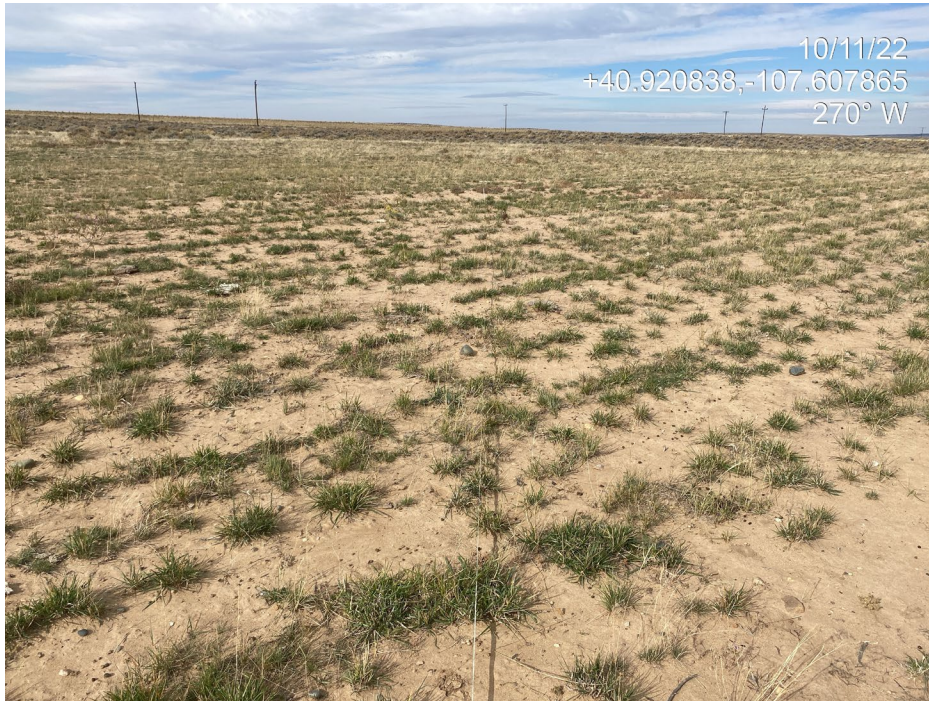
Photo 4. Photo taken from the center of the Location shows the start of disturbed area vegetation monitoring transect #1.

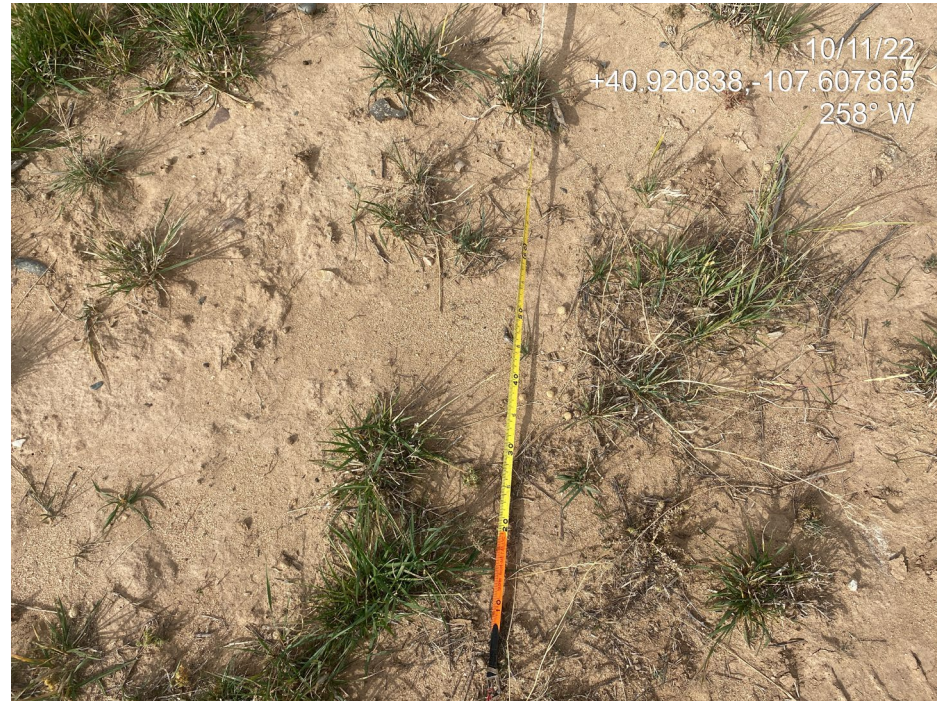
Photo 5. Photo taken from the center of the Location shows the ground surface at the start of disturbed area vegetation monitoring transect #1.

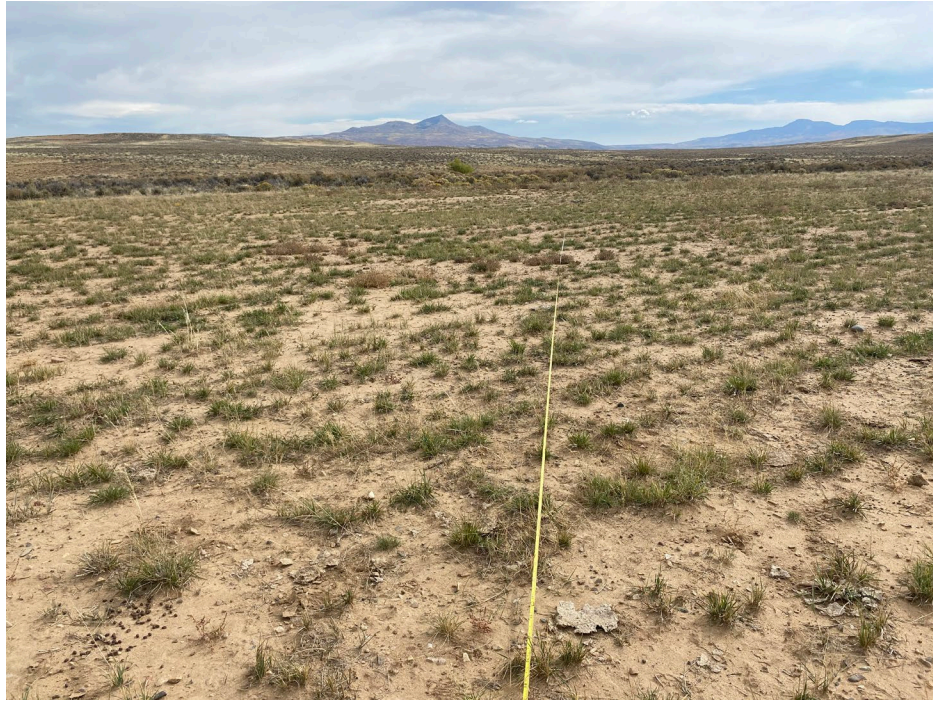
Photo 6. Photo taken from the center of the Location shows the end of disturbed area vegetation monitoring transect #1.

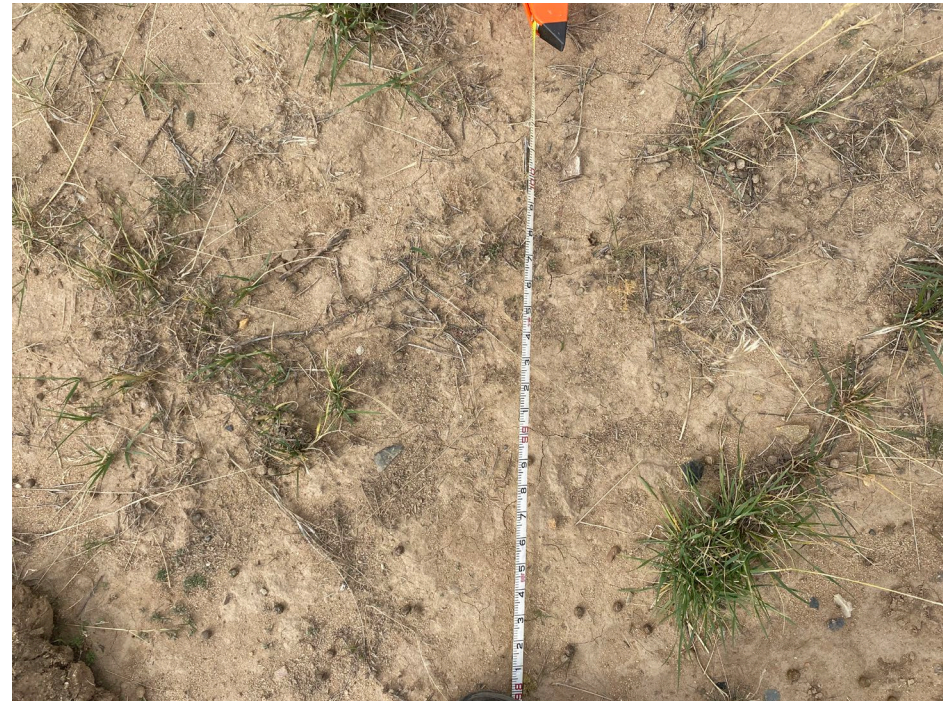
Photo 7. Photo taken from the center of the Location shows the ground surface at the end of disturbed area vegetation monitoring transect #1.

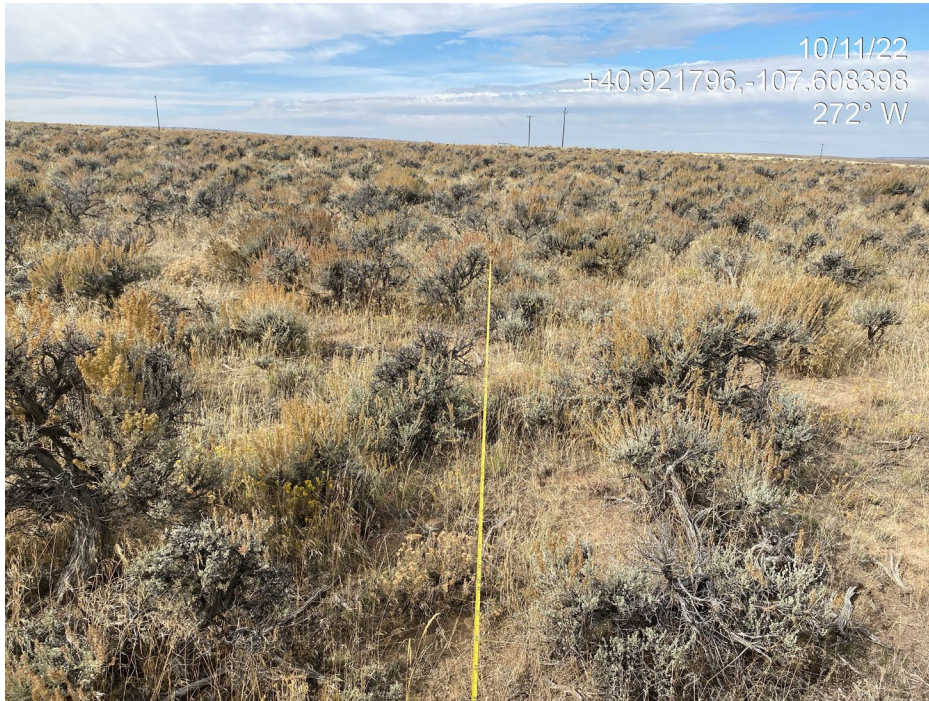
Photo 8. Photo taken from the adjacent reference area to the north of the Location shows the start of reference area vegetation monitoring transect #1.

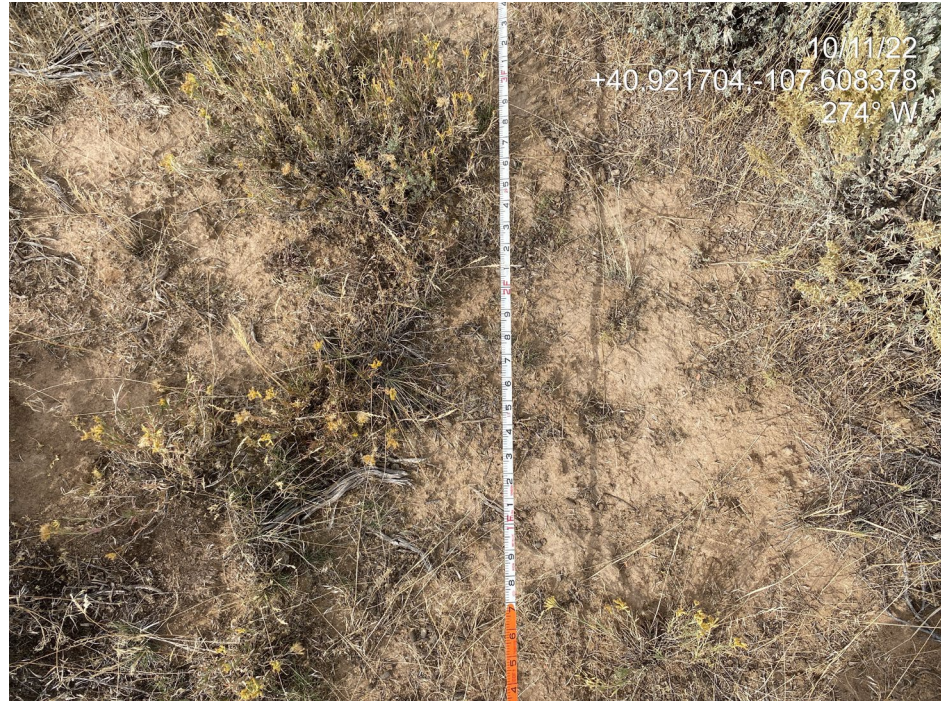
Photo 9. Photo taken from the adjacent reference area to the north of the Location shows the ground surface at the start of reference area vegetation monitoring transect #1.

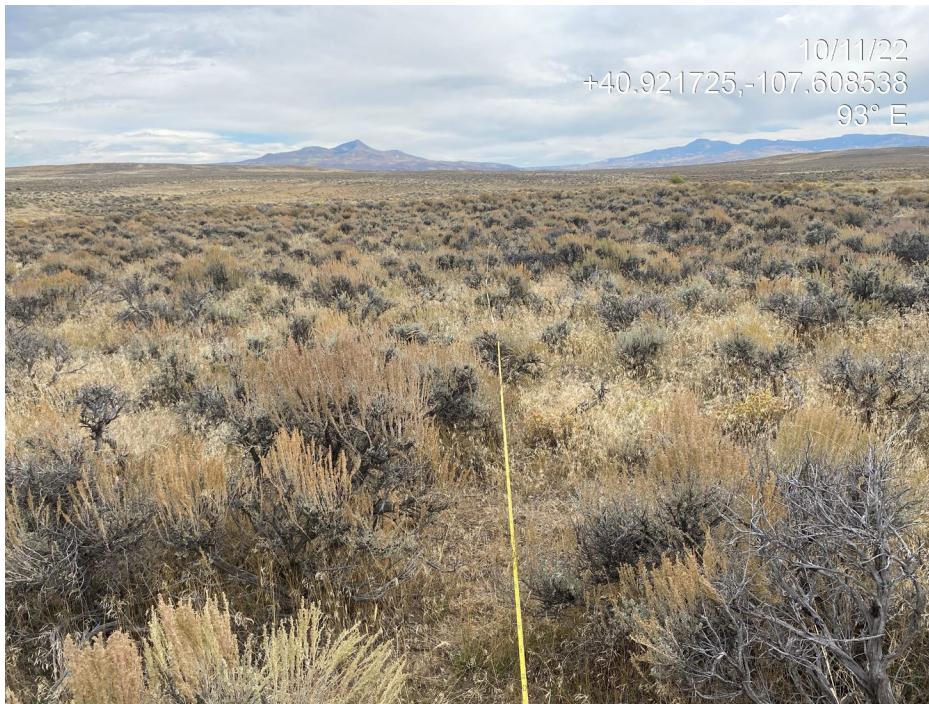
Photo 10. Photo taken from the adjacent reference area to the north of the Location shows the end of reference area vegetation monitoring transect #1.

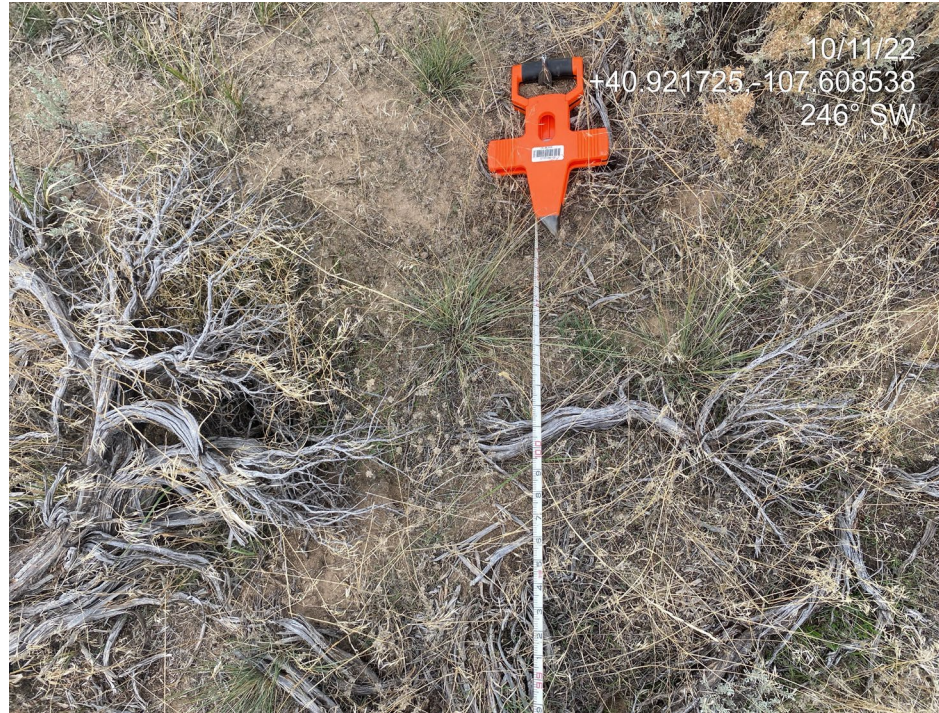
Photo 11. Photo taken from the adjacent reference area to the north of the Location shows the ground surface at the end of reference area vegetation monitoring transect #1.

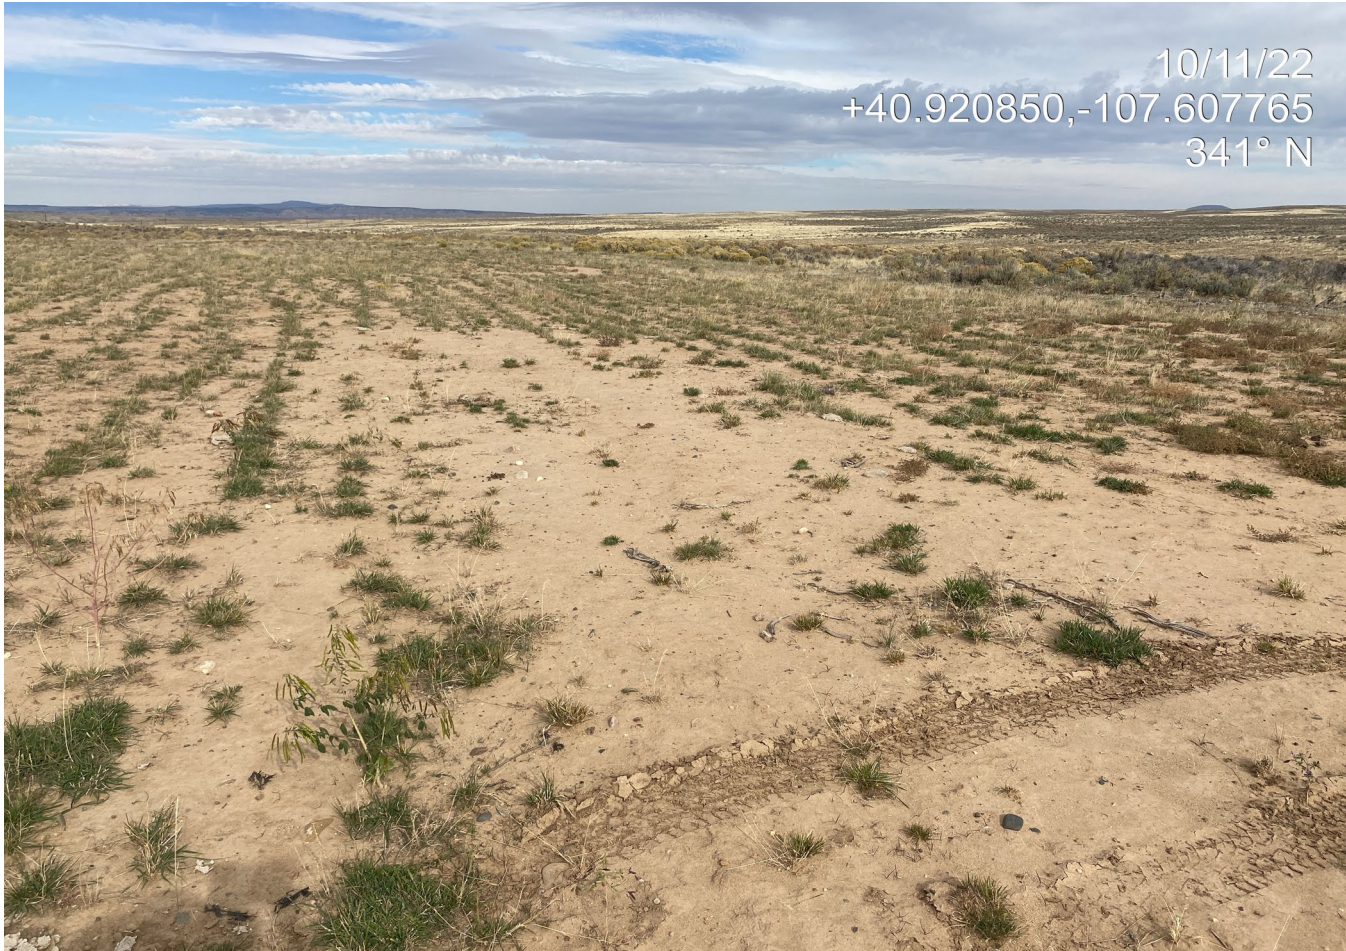
Photo 12. Photo taken from the east shows portions of the Location where perennial establishment is relatively low. Areas of poor establishment appear to be at former equipment footprints and working pad area road. Note also vehicle tracks.
