# Final Reclamation and Stormwater Inspection

Operator: MALLARD EXPLORATION LLC 10670

Location ID: 447902

Inspection Photos  
Location Name: Shull Pad 9-59-31  
Location ID: 447902

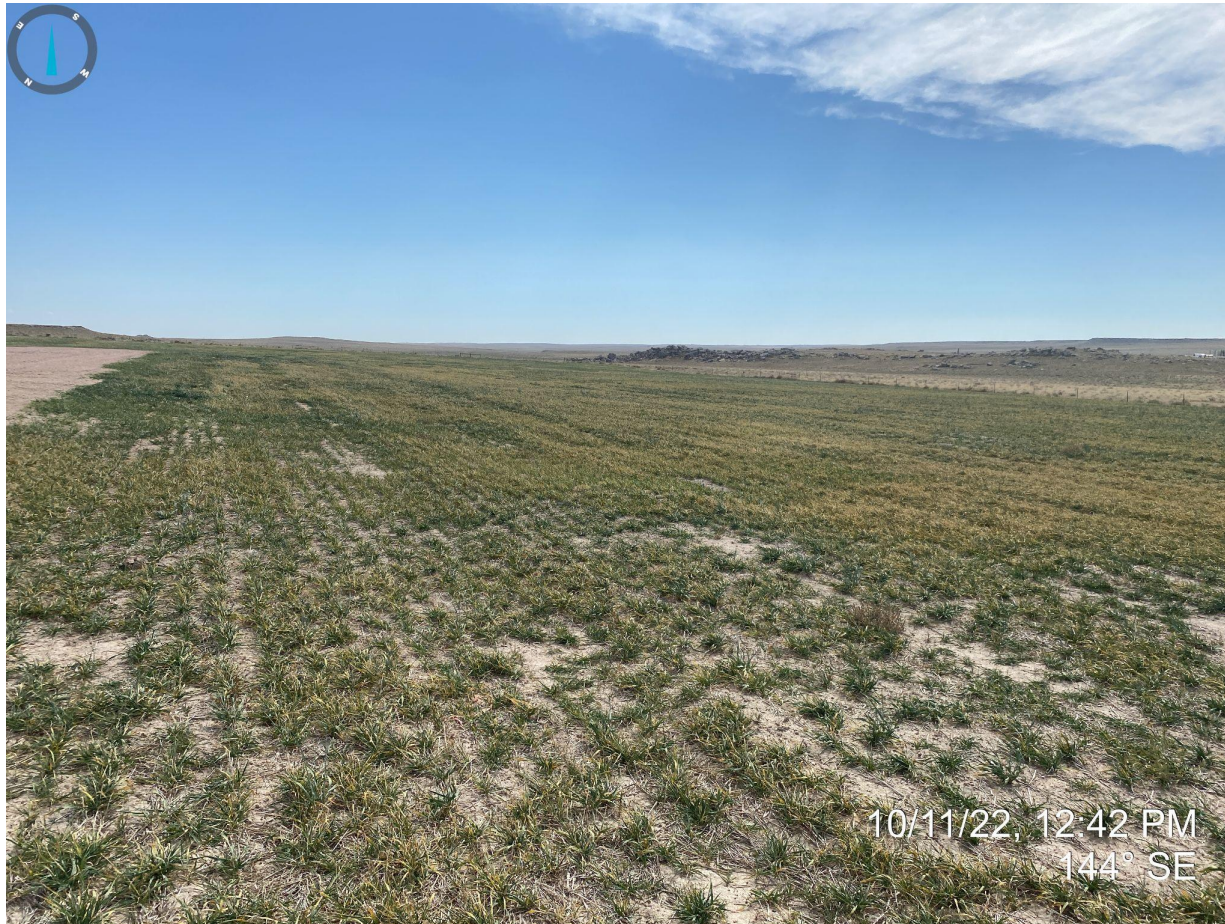
**Photo 1.** Taken near the entrance of location, facing southeast. Photo illustrates interim reclamation areas have been revegetated and are progressing towards standards.

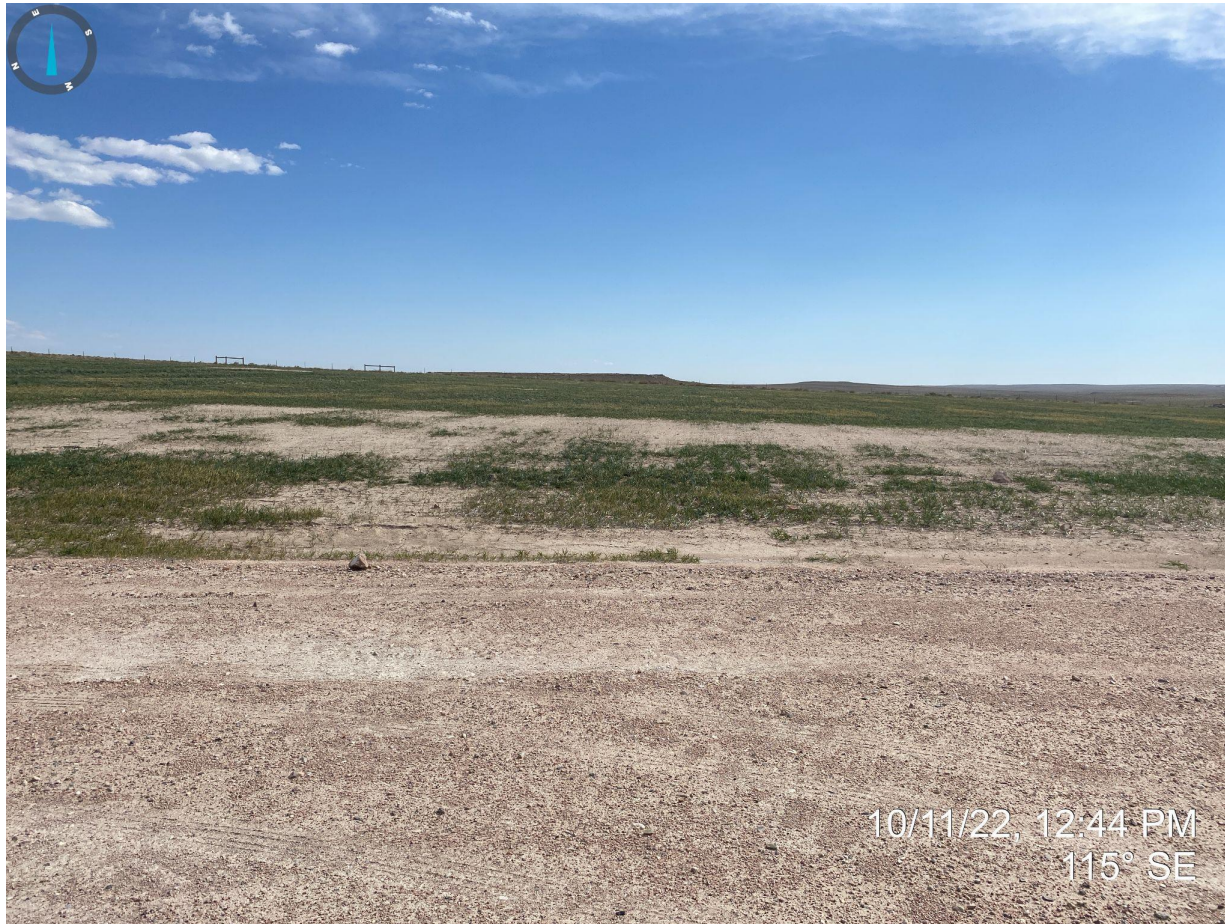
**Photo 2.** Taken from eastern portion, facing southeast. Photo illustrates an approximate 100' x 30' area that has not revegetated; some germination was observed in bare soil areas.

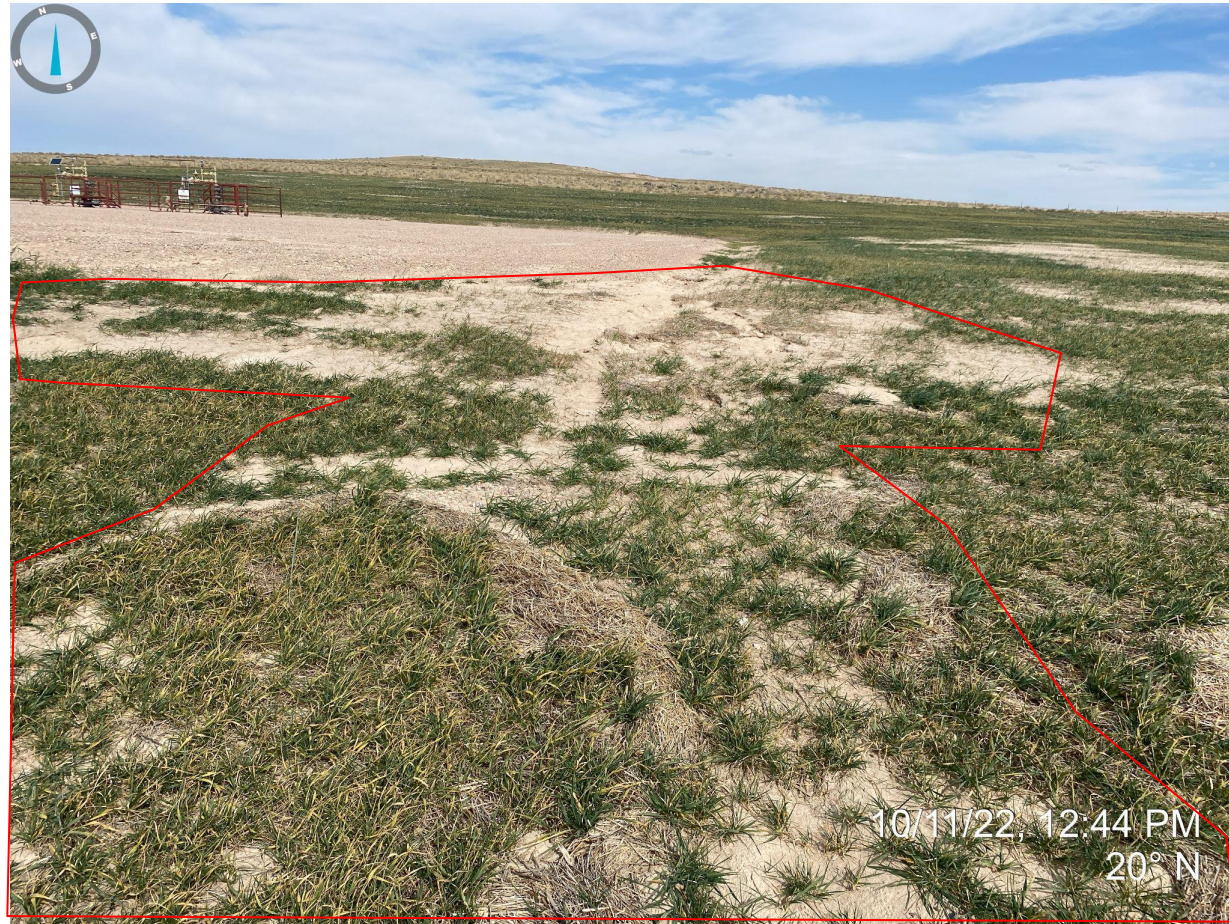
**Photo 3.** Taken from southeastern portion of production area, facing north. Photo illustrates sediment laden stormwater appears to have discharged off of the production area and into the interim area.

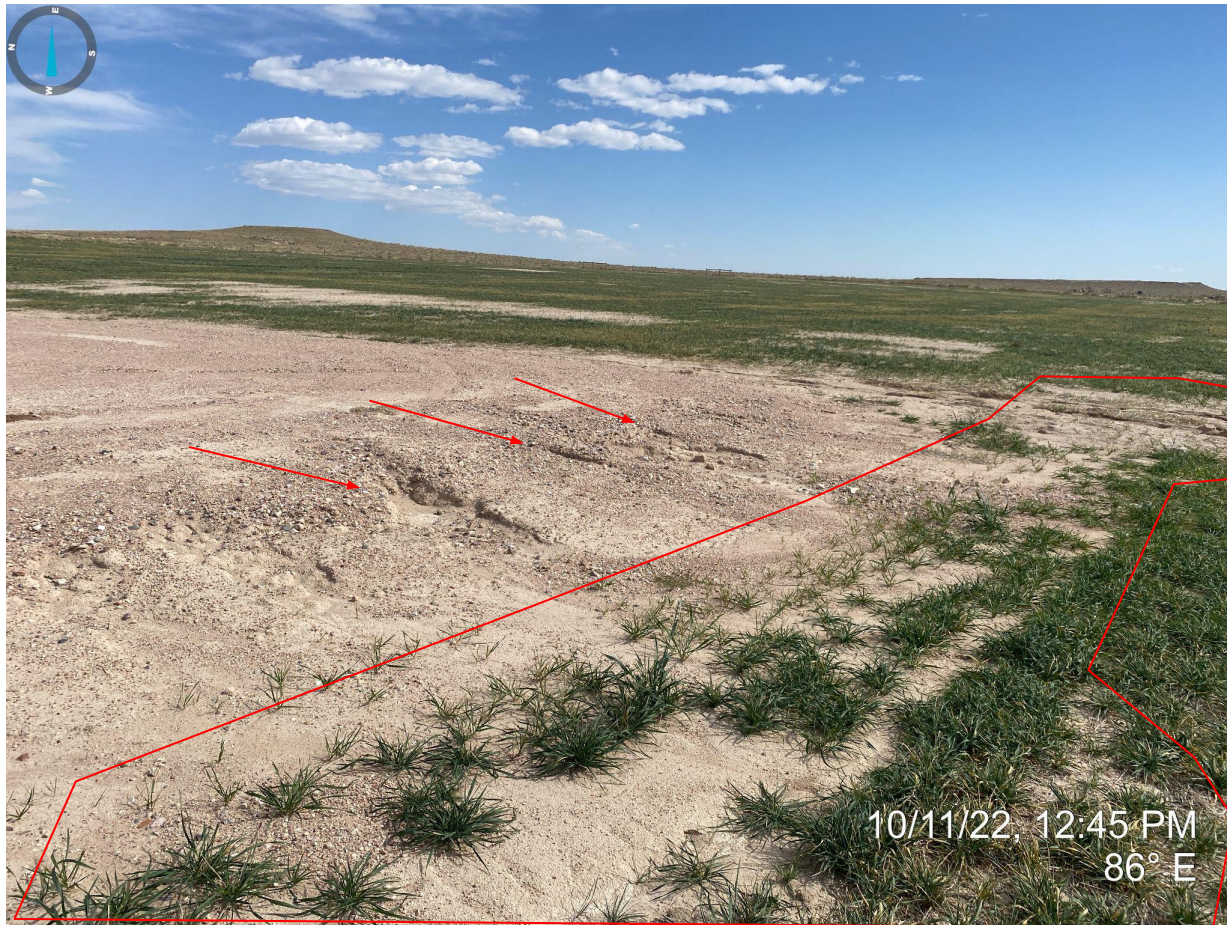
**Photo 4.** Taken from the southeastern portion, facing east. Photo illustrates rill erosion (red arrows) and sediment laden stormwater discharged into interim reclamation areas, red outline.
