# Final Reclamation Inspection

Operator: PDC ENERGY INC - 69175

Location ID: 322652

Inspection Photos  
Location Name: Swanson 44-22  
Location ID: 322652

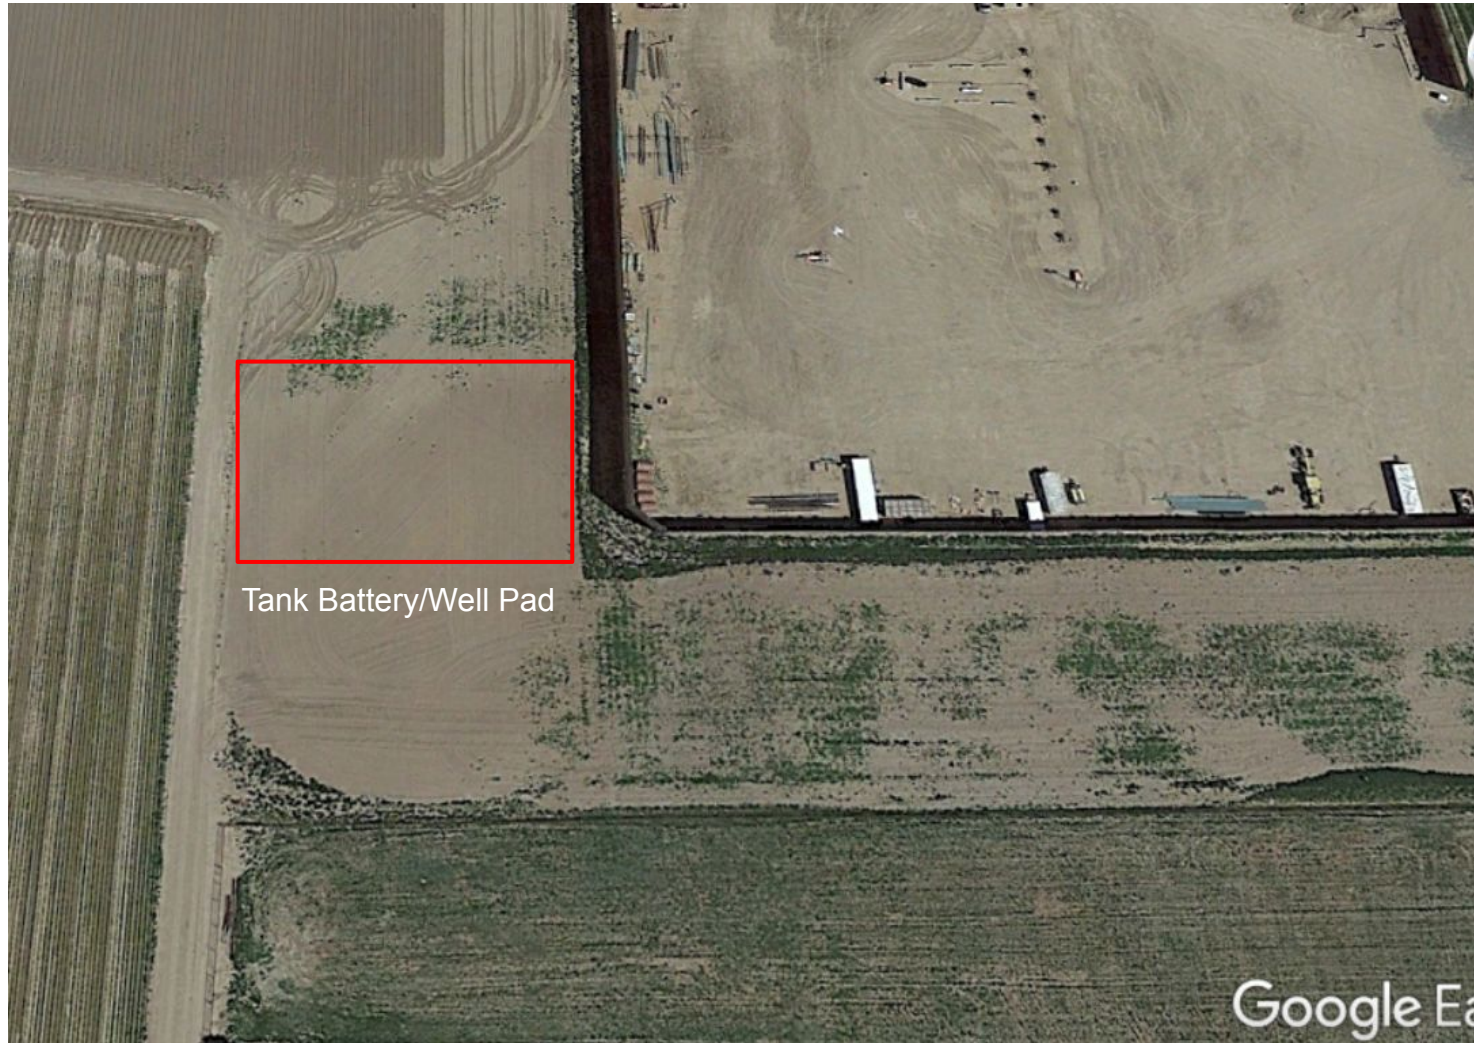
**Photo 1.** 2021 aerial imagery of the well pad and tank battery. Note: well pad and tank battery shared a disturbance.

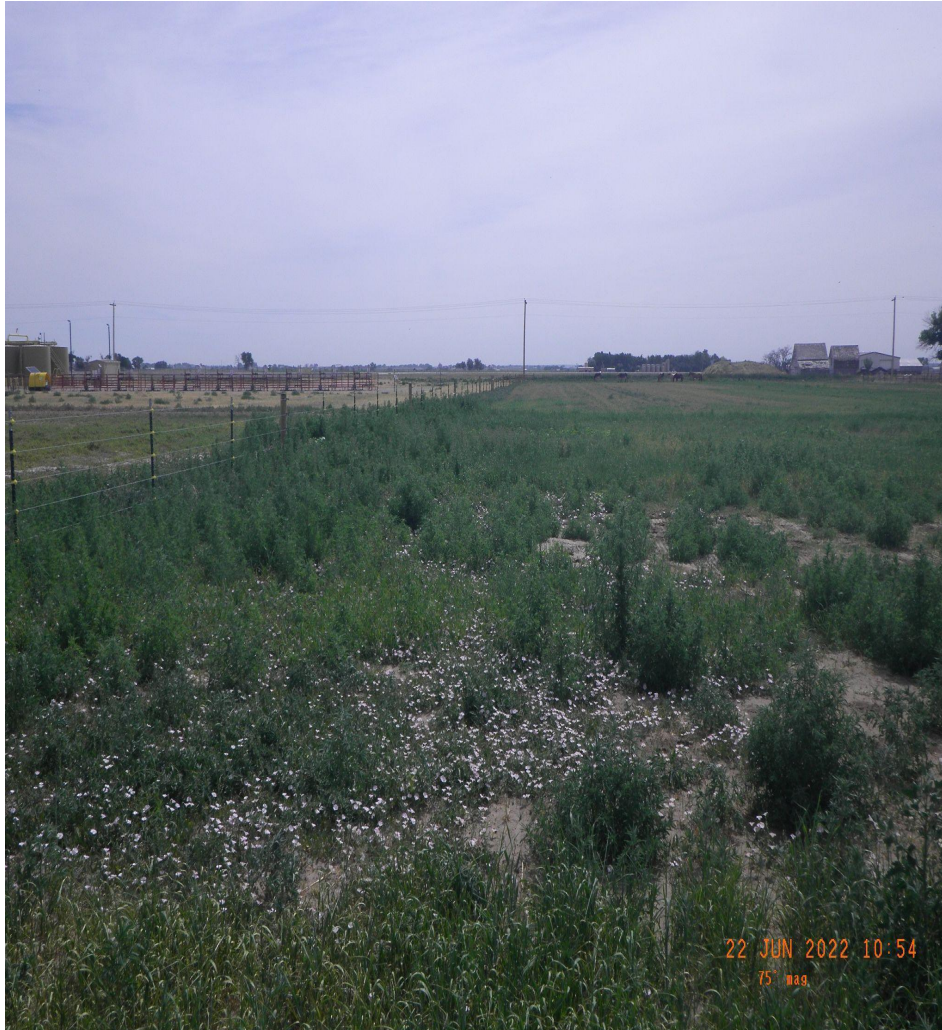
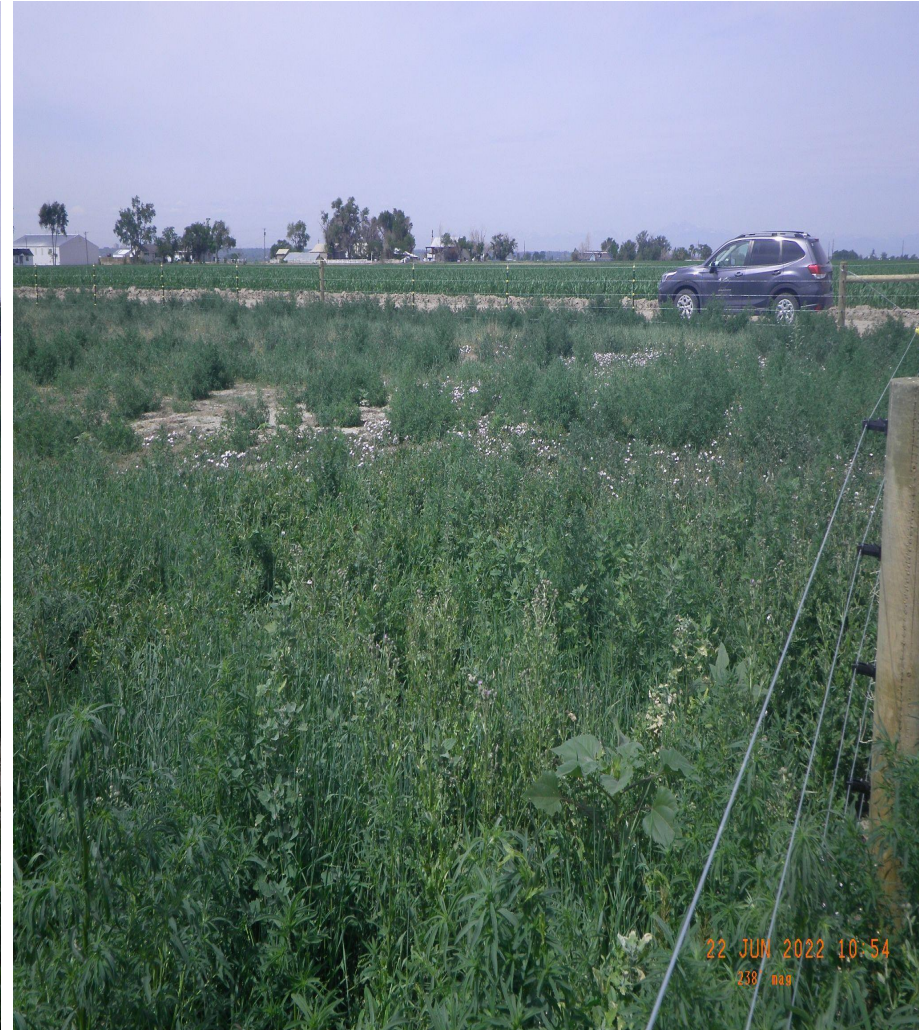
**Photo 2.** Overview photos of the tank battery/well pad disturbance taken at ground level from the western (left) and northern (right) edges. Note: disturbance falls within a horse corral, however, disturbance does not appear consistent with area just to the east (also within horse corral) and has a higher density of weeds (field bindweed).

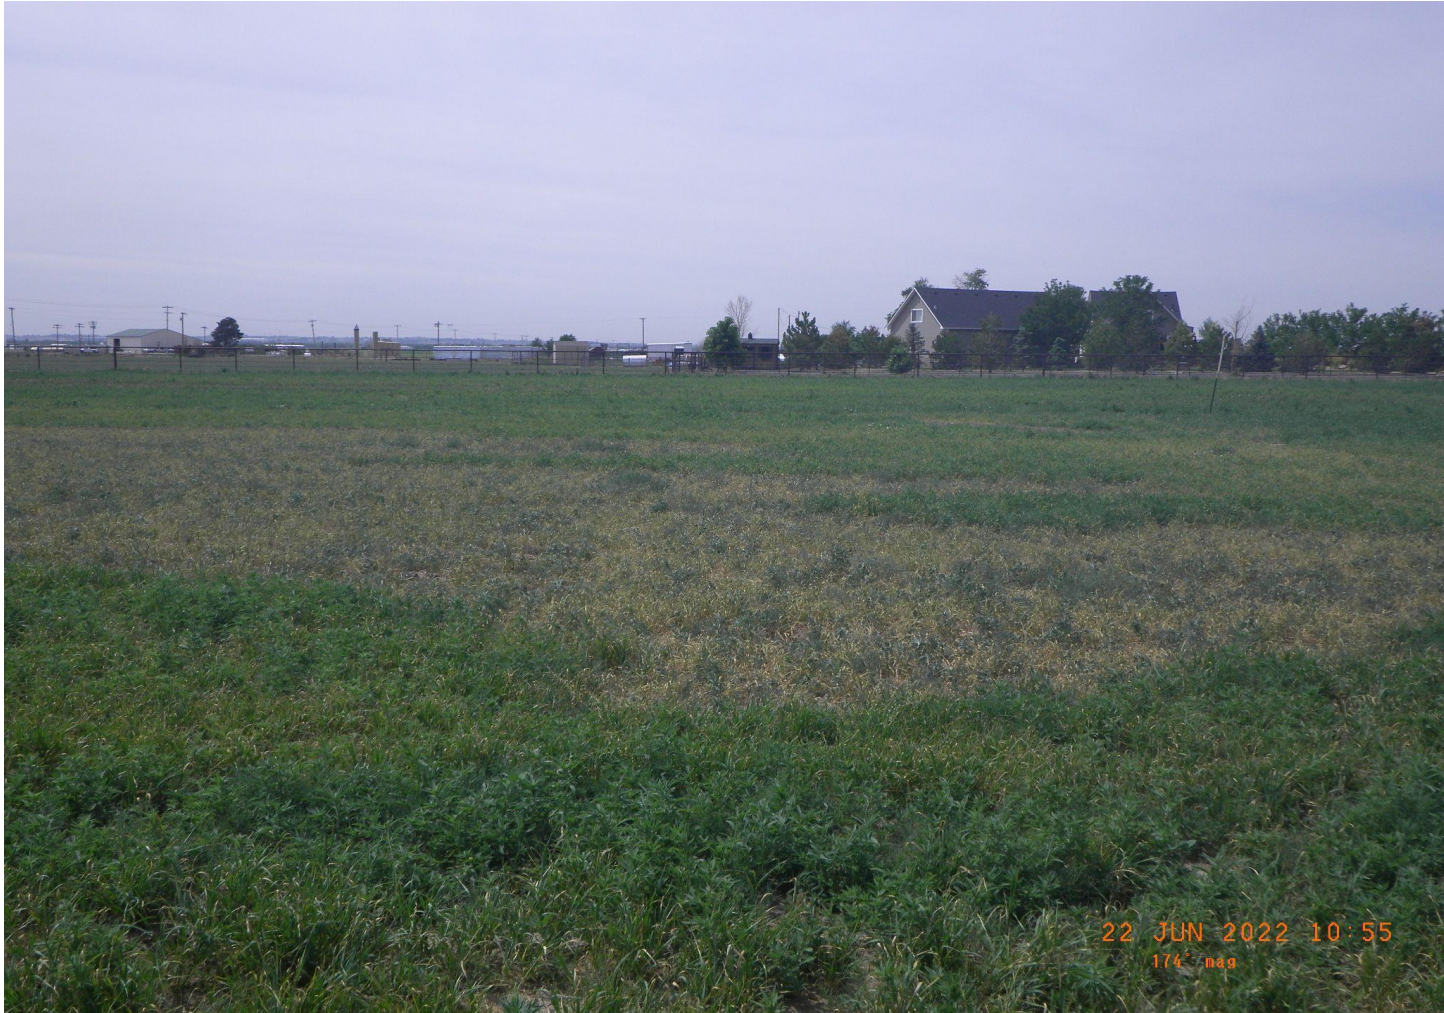
**Photo 3.** Tank battery/well pad reference area.
