Inspection Photos

Operator: EOG Resources Inc - #27742

Location Name: GEHRIG UNIT-612N94W/23SWNW

Inspection Document #: 702800854

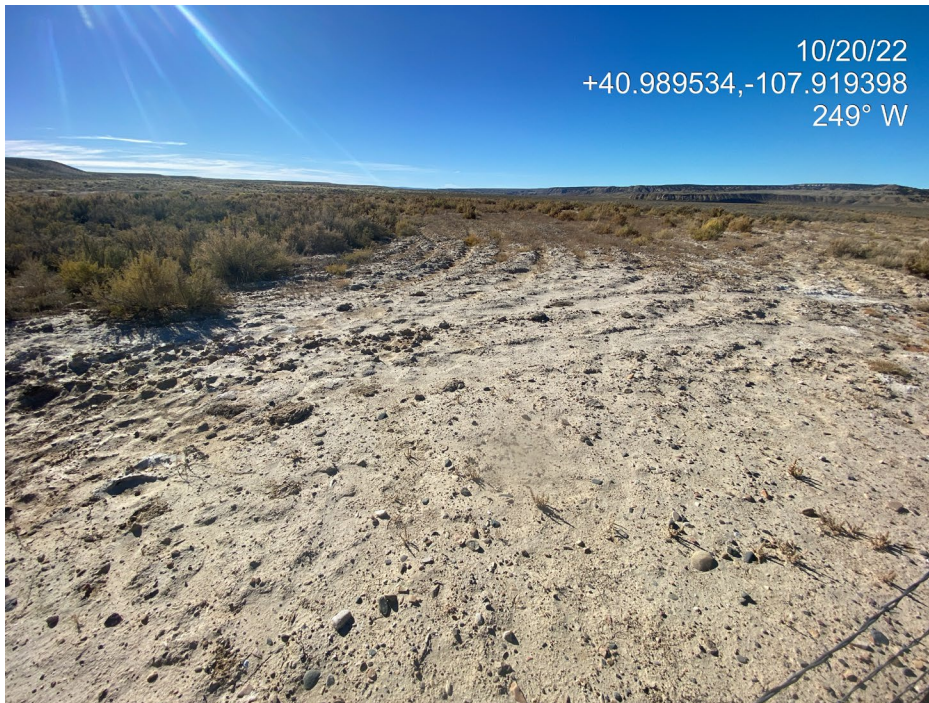
Photo 1. Photo taken to the east of the Location shows the access road is dominated by bare ground and kochia, an annual undesirable plant species/weed.

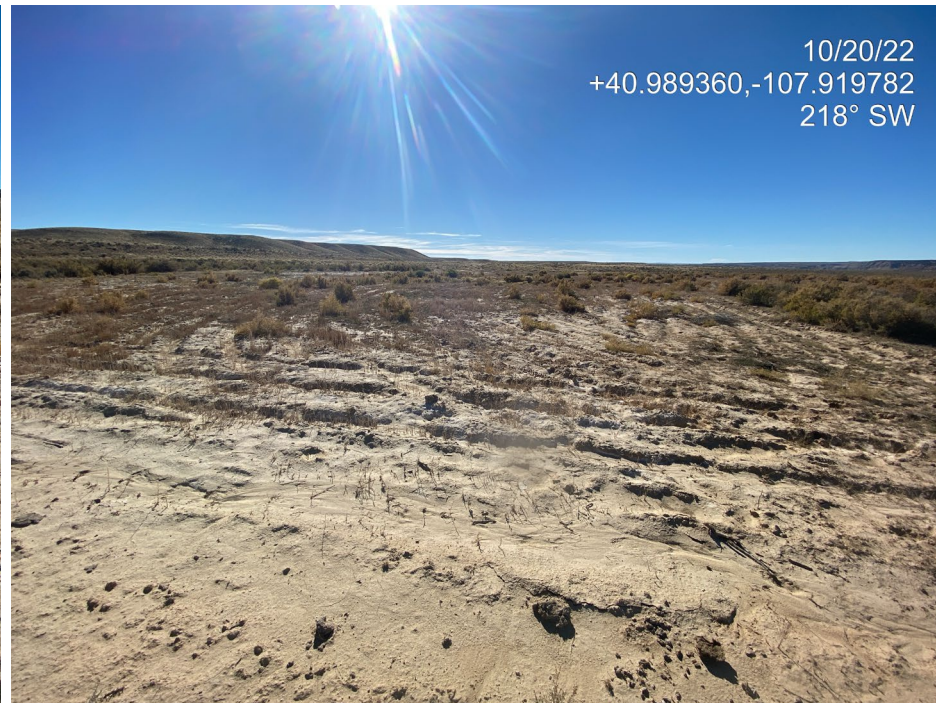
Photo 2. Photo taken from the east shows an overview of the Location. The species shown colonizing the Location in this photo are kochia, annual wheatgrass (annual undesirable plant species) and halogeton (noxious weed). Native shrubs are also present towards the center of the Location.

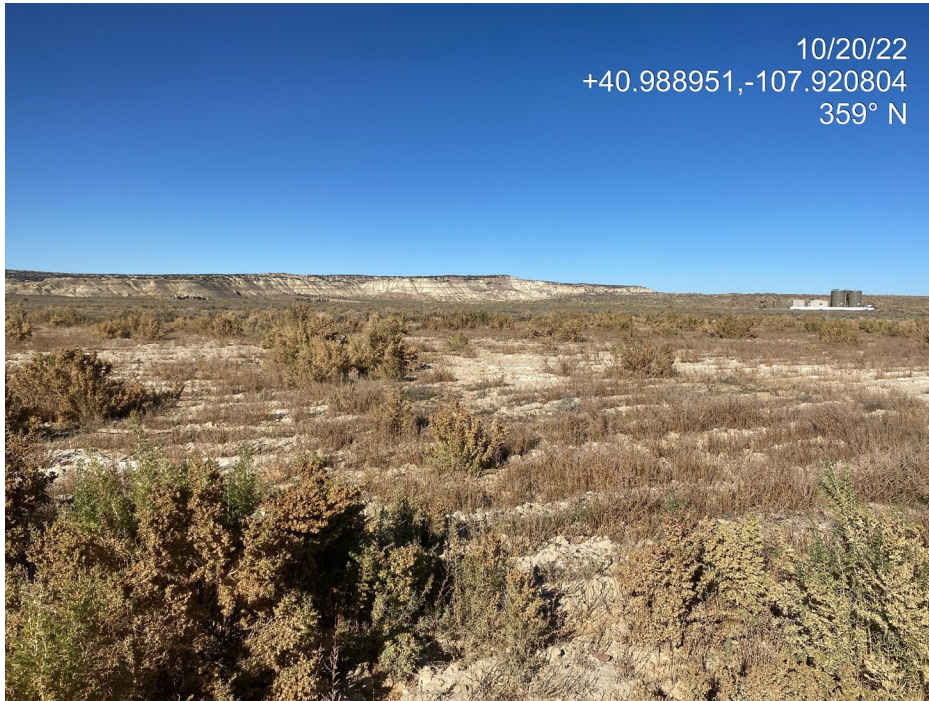
Photo 3. Photo taken from the center of the Location shows an overview to the north. Native shrubs (saltbush spp., rabbitbrush, greasewood) are common. Grasses which appear to have been seeded (western wheatgrass) are rare. The plant community is dominated by annual weeds.

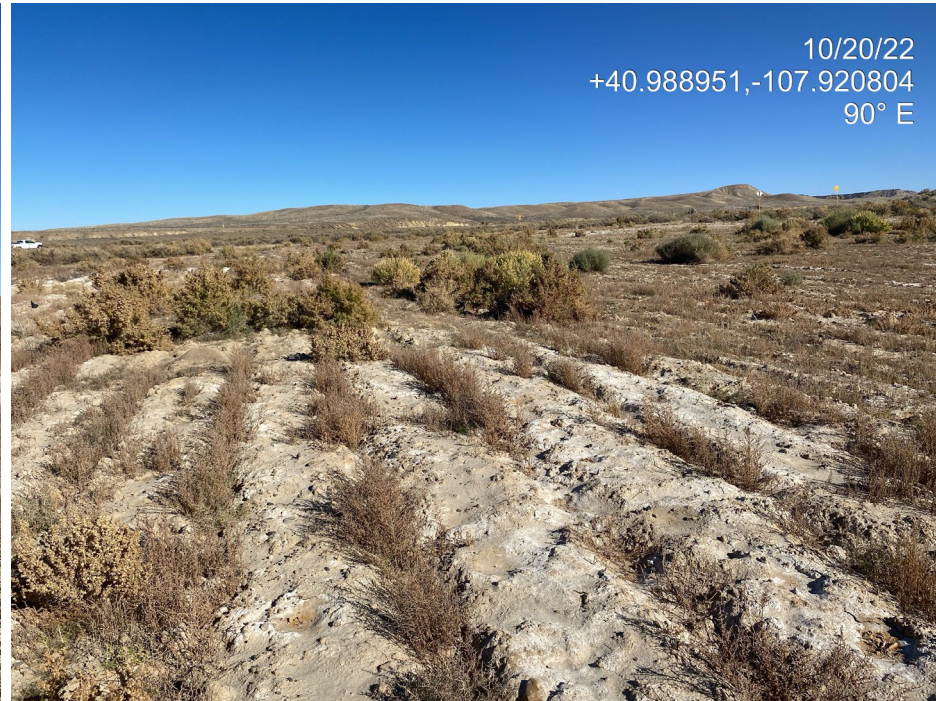
Photo 4. Photo taken from the center of the Location shows an overview to the east.

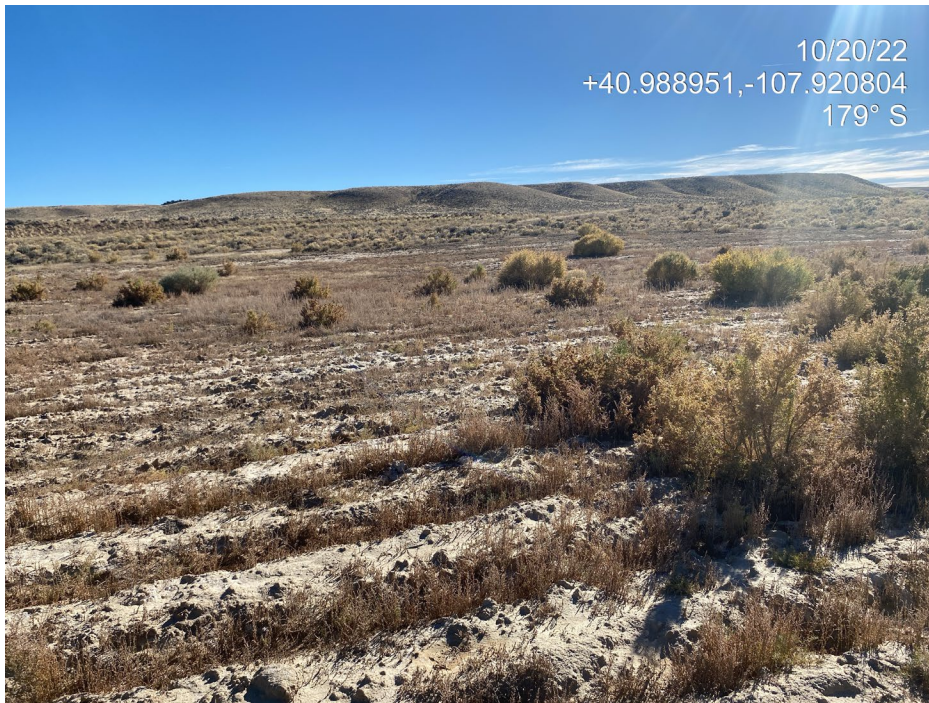
Photo 5. Photo taken from the center of the Location shows an overview to the south.

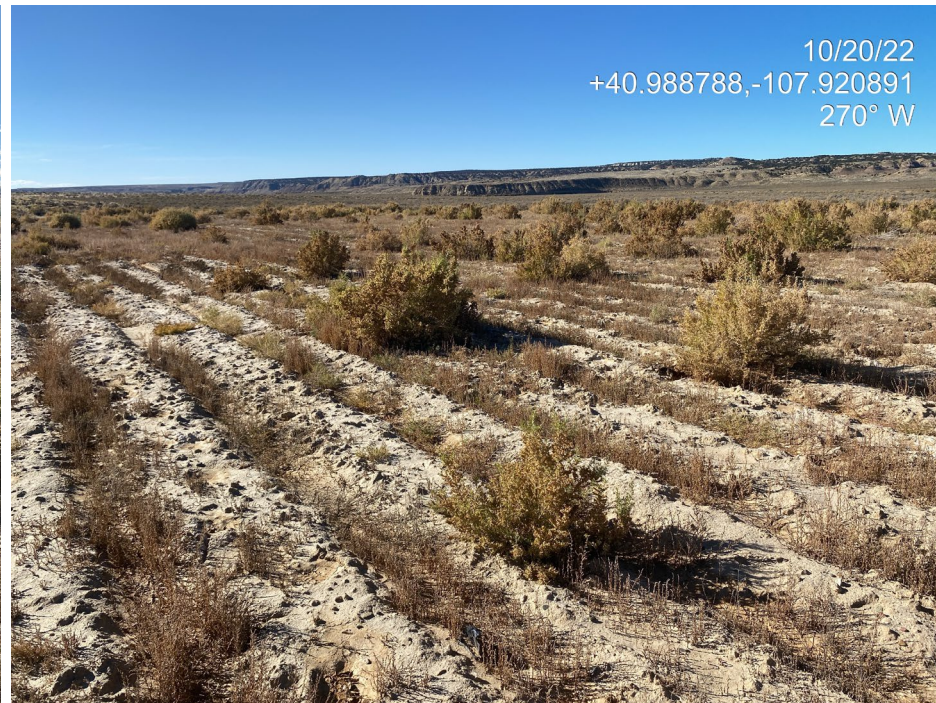
Photo 6. Photo taken from the center of the Location shows an overview to the west.

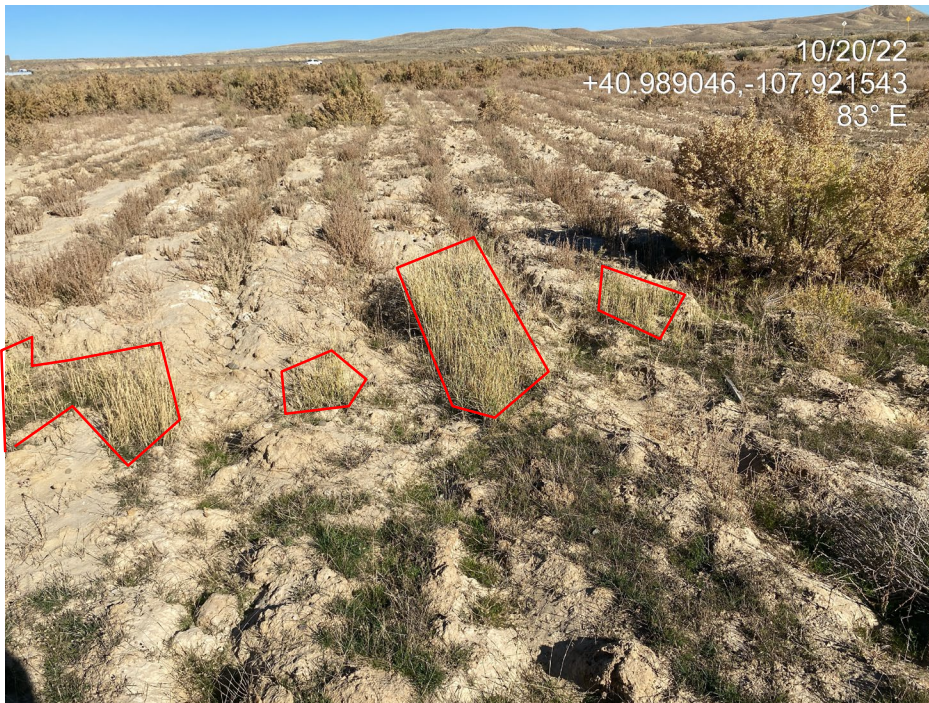
Photo 7. Photo taken from the west of the Location shows small patches of western wheatgrass, a native perennial grass which appears to have been seeded, but is rare and largely unsuccessful. All other herbaceous species pictured are noxious weeds and undesirable plant species.

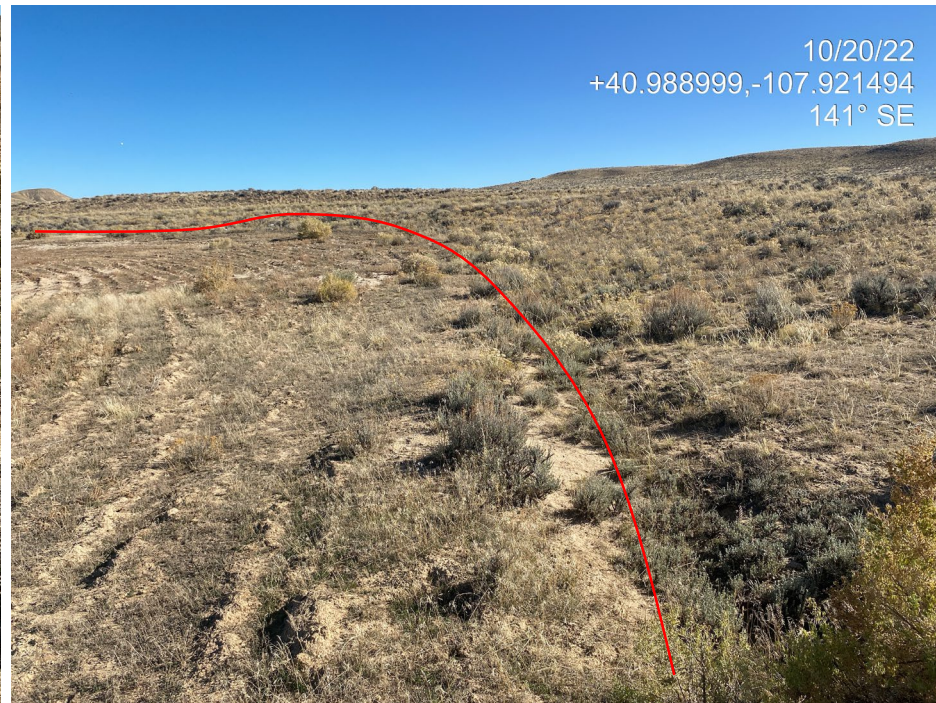
Photo 8. Photo taken from the west shows the contrast between the disturbed Location (left) and adjacent reference area (right).

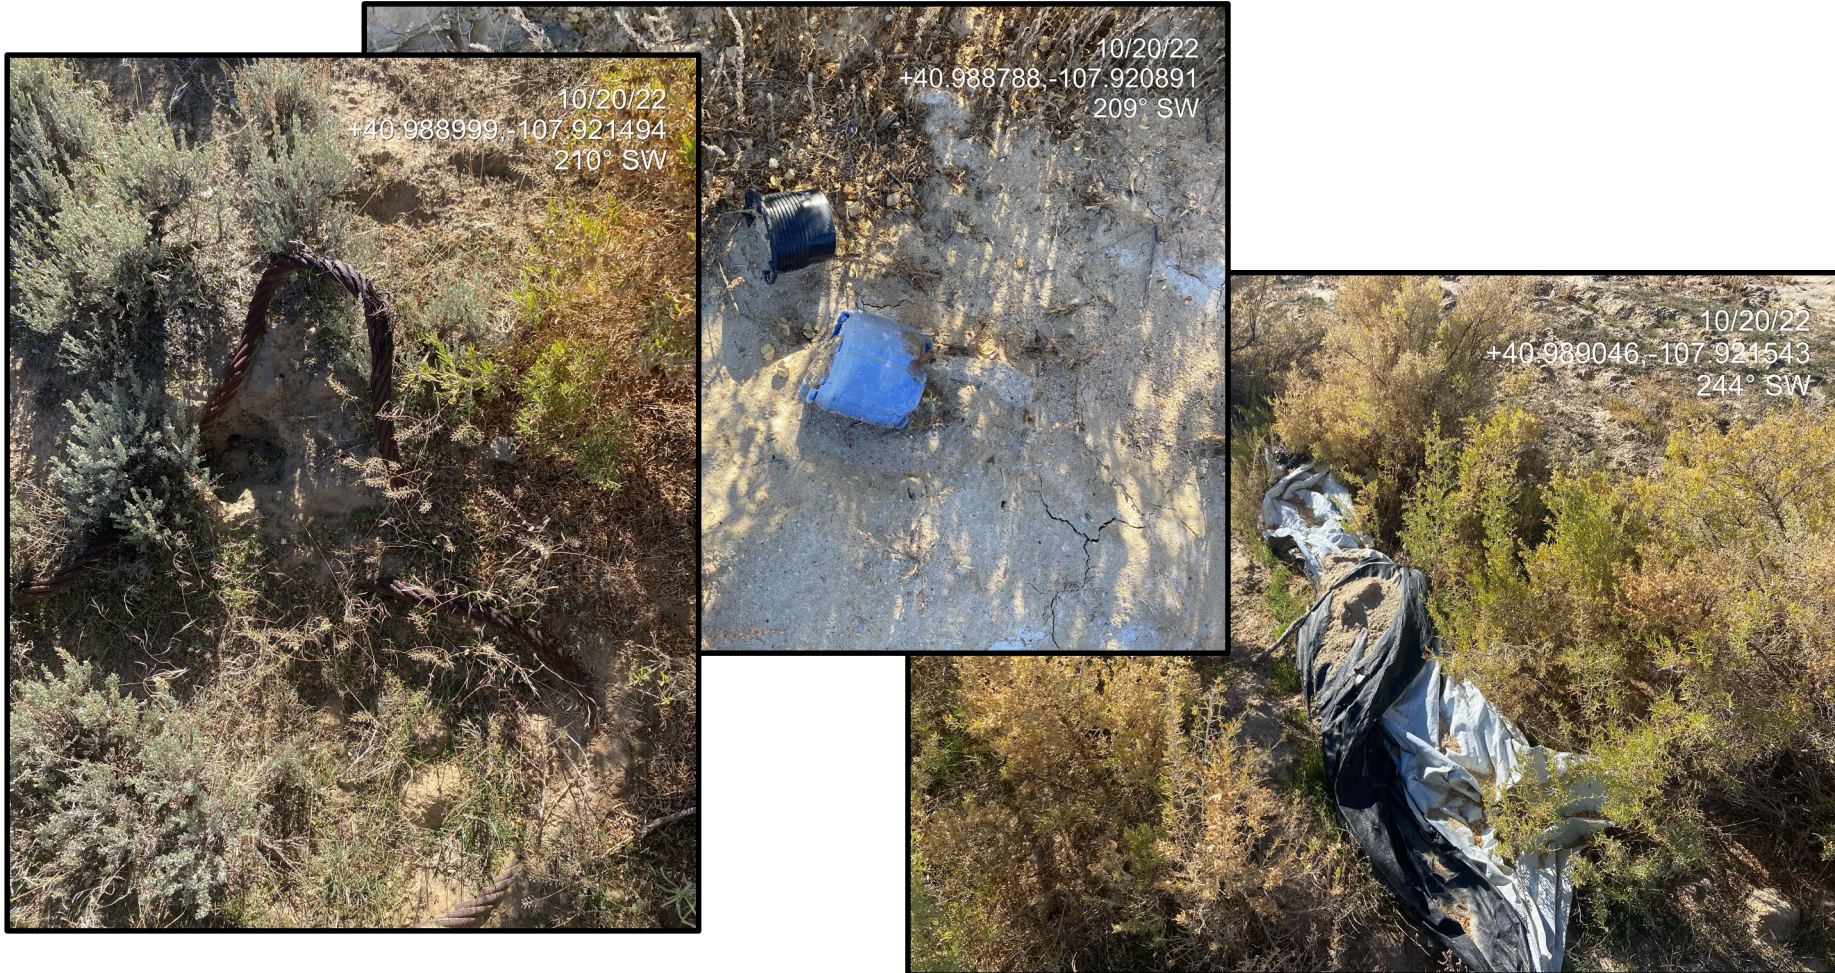
Photo 9. Photos show examples of trash/debris on Location.

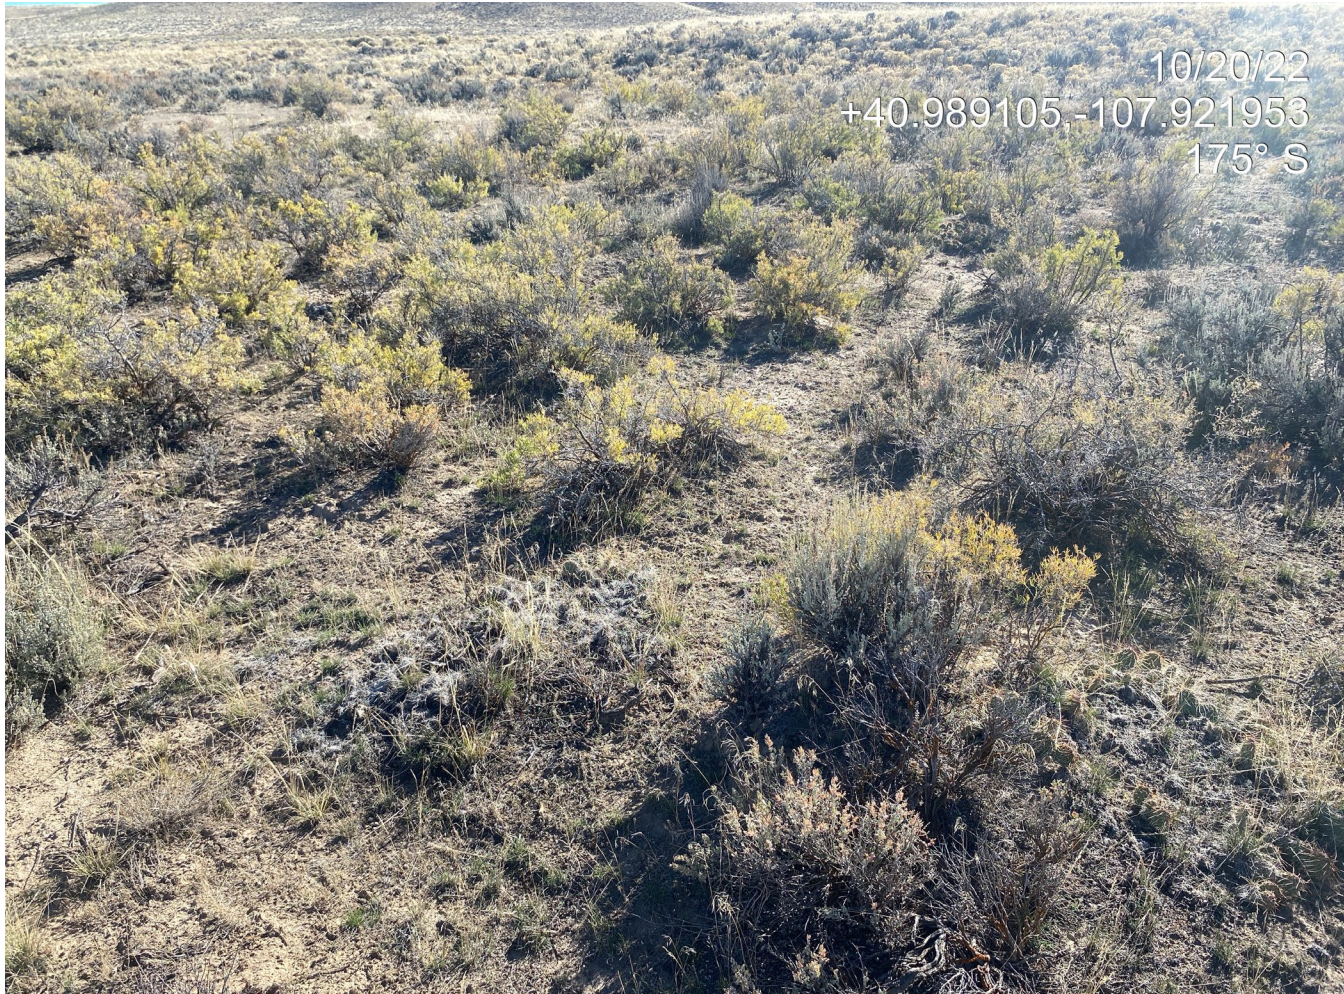
Photo 10. Photo taken to the northwest shows the reference area vegetation community.
