Interim Reclamation and Stormwater Inspection

Operator: VERDAD RESOURCES LLC #10651

Location ID: 429096

Inspection Photos
Location Name: Pergamos/3-11-7-60
Location ID: 429096

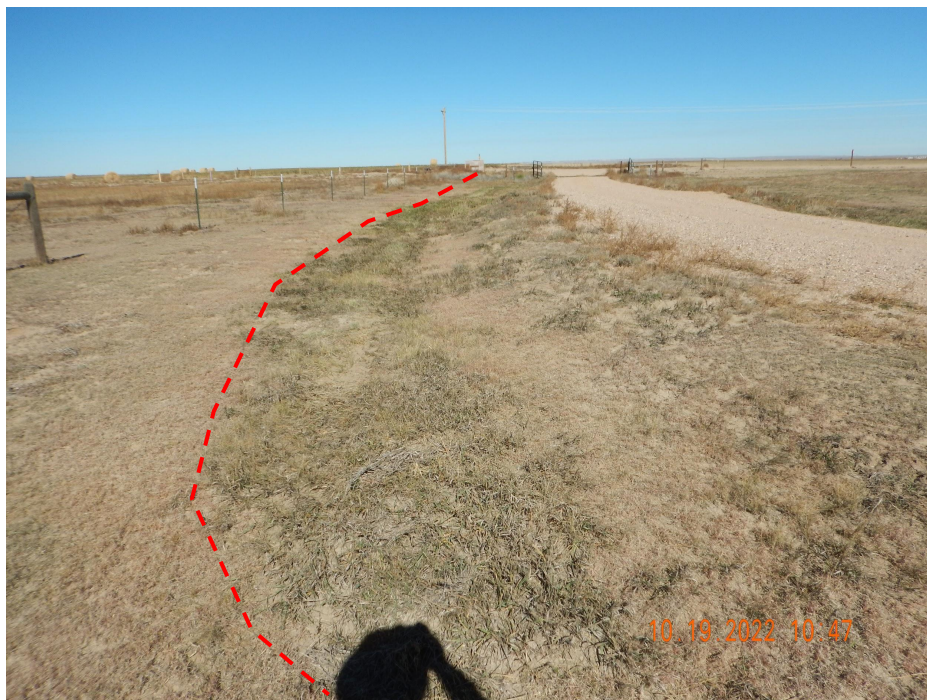
Photo 1. Photo taken from the northwestern interim reclamation area, facing North. Photo illustrates the establishment of mostly introduced grass species which is not reflective of reference areas.

Reference areas are to the left of the red-dashed; interim areas are to the right.

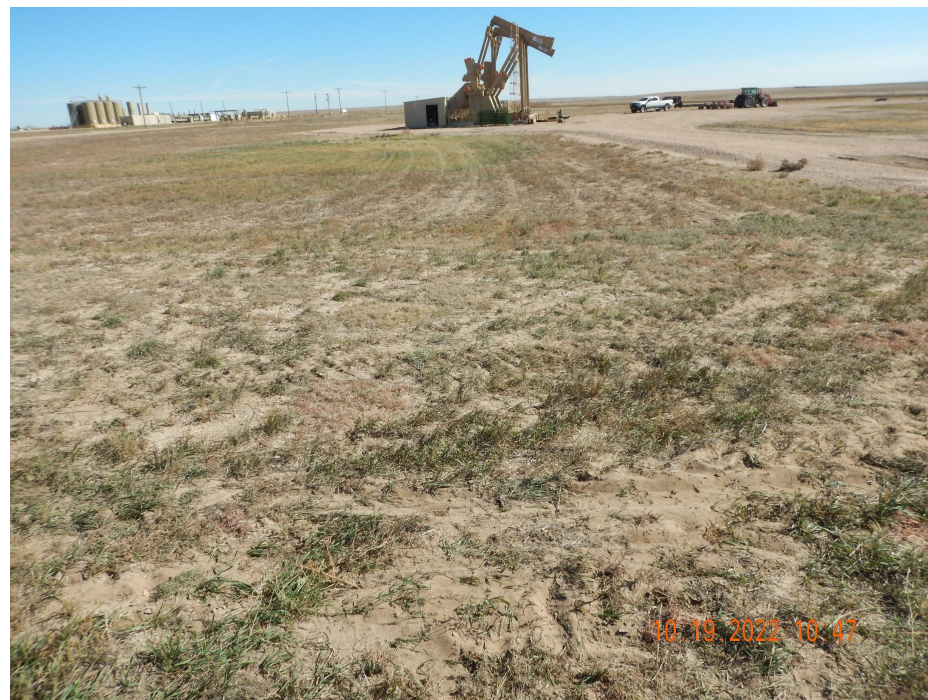
Photo 2. Photo taken from the northwestern interim reclamation area, facing East. See comments under Photo 1.

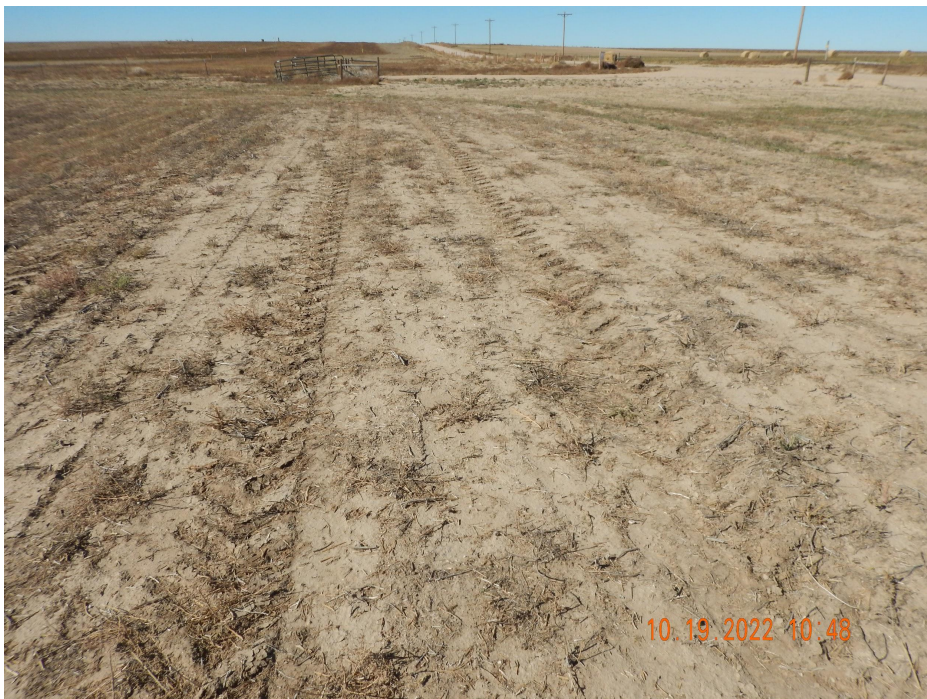
Photo 3. Photo taken from the northern interim reclamation area, facing West. Photo illustrates bare ground with some Kochia establishment.

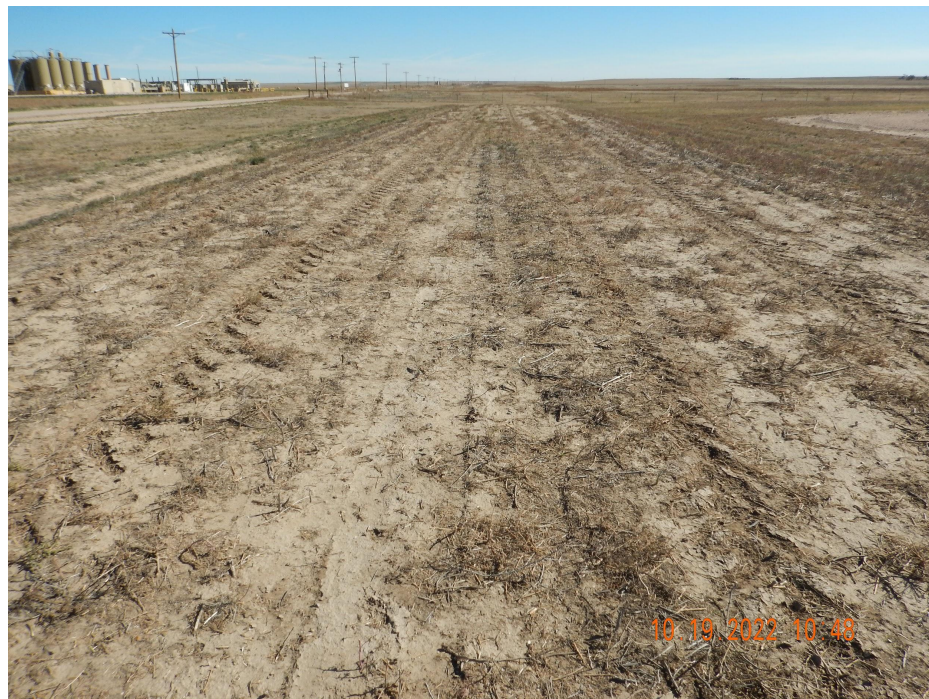
Photo 4. Photo taken from the northern interim reclamation, facing East. See comments under Photo 1.

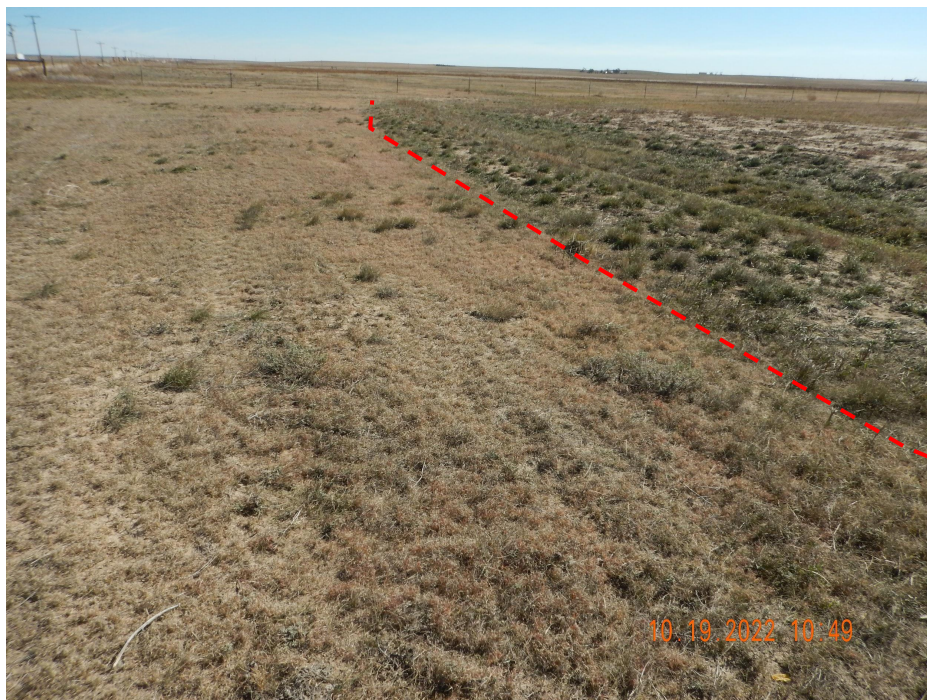
Photo 5. Photo taken from the northeastern interim reclamation area, facing East. Photo illustrates the establishment of introduced grass species within the interim reclamation areas which is not reflective of reference areas.

Reference areas are to the left of the red-dashed; interim areas are to the right.

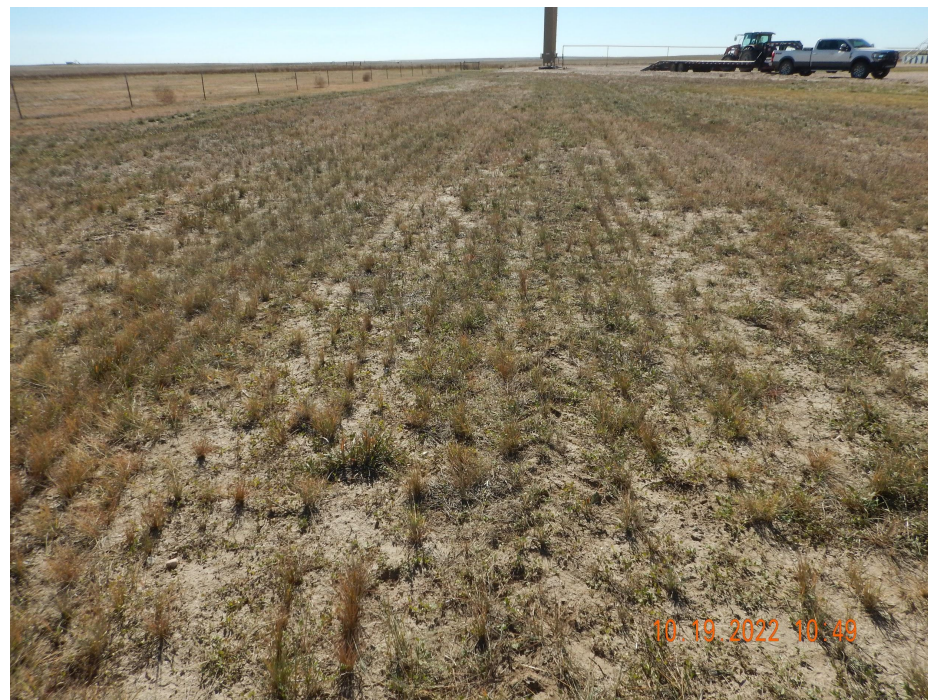
Photo 6. Photo taken from the northeastern interim reclamation area, facing South. Photo illustrates a mix of native and introduced grass species.

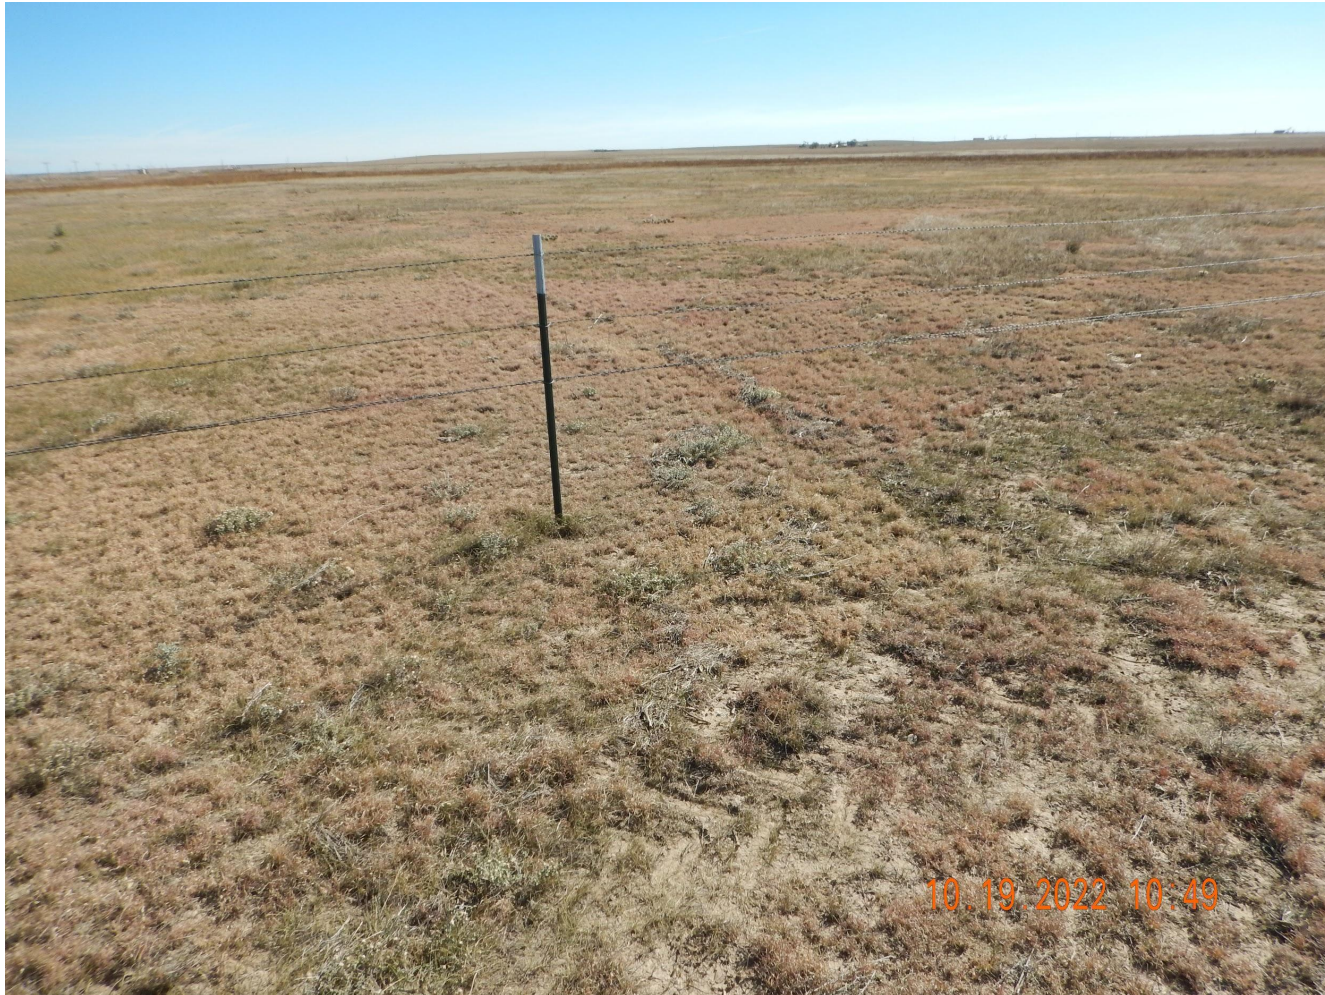
Photo 7. Reference photo taken from the eastern location, facing East. Photo illustrates native grass species and no introduced grass species were observed.
