# Inspection Photos

Operator: EOG Resources Inc - #27742

Location Name: BIG HOLE GULCH UNIT #3/3

Inspection Document #: 702800865

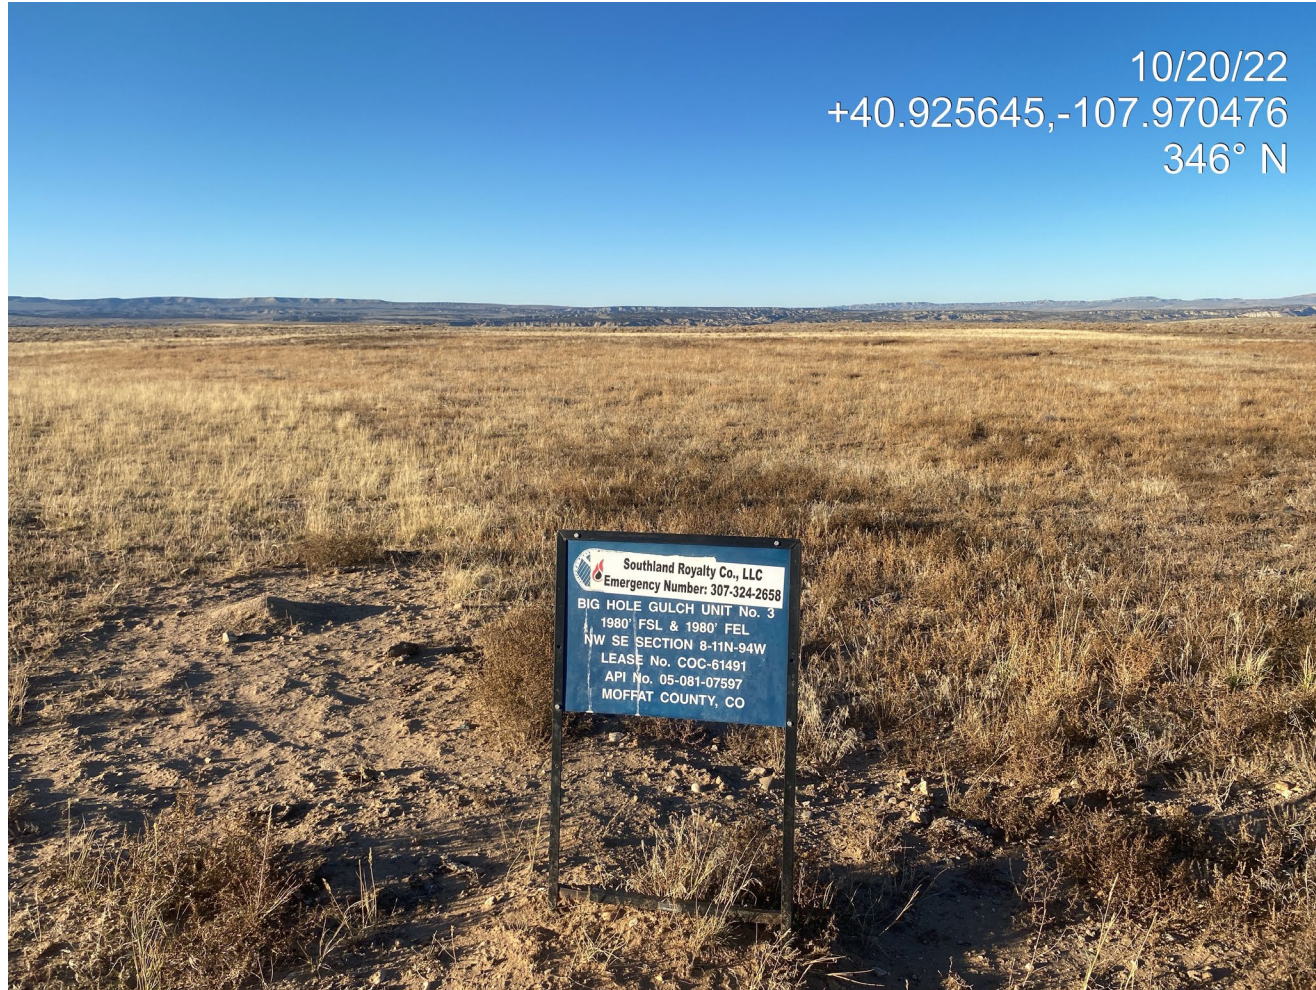
**Photo 1.** Photo taken from the south shows an overview of the Location.

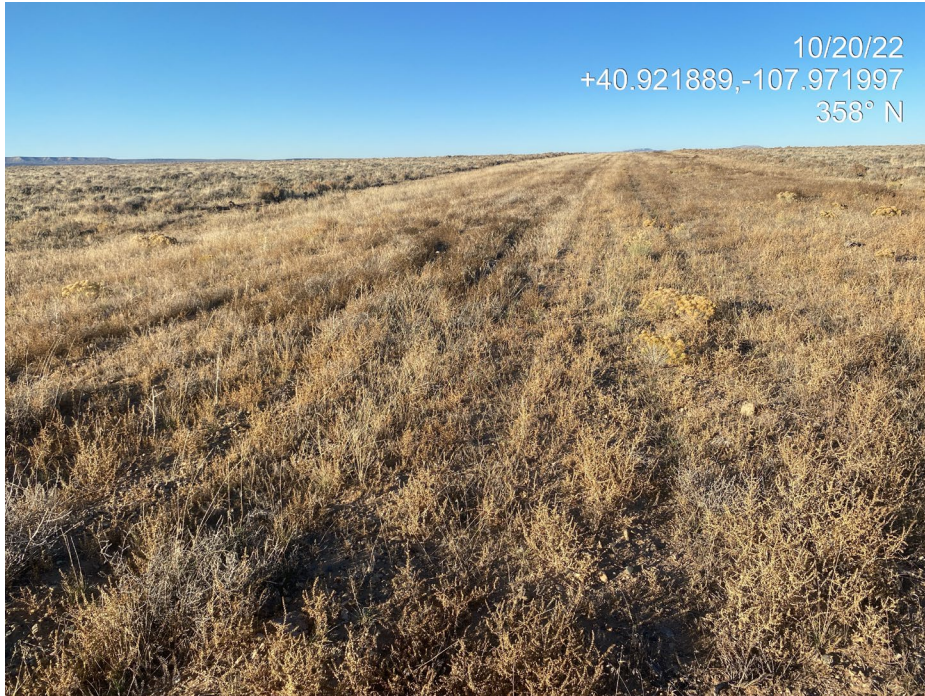
**Photo 2.** Photo taken to the south shows the reclaimed access road.

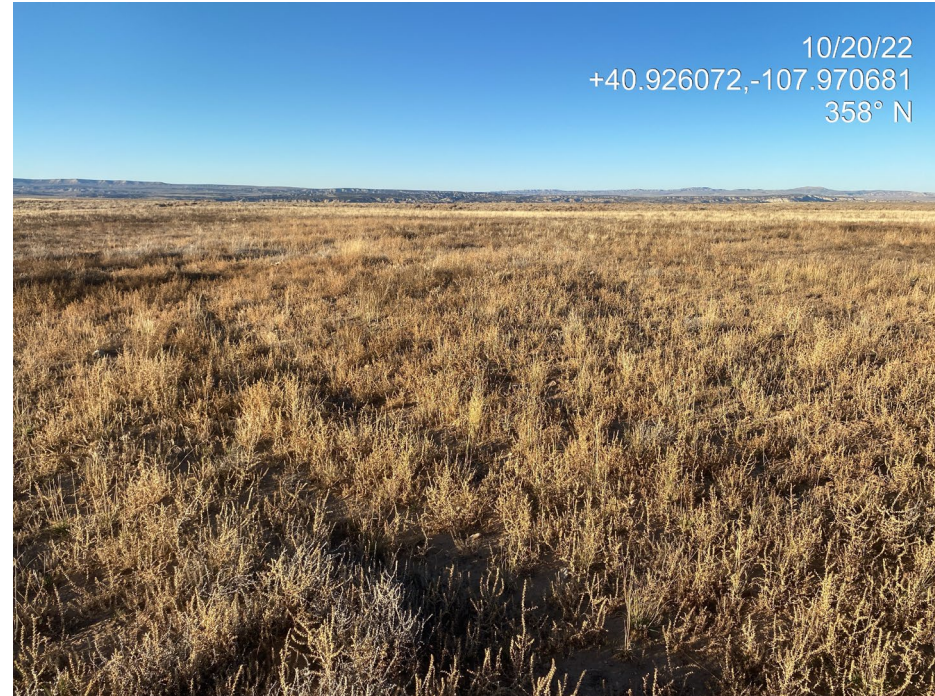
**Photo 3.** Photo shows newly reclaimed areas are a mix of seeded perennial species and annual undesirable plant species/weeds.

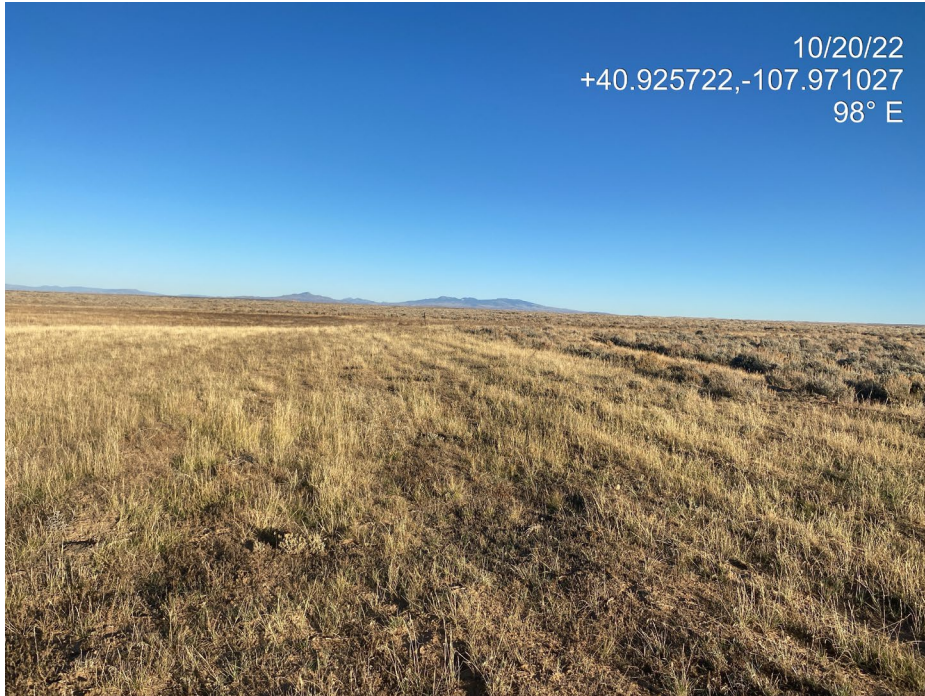
**Photo 4.** Photo taken from the southwest shows previously reclaimed interim areas. Perennial grasses are well established, but do not yet appear to meet 1004 vegetation standards.

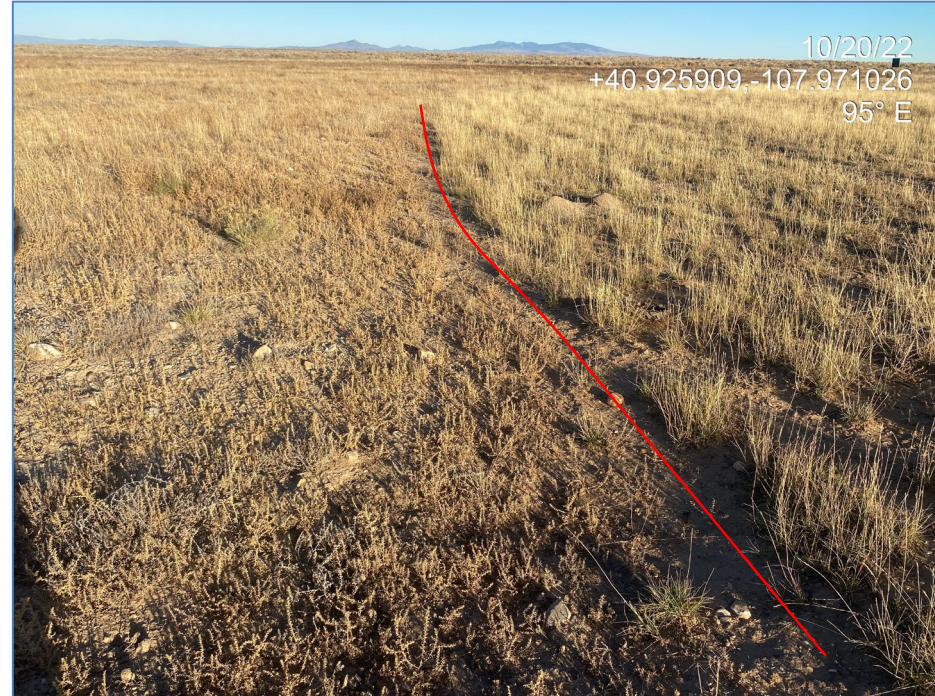
**Photo 5.** Photo taken from the southwest shows previously reclaimed interim areas (right) and recently reclaimed areas (left) where annual weeds are very common and perennial species are less common.

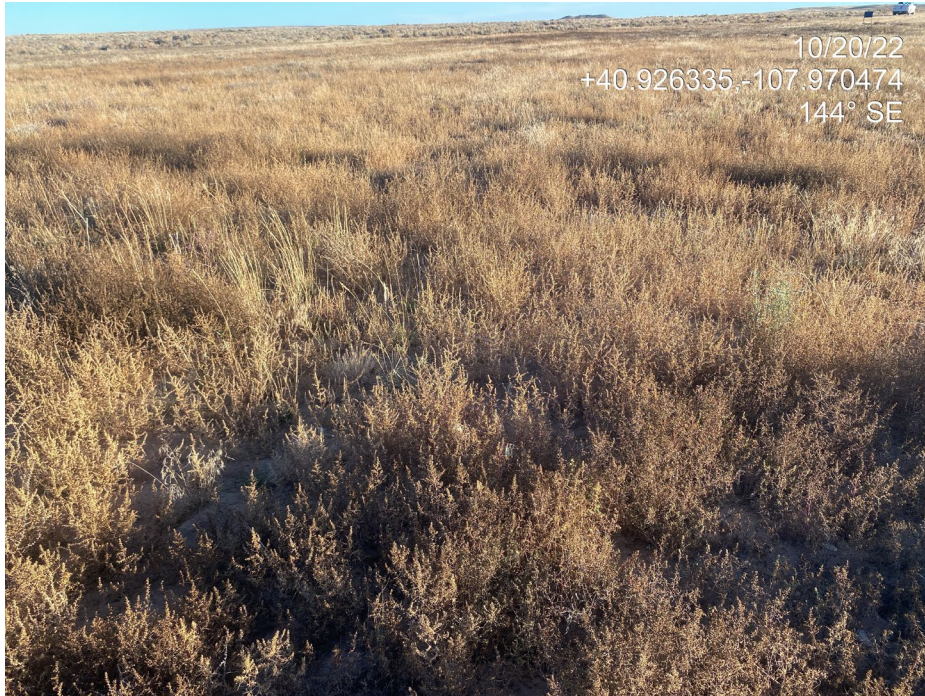
**Photo 6.** Photo taken from the north of the recently reclaimed area. Photo shows some perennial grass establishment and dense cover of annual undesirable plant species/weeds (Russian thistle).

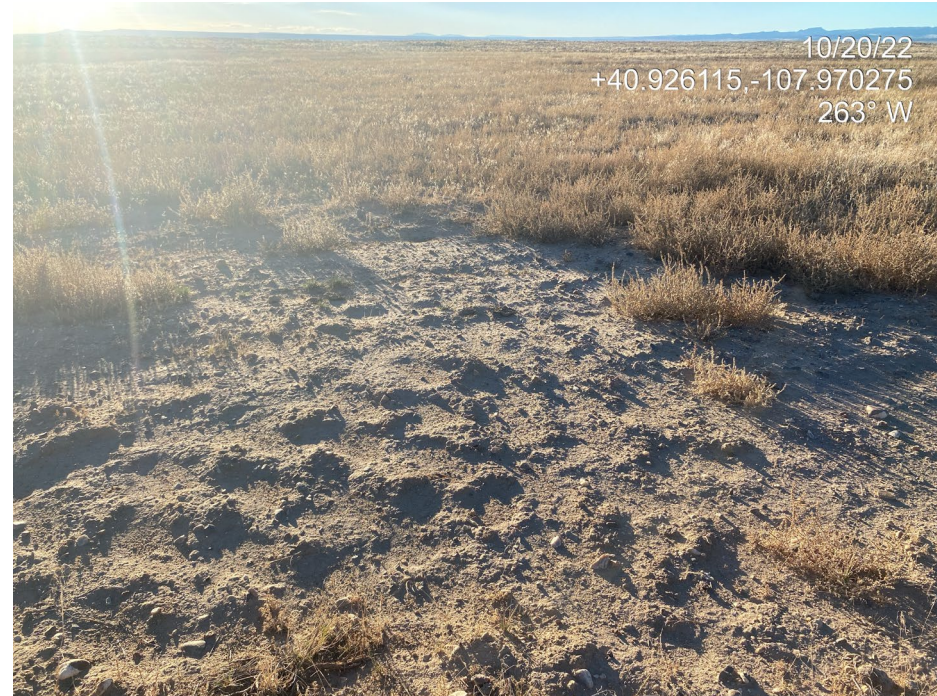
**Photo 7.** Photo shows bare ground, poor perennial establishment and dominance of Russian thistle.

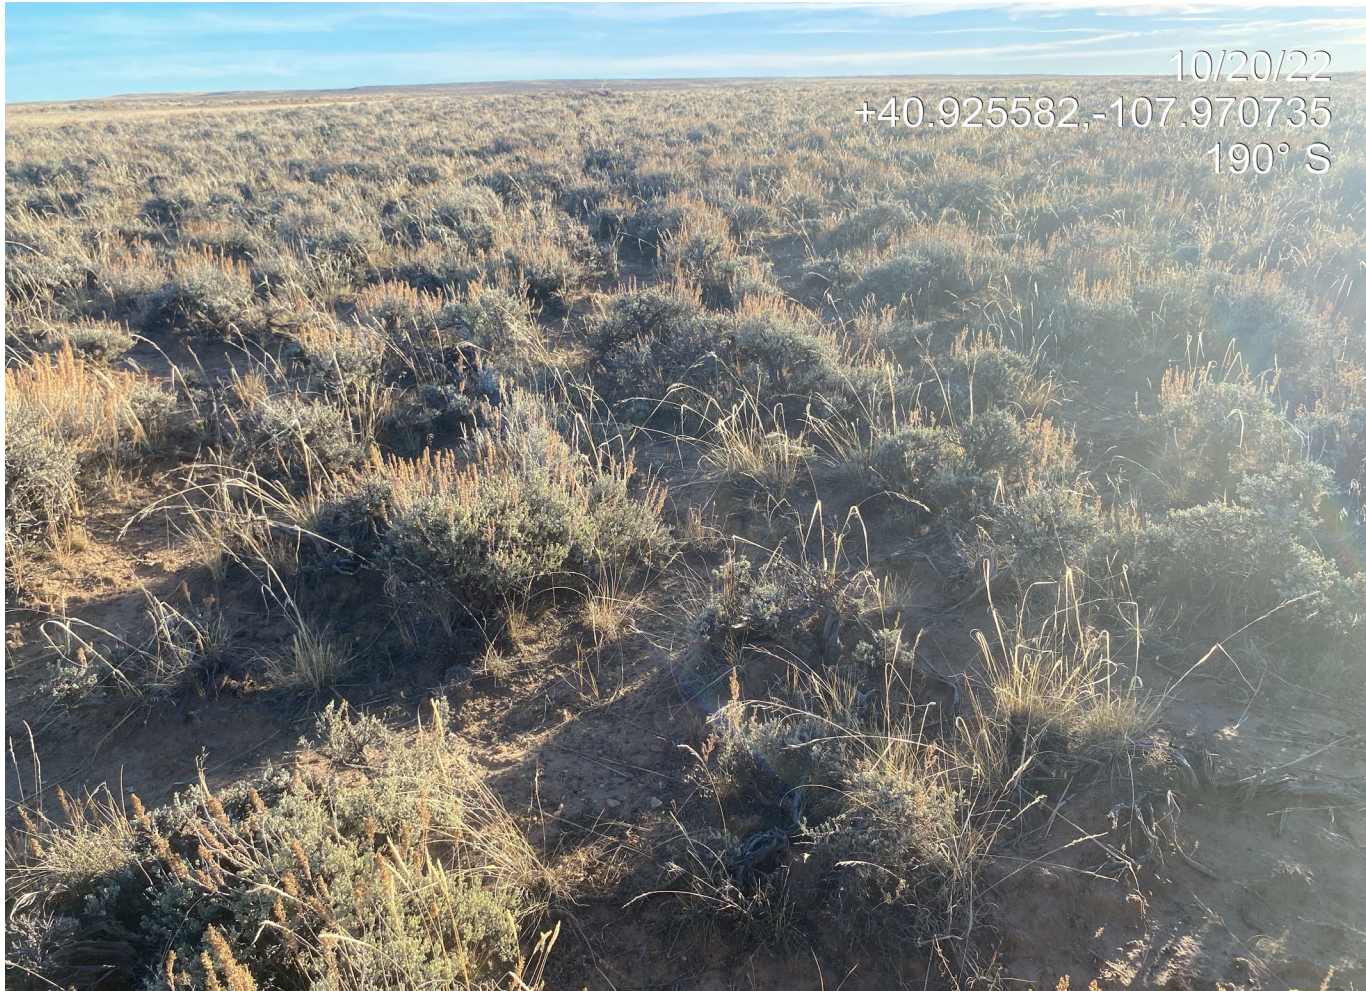
**Photo 8.** Photo taken to the south shows the reference area vegetation community.
