Final Reclamation and Stormwater Inspection

Location ID: 387770

Inspection Document #: 696105554

Inspection Photos
Location Name: LUTHER #1
Location ID: 387770

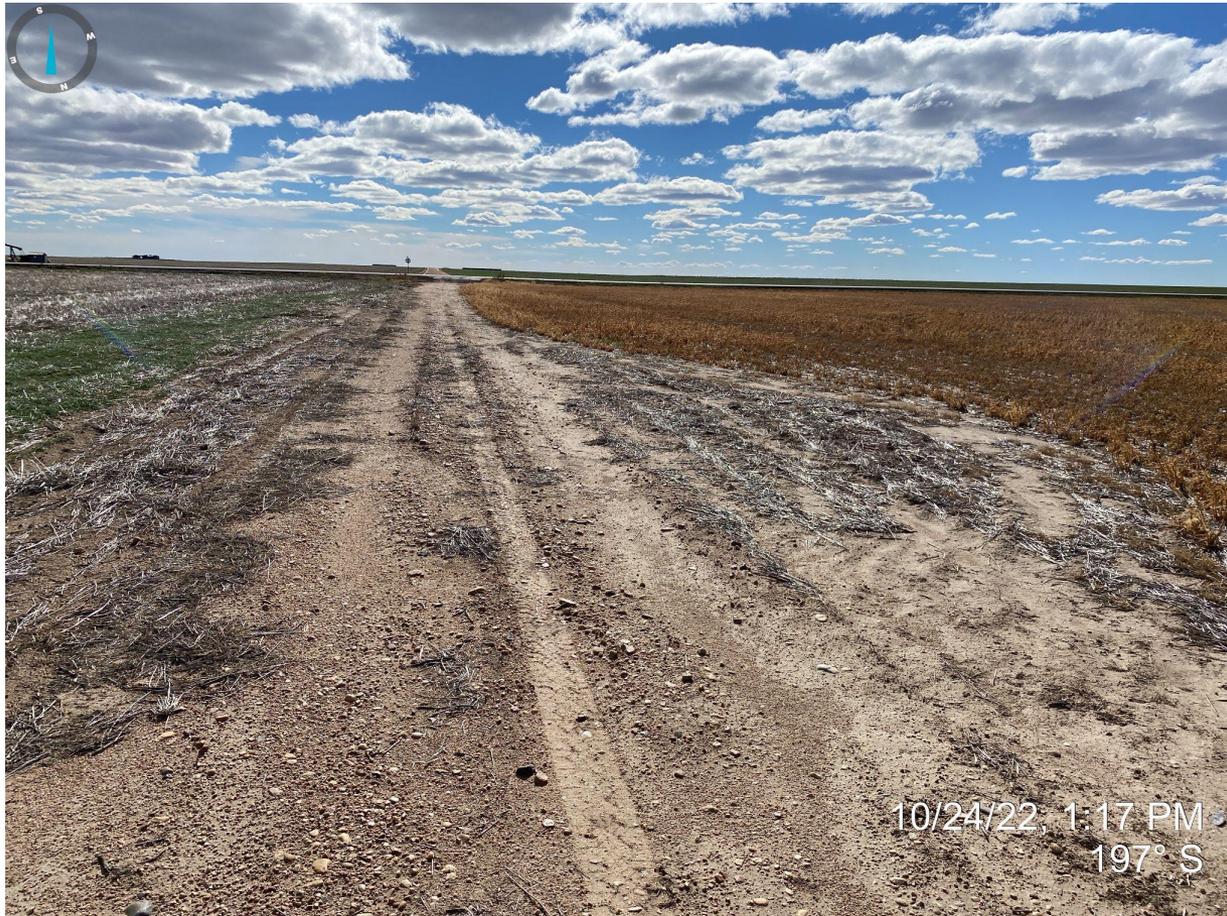
Photo 1. Taken from access road, facing south. Photo illustrates the access road has not been reclaimed with presence of road base/gravel.

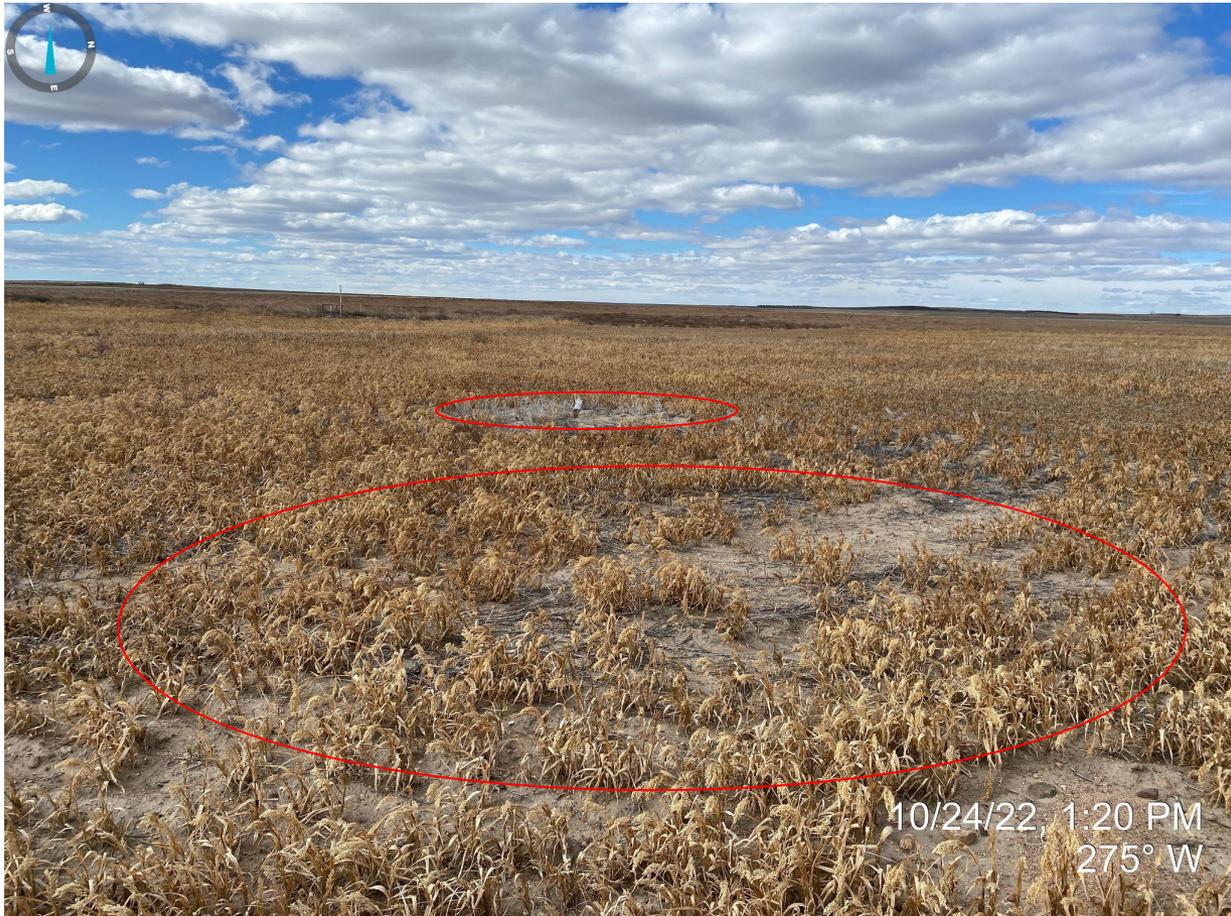
Photo 2. Taken near well location, facing west. Photo illustrates non-uniform vegetation cover and pipe sticking out of the ground.

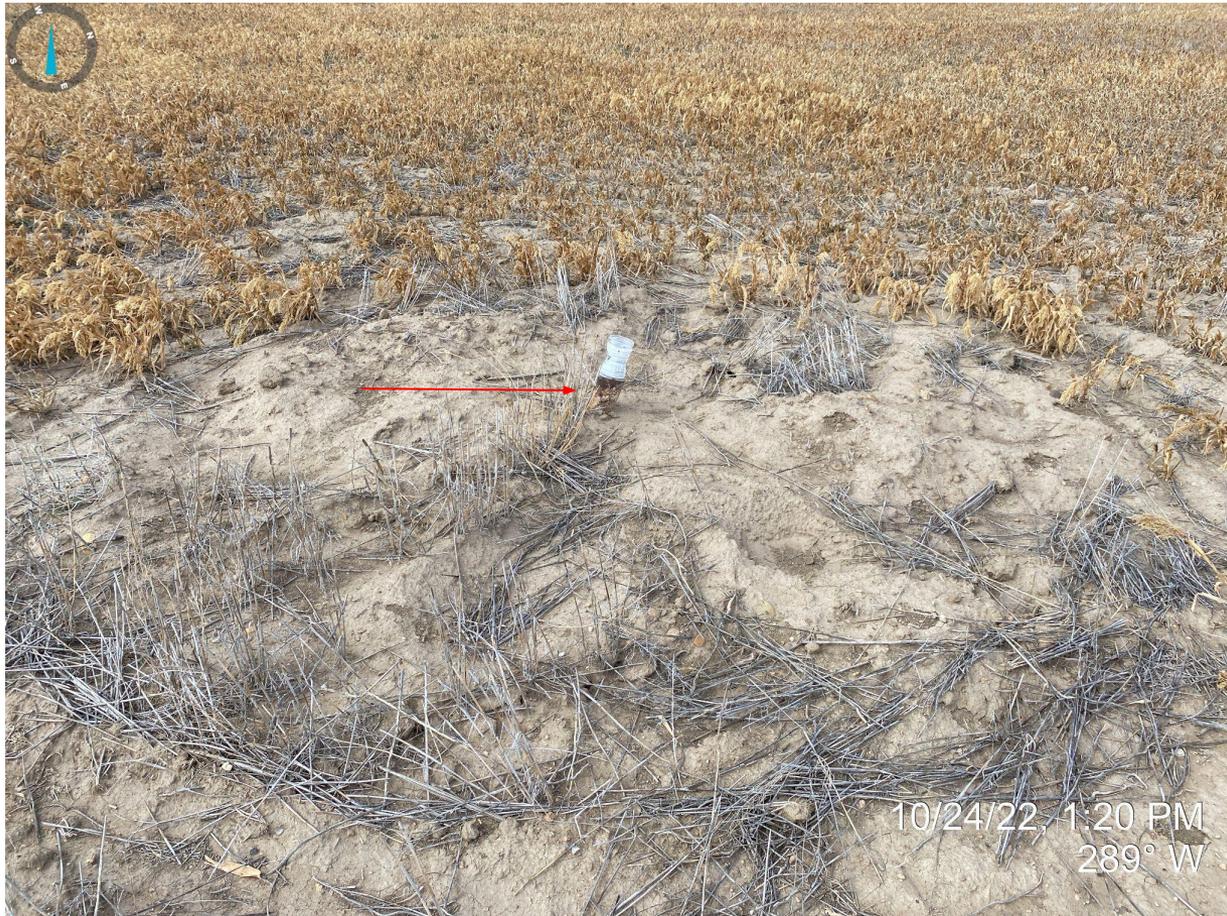
Photo 3. Close up photo of well location. See comments in Photo 2.

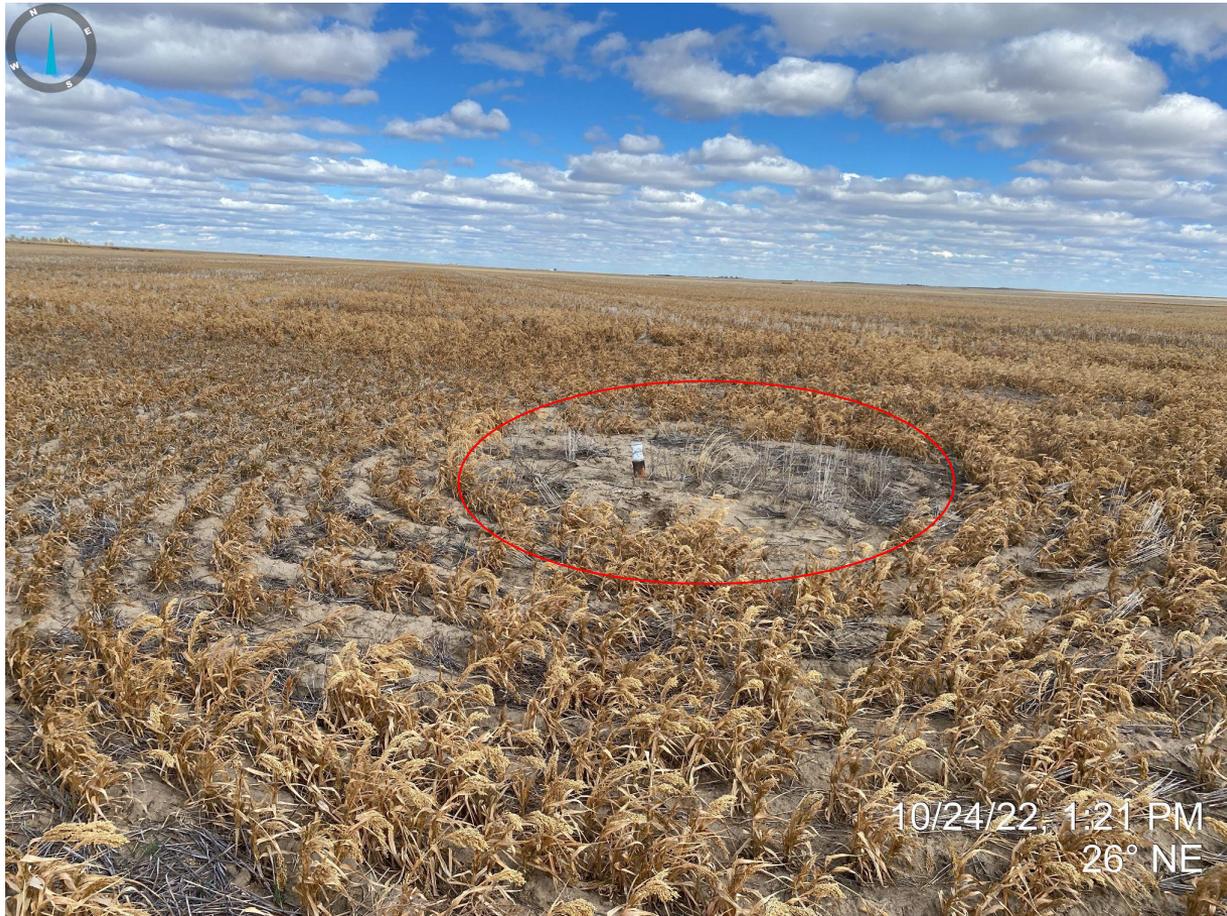
Photo 4. Facing northeast, see comments in Photo 2.

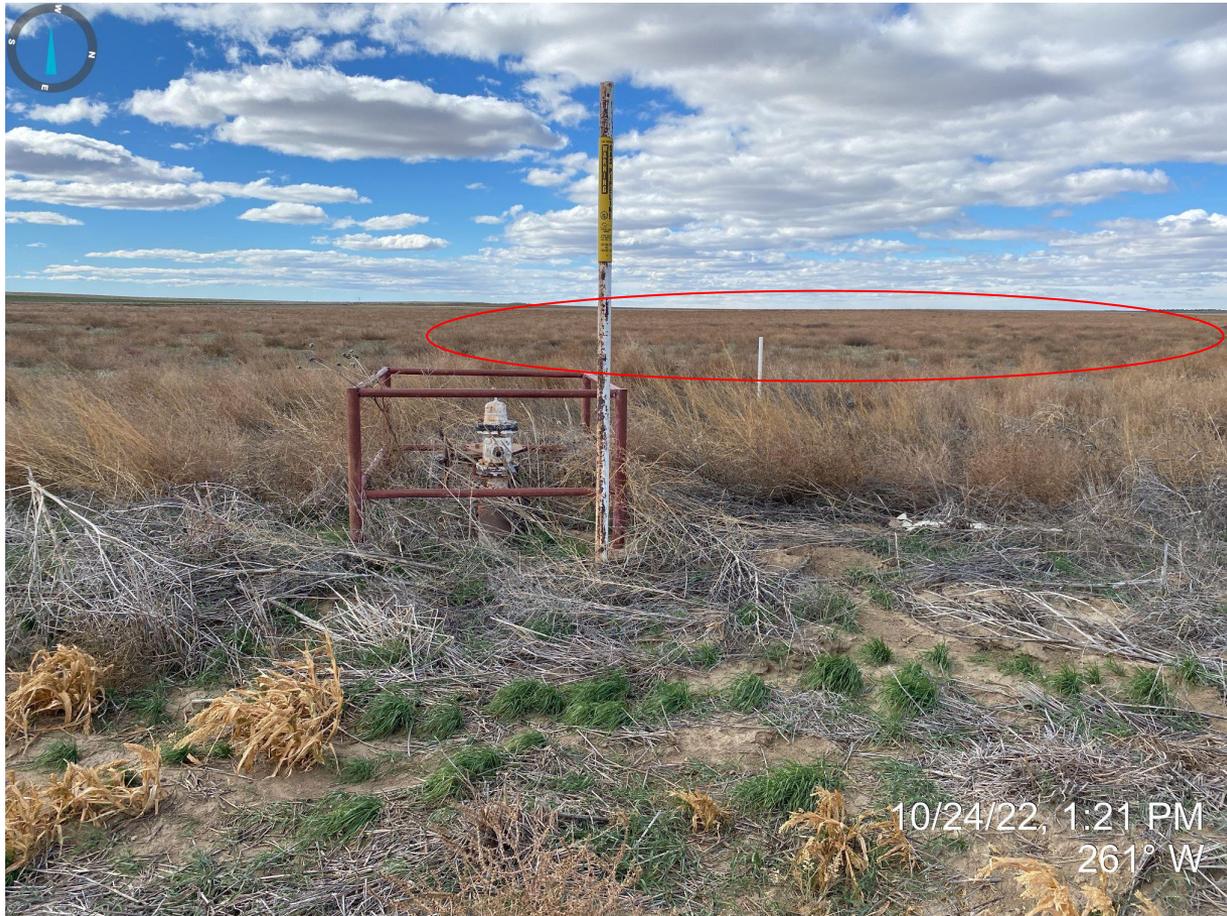
Photo 5. Taken west of location, facing west. Background illustrates pit location is predominantly undesirable vegetation (e.g. kochia) outlined in red.

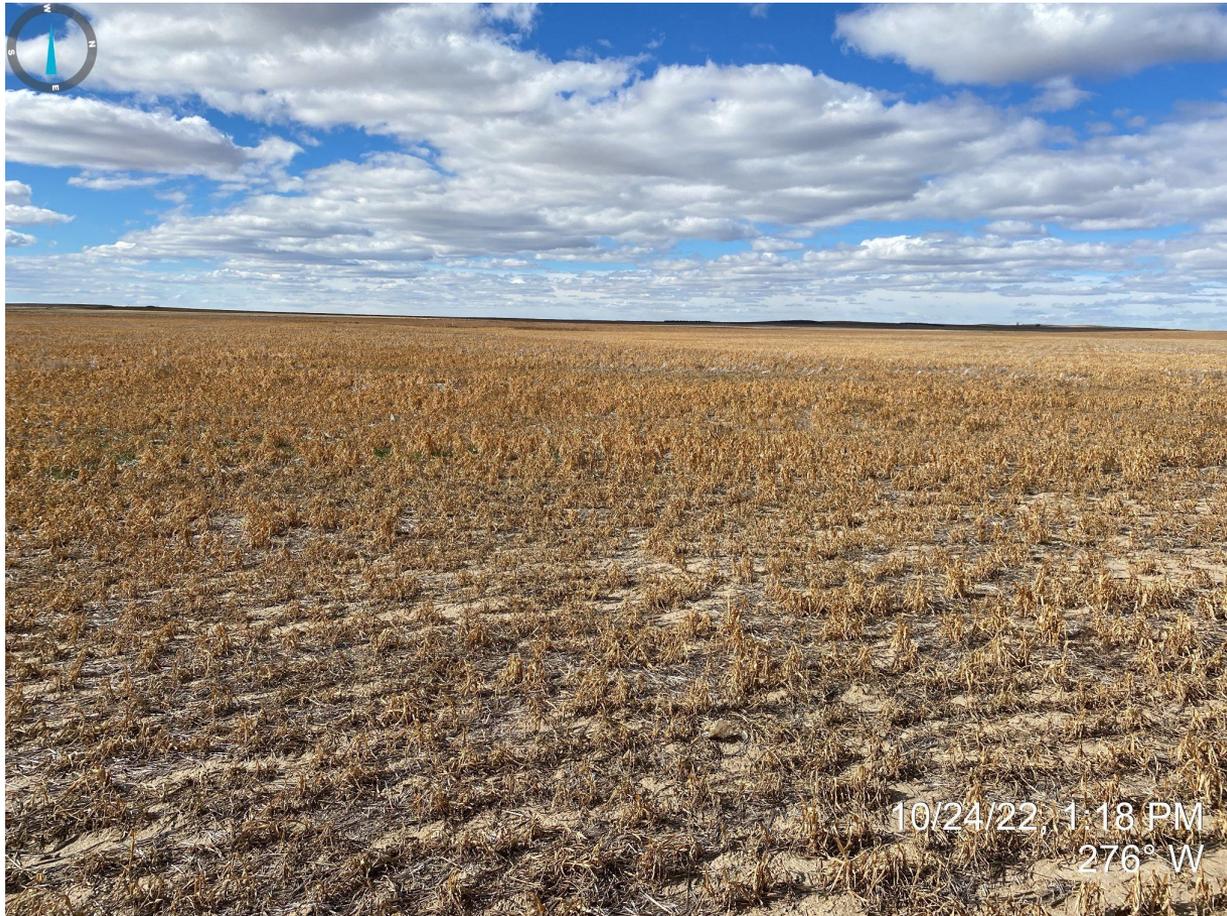
Photo 6. Taken south of location, facing west. Photo illustrates reference area.
