Inspection Photos

Operator: Argali Exploration Company - #3975

Location Name: STATE-69N91W/36SWSE

Inspection Document #: 702800873

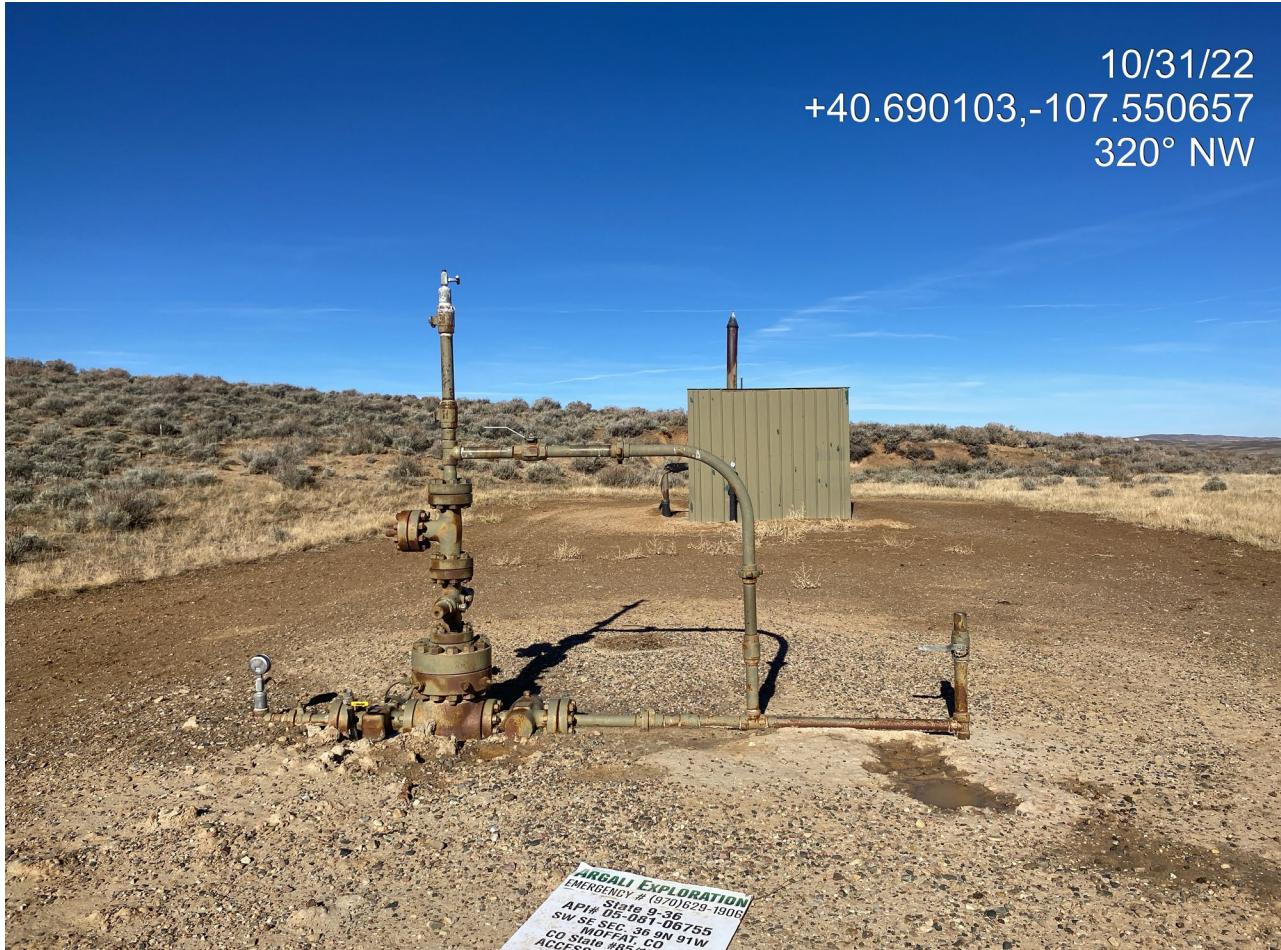
Photo 1. Photo taken from the center of the Location shows an overview of the production area. Sign has been updated with current Operator information but remains in disrepair.

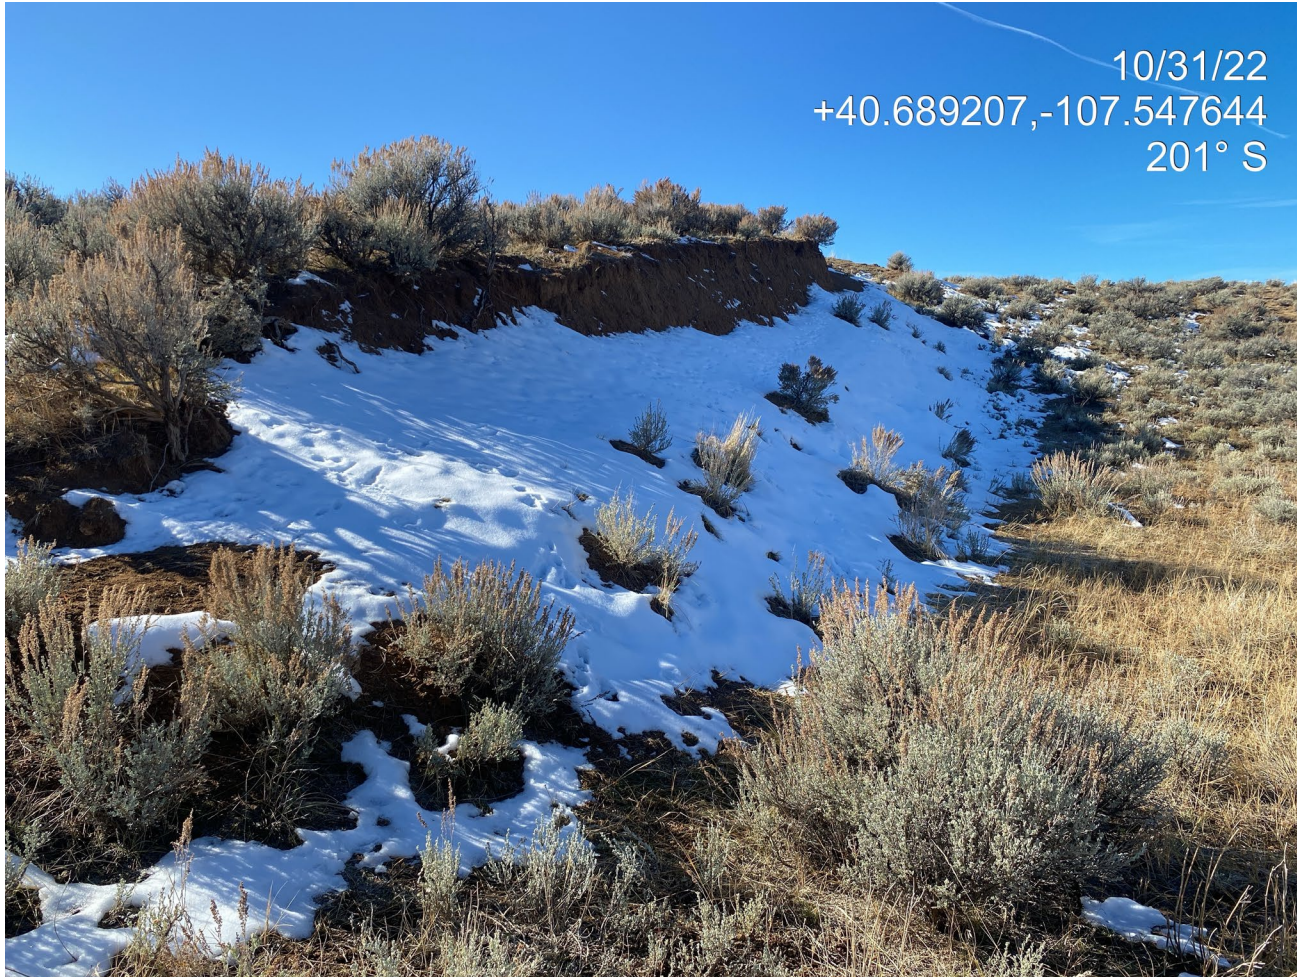
Photo 2. Photo taken from the southwest of the Location shows the cut slope has not been properly reclaimed; vertical cut must be recontoured to match the surrounding landscape and stabilized to prevent erosion.

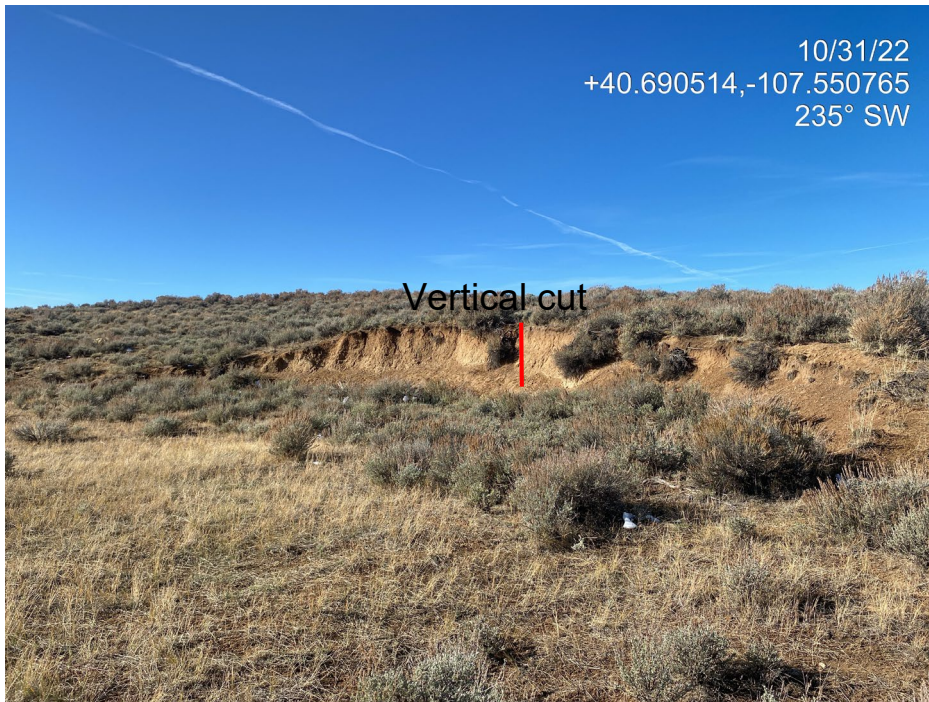
Photo 3. Photo taken from the northwest of the Location shows the cut slope has not been properly reclaimed; vertical cut must be recontoured to match the surrounding landscape and stabilized to prevent erosion.

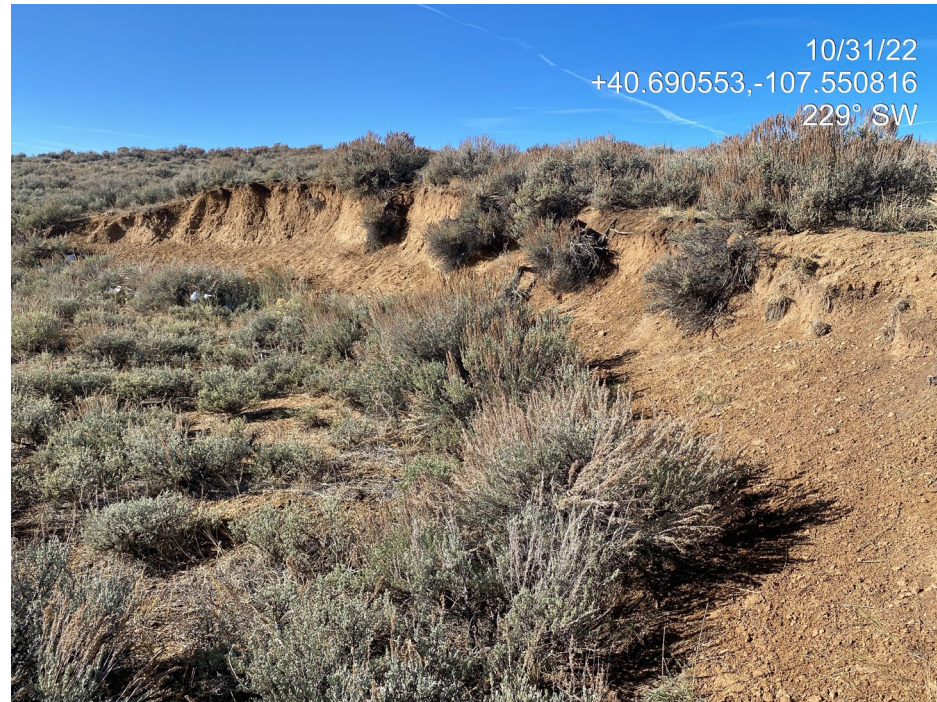
Photo 4. Refer to Photo 3 comment.

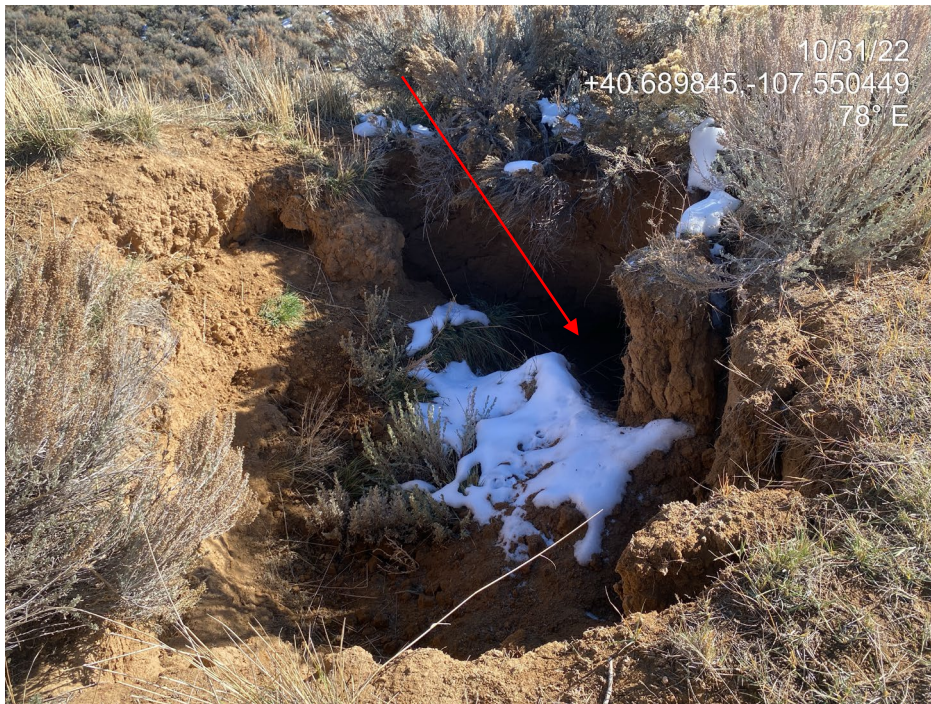
Photo 5. Photo shows erosion occurring in the fill slope at the east of the Location. The hole was approximately 8 by 9 feet wide and 3 feet deep. Arrow indicates the deepest part of the hole which was approximately 10 feet deep.

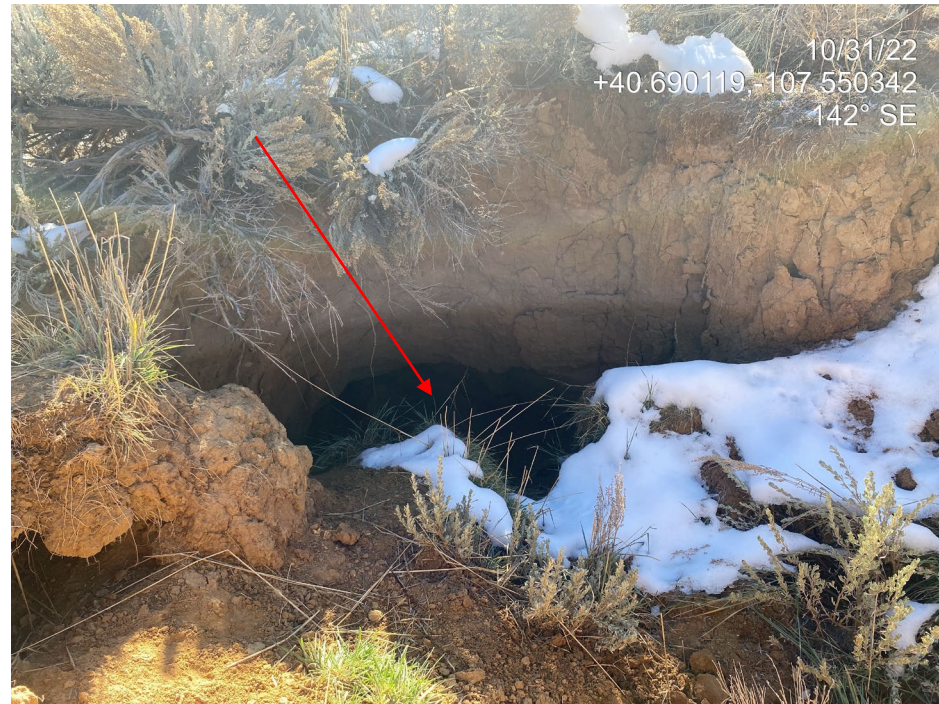
Photo 6. Photo shows erosion occurring in the fill slope at the east of the Location. Arrow indicates the deepest part of the hole which was approximately 10 feet deep.
