Inspection Photos and Issue Report

Operator: GUNNISON ENERGY LLC - 10515

Location #324464

COGCC

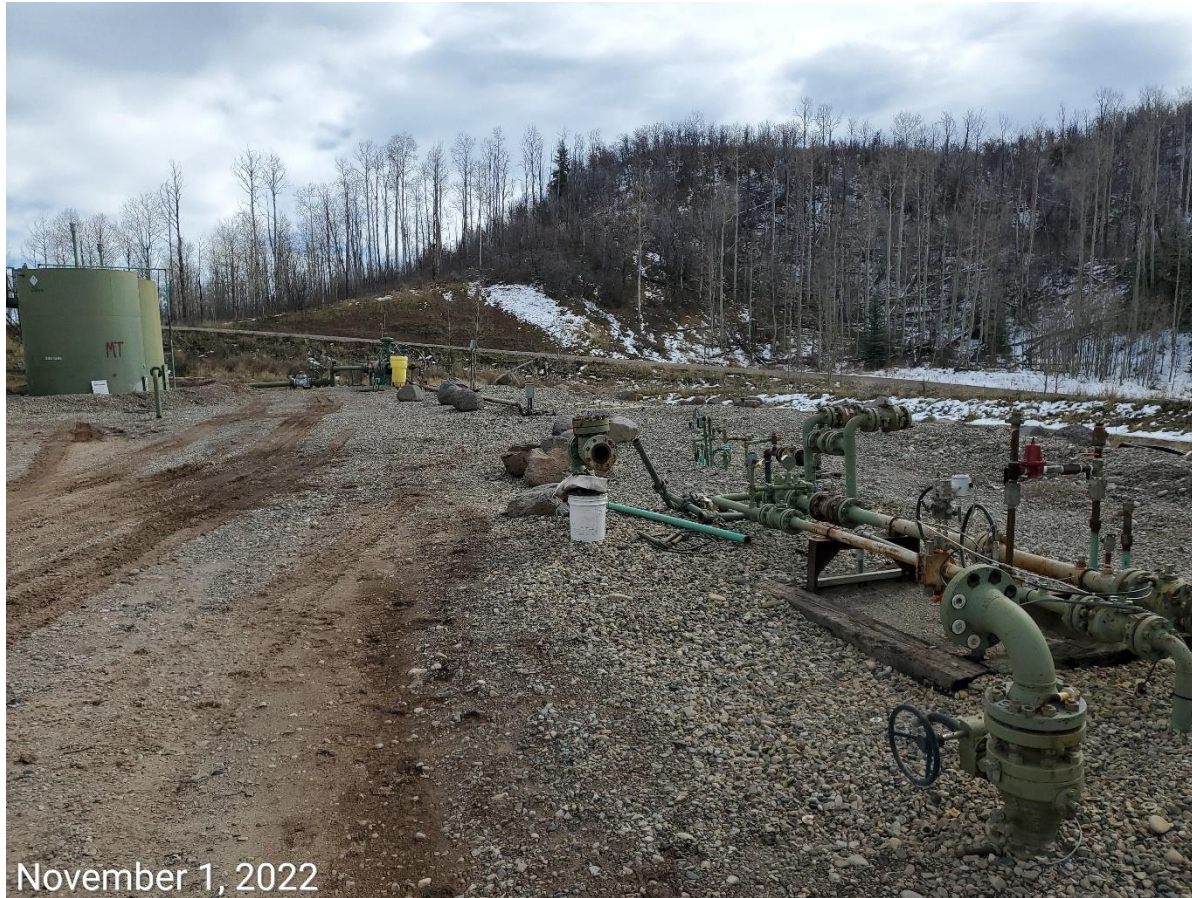
Photo 1: Photo taken from west end of the Location, and shows areas of the former Ragged Mountain Compressor Facility. Photos shows various equipment (pipe, risers, etc..) that appear to have been associated with the facility remain on site. This issue is being forwarded to the COGCC Environmental Group.

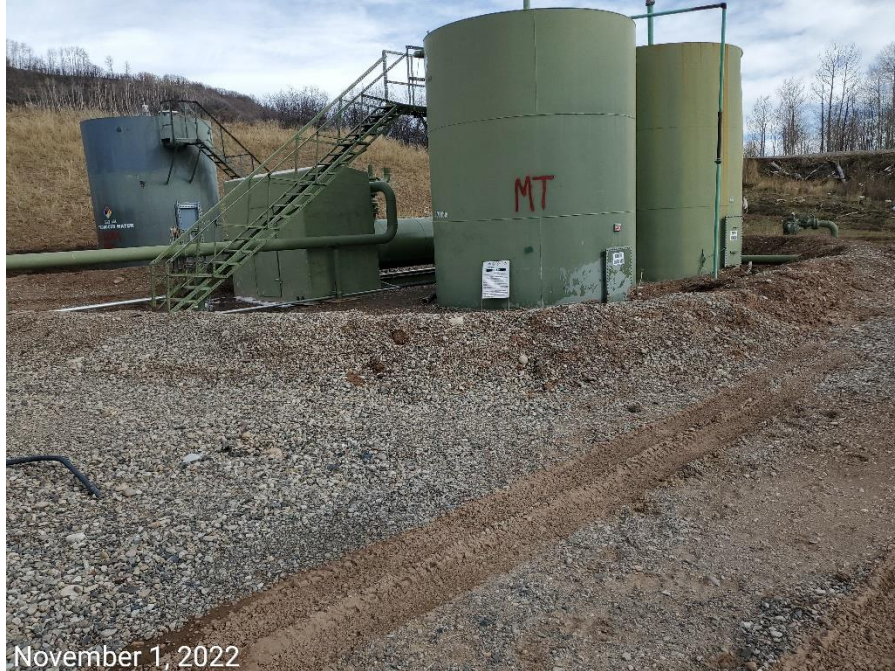
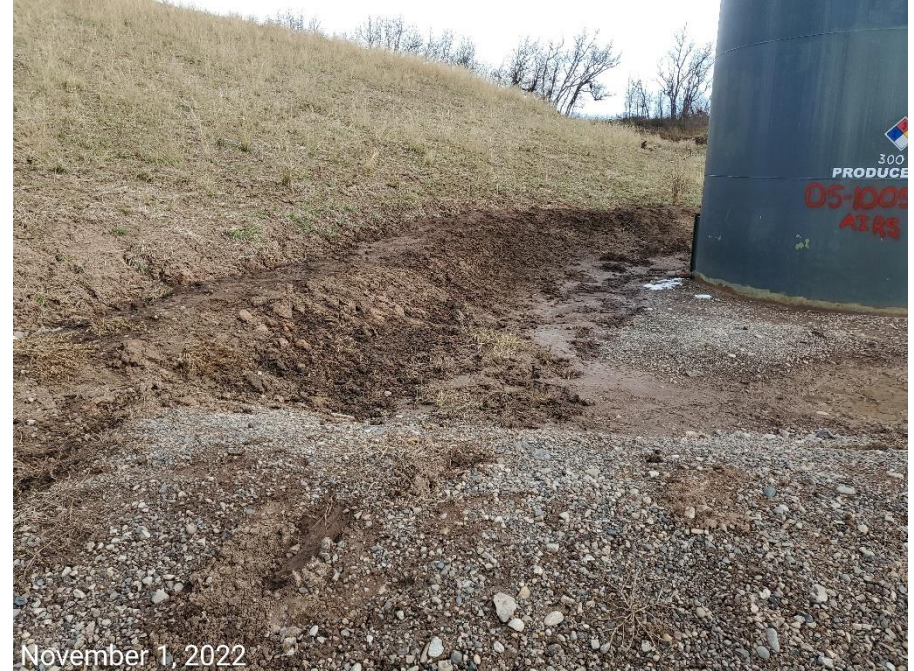
Photo 2: Photos show secondary containment BMPs at the tank battery have been installed or repaired.

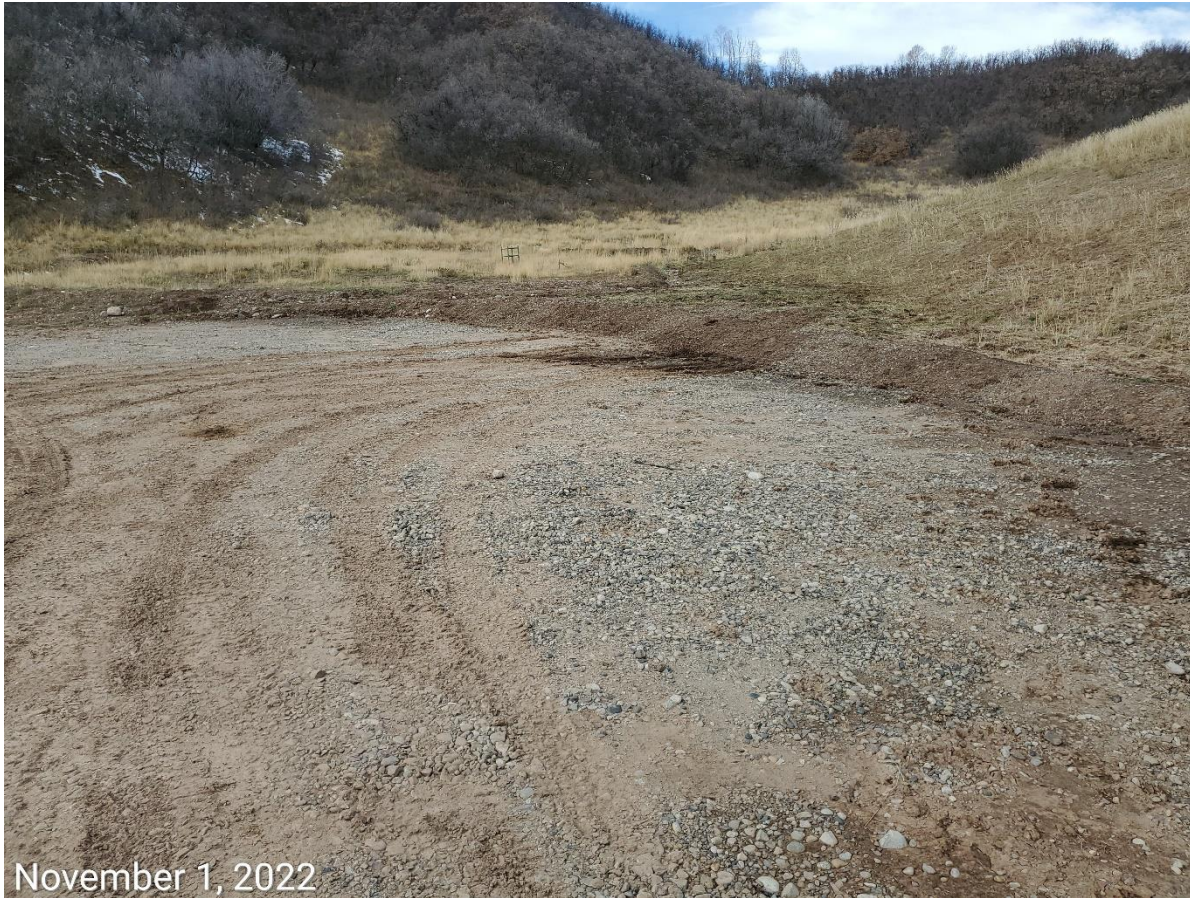
Photo 3: Photo shows soil stockpile stored on the northeast end of the Location has been removed.

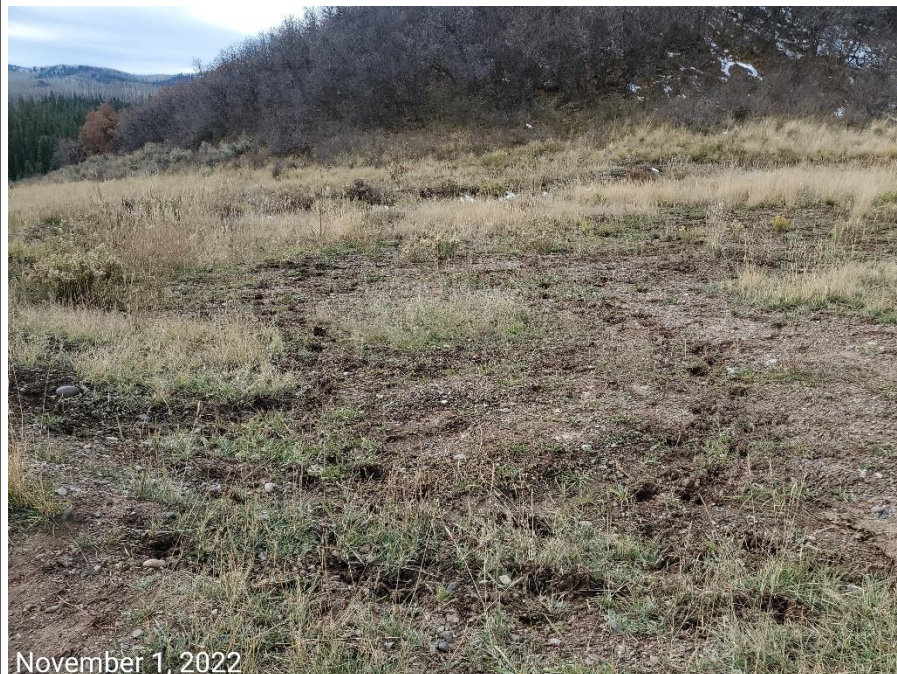
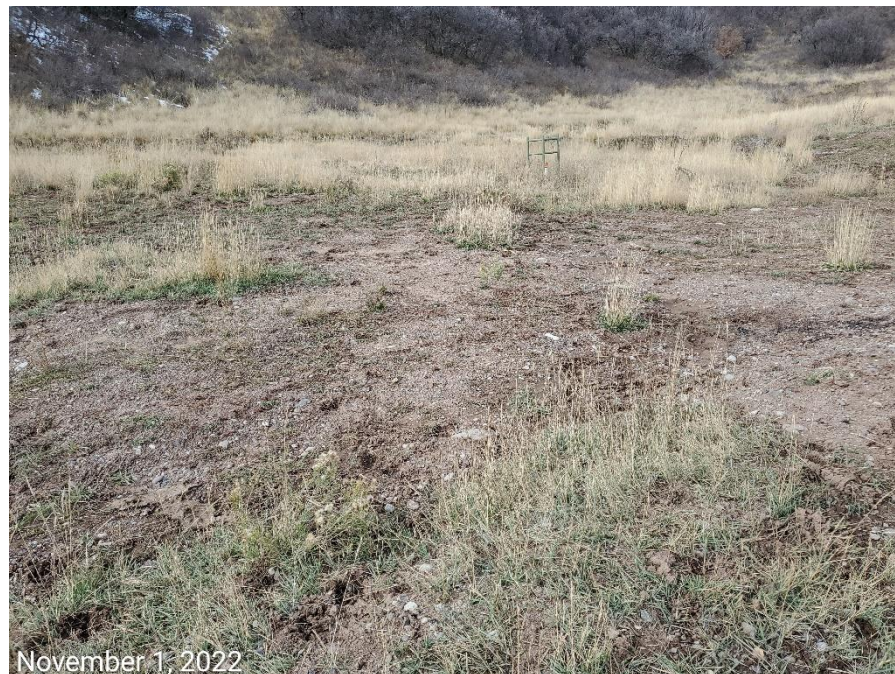
Photo 4: Photos taken from the interim areas on the north/northwest end of the Location. Photos show areas not needed for production operations. Previous inspections required Operator to conduct interim reclamation by 6/7/2021. Unable to find evidence that interim reclamation work has been completed; Operator on site also confirmed that reclamation work has not yet been performed.

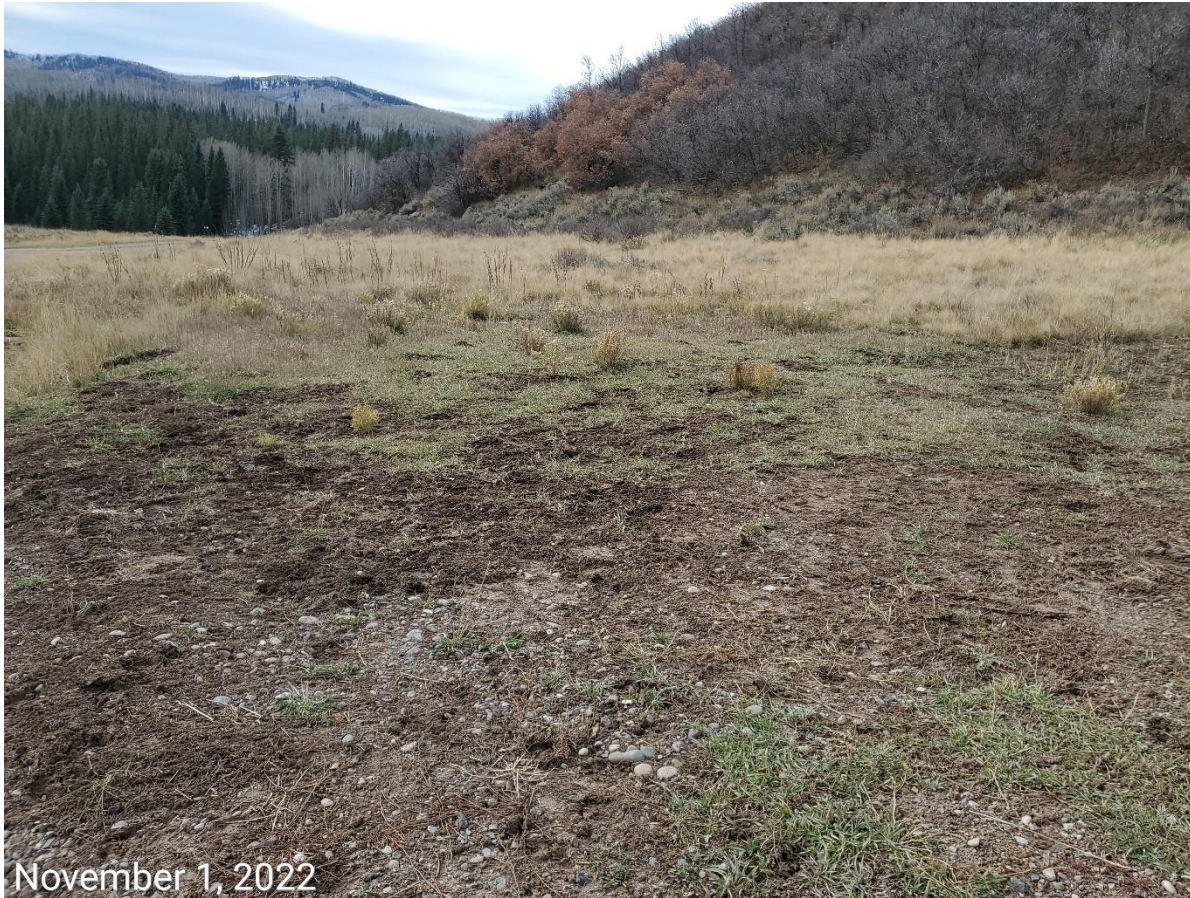
Photo 5: Photo taken from off-site areas northwest of the Location. Photo shows areas where Operator improperly stored various unused trash/debris/equipment. Disturbed areas are apparent; noxious weed establishment observed.
