# Inspection Photos

Operator: Argali Exploration Company - #3975

Location Name: FEDERAL SANDWASH-68N91W/1NWNE

Inspection Document #: 702800875

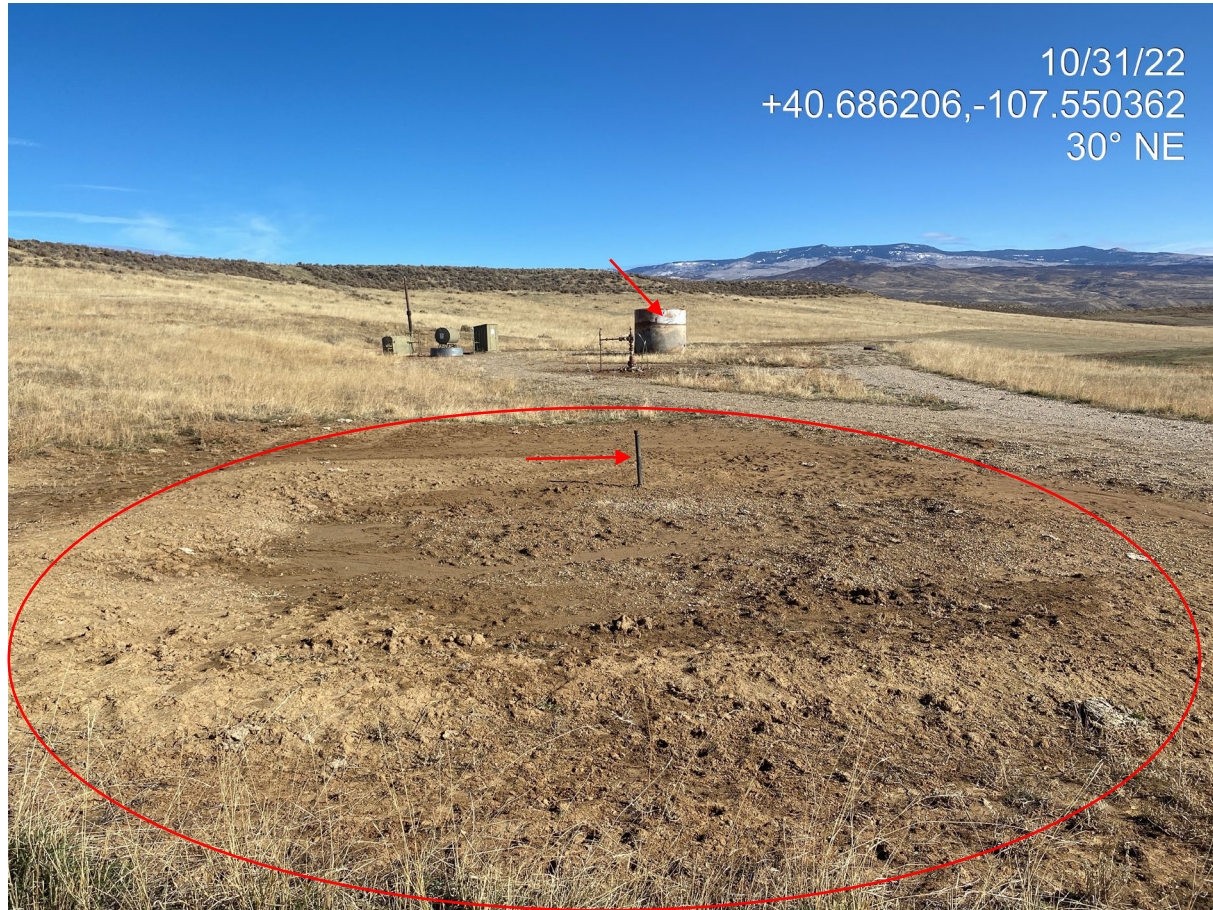
**Photo 1.** Photo taken from the southwest shows an overview of the Location. Decommissioned facilities (foreground) require site investigation, remediation, and closure followed by interim reclamation after compliance with 915-1 standards. Remaining pipe must be removed. Unused tank must be removed.

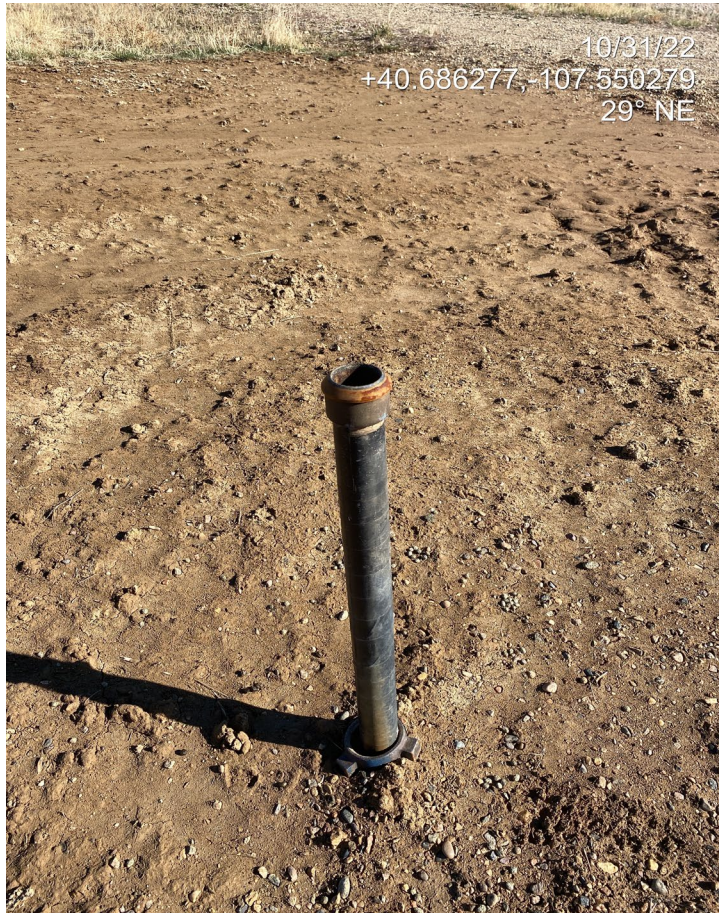
**Photo 2.** Photo taken from the southwest shows a pipe remaining at the produced water tank facility. Pipe must be removed.

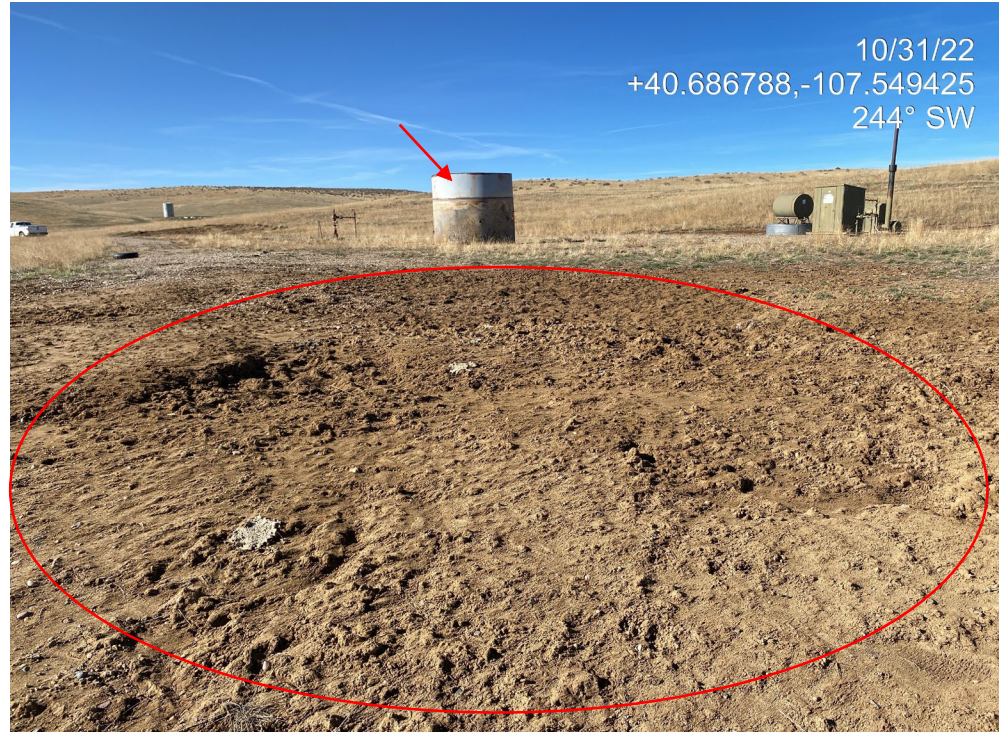
**Photo 3.** Photo taken from the northeast of the Location shows a decommissioned partially buried tank facility. Decommissioned facilities require site investigation and remediation followed by interim reclamation after compliance with 915-1 standards. Note also, unused tank.

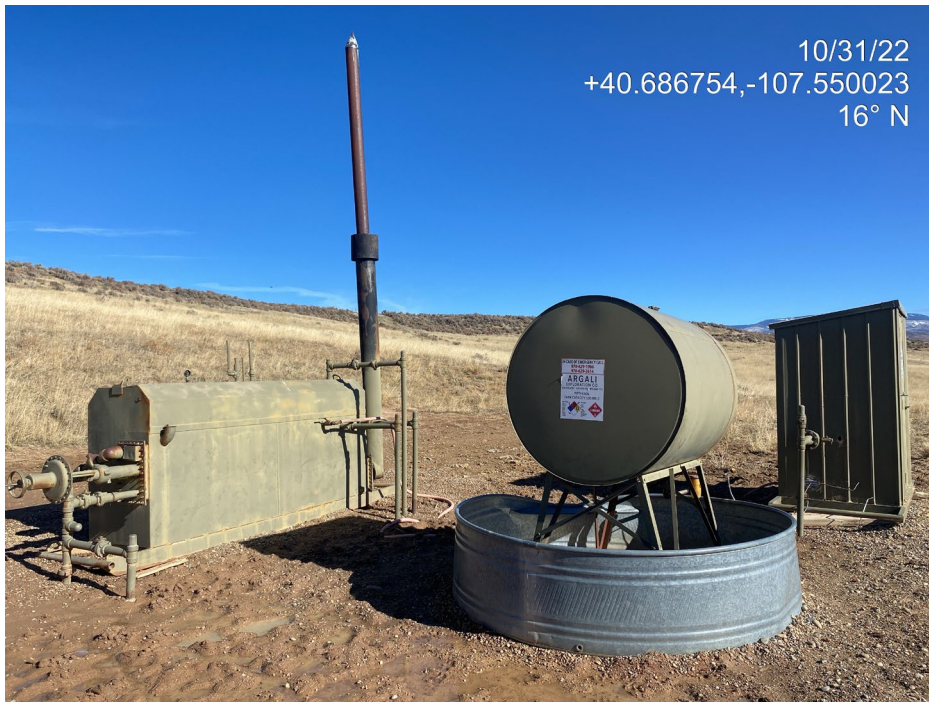
**Photo 4.** Photo taken from the northwest. The methanol tank secondary containment lacks wildlife protection BMPs. The tank label is inaccurate; tank capacity reads 500 BBLs.

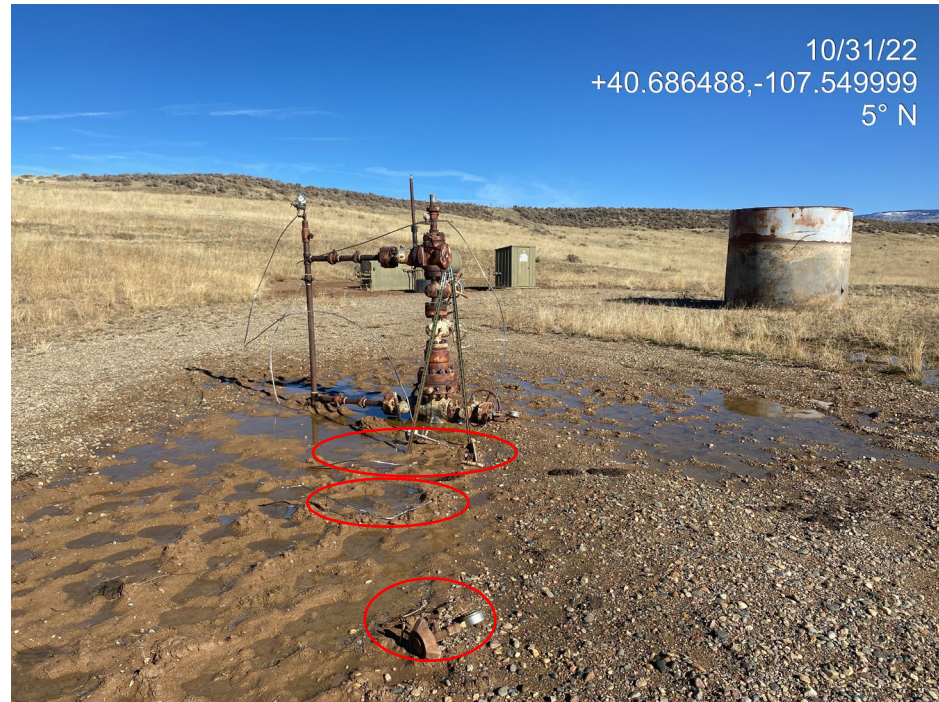
**Photo 5.** Photo shows the wellhead. Wellhead signage does not comply with Rule 605.d. Photo also shows trash around the wellhead.

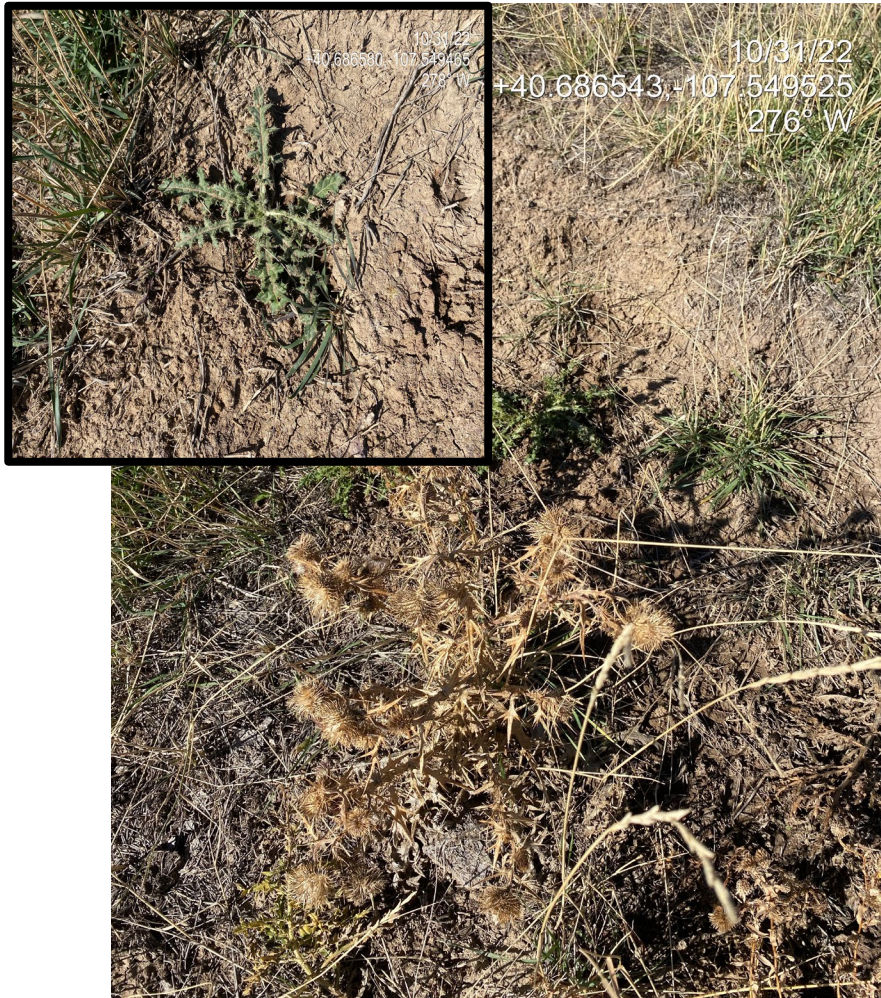
**Photo 6.** Photos shows a bull thistle (List B Noxious) which has gone to seed and a basal rosette.

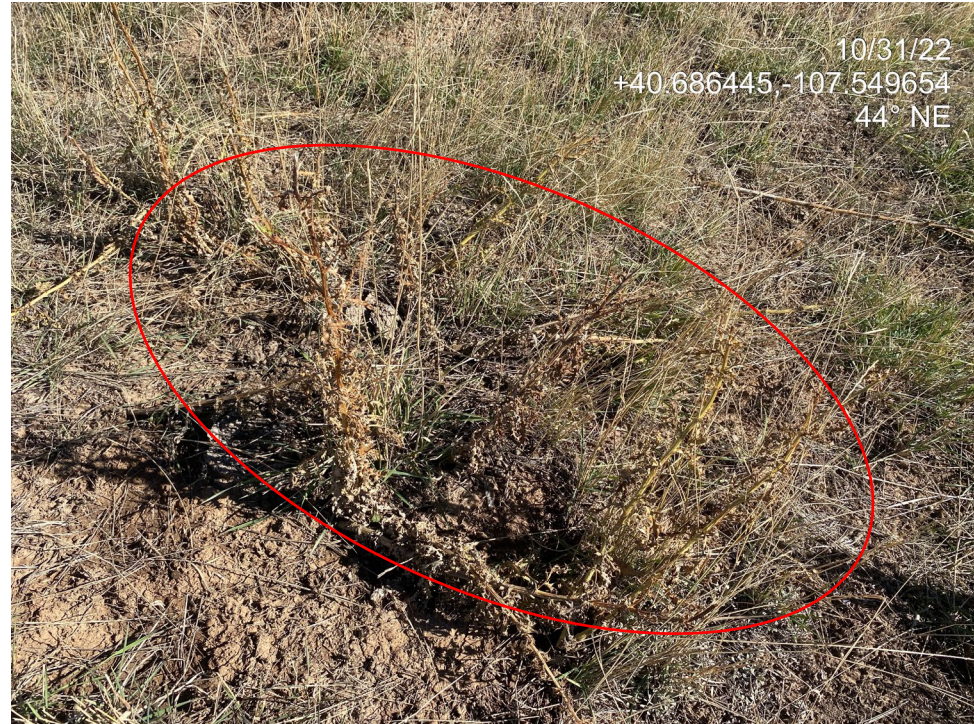
**Photo 7.** Photo shows Canada thistle (List B Noxious).

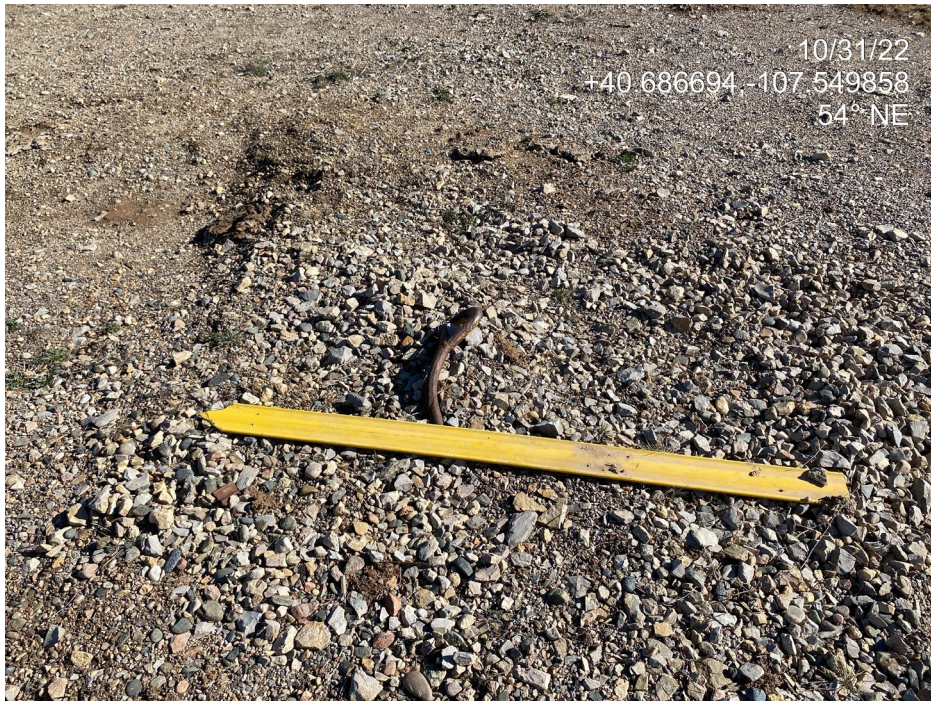
**Photo 8.** Photo shows an anchor marker in disrepair.

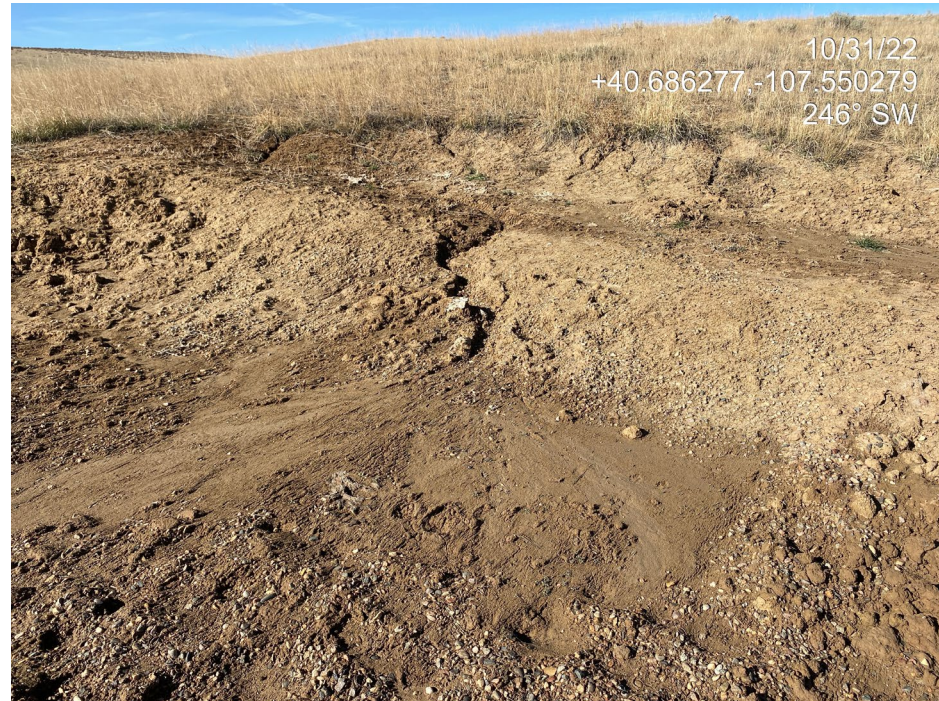
**Photo 9.** Photo taken from the southwest of the Location shows rill erosion occurring in bare, unprotected soils.

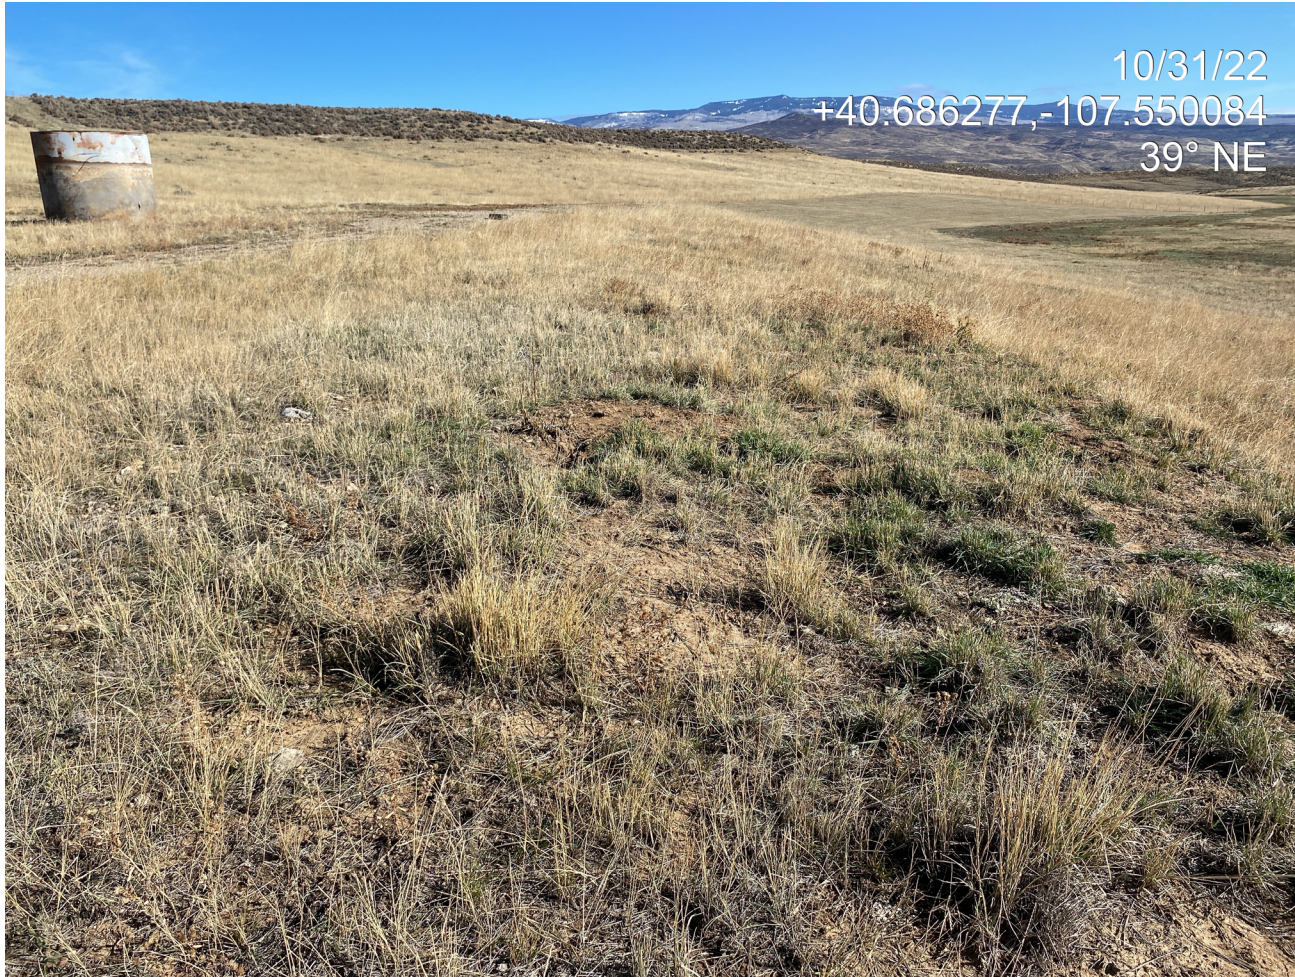
**Photo 10.** Photo taken from the east of the Location show fill slopes and interim areas vegetated with perennial grasses. Photo also shows similarity with reference area vegetation.
