# Final Reclamation Inspection

Operator: KERR MCGEE OIL & GAS ONSHORE LP #47120

Location ID: 323453

Inspection Photos  
Location Name: HALVERSON 1  
Location ID: 323453

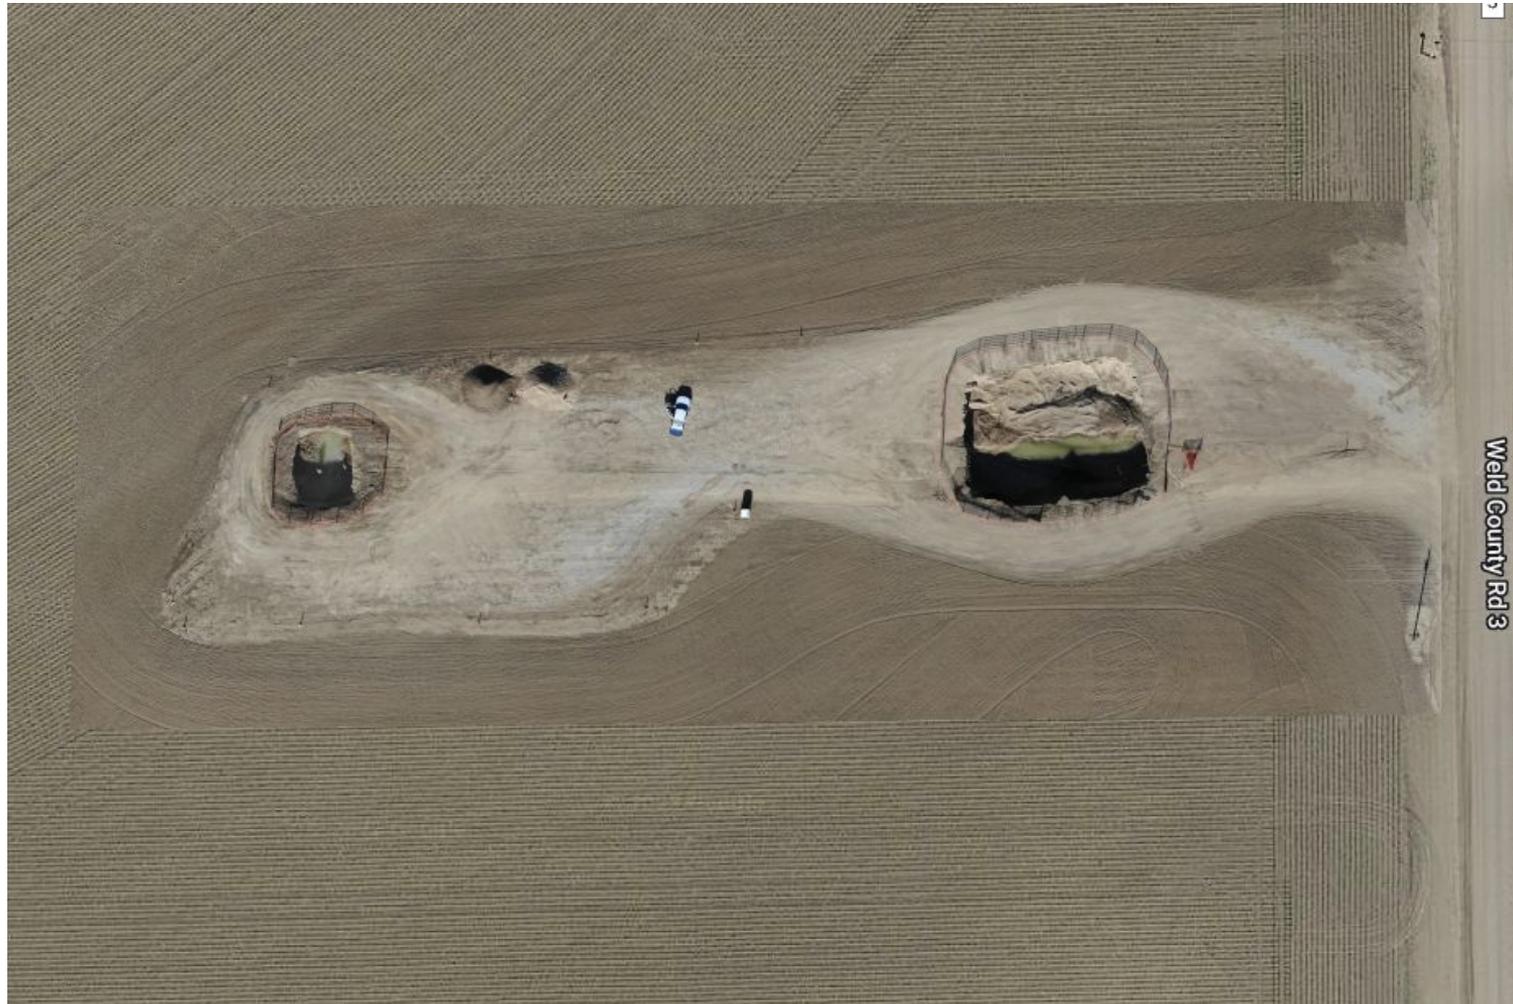
**Photo 1.** COGCC drone aerial imagery taken on 11/2/2022 illustrating the active remediation projects related to the Halverson 1 well. Photo illustrates an open remediation for the wellhead and tank battery.

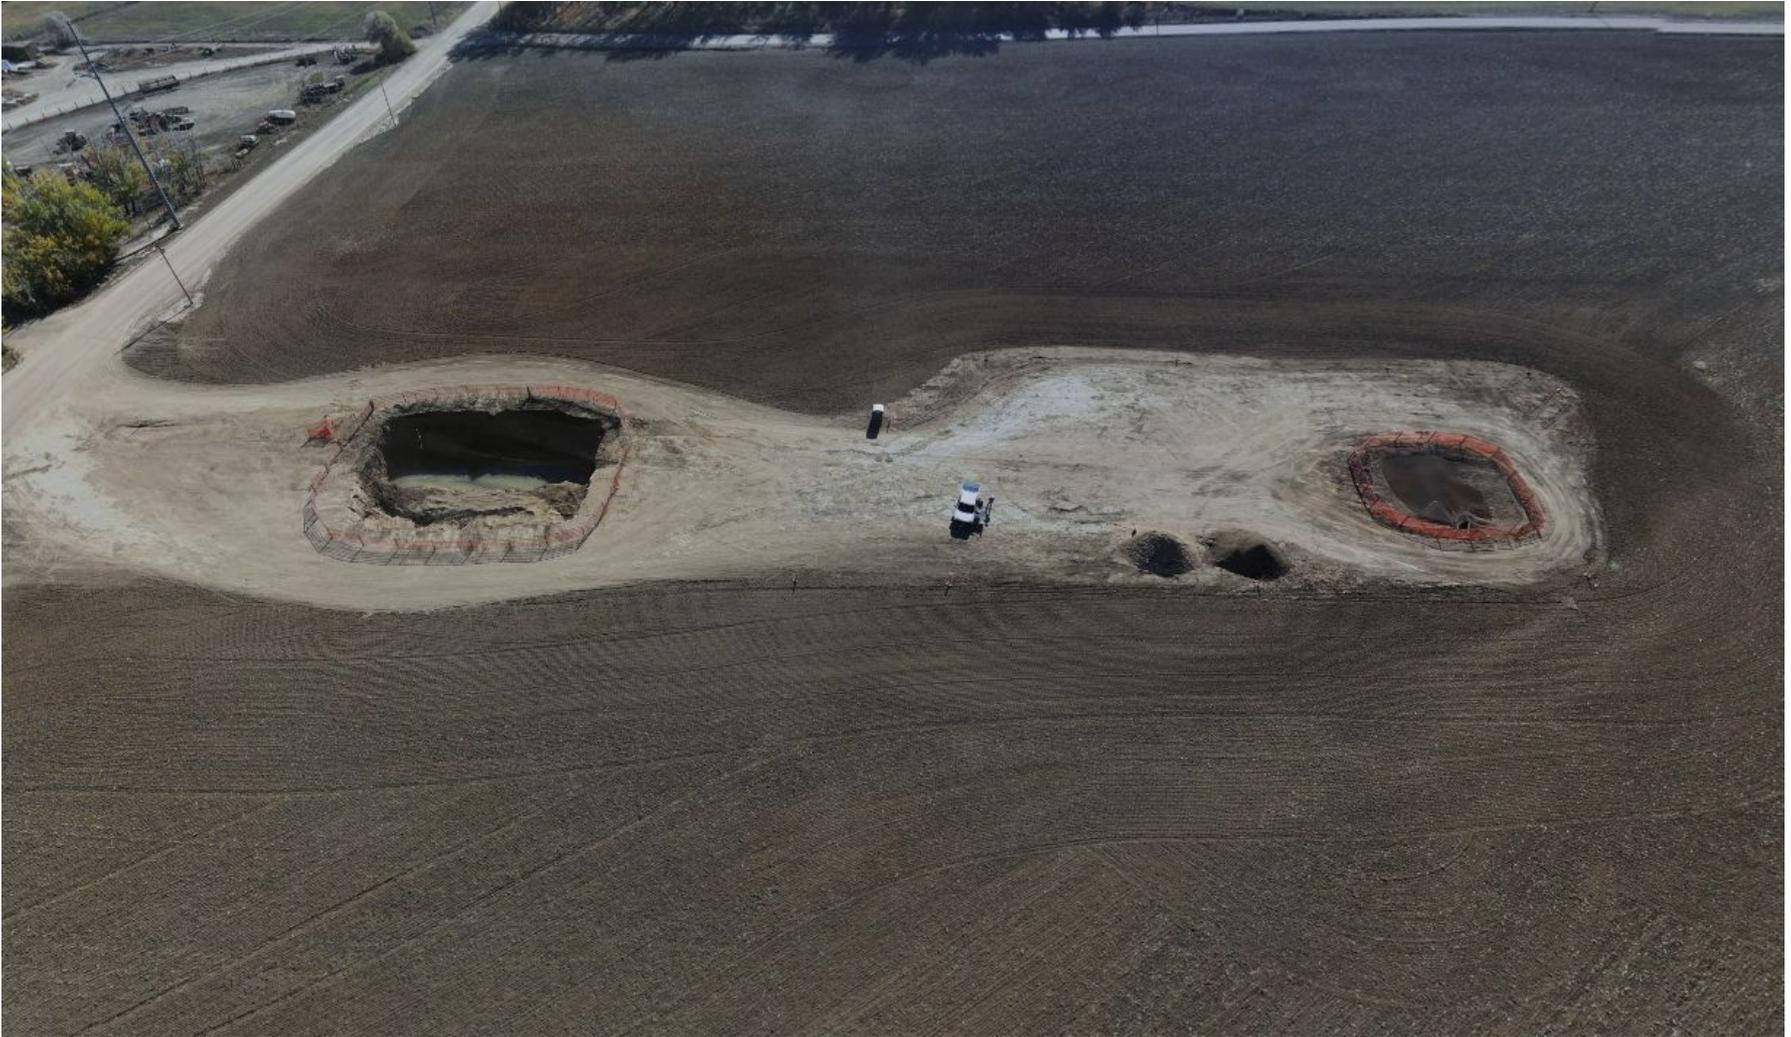
**Photo 2.** COGCC drone aerial imagery taken on 11/2/2022 illustrating the active remediation projects related to the Halverson 1 well. Photo illustrates an open remediation for the wellhead and tank battery. Photo illustrates the adjacent cropland is fallow and will likely go back into crop production next Spring.

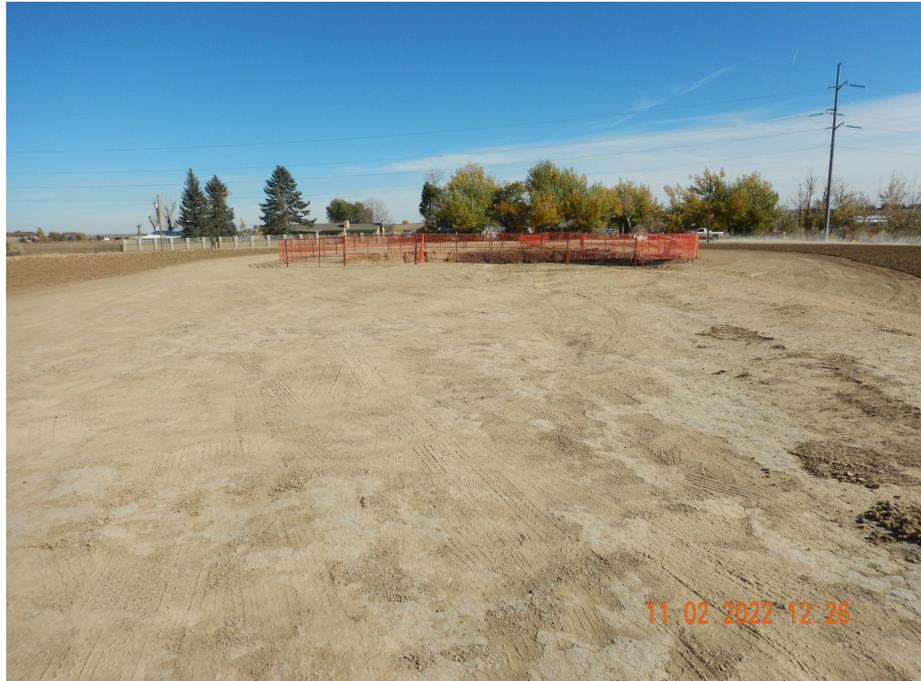
**Photo 3.** Photo taken from the central location, facing East. Photo illustrates the open excavation for the tank battery which has been fenced off.

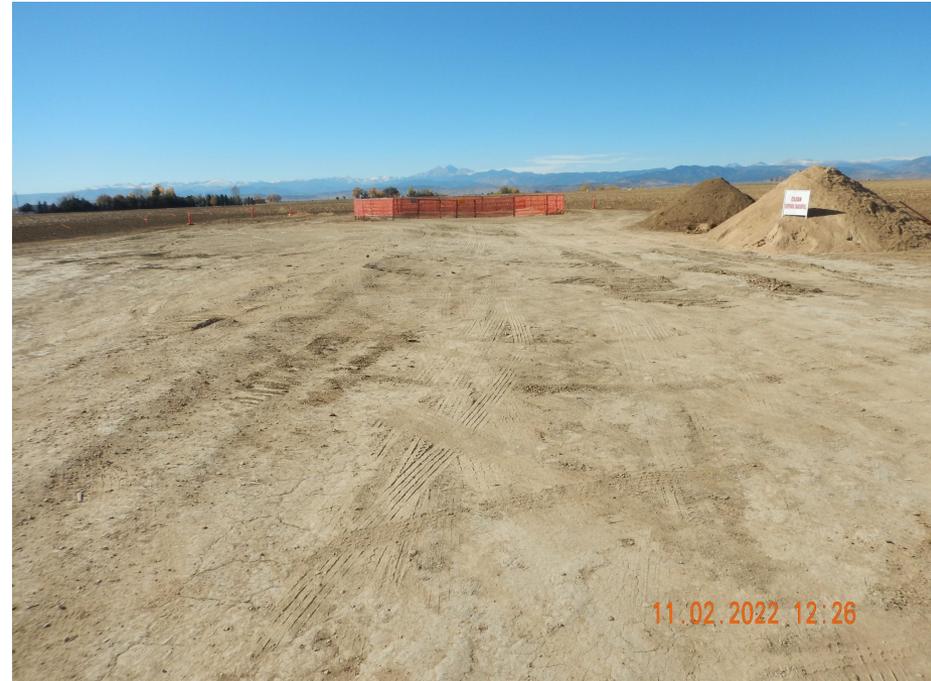
**Photo 4.** Photo taken from the central location, facing West. See comments under Photo 3.

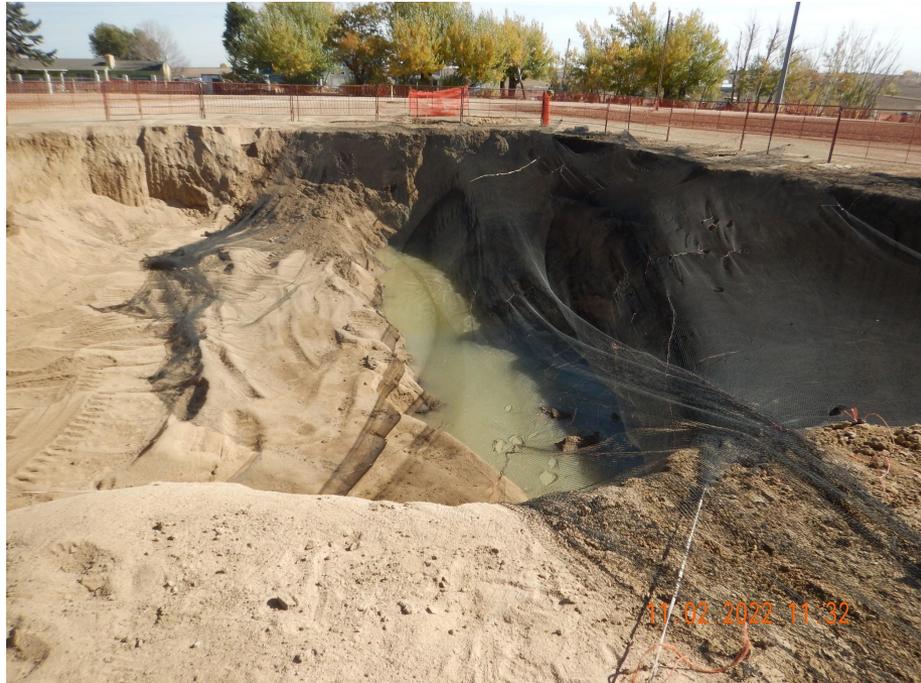
**Photo 5.** Photo taken from the tank battery excavation, facing East. Photo illustrates netting over the groundwater portion and sand to the north of the groundwater.

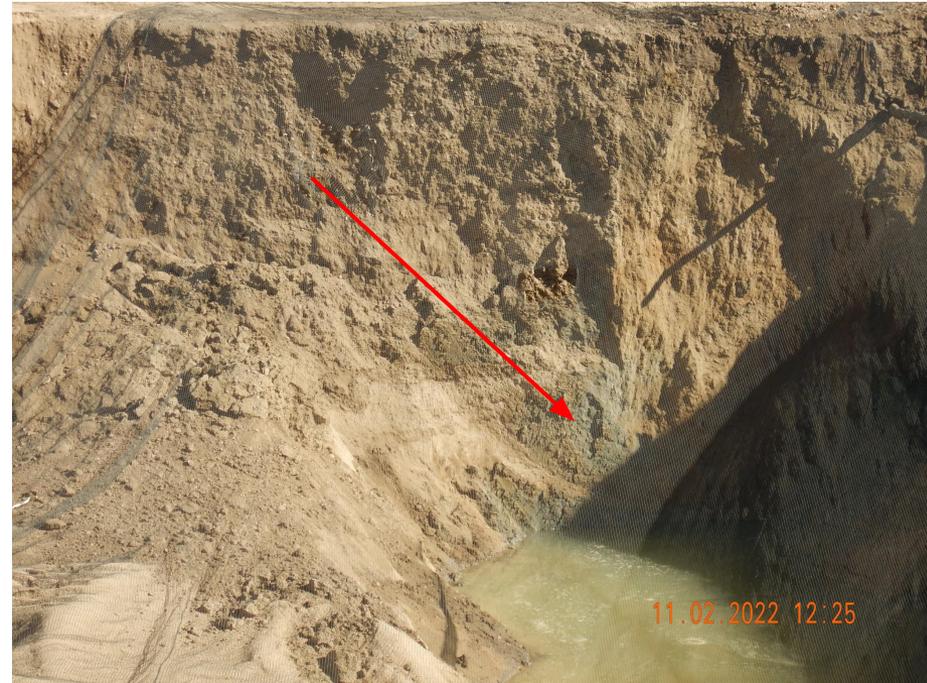
**Photo 6.** Photo taken of the eastern tank battery sidewall. Photo illustrates sidewall impacts appear to be evident.

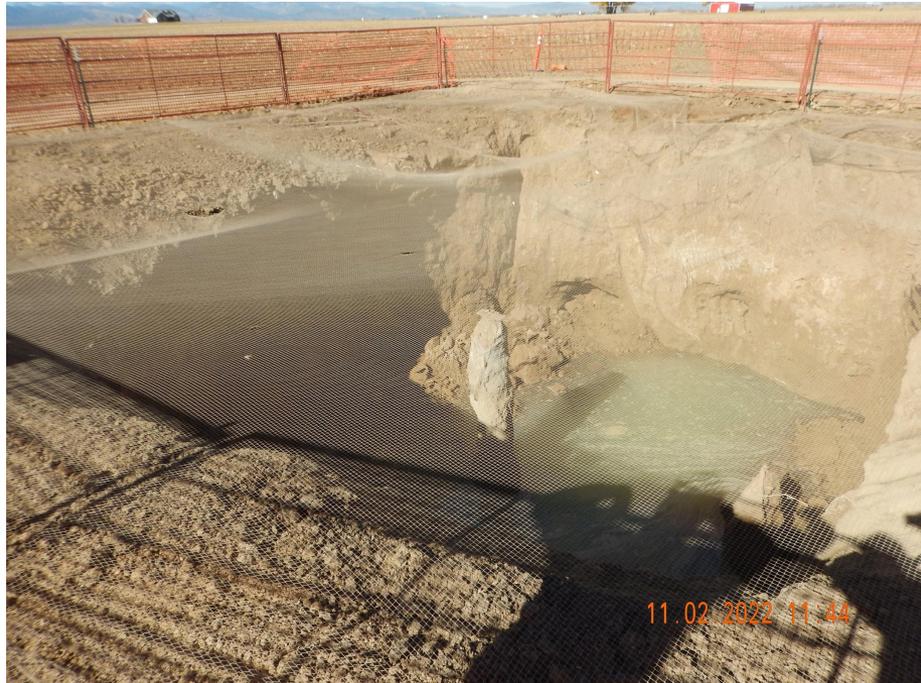
**Photo 7.** Photo taken from the wellhead excavation, facing Northwest. Photo illustrates netting over the excavation.

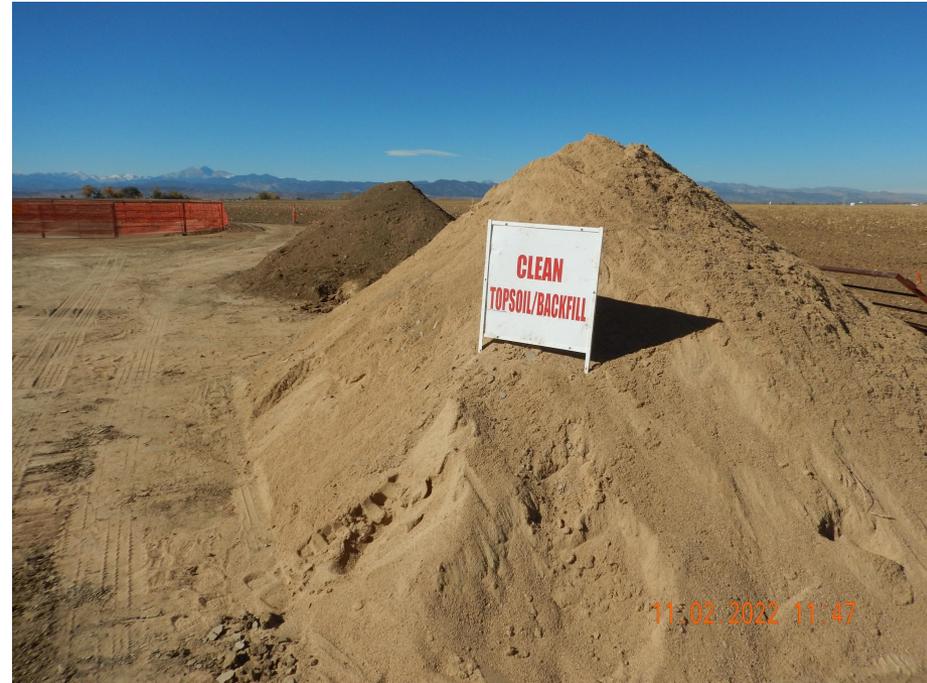
**Photo 8.** Photo taken from the north central location, facing West. Photo illustrates a stockpile of sand, not topsoil.
