Inspection Photos and Issue Report

Operator: GUNNISON ENERGY LLC - 10515

Location #412922

Gunnison County, CO

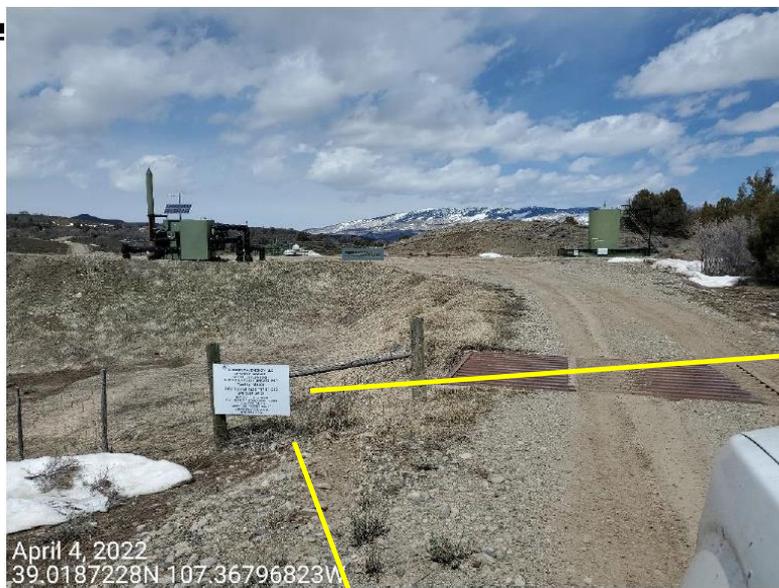
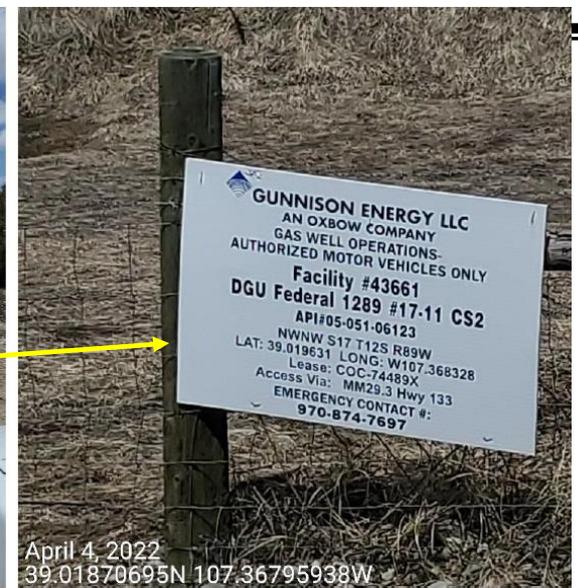
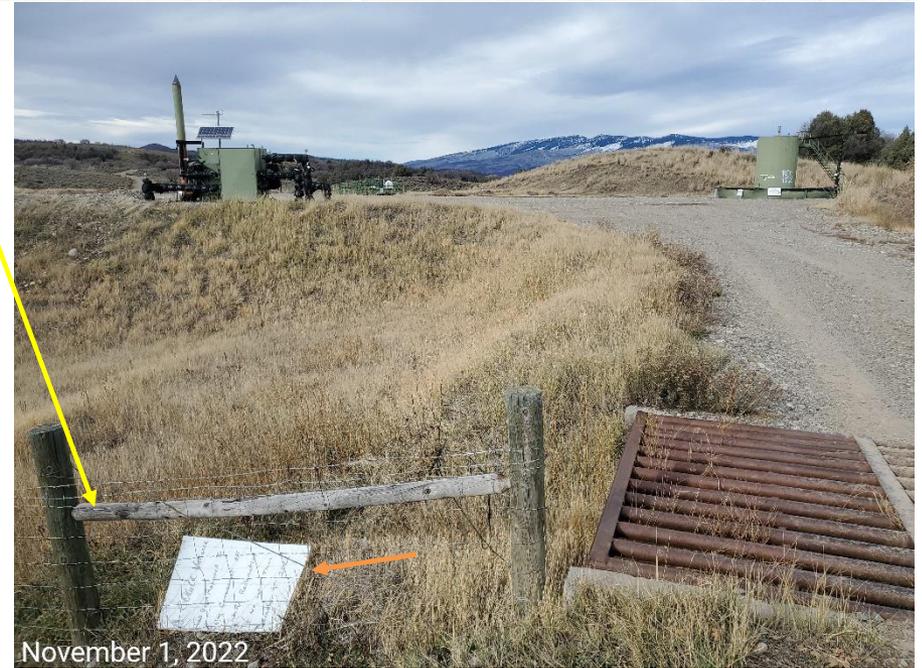
Photo 1: Photos taken from the Location entrance. Photos at above from the 4/4/2022 inspection and show the Location signage. Photo bottom right shows location signage has been removed. Photo bottom right also shows that Operator has attempted to install signage required per the Delayed IR Variance conditions (orange arrow), however sign has not been properly secured and is now debris. Sign is also made of poor quality material and is deteriorating.

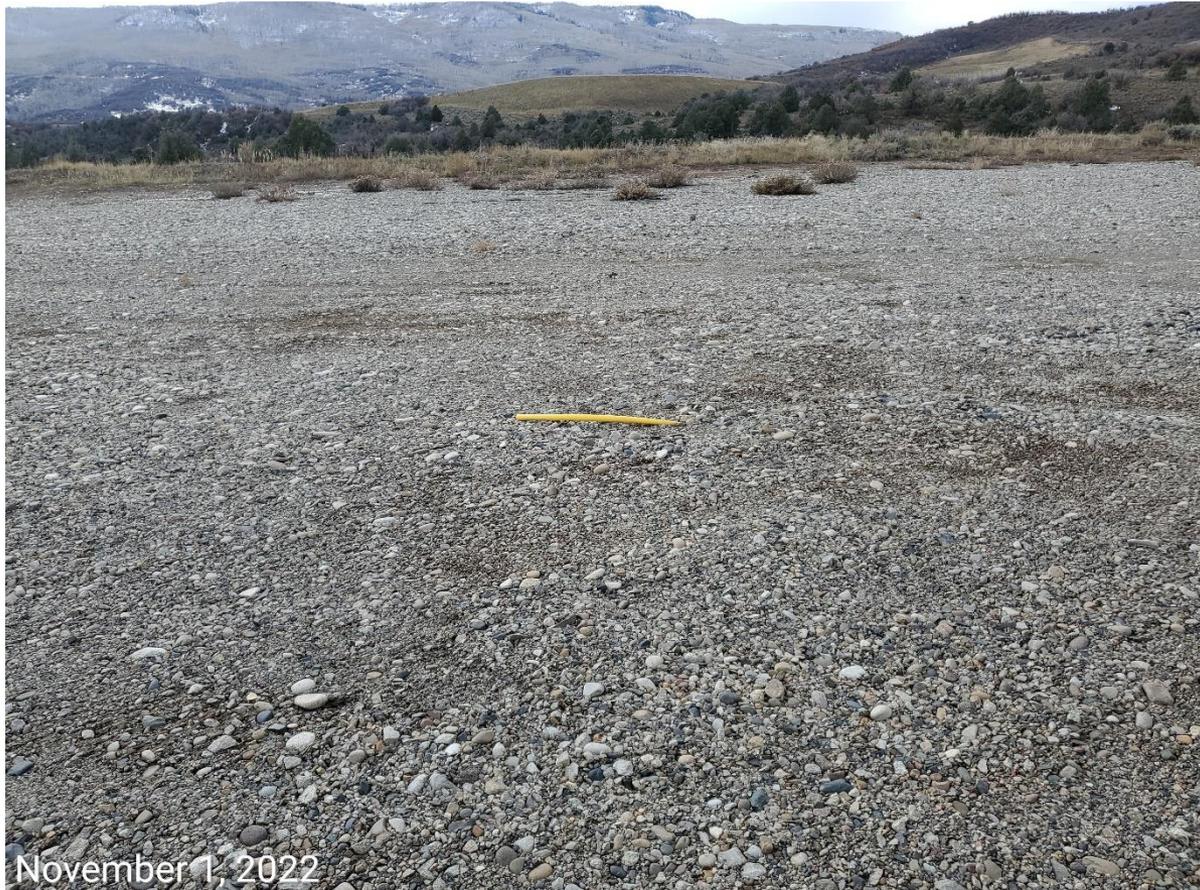
Photo 2: Photo example showing anchor marker not in proper functioning condition.

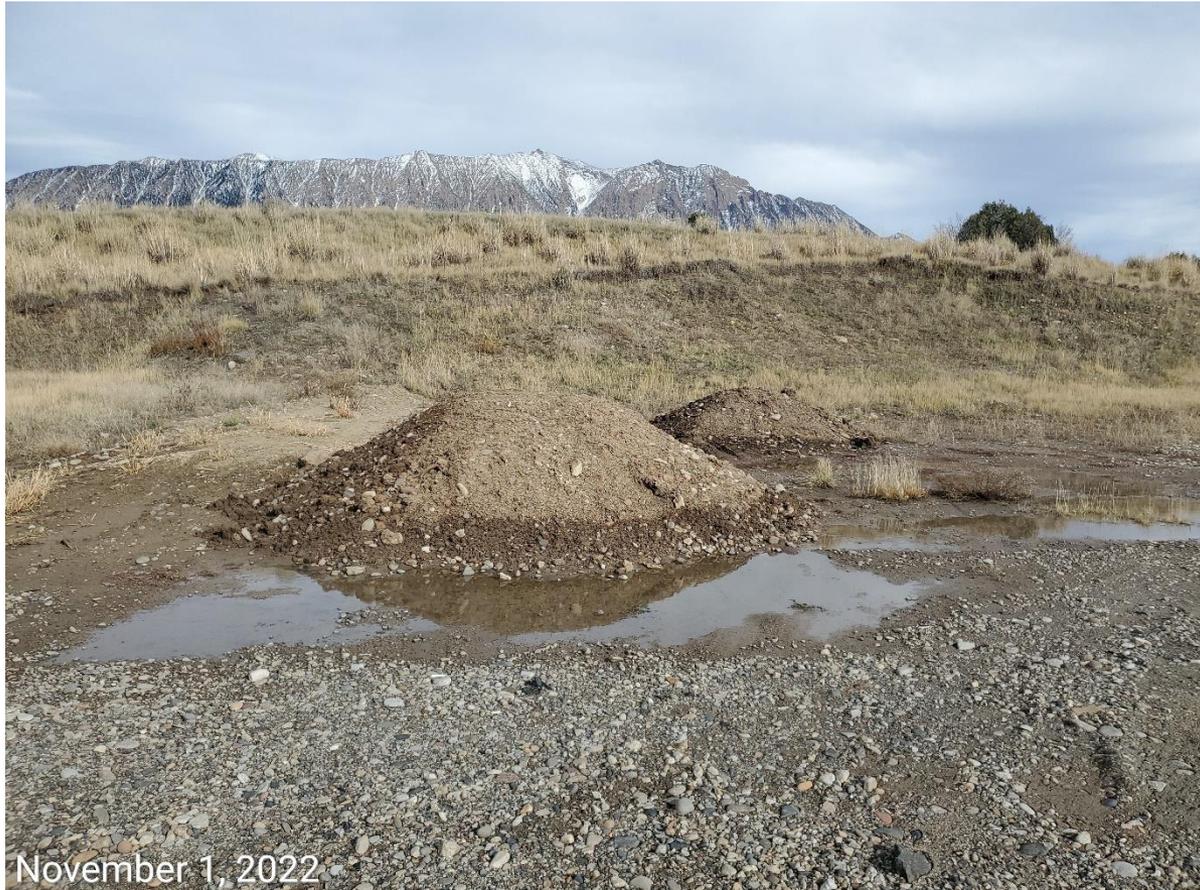
Photo 3: Photo taken from the north end of the Location. Photo shows soils stockpiles with missing BMPs to protect stockpiles from wind and water erosion, as well as to minimize erosion, degradation and sediment transport
