Inspection Photos and Issue Report

Operator: SG INTERESTS I LTD - 77330

Location #429333

Gunnison County, CO

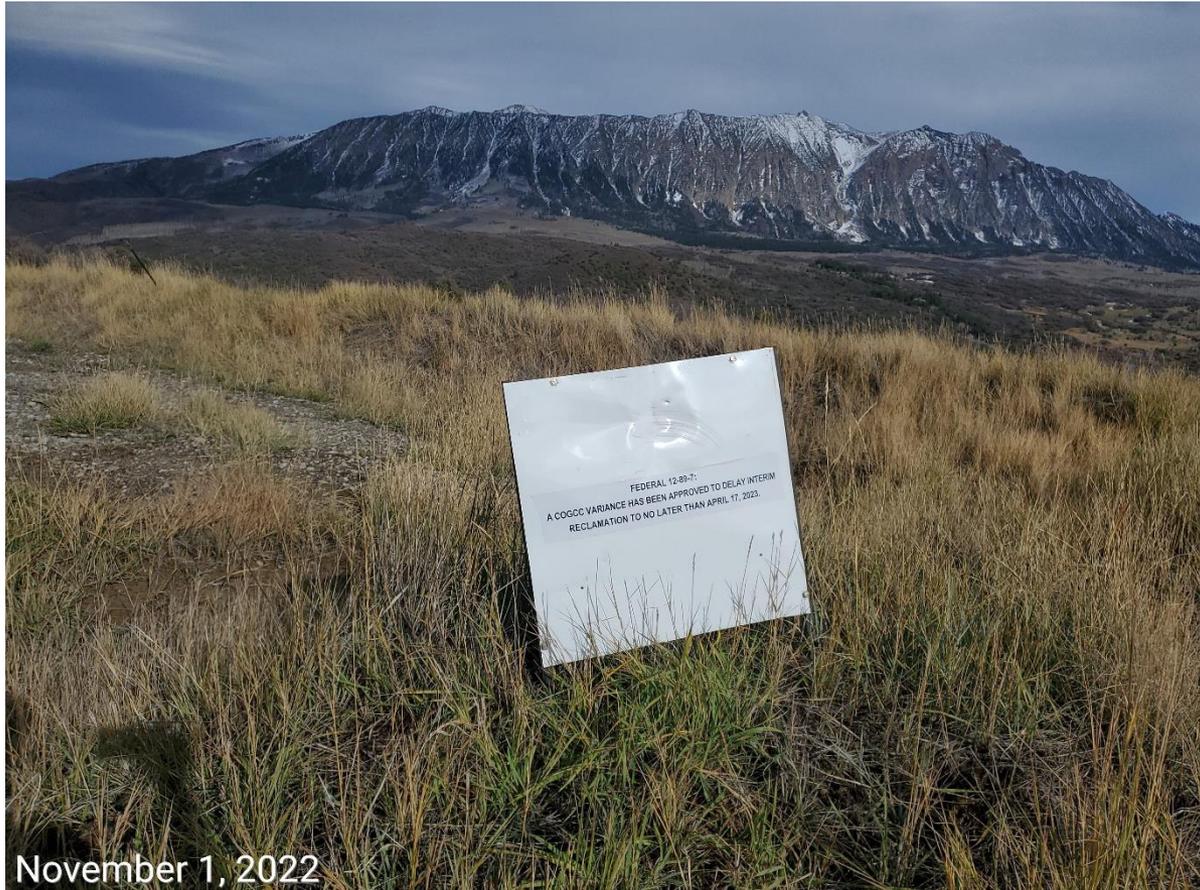
Photo 1: Location signage detailing variance information. “Reclamation no later than” date requires updating to reflect new variance termination date of 9/11/2024.

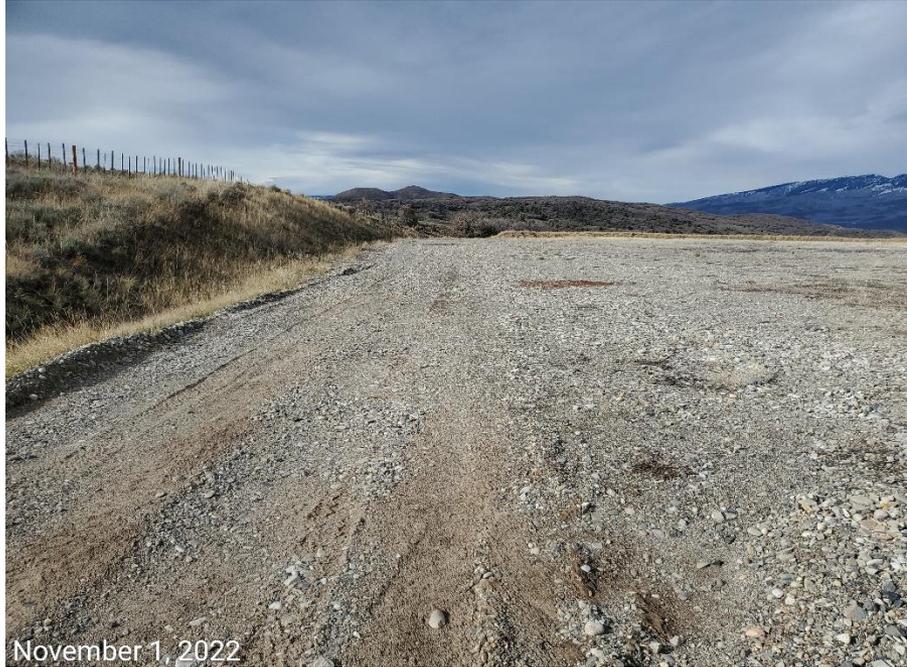
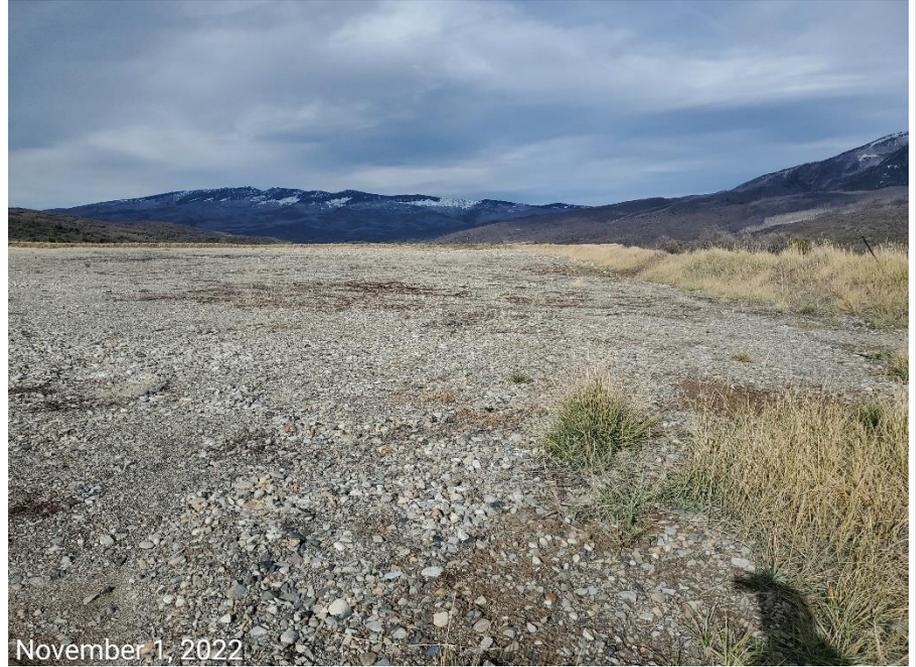
Photo 2: Photos taken from the south end of the Location. Photos provide an overview of the location from north to northeast.

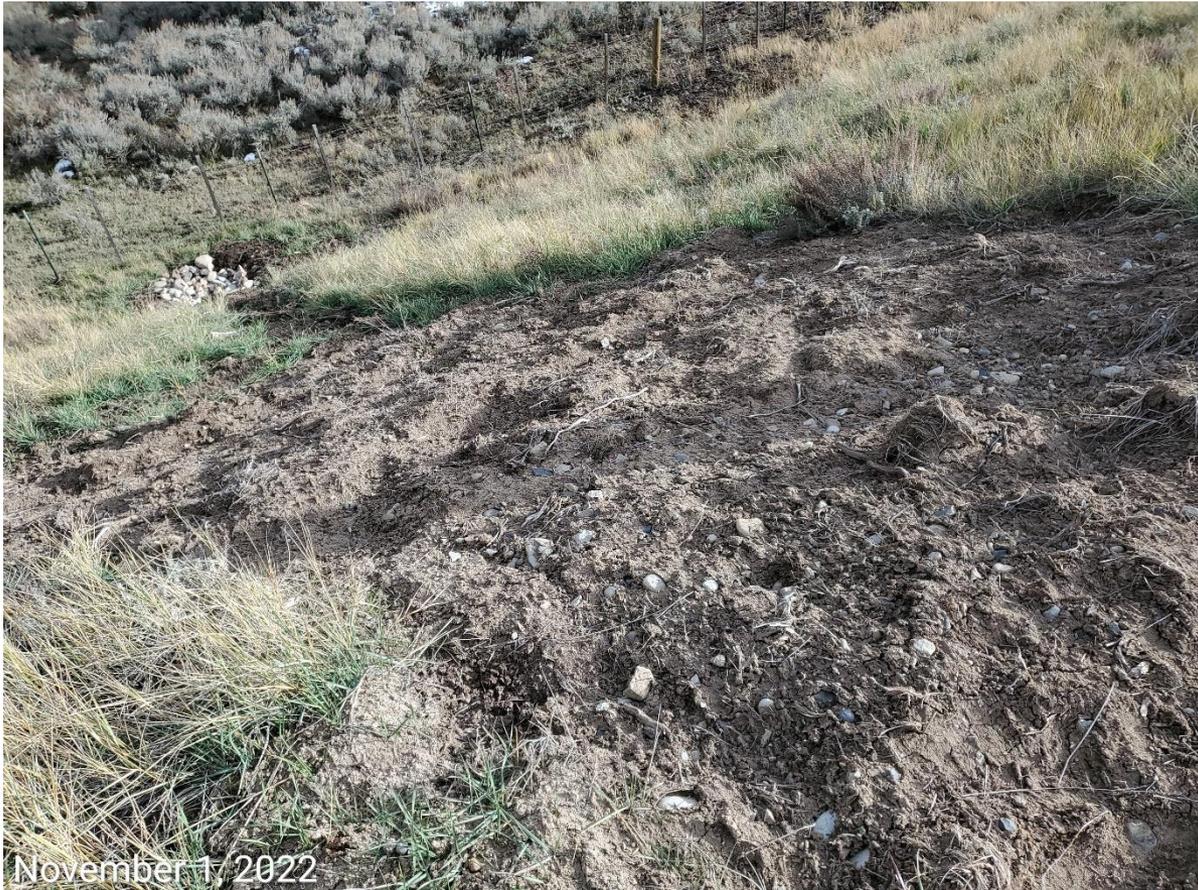
Photo 3: Photo taken from the southeast end of the Location. Photo shows areas where Operator appears to have installed a slope drain. Soils on the slopes have been left bare and at risk to erosion degradation.

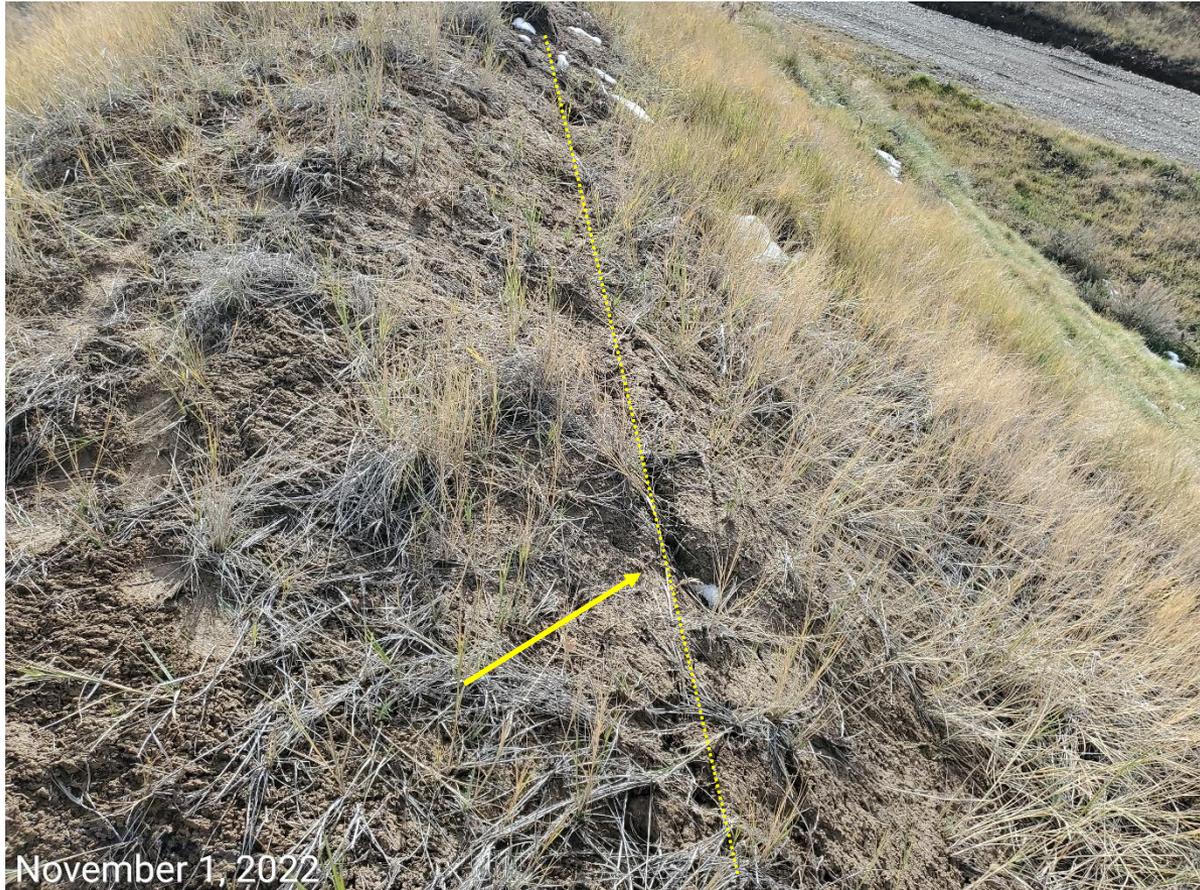
Photo 4: Photo taken from the perimeter berm on the northwest end of the Location. Photo shows cracks along the perimeter of the location are beginning to re-develop.

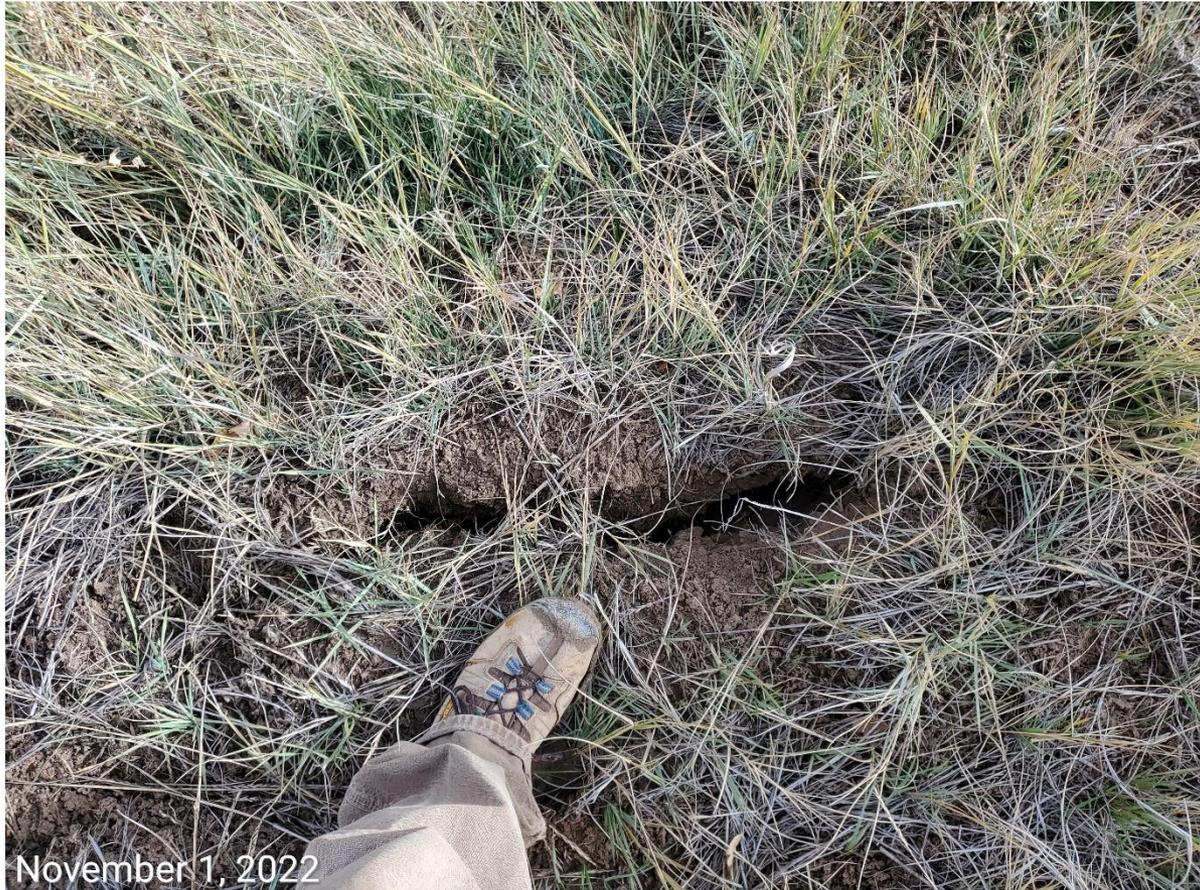
Photo 5: Photo taken from the perimeter berm on the southeast end of the Location. Photo shows cracks along the perimeter of the location are beginning to re-develop.
