Final Reclamation and Stormwater Inspection

Operator: VESSELS OIL & GAS COMPANY - 93200

Location ID: 376661

Inspection Photos
Location Name: Colorado Horth #1
Location ID: 376661

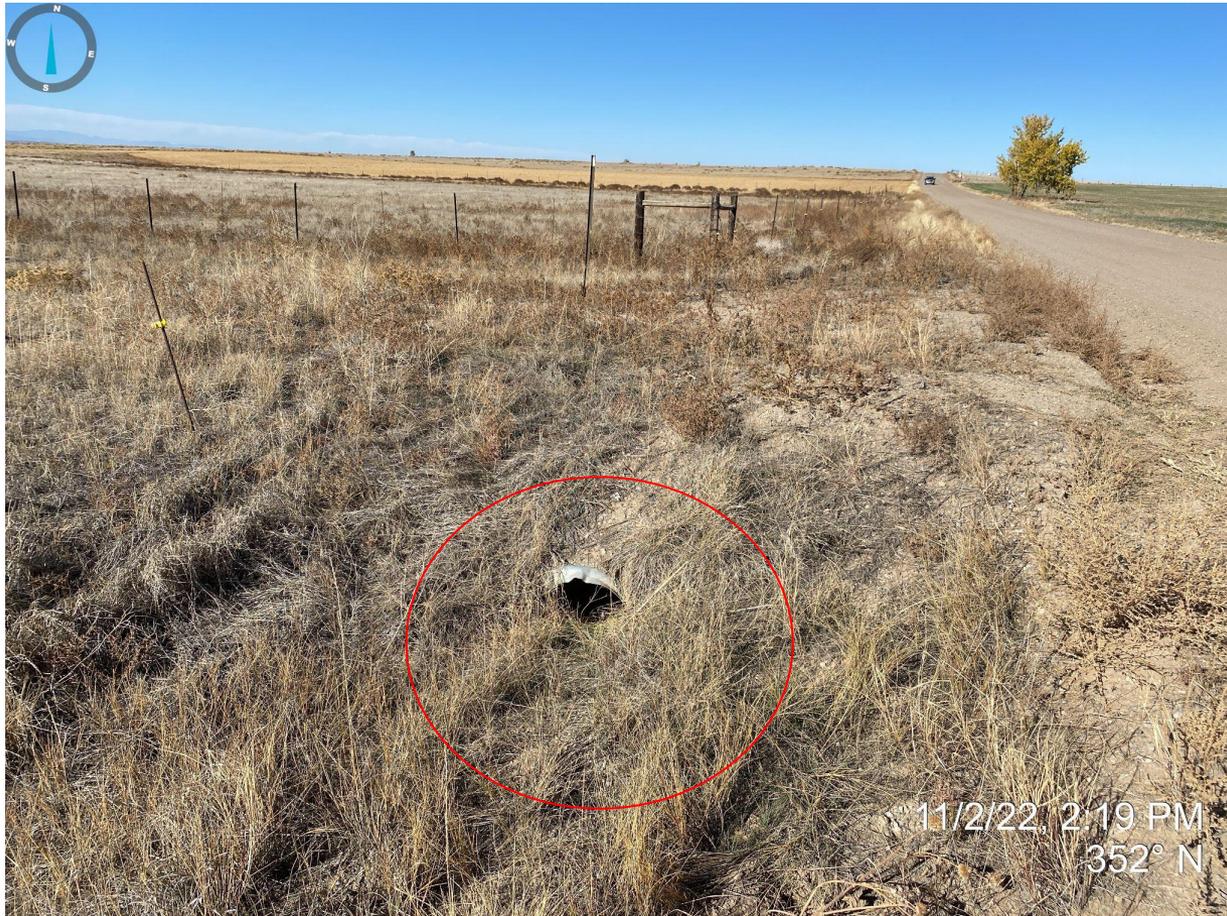
Photo 1. Taken from county road, facing north. Photo shows that the culvert has not been removed from the access road, outlined in red.

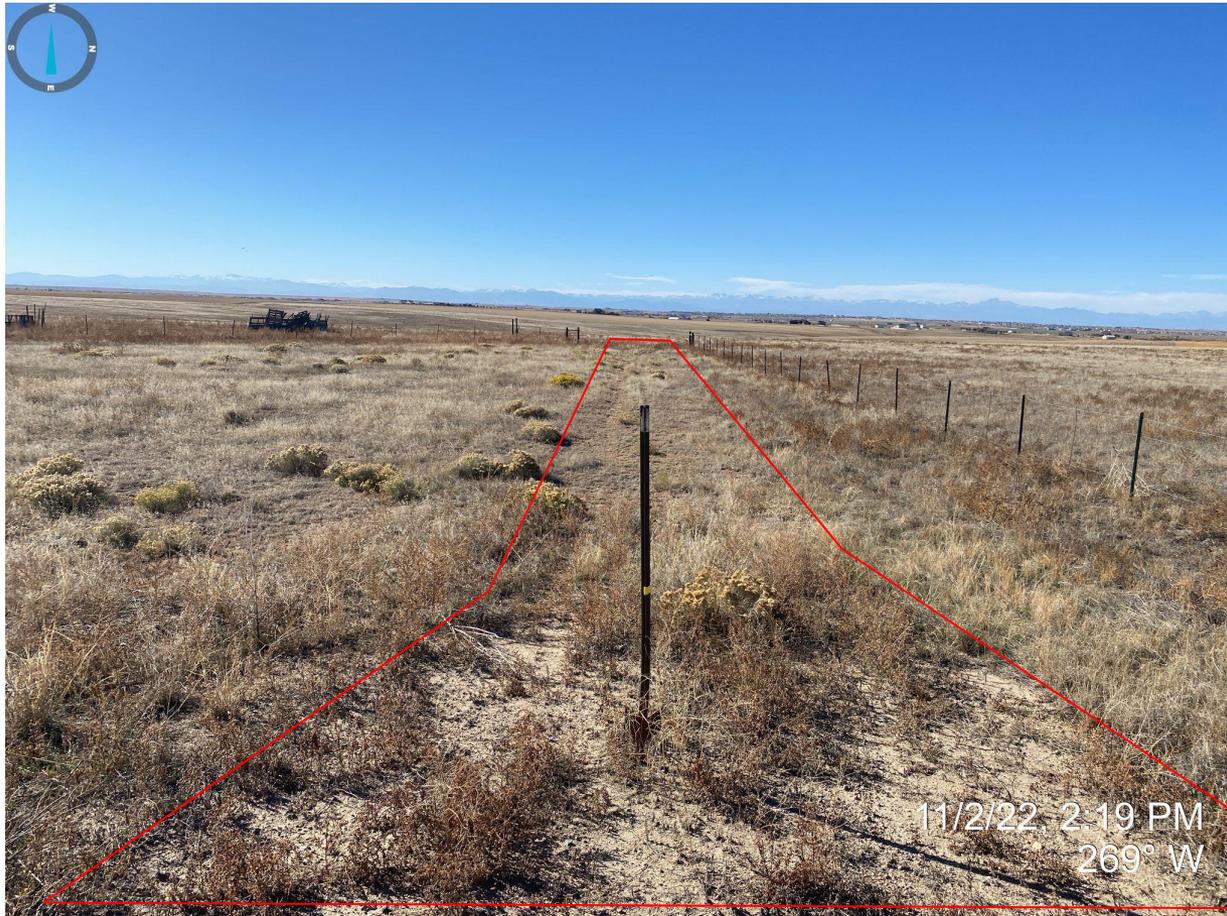
Photo 2. Taken from beginning of access road, facing west. Photo illustrates that the access road has not been reclaimed with presence of gravel/road base and contour issues (rutting) observed.

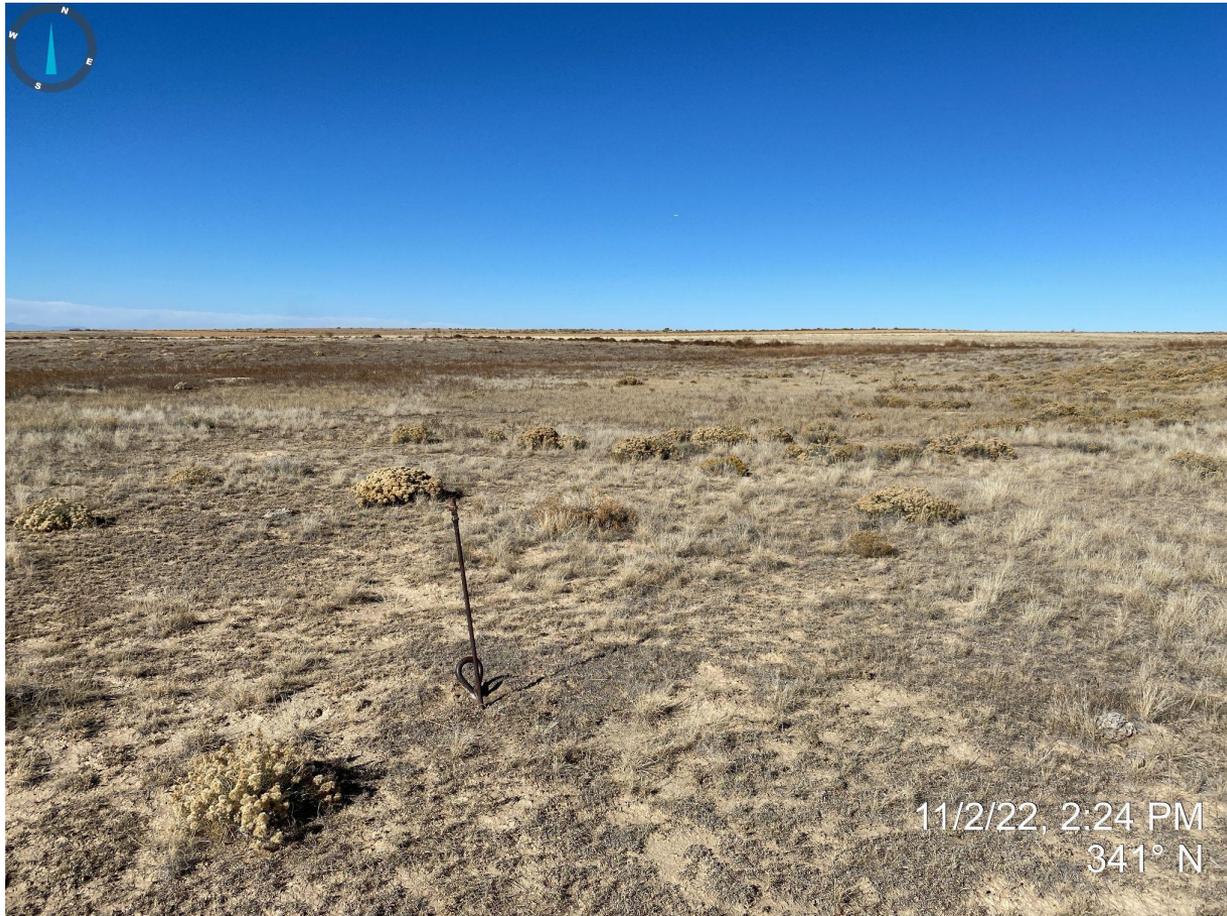
Photo 3. Taken from the southeast portion of the location, facing north. Photo illustrates guyline anchors and marker are still installed. All oil and gas equipment needs to be removed.

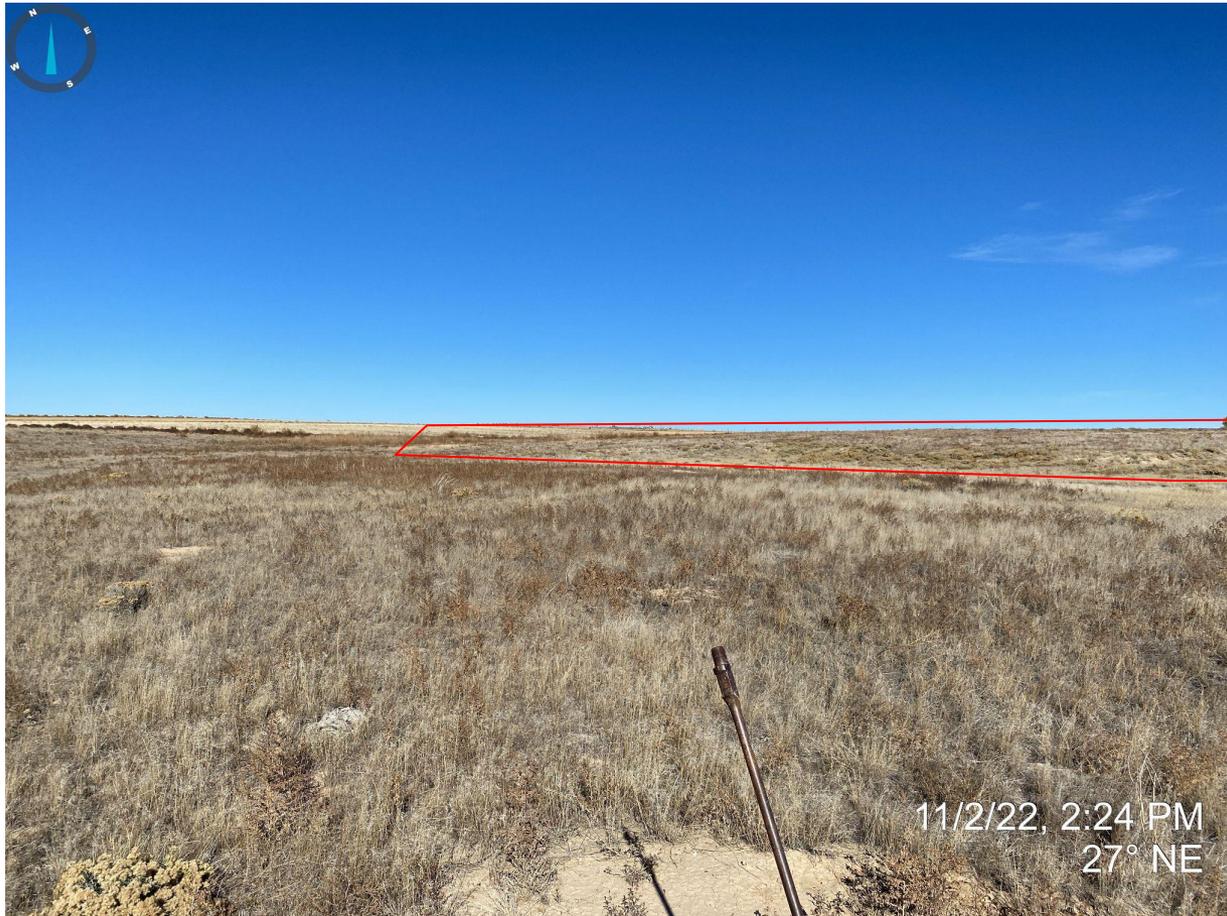
Photo 4. Taken from the southwest corner of the location, facing northeast. Photo illustrates guyline anchor and marker are still installed. The location is relatively flat and has not been recontoured as the eastern portion of the location has a pronounced cut slope, outlined in red.

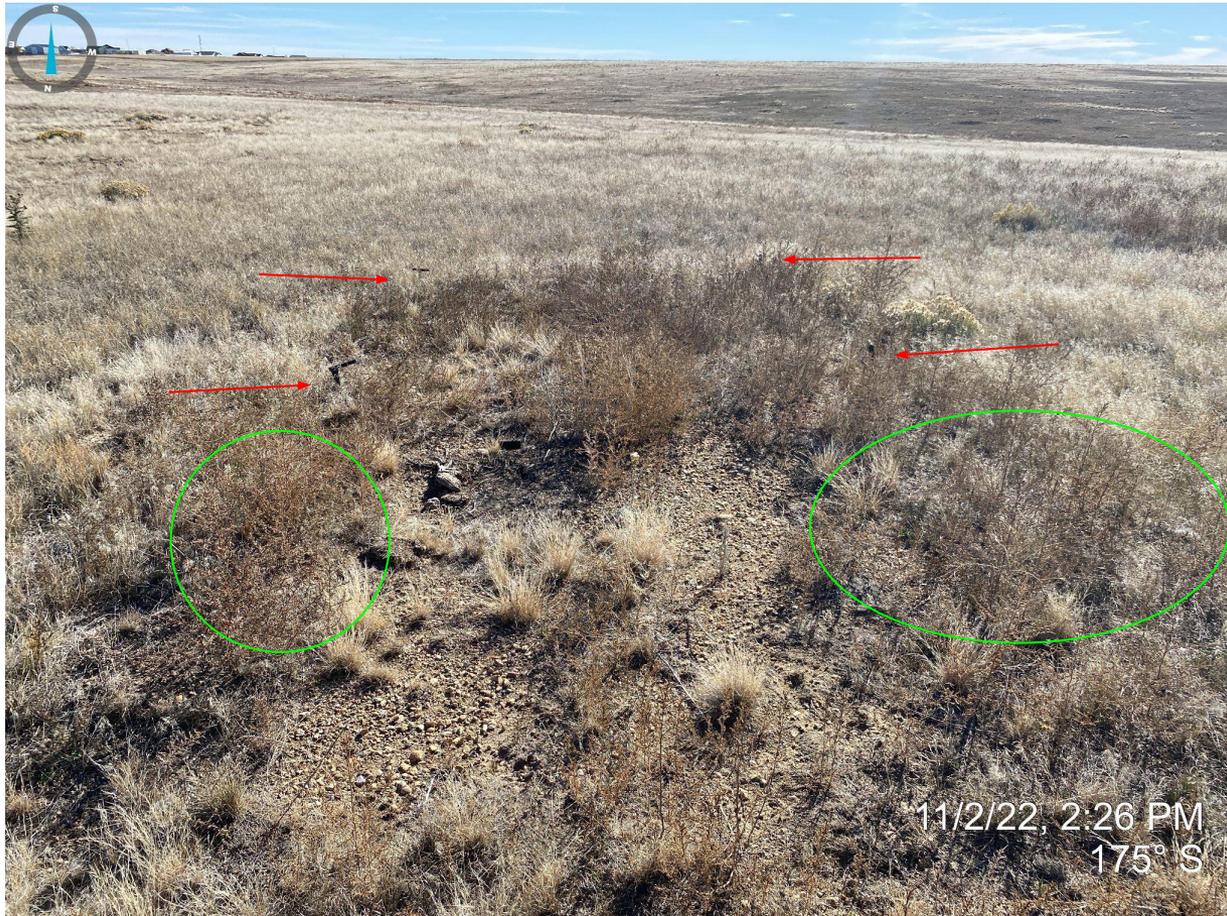
Photo 5. Taken from the center of the location, facing south. Photo illustrates an area approximately 12'x 16' that has not been reclaimed with evidence of gravel and anchors installed in the ground, identified with red arrows. Kochia and cheatgrass also observed throughout the location, outlined in this photo in green.

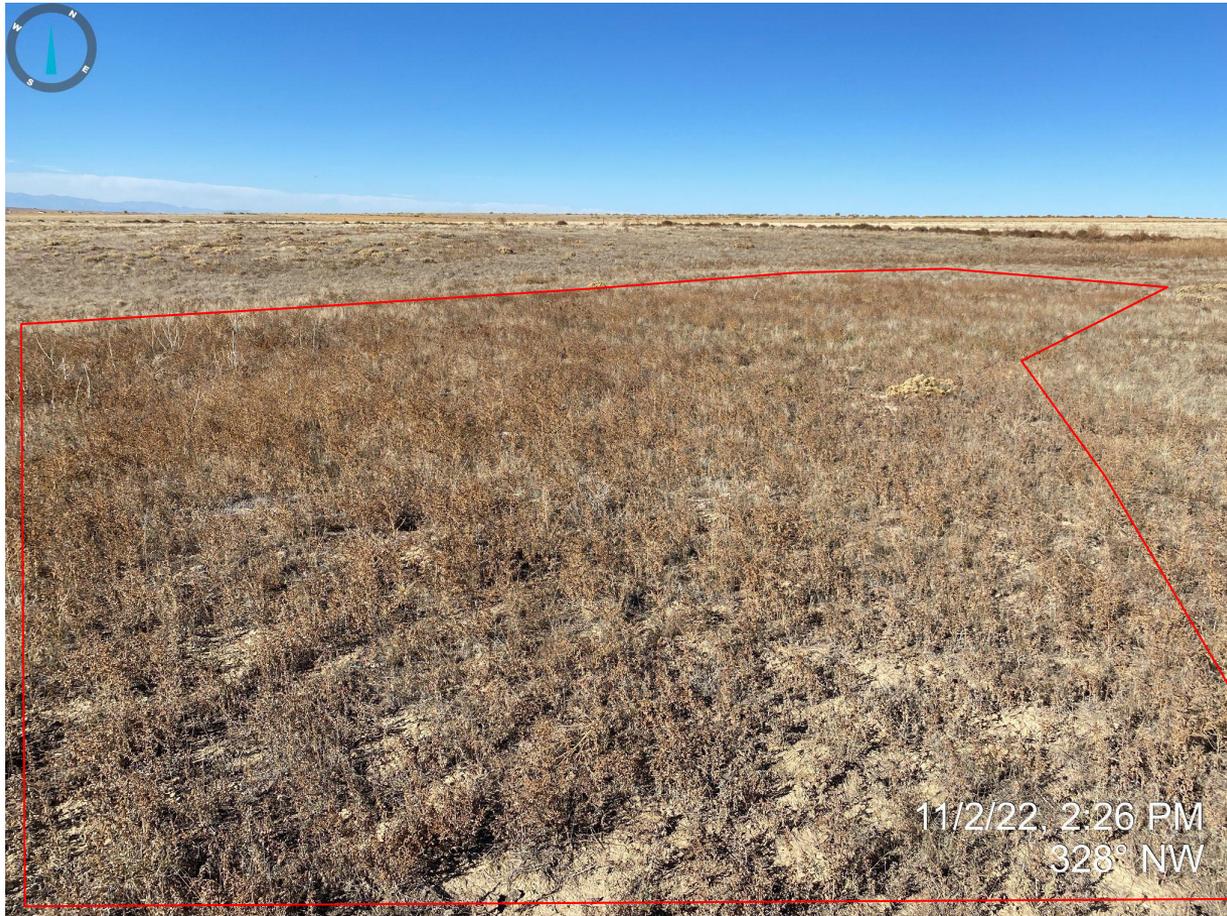
Photo 6. Taken from the center portion of the location, facing northwest. Photo illustrates a large infestation of undesirable vegetation (e.g. kochia and russian thistle) outlined in red. Some desirable vegetation was also observed interspersed throughout the location.

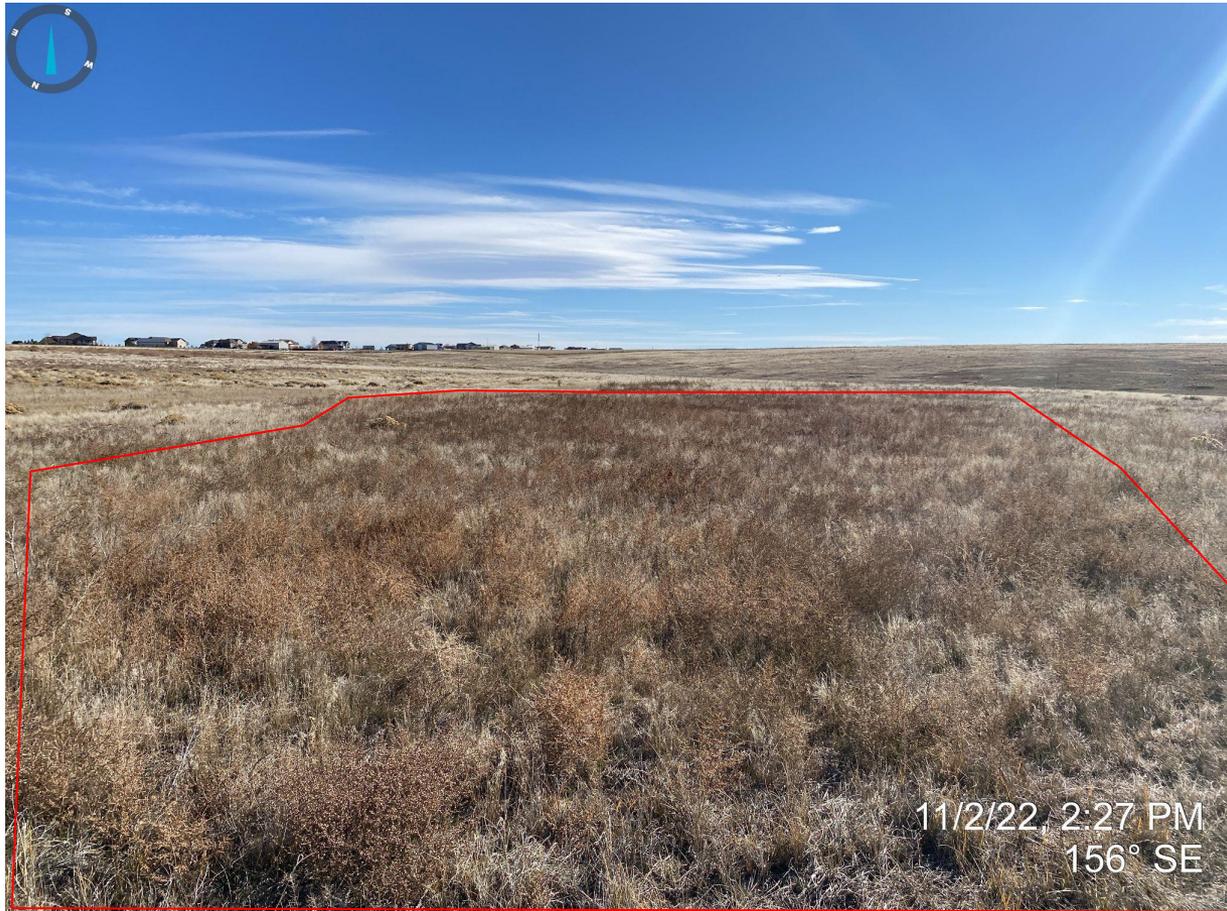
Photo 7. Taken from the northern portion of the location, facing southeast. See comments in Photo 6.

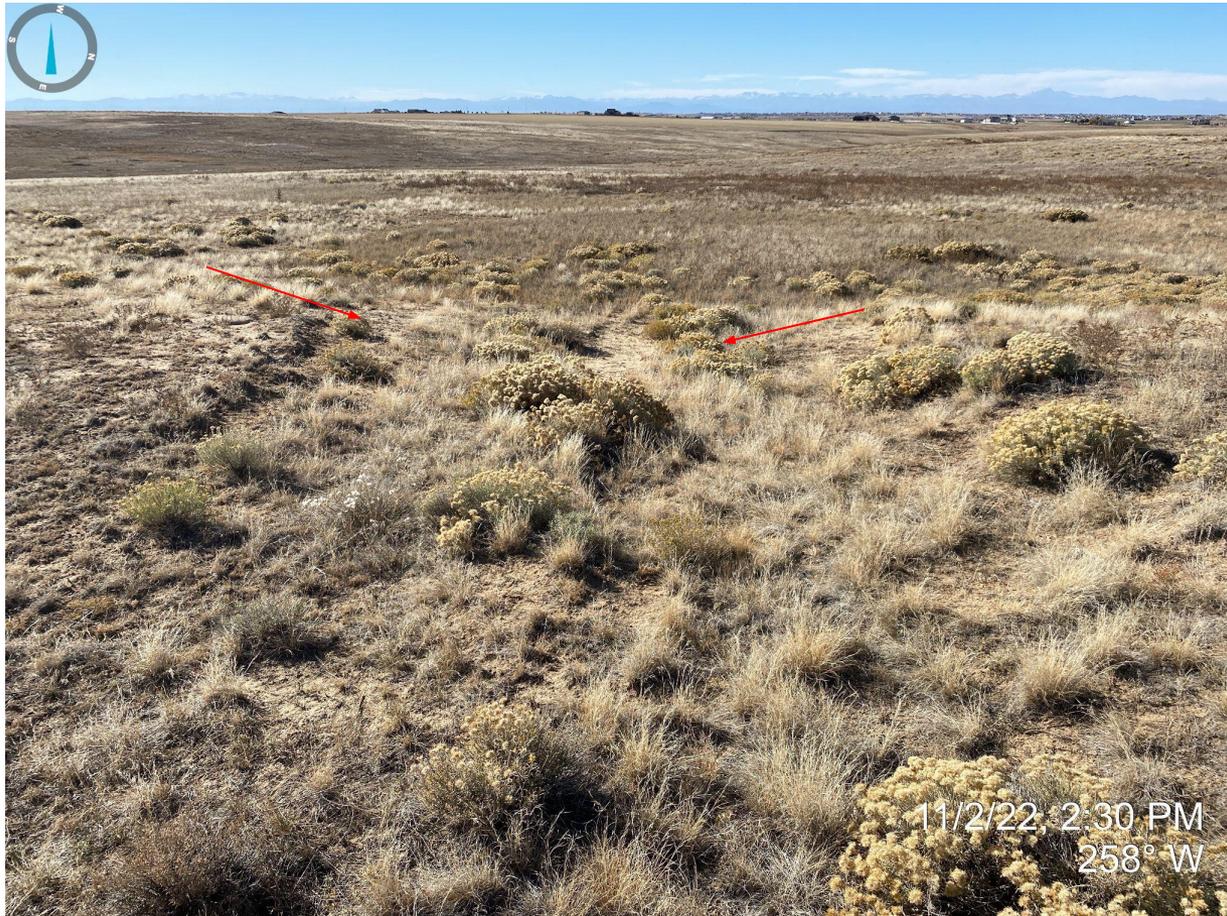
Photo 8. Taken from the access road/location transition, facing west. Photo illustrates the access road and location has not been reclaimed with evidence of cut slopes and absence of contouring and grading to reflect pre-disturbance levels, indicated by red arrows.

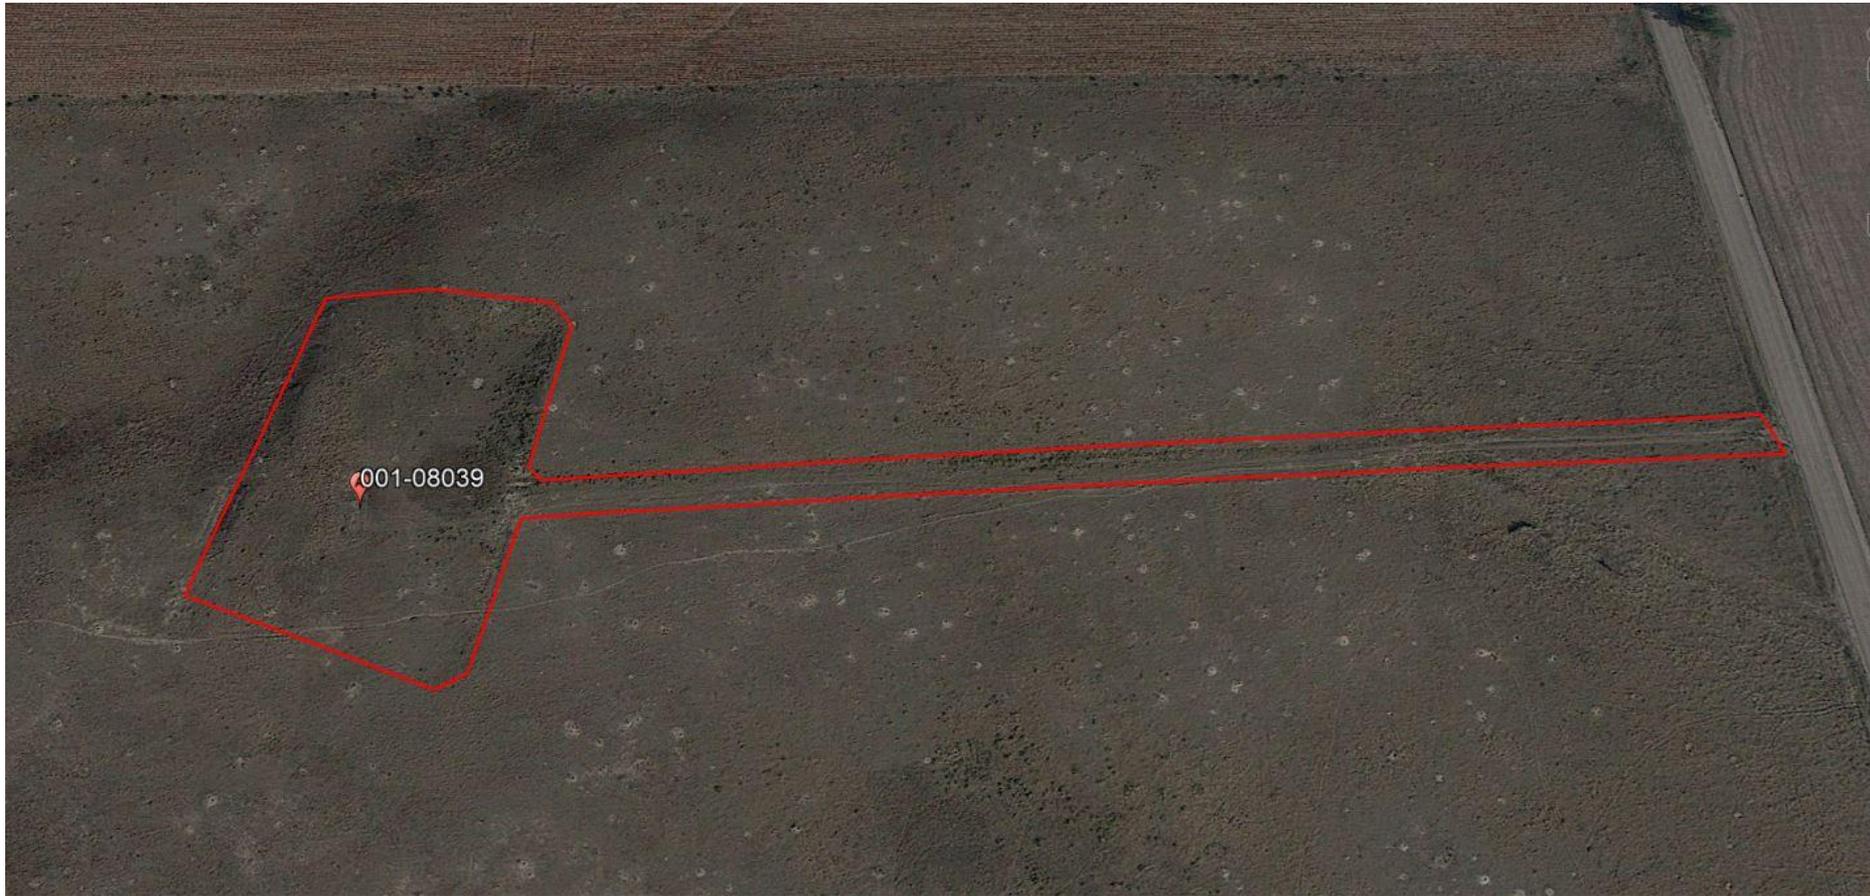
Photo 9. Google Earth aerial imagery taken circa 2020, illustrating the perimeter of the access road and location (approximately 2 acres) that needs to be reclaimed.
