Final Reclamation and Stormwater Inspection

Operator: MERIT ENERGY COMPANY - 56565

Location ID: 319665

Inspection Photos
Location Name: Bergman #1
Location ID: 319665

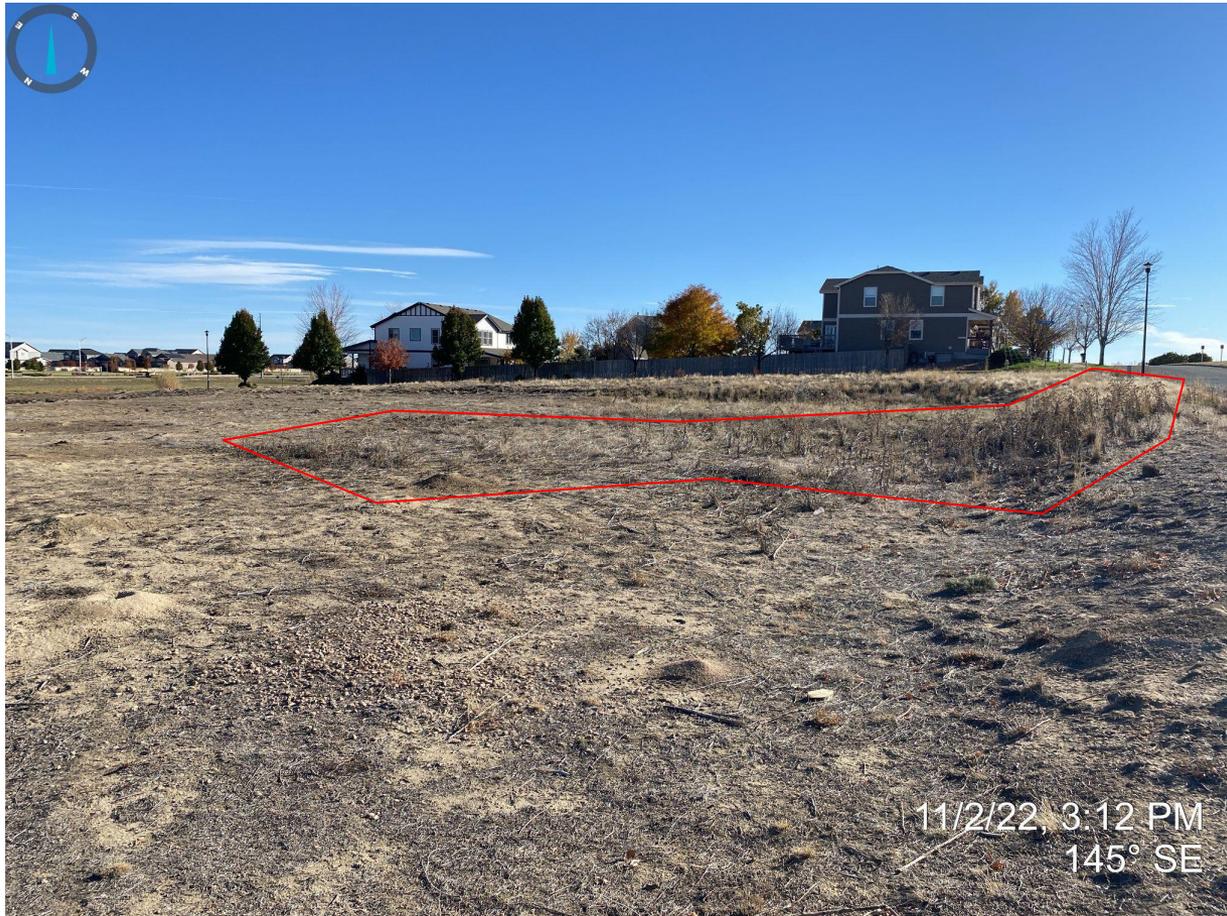
Photo 1. Taken from access road entrance, facing southeast. Photo illustrates location has not been reclaimed, per the Corrective Action, since the last inspection (Doc #696105344). The location remains unvegetated with evidence of bare soil and presence of noxious weeds (e.g. scotch and musk thistle) outlined in red.

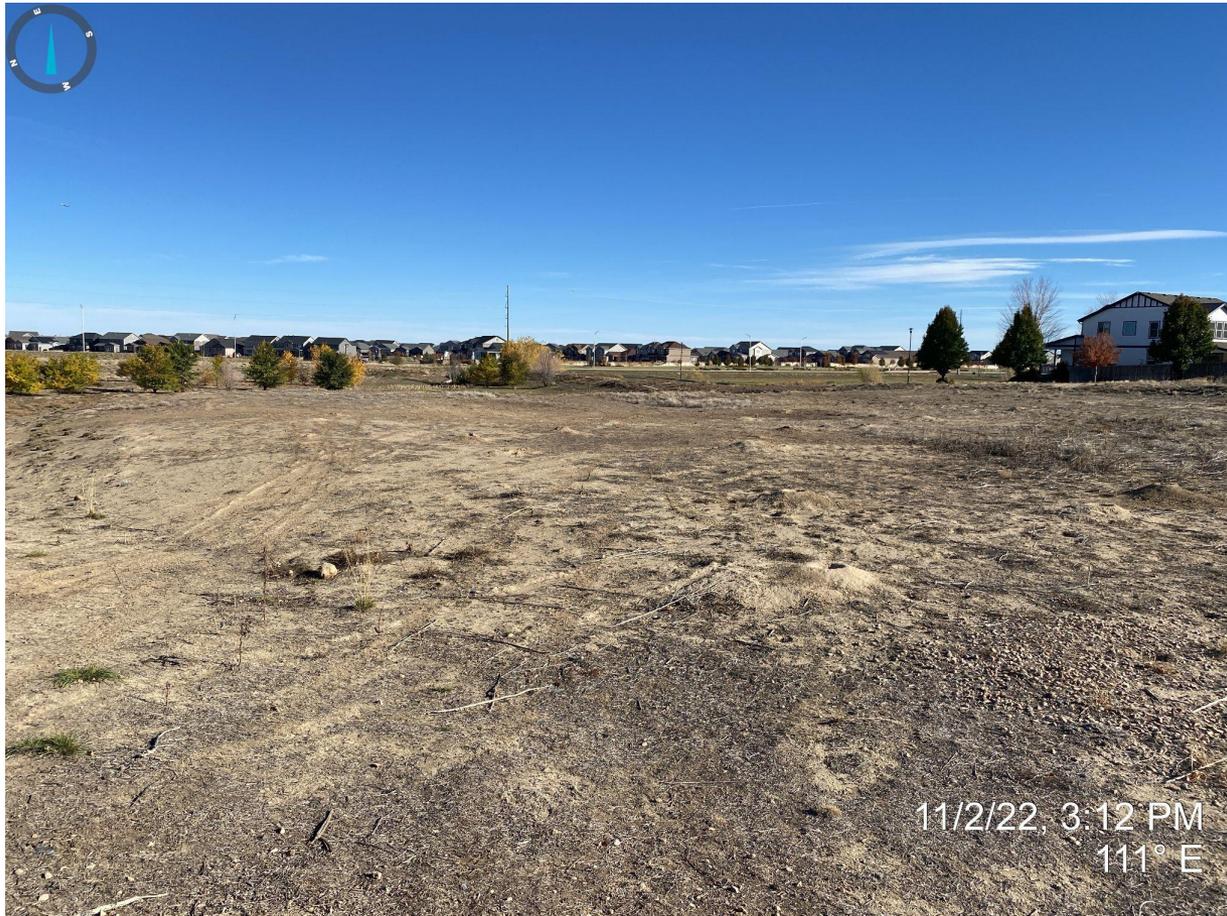
Photo 2. Taken from access road entrance, facing east. See comments in Photo 1.

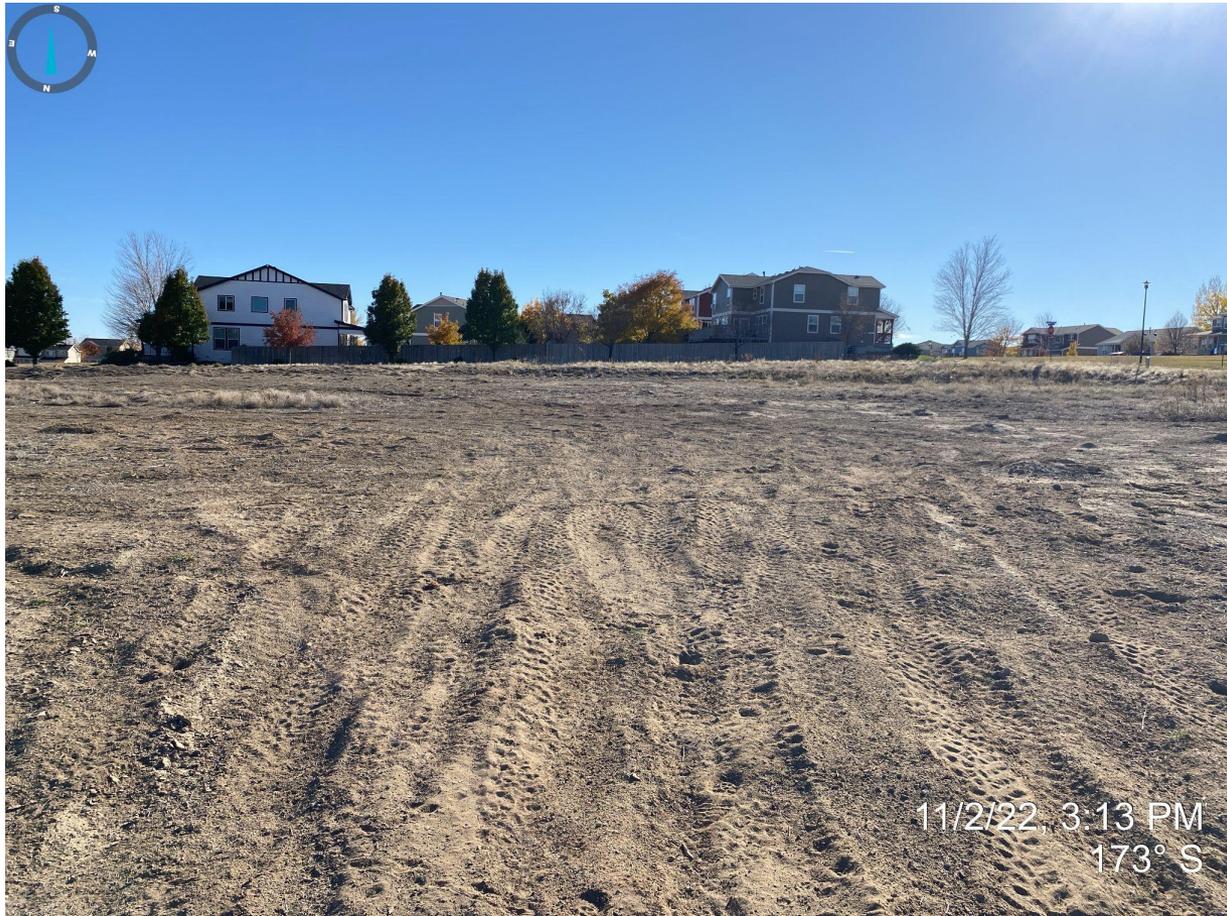
Photo 3. Taken from northern portion of location, facing south. Photo illustrates vehicle traffic observed on location.

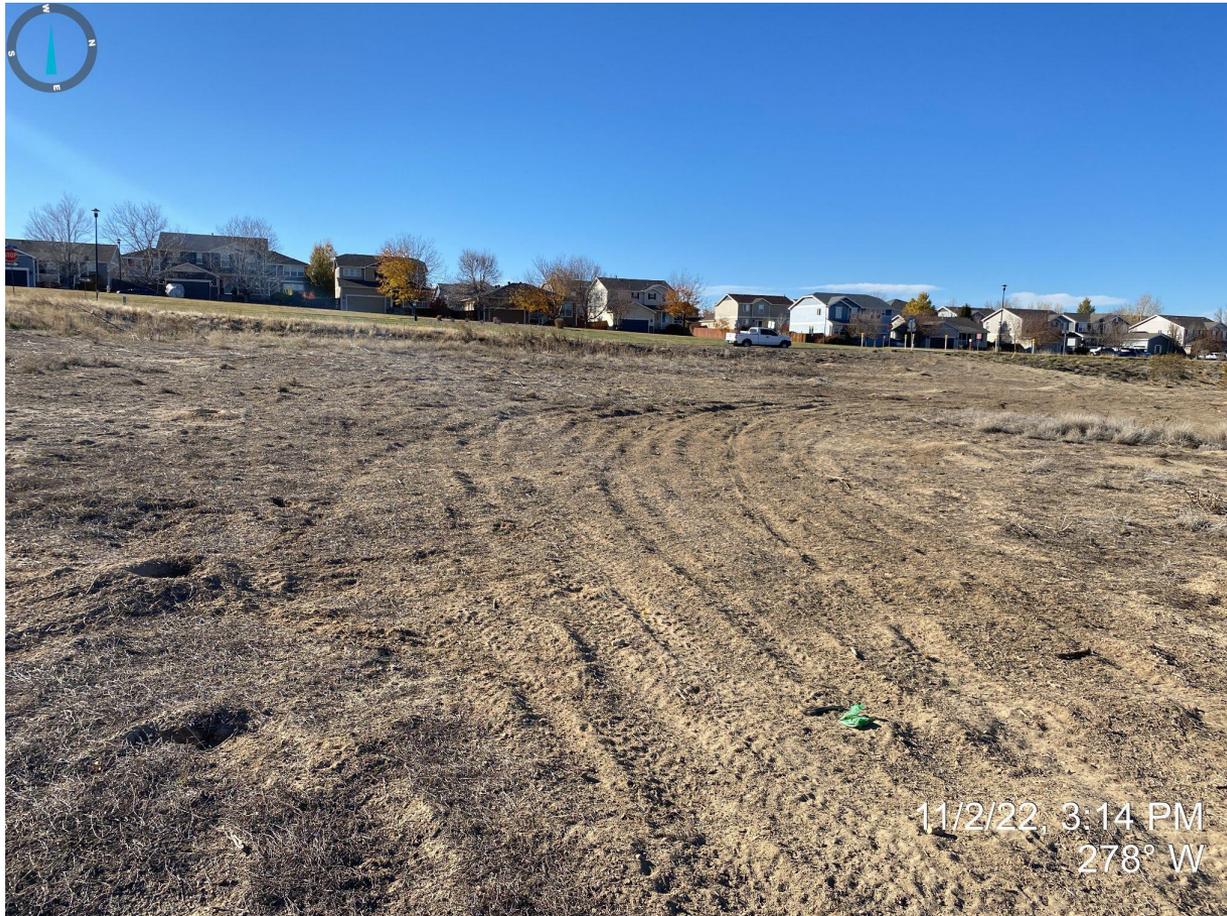
Photo 4. Taken from center portion of location, facing west. See comments in Photo 3.

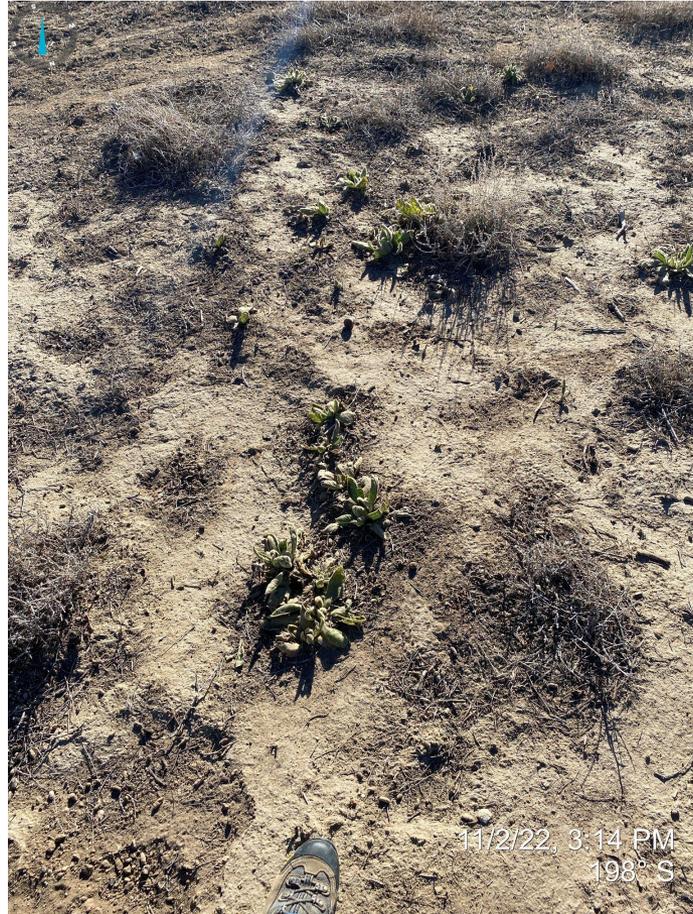
Photo 5. Close up photo taken from eastern portion of location. Photo illustrates CO List C Noxious Weed (e.g. Common Mullein).

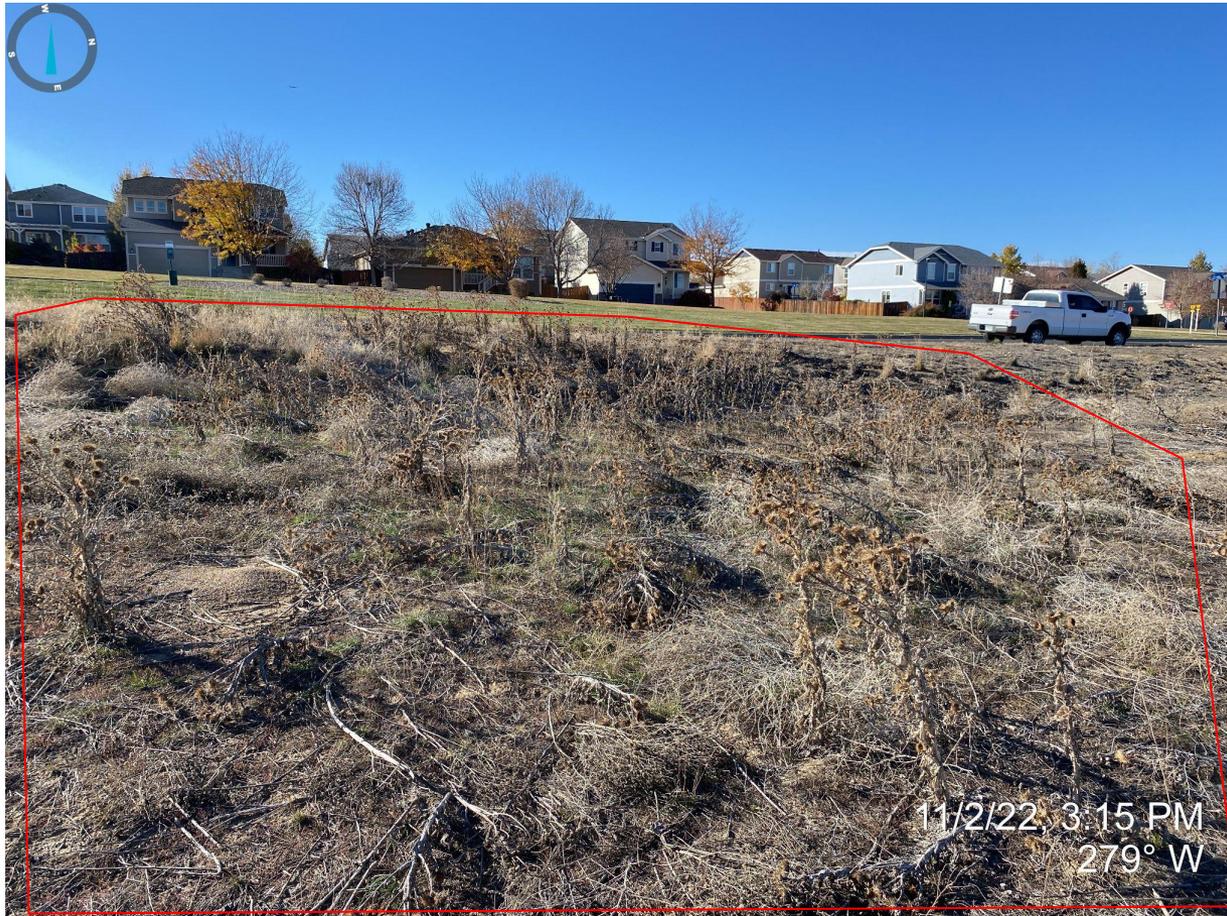
Photo 6. Taken from the center portion, facing west. Photo illustrates the CO List B Noxious weeds (e.g. Musk and Scotch Thistle) appears to have not been managed since identified in last inspection.
