# Final Reclamation and Stormwater Inspection

Location ID: 324943

Inspection Document #: 696105576

Inspection Photos  
Location Name: BEESON 4-21  
Location ID: 324943

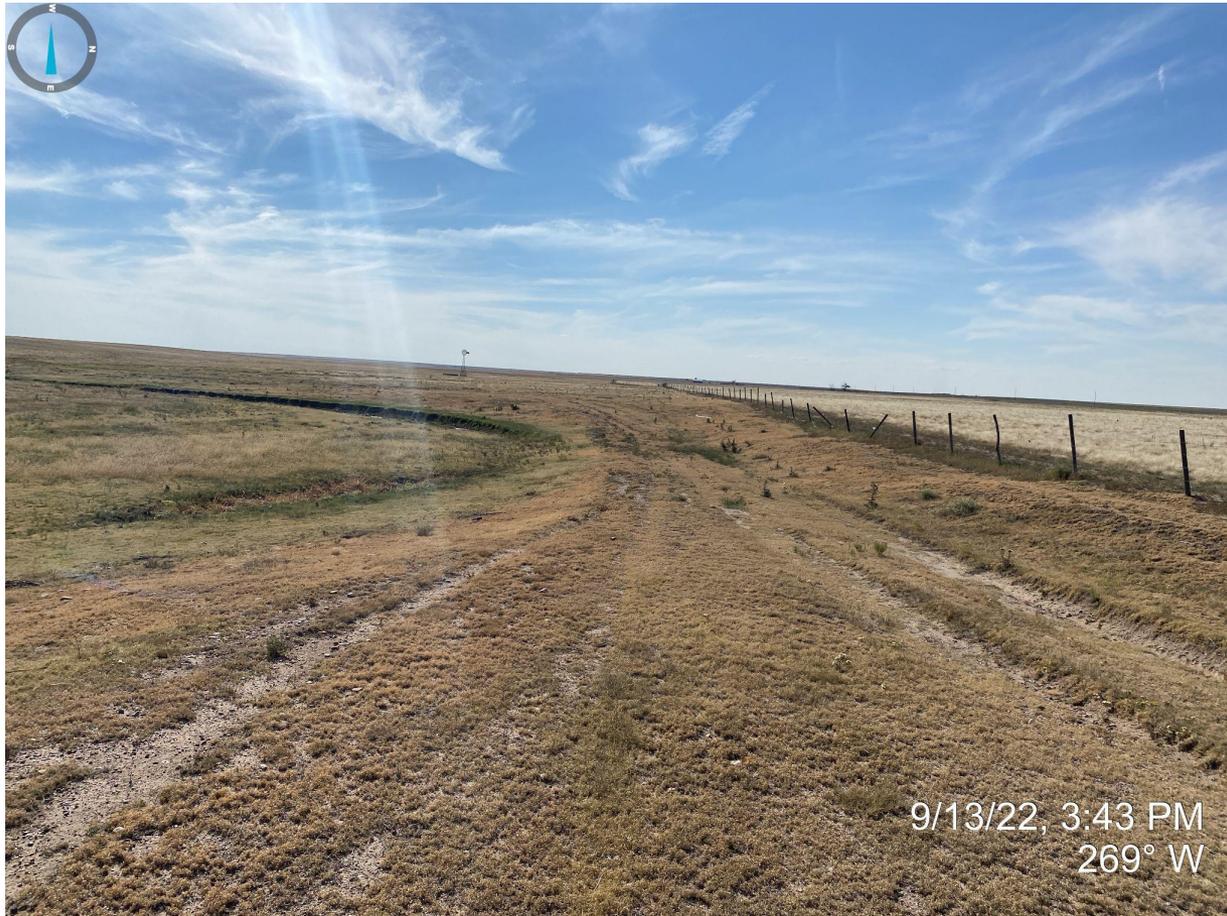
**Photo 1.** Taken from the beginning of the EXISTING access road, facing west. This portion of the access road was identified in a previous inspection (FIR Doc #696105427) and Photo 1 (Inspection Photos Doc #696105444) stating that the access road has not been reclaimed. The pictured access road was built prior to any oil and gas development, see Photo 2, and does not need to be reclaimed by the operator.

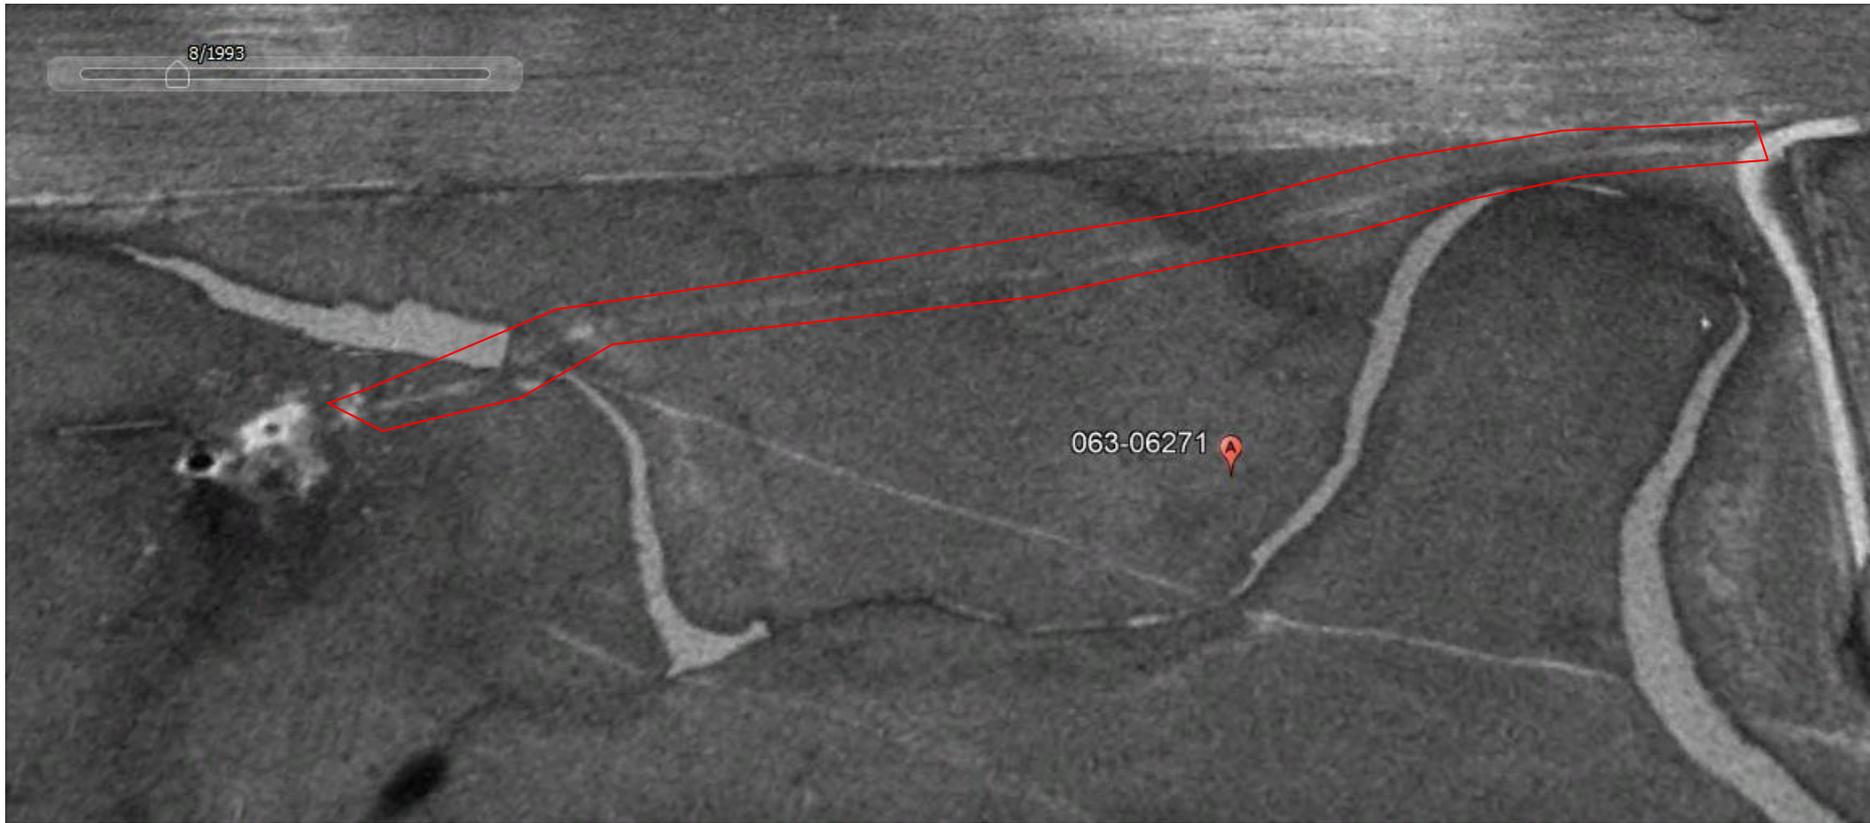
**Photo 2.** Google Earth aerial imagery taken circa 08/1993, illustrating access road was built prior to any oil and gas development (Well API# 063-06271, spud date of 09/03/1995). Red outline illustrates access road.

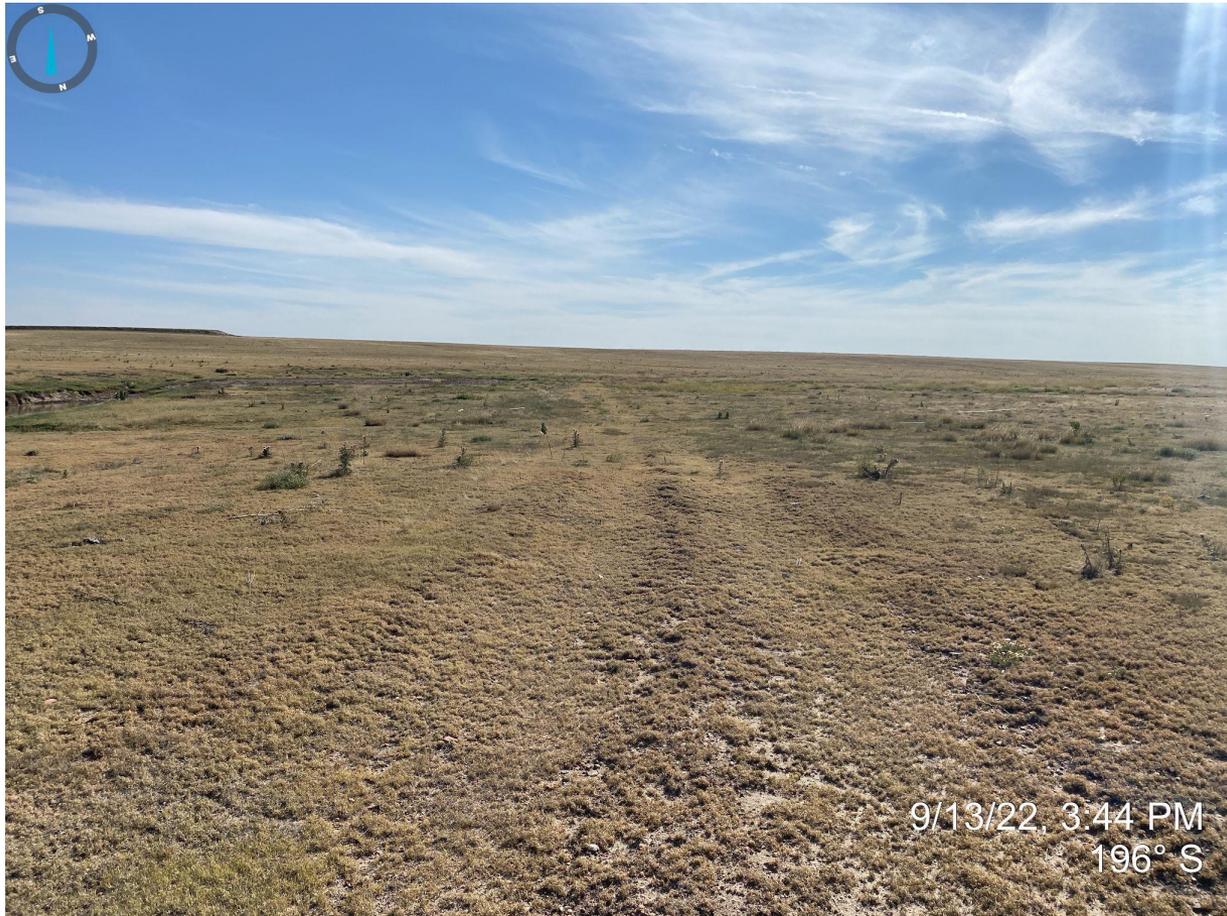
**Photo 3.** Taken south of the access road “Y intersection”, facing south. Photo illustrates that the location’s access road has minimal contour and grading differences with the adjacent reference areas. The access road also appears to have achieved COGCC final reclamation vegetation standards (e.g. predominantly buffalo grass).

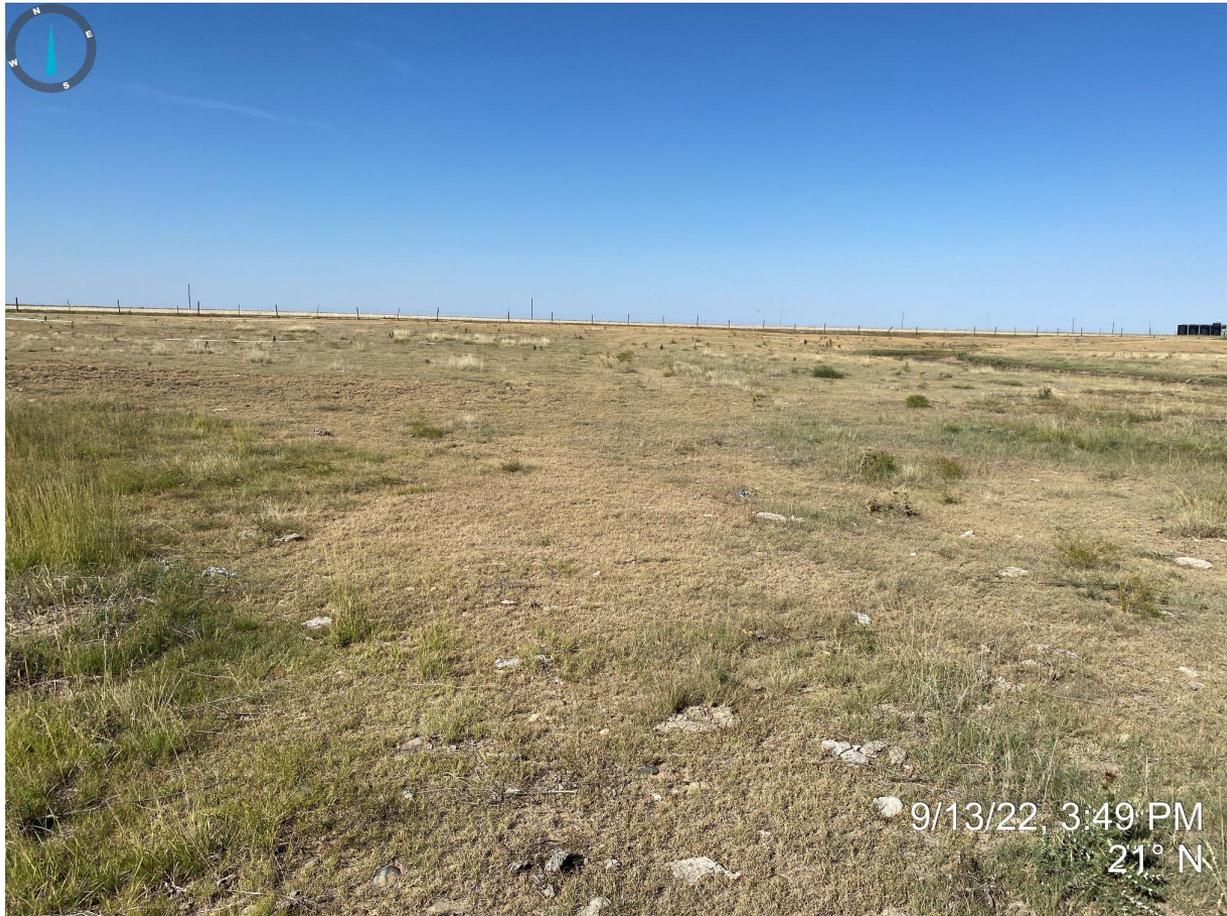
**Photo 4.** Facing north from the northeastern portion of the location, see comments in Photo 3.

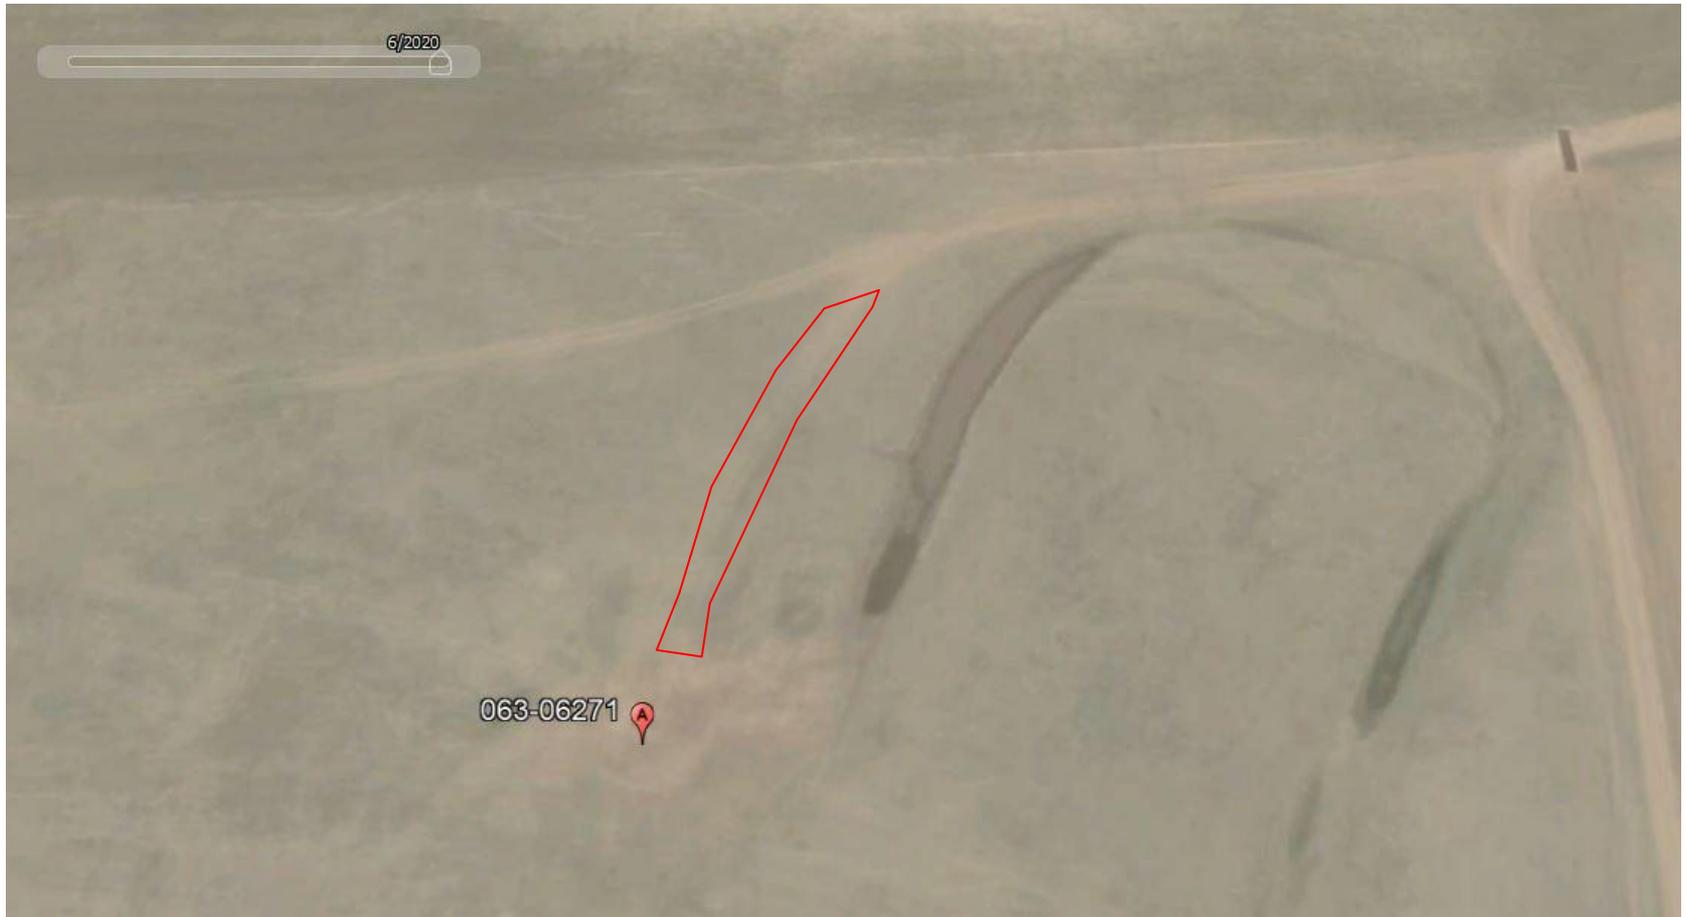
**Photo 5.** Google Earth aerial imagery taken circa 06/2020, illustrating oil and gas access road that does not need to be reclaimed, outlined in red.
