Inspection Photos

Operator: TEP Rocky Mountain LLC - #96850

Location Name: FEDERAL/RWF 12-9

Inspection Document #: 702800901

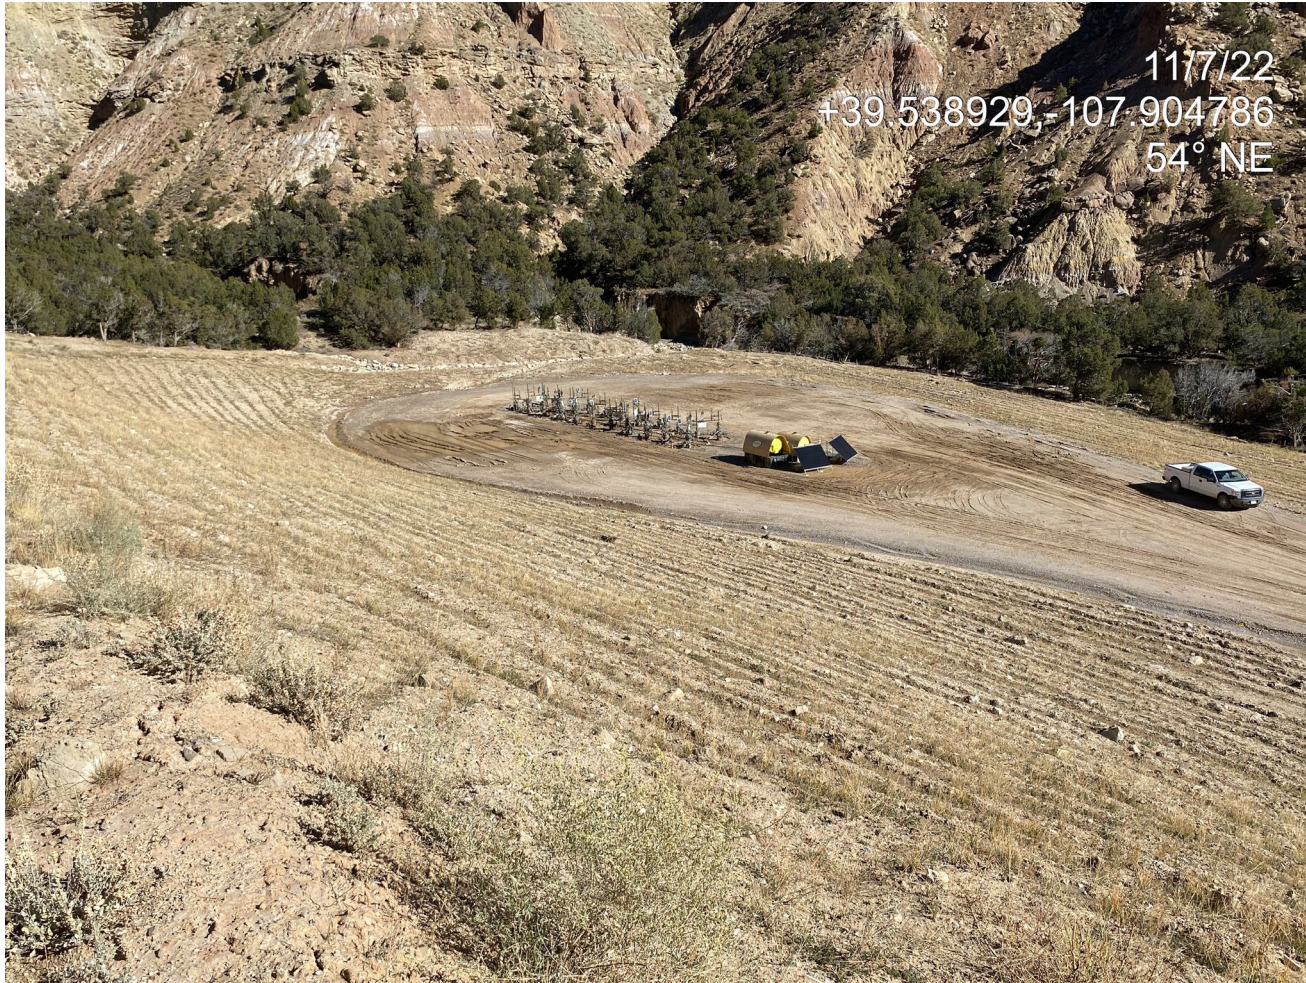
Photo 1. Photo taken from the southwest shows an overview of the Location.

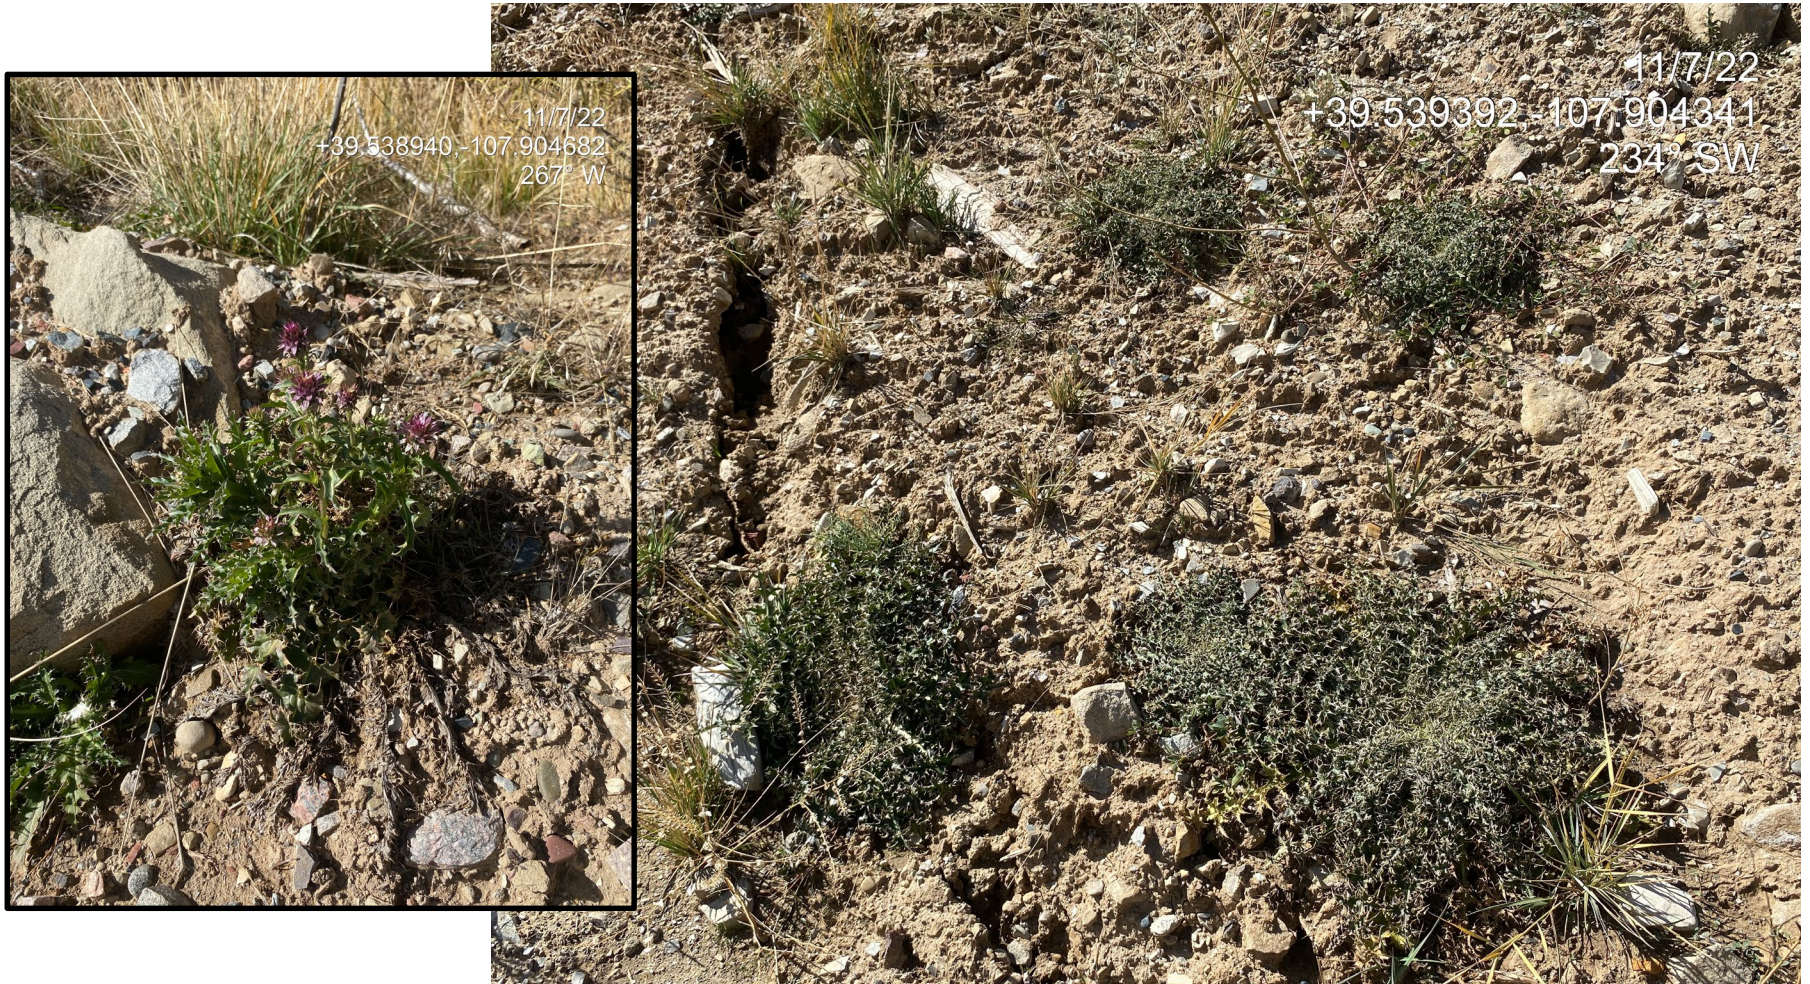
Photo 2. Photos taken from the northwest shows musk thistle (List B Noxious) in the interim area.

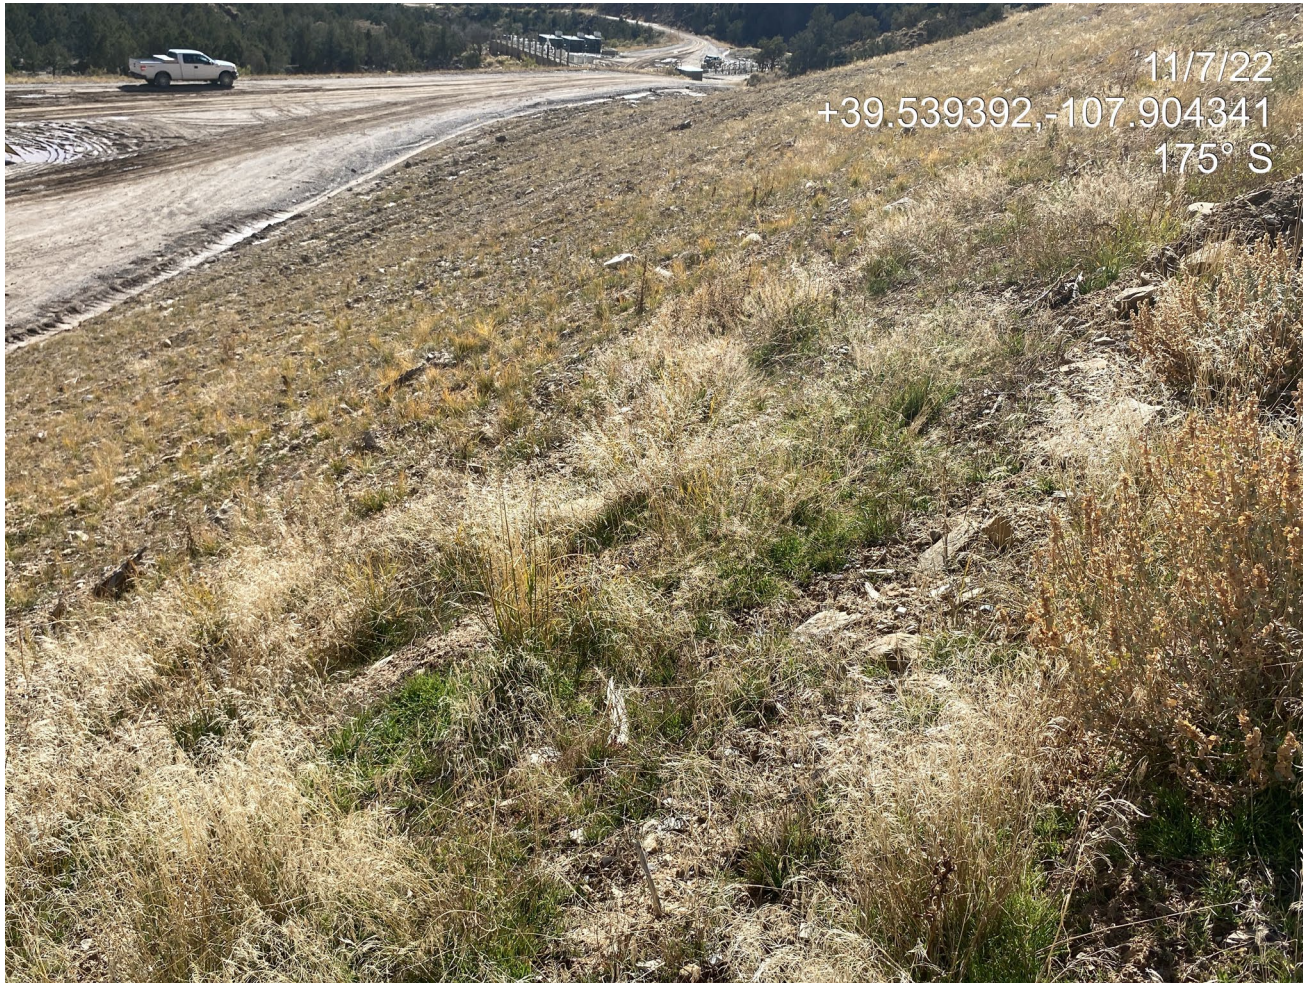
Photo 3. Photo taken from the northwest shows a portion of the interim area with relatively high cover of cheatgrass (List C Noxious). Note establishment of seeded perennials in the rest of the interim area.

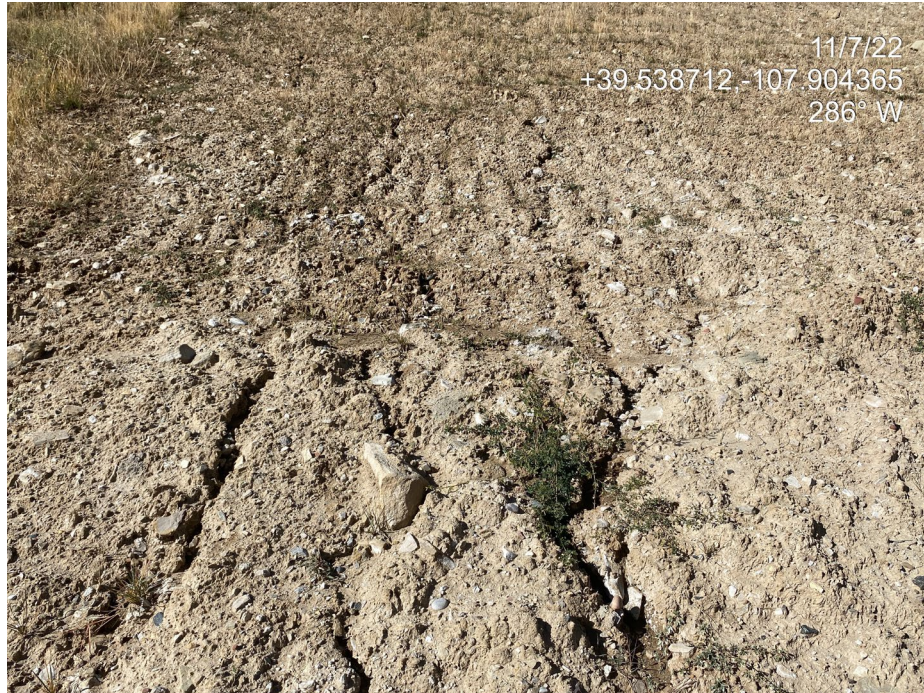
Photo 4. Photo shows a portion of the western interim area, at the base of the slope where erosion degradation is occurring.

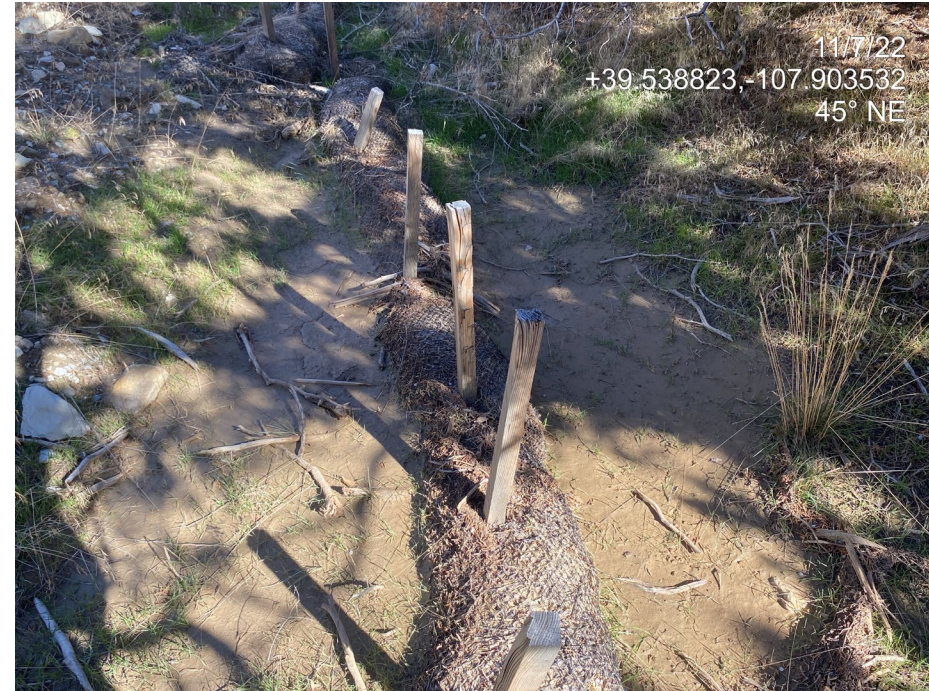
Photo 5. Photo shows where sediment laden stormwater flows have overtopped a wattle at the eastern perimeter of the Location.

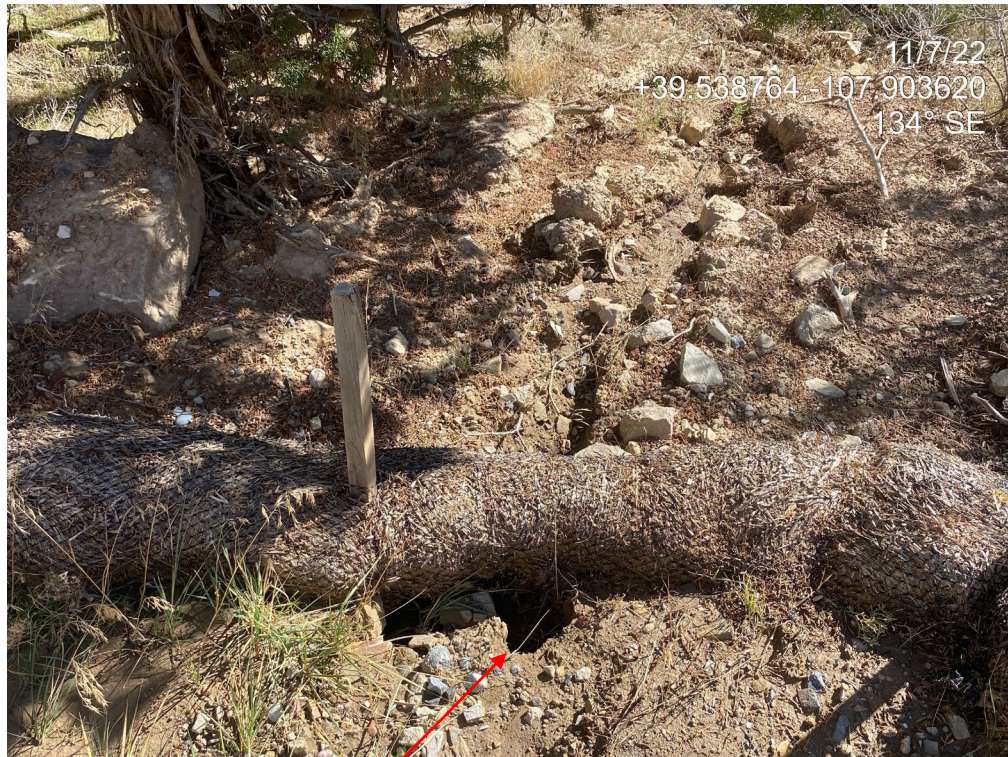
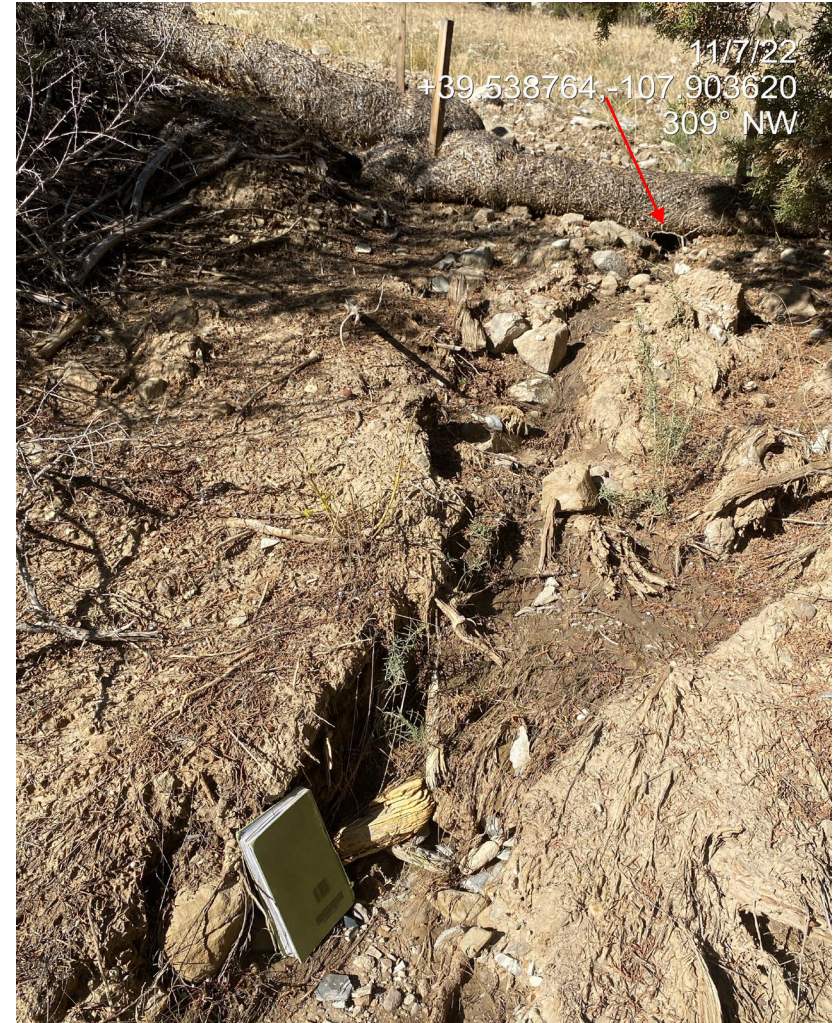
Photo 6. Photos taken at the southeast of the Location shows a wattle installed along the downslope perimeter is not in proper functioning condition; stormwater has cut under the wattle, resulting in offsite degradation.

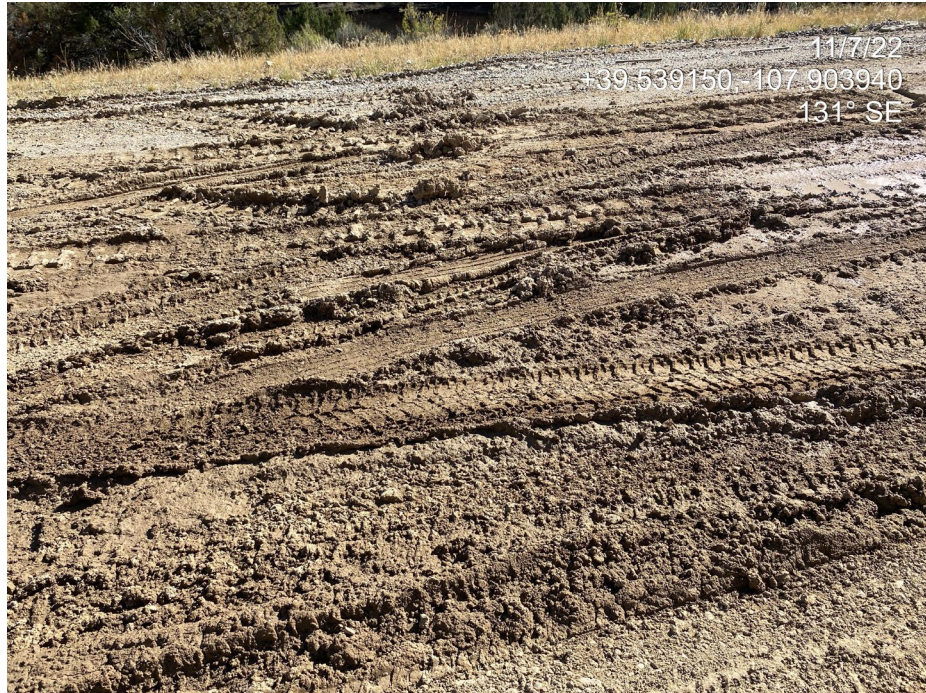
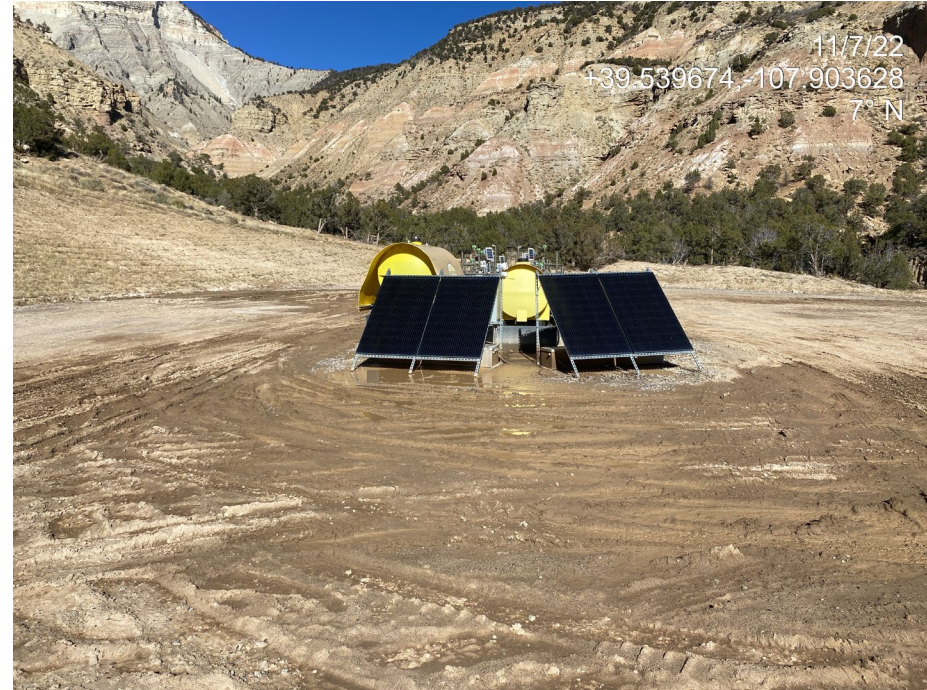
Photo 7. Photos show a lack of stabilization/compaction degradation to the pad surface.

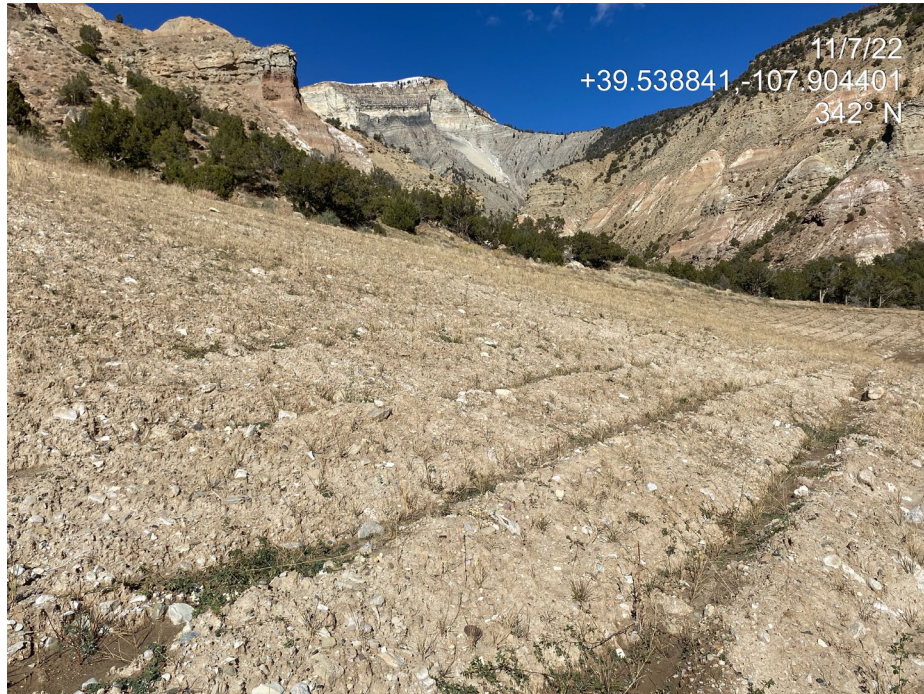
Photo 8. Photo shows interim areas at the west of the Location are overall stable at the time of this inspection. Initial establishment of seeded species is widespread.

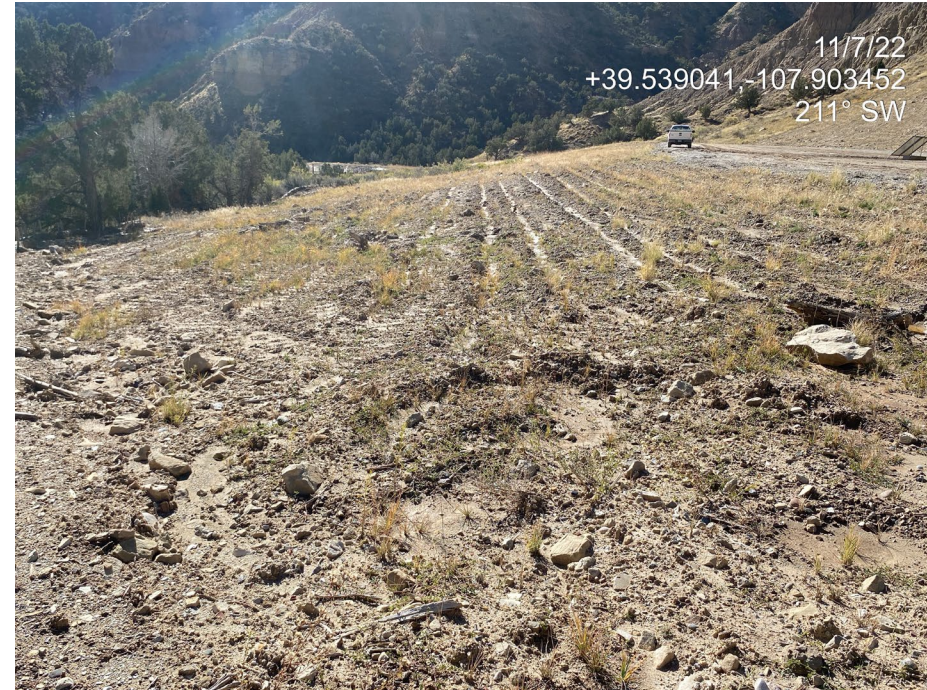
Photo 9. Photo shows interim areas at the east of the Location are overall stable at the time of this inspection. Initial establishment of seeded species is widespread.
